NATIONAL HIGHWAY SYSTEM CONNECTORS TO FREIGHT FACILITIES

IN THE DELAWARE VALLEY REGION

DELAWARE VALLEY REGIONAL PLANNING COMMISSION

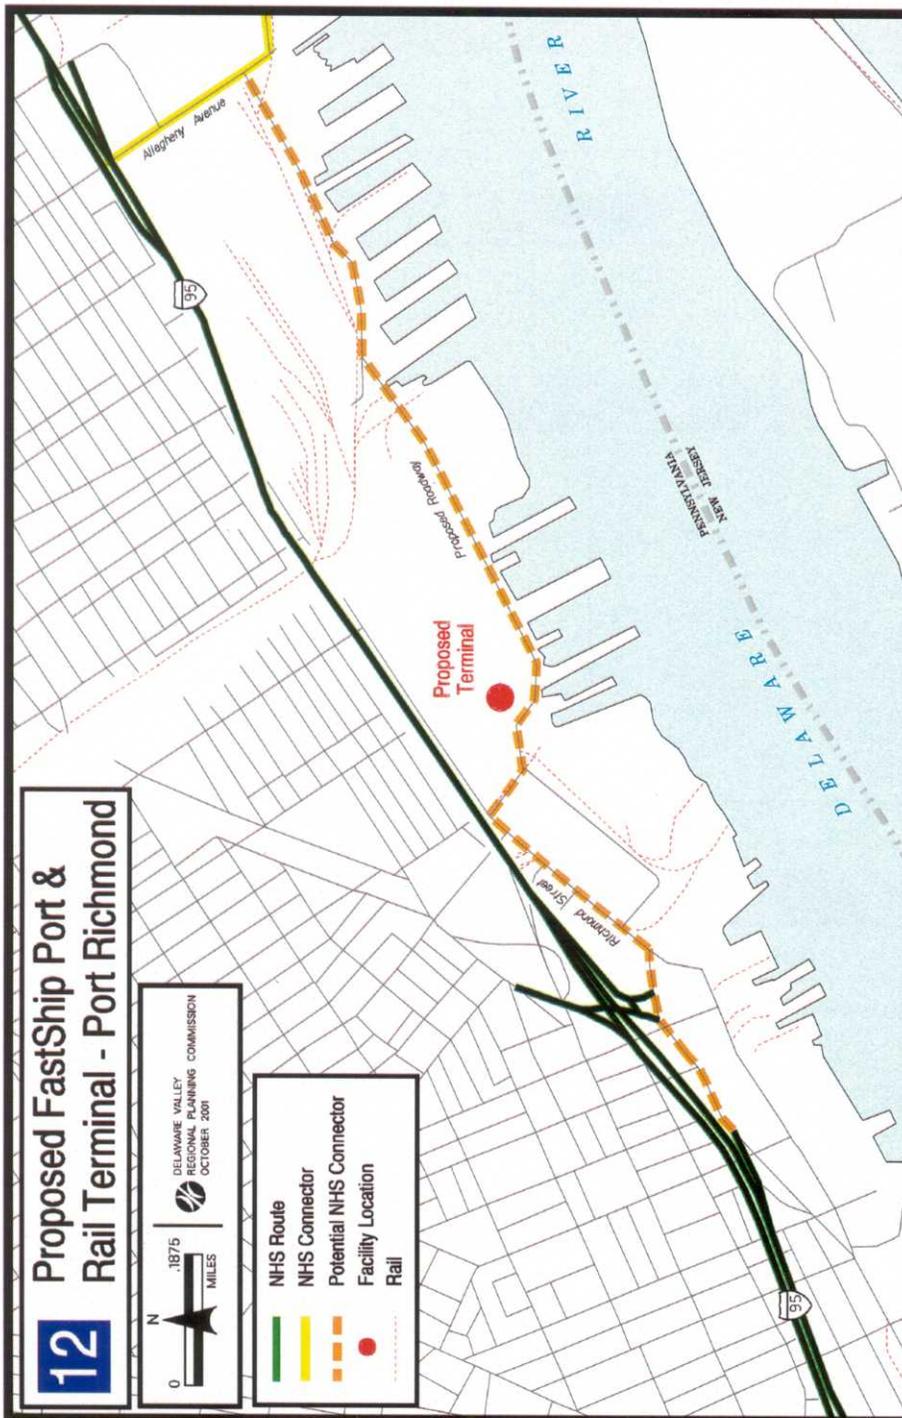
12

Potential Connector Description: 1) To terminal from I-95 sb & from terminal to I-95 sb via Allegheny Ave. & potential roadway connecting Cumberland St. & Allegheny Ave., and; 2) To terminal from I-95 nb & from terminal to I-95 nb via Delaware Ave., Richmond St., Cumberland St., & potential roadway 1.770 miles (excludes mileage of existing connector links along Allegheny Ave.)

Potential Connector Length: 1.770 miles (excludes mileage of existing connector links along Allegheny Ave.)
