**EVALUATION OF A NEW REHABILITATION
TECHNOLOGY FOR BRIDGE PIERS WITH
COMPOSITE MATERIALS**

Roberto Lopez-Anido, Rakesh Gupta, Hota V.S.
Gangarao, Udaya B. Halabe, Sachin Kshirsagar and
Reynold Franklin
West Virginia University

1. AGENCY USE ONLY (Leave blank)	2. REPORT DATE June 1999	3. REPORT TYPE AND DATES COVERED Final Report November 1996-June 1999	
4. TITLE AND SUBTITLE Evaluation of a New Rehabilitation Technology for Bridge Piers with Composite Materials		5. FUNDING NUMBERS 20-30/NCHRP-96-ID33

IDEA PROJECT FINAL REPORT

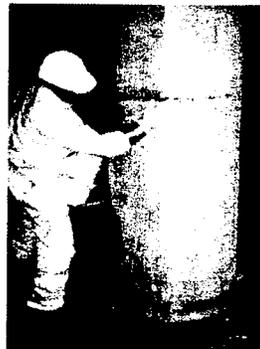
Application of fiber composite wrap in Pond Creek Bridge

Pier concrete column after wrapping

A bridge in need of column repair was selected by West Virginia Department of Transportation, Division of Highways (WVDOT-DOH) to demonstrate the IDEA Product. The subject bridge is the Pond Creek Road Overpass Bridge carrying Interstate Route 77 in Wood County, West Virginia. According to the WVDOT-DOH Condition Report, six columns of two piers had vertical hairline cracking. These cracks resulted from a previous unsuccessful repair with a concrete layer after the columns were subjected to fire and the original concrete cover was lost. Three columns of the Pier 2 of the Bridge Northbound were repaired in July 1998 with the fiber composite wrap system evaluated through the IDEA Project. The other three columns were repaired with an alternative rehabilitation method using prefabricated composite cylindrical shells. The field performance of the repaired concrete columns was monitored during the first year after installation and the results were satisfactory.

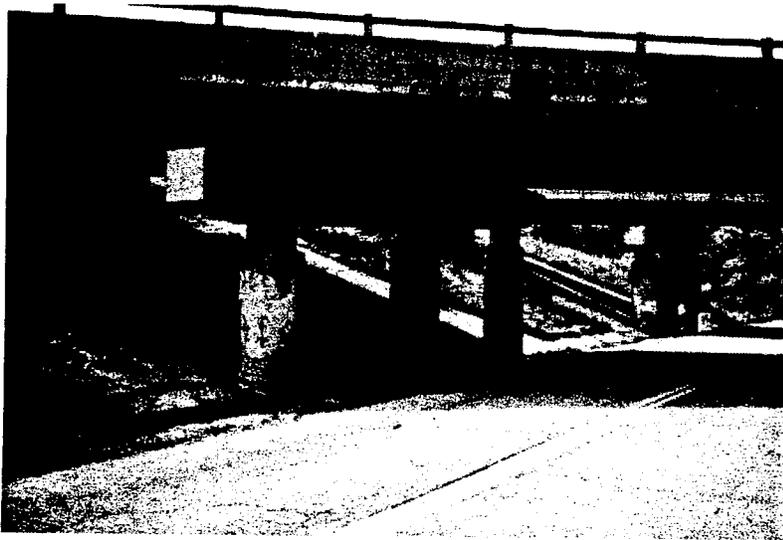
A bridge in need of column repair was selected by West Virginia Department of Transportation, Division of Highways (WVDOT-DOH) to demonstrate the IDEA Product. The subject bridge is the Pond Creek Road Overpass Bridge carrying Interstate Route 77 in Wood County, West Virginia.

According to the WVDOT-DOH Condition Report, six columns of two piers had vertical hairline cracking. These cracks resulted from a previous unsuccessful repair with a concrete layer after the columns were subjected to fire and the original concrete cover was lost.

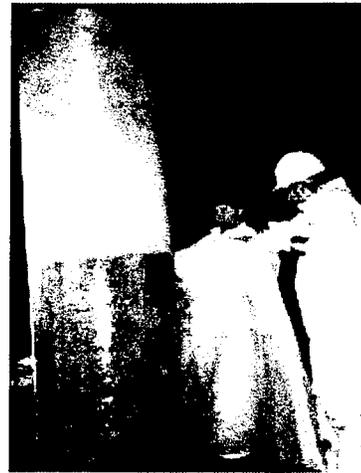
Wrap being applied to the column

Three columns of the Pier 2 of the Bridge Northbound were repaired in July 1998 with the fiber composite wrap system evaluated through the IDEA Project. The other three columns were repaired with an alternative rehabilitation method using prefabricated composite cylindrical shells.

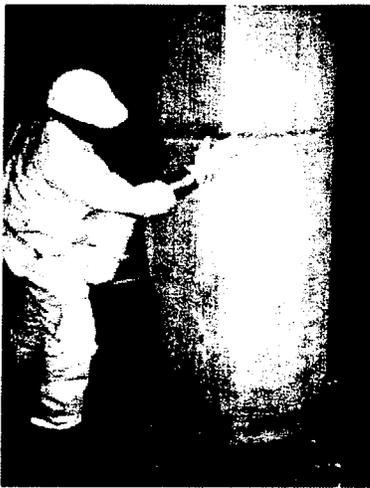
Wrapped Column

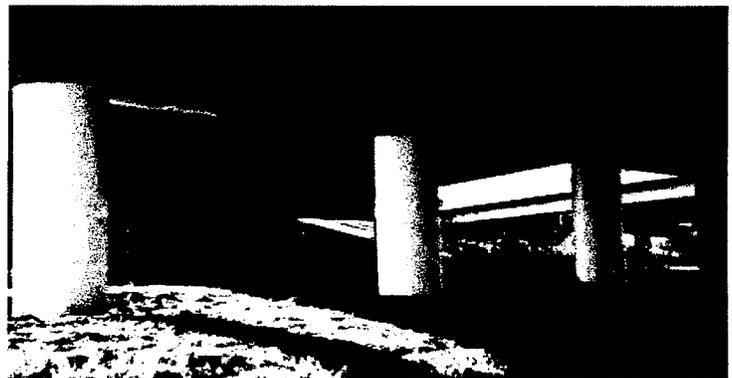
Project Completed

The field performance of the repaired concrete columns was monitored during the first year after installation and the results were satisfactory.

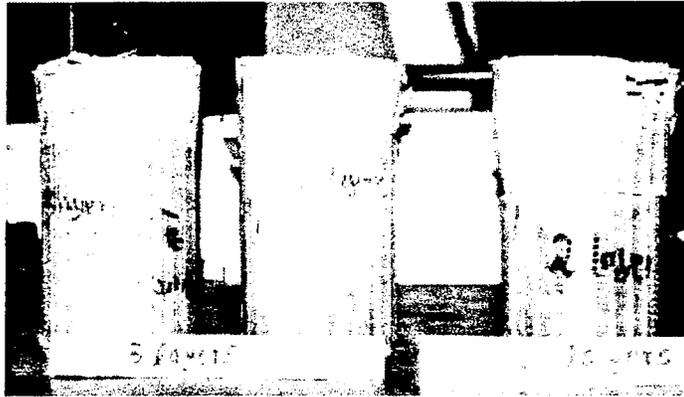
Figure B4. Failed Concrete Cylinders (2 and 3 Layers of Wrap)
