DOT HS 809 172

August 2000

Blowout Resistant Tire Study for Commercial Highway Vehicles

7. Author(s) Z. Bareket, D.F. Blower, and C. MacAdam		8. Performing Organization Report No. UMTRI-2000-28		10. Work Unit No. (TRAI5)	
9. Performing Organization Name and Address The University of Michigan Transportation Research Institute 2901 Baxter Road, Ann Arbor, Michigan 48109		11. Contract or Grant No. DTRS57-97-C-00051		13. Type of Report and Period Covered Final 9/9/99 - 5/31/00

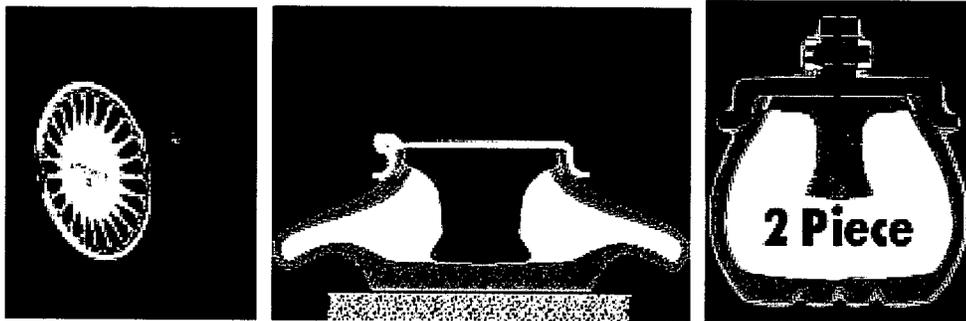
Figure 2. Hutchinson’s RunFlat

The last two devices were individual designs which involved the tire/rim assembly: a (then) newly-developed tire (Cantilever), whose width and structure characteristics were such that reduced the likelihood of the sidewalls buckling and collapsing under the rim, and a “Safety Roller” insert, with a design similar to the “RunFlat” by Hutchinson (see Figure 2).

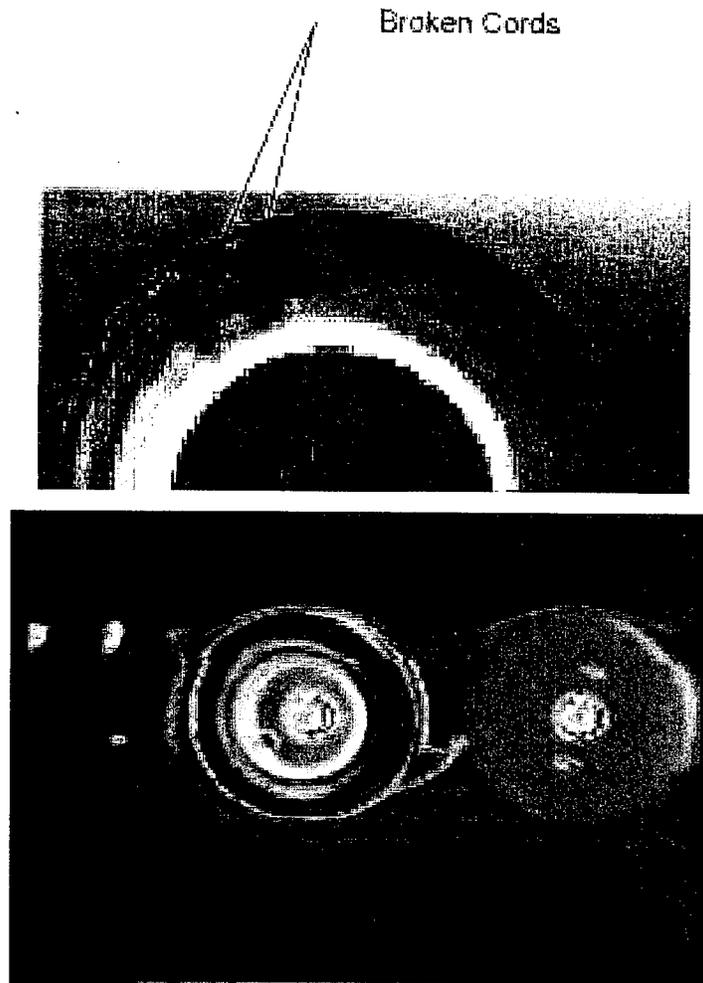
Figure 3. TACOM / Radian Infrared Photographs

The following two infrared photographs in Figure 3 illustrate the benefits and the potential of this IR system. The top picture was taken in a laboratory during a research work involving thermal-imaging analysis of tires (US. Army TACOM/TARDEC report "Endurance/Infrared Tire Test," dated 29 March, 1999.) The picture shows the top half of a tire with broken cords which were not apparent externally. The second picture is a frame captured from a video made by Radian Inc. intended to demonstrate the concept of using thermal-imaging video camera to monitor the condition of truck tires as they go by. The direction of motion is from left to right, and clearly the rear dual set is hotter than the front set. However, there are no apparent hot-spots.

What do good tires look like to the IR camera? How do certain defects/damages seen on the IR image? The objective is that eventually, by having a truck driven past the IR camera (e.g., when going over the scales in a weighting station), the tire image will provide information that will allow an immediate analysis of the "health status" of the tire and even to predict an imminent failure so that the tire can be prevented from going on the road again.

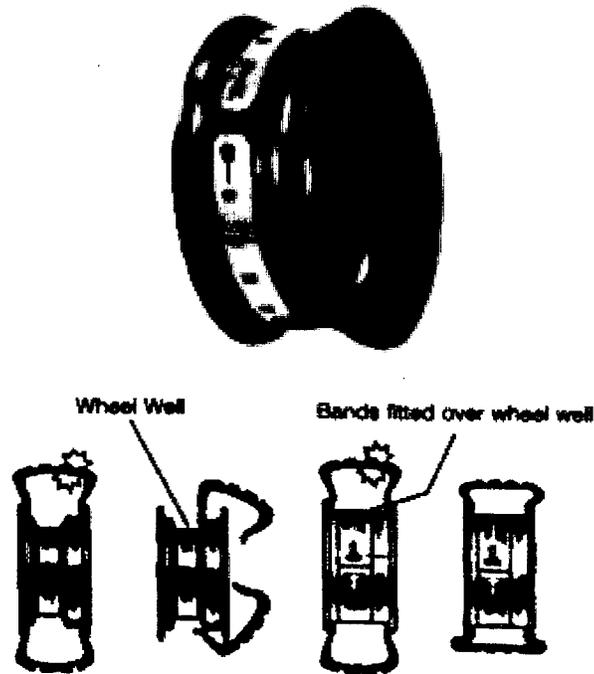
Figure 8. Tyson Band System

The Tyson Band, seen in Figure 8. is fitted to the vehicle's wheel and converts the standard drop-center tubeless wheel to what they call a "safety wheel." Following tire deflation, the deflated tire is locked to the wheel (see figure) to provide the driver with better control.

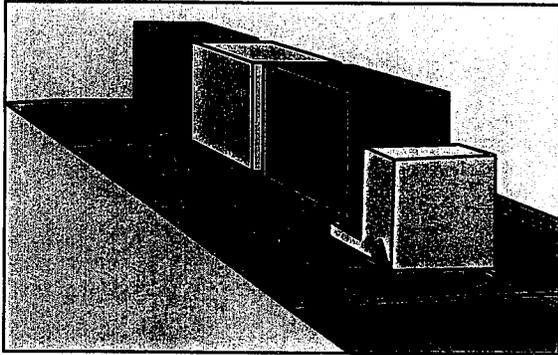
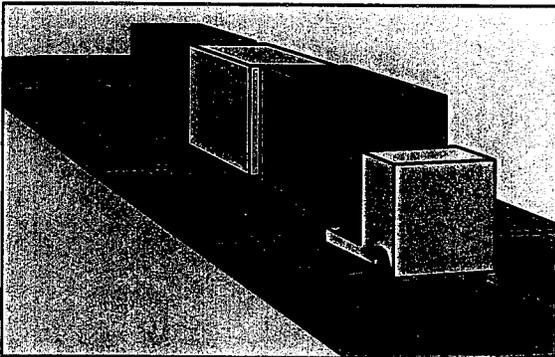
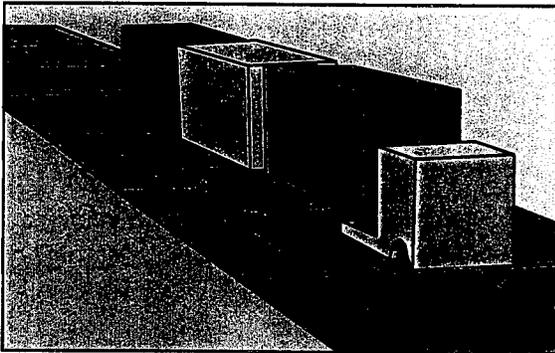
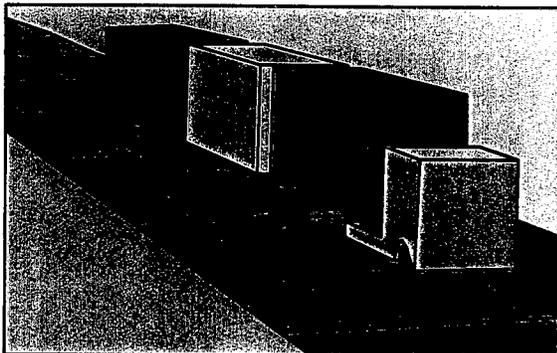
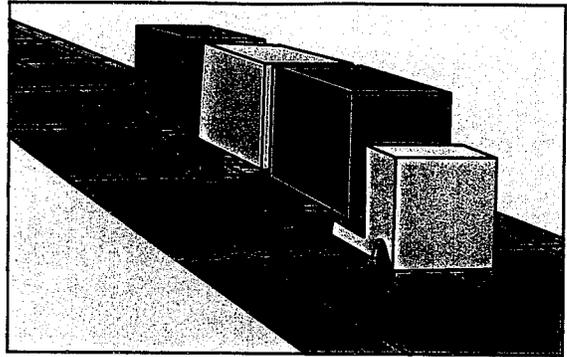
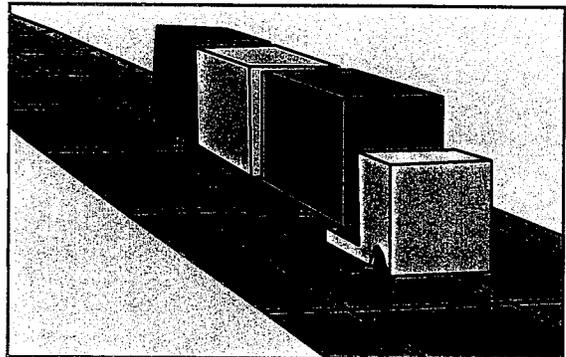
Left Front Tire Blowout Example
Loaded Triples @ 55 mph

Driver reaction and compensatory steering behavior also plays an important role in affecting peak lateral displacement of the vehicle during a post-blowout recovery. The driver behavior in this example is idealized in the sense that driver corrective steering reaction occurs within 0.25 seconds and is further improved 1.5 seconds later by additional steering gain corrections (driver adaptation) that account for the loss of available lateral tire force from the blown tire. For cases in which a driver is not particularly attentive and adapts more slowly to the blowout disturbance and its steering control requirement, significantly larger lateral path motions would be expected.
