Report No. K-TRAN: KSU-00-4
FINAL REPORT

REDUCING CROSSOVER ACCIDENTS ON KANSAS HIGHWAYS USING MILLED CENTERLINE RUMBLE STRIPS

Eugene R. Russell
Margaret J. Rys

Kansas State University
Manhattan, Kansas

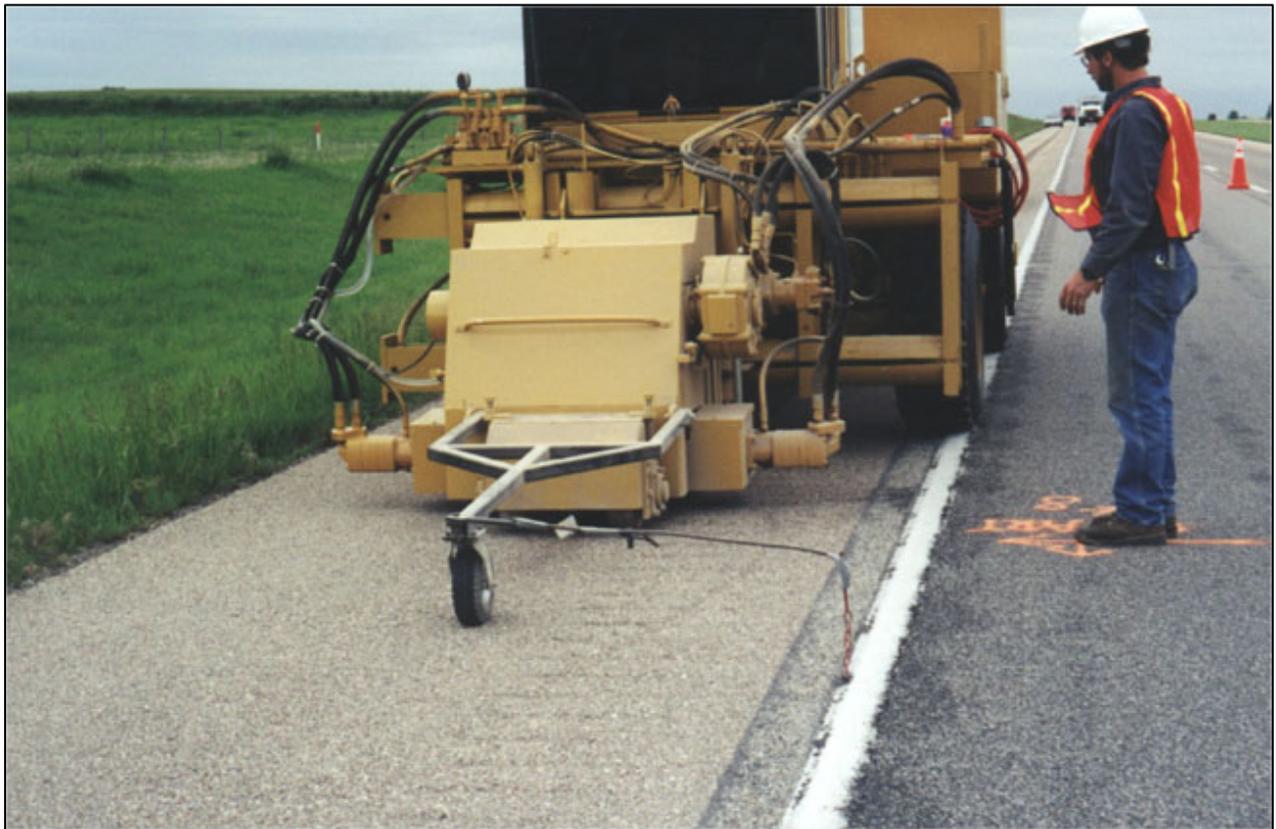
Figure 5.1: Dustrol Inc. Milling Machine
(Brin, 2001)

The cutting spindle on the milling machine used had a 12-inch milling radius and the depth of cut was 0.5 inch on all patterns.
