CASE HISTORY: USE OF TENAX AND TENSAR GEOGRIDS
FOR BASE COURSE STABILIZATION

LAKESHORE DRIVE IMPROVEMENTS PROJECT (MANDEVILLE)
FEDERAL AID PROJECT NO. STP-9998(002)
STATE PROJECT NO. 742-07-0095
ST. TAMMANY PARISH

Technical Assistance Report No. 18

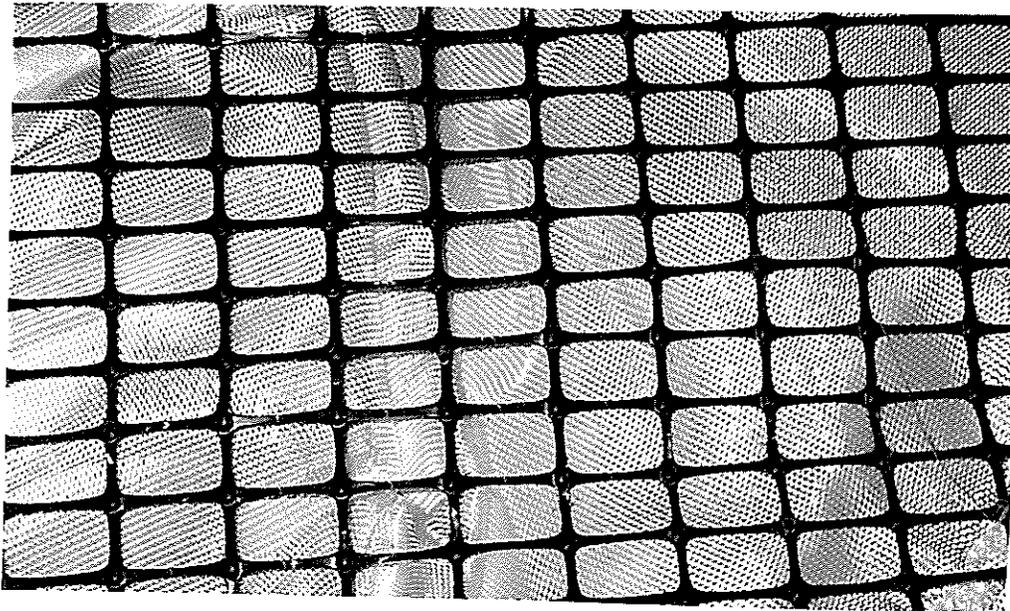
Figure 2
Tensar geogrid

Crushed gravel aggregate stabilized with fly ash was used for class II base course. The Terratex fabric conformed to the properties of class S stabilization fabric in the standard specifications. The Tensar geogrid, conforming to the state specification for stabilization geogrid, was manufactured from polypropylene sheets that are punched and stretched to form a grid (figure 2). A loaded haul truck was placed on the test sections to simulate construction traffic. Test sections A, B and C experienced pumping and rutting. Test section D with the geogrid performed satisfactorily. The number of truck passes was not recorded.

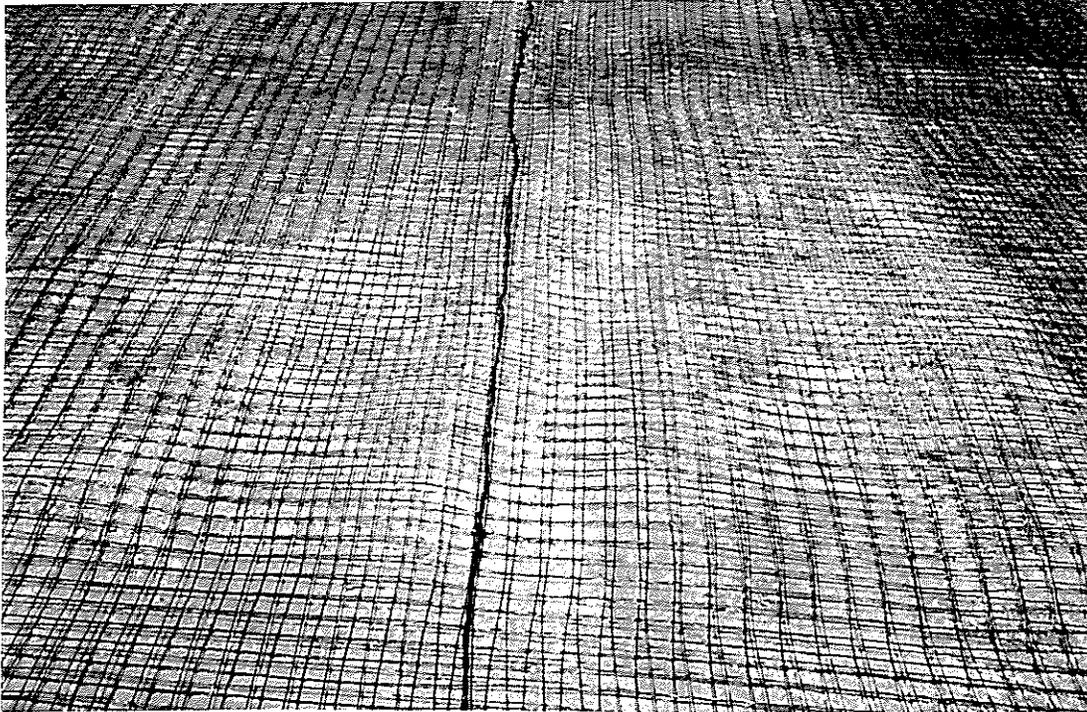
Figure 3
Tenax geogrid

Based on the results of the test sections, a plan change was approved to include a geogrid at the bottom of the base course throughout the project. A generic specification supplied by the DOTD Pavement & Geotechnical Design Section was used in the plan change to incorporate minimum material properties of the geogrid. The geogrid specification is presented in Appendix C. The contractor submitted Tenax MS220 geogrid rather than the Tensar BX1100 used in the test section. The Tenax geogrid was composed of two layers of extruded polypropylene mesh (Figure 3). The geogrid was approved for use based on the manufacture's certificate of compliance submitted in accordance with the specifications.

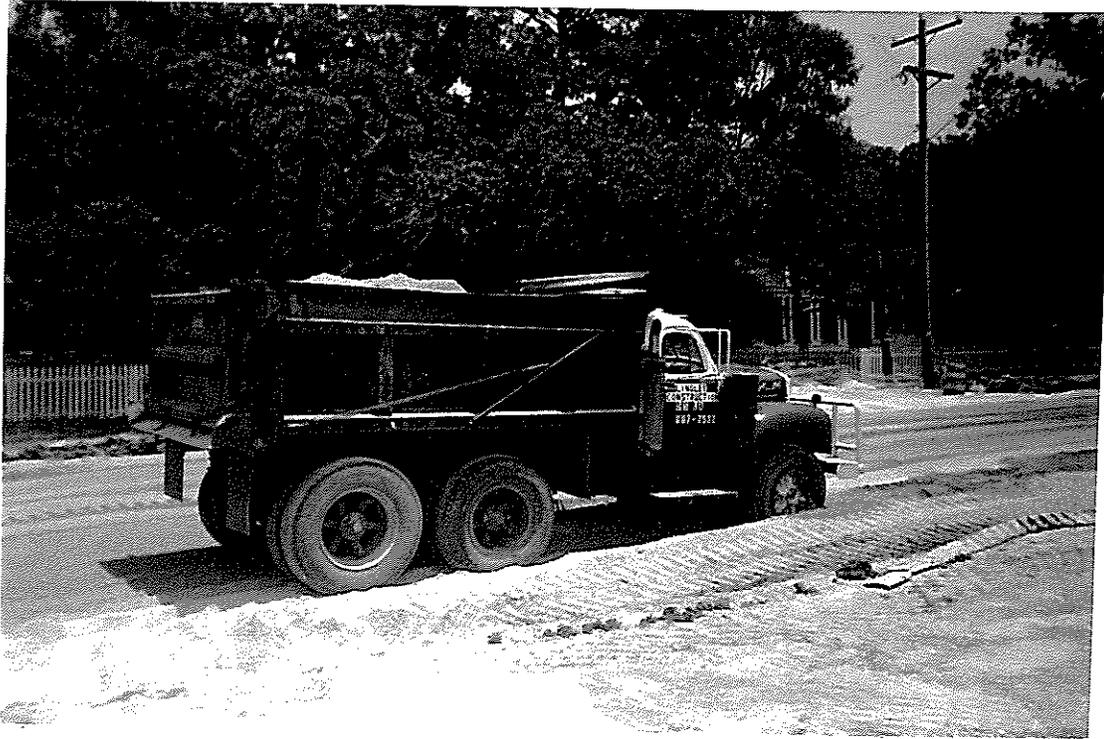
Figure 4
Haul truck traffic

Stage one of the project extends from the west end of the project to station 139+00. For this portion of the project, the contract required haul trucks to enter on Carondalet Street (station 109+87) and exit on Wilkinson Street (station 166+75). This restriction placed a large number of truck passes on the base course (figure 4). It should be noted that the amount of truck traffic placed on the base course was much greater than was placed on the contractor's initial test sections. Soon after construction, a large portion of the base course began pumping and rutting (figure 5). Many areas experienced local base failures with the Tenax geogrid rupturing and becoming exposed at the surface (figure 6) A graphical representation of the failed locations is given on the layout sheet in appendix A. Of the 12,995 square feet of eight inch base course constructed on stage one of the project, 3140 square feet required excavation and repair. This amounted to an unacceptable 24 percent of the base constructed.

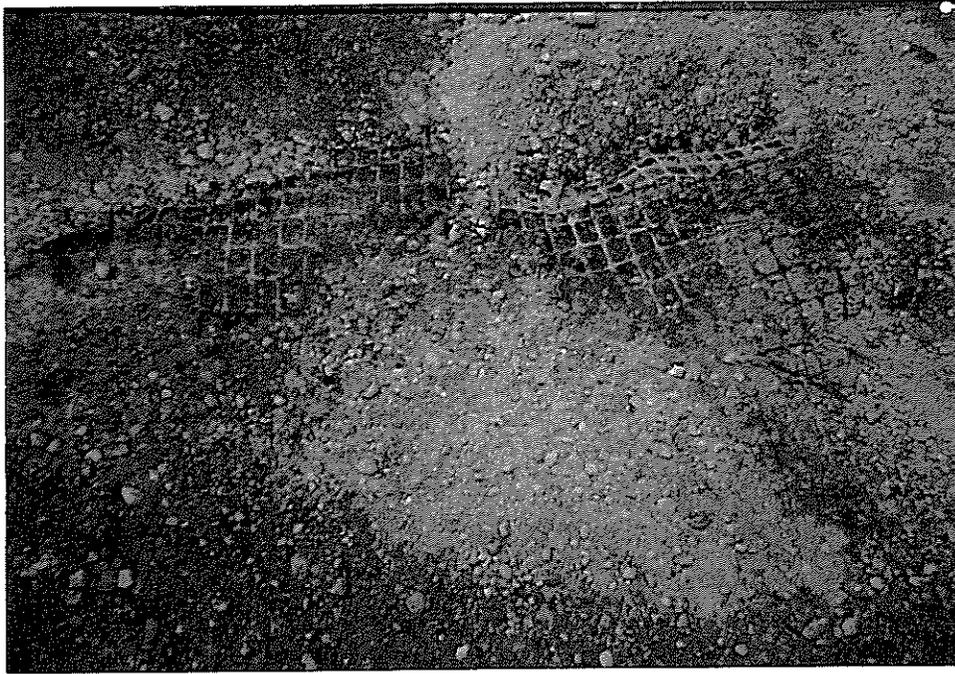
An unanswered question remained as to whether the single layer geogrid used in the contractor's test section would have prevented subgrade pumping and subsequent base failures. An attempt to answer this question was attempted in two of the failed areas. Station 141+24 to station 142+06 was repaired with an eight inch base course placed on a Tensar BX1200 geogrid. Tensar BX1200 geogrid is stronger than both the Tenax MS220 geogrid used in stage one or the Tensar BX1100 geogrid used in the contractor's test sections. Another small repair was placed at the intersection of Lakeshore Drive and Carroll. The mainline section performed satisfactorily while the small repair at the intersection failed (figure 8). The results were inconclusive.

Figure 8
Local base failure with ruptured Tensar BX1200 geogrid

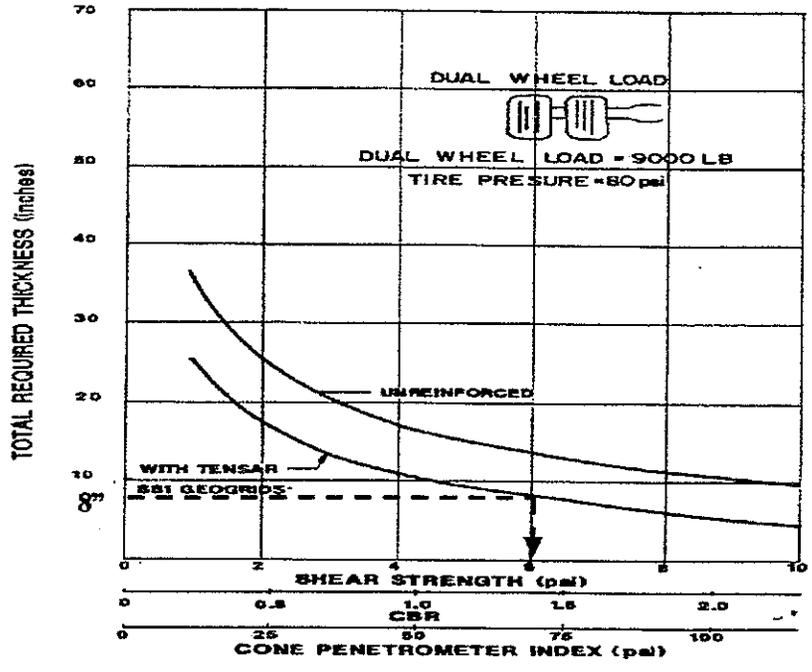
There were not enough funds available in the contract to increase the thickness of the aggregate between the geogrid and the pavement to twenty inches for the remainder of the project. Prior to starting phase two of the project, a design analysis was performed by the authors to determine what thickness of aggregate would be adequate to handle the construction loads. The Tensar Technical Note TTN:BR5, *Design Guideline for Subgrade Improvement Under Dynamic Loading with Tensar Geogrids* was used. The required parameters includes wheel load, tire pressure and soil shear strength. To simulate the construction haul vehicles, a dual wheel load of 9,000 pounds and a tire pressure of 80 psi was used. Since the geotechnical analysis did not provide soil shear strength testing, the values used in the redesign was back calculated using the present base failures. The TTN design chart was also checked using the soil consistency classifications taken from the geotechnical report. The majority of the failures occurred over medium clayey sand and silts in the vicinity of borings A-3, A-4 and A-6, over a soft clay near boring A-7 and over a loose sand near boring A-5. Back calculating the minimum soil strength necessary to support the loads with eight inches of base on a Tensar BX1100 geogrid, the soil strength was determined to be approximately six psi (figure 9). Using table 1 of the Tensar TTN:BR5, *Guide for Estimating Subgrade Soil Strengths (Fine Grain Soils)*, a shear strength of six psi falls within the upper range of a medium consistency soil. A copy of this table can be found in appendix D. Therefore, any soil shear strength less than six psi would be susceptible to failures. Using the median value for the strength consistency ranges, the minimum aggregate thickness for the base course in the areas of borings A-3, A-4 and A-6 (medium sandy clay - 5.2 psi) would be nine inches. The minimum aggregate thickness in the areas of borings A-7 and A-5 (soft clay, loose sand - 2.6 psi) would be fourteen inches (figure 10). Considering an aggregate thickness of eight inches was constructed, base failures were understandable.

Figure 9
 Back-calculation to estimate soil strength

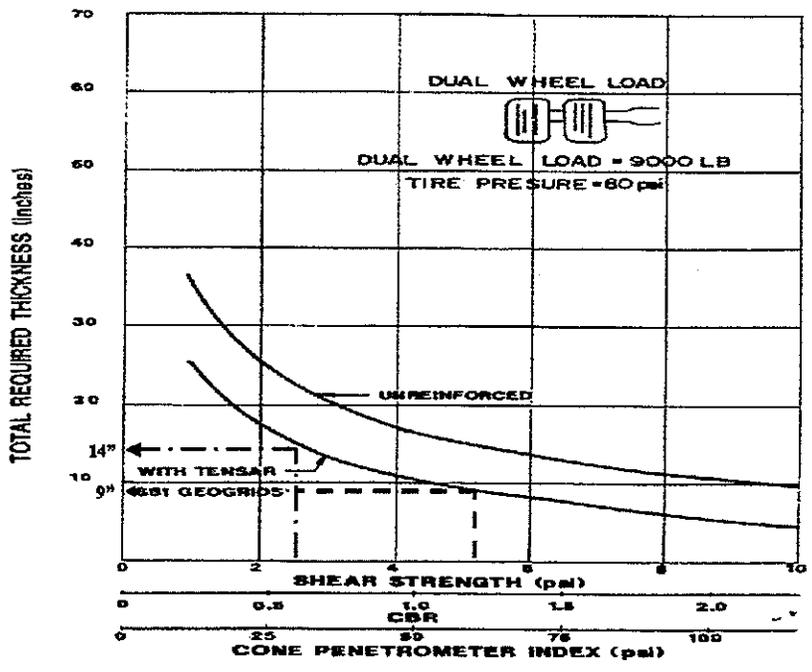
Figure 10
 Stage one minimum reinforced aggregate thickness from design chart

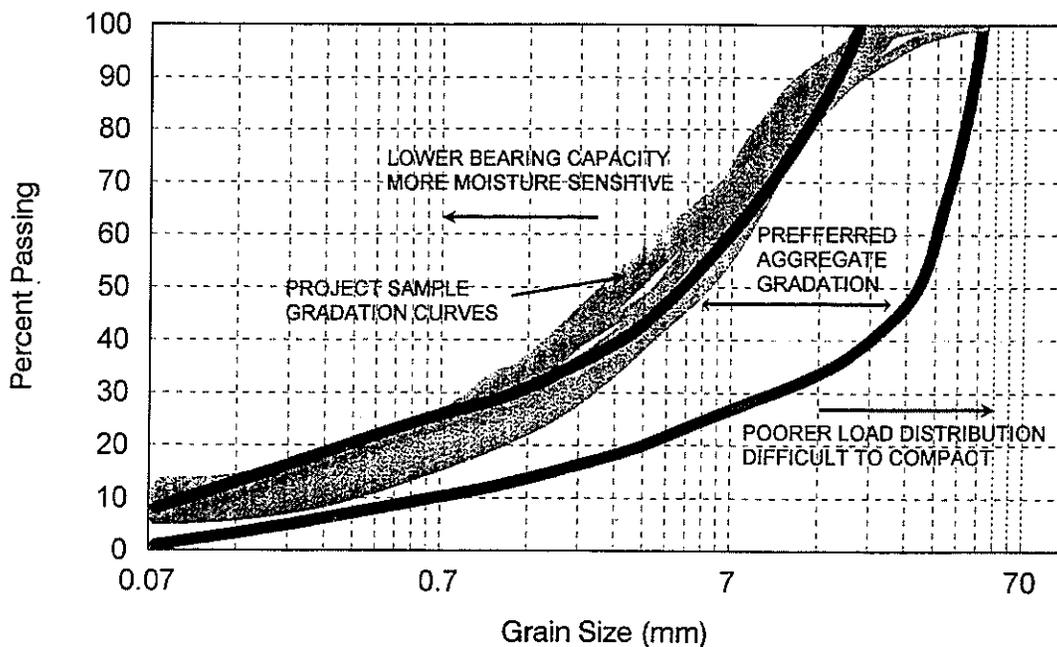
Another contributing factor for the failures could have been with the size of the aggregate used on this project. The aggregate gradation curves were plotted along with the range of preferred aggregate size as recommended by Tensar Earth Technologies (figure 11). Based on the overlap of the gradation curves, most of the aggregate used on the project had a smaller diameter than recommended. This could have resulted in a more moisture sensitive base with a lower bearing capacity than desired.

Figure 11
Base course gradation

For the geogrids to have a better chance of success on weak subgrades, the appropriate base course aggregate size should be specified in the contract.

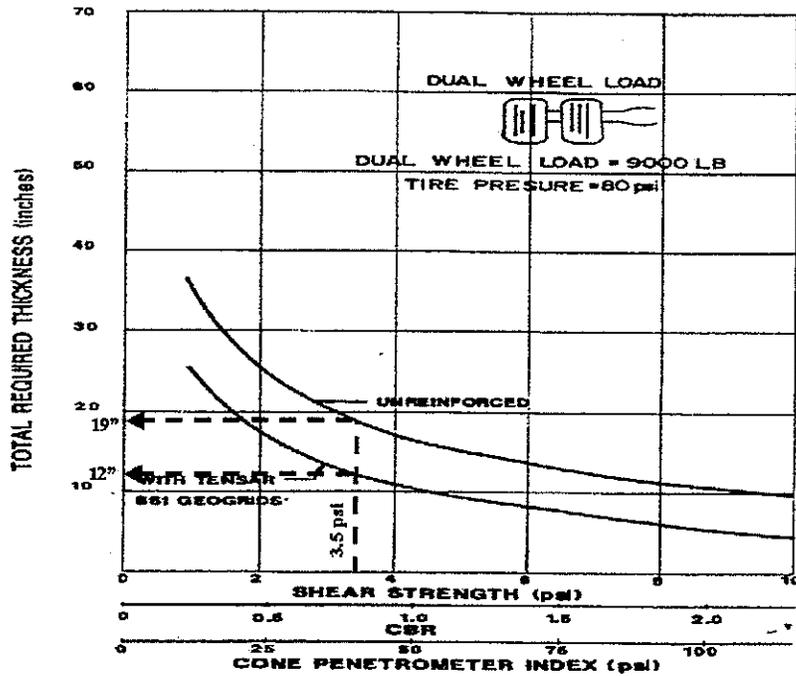
The subgrade soils on stage II of the project consists of extreme strength differences from very soft to soft clays near borings A-8, A-11 and A-15 to medium stiff sandy clays near borings A-9, A-13 and A-14 to stiff sandy clays at borings A-10 to A-12. Considering the numerous failures on stage I, the lower range of the medium soils with a strength of 3.5 psi was chosen as the average soil design strength. With this strength an unreinforced section would require nineteen inches of aggregate and a reinforced section with geogrid would require twelve inches of aggregate (figure 12). Therefore the base course thickness on stage II of the project was plan changed to twelve inches. As indicated in the correspondence to initiate the plan change, future patching may still be required with this thickness. In areas of very soft soils or in areas subject to high traffic, some failures were still anticipated. Although there was some amount of risk with the twelve inch base thickness it was selected because it was the most economical alternative considering the remaining funds available in the contract. Any over-run would require matching funds from the city of Mandeville.

Figure 12 Stage two aggregate thickness design

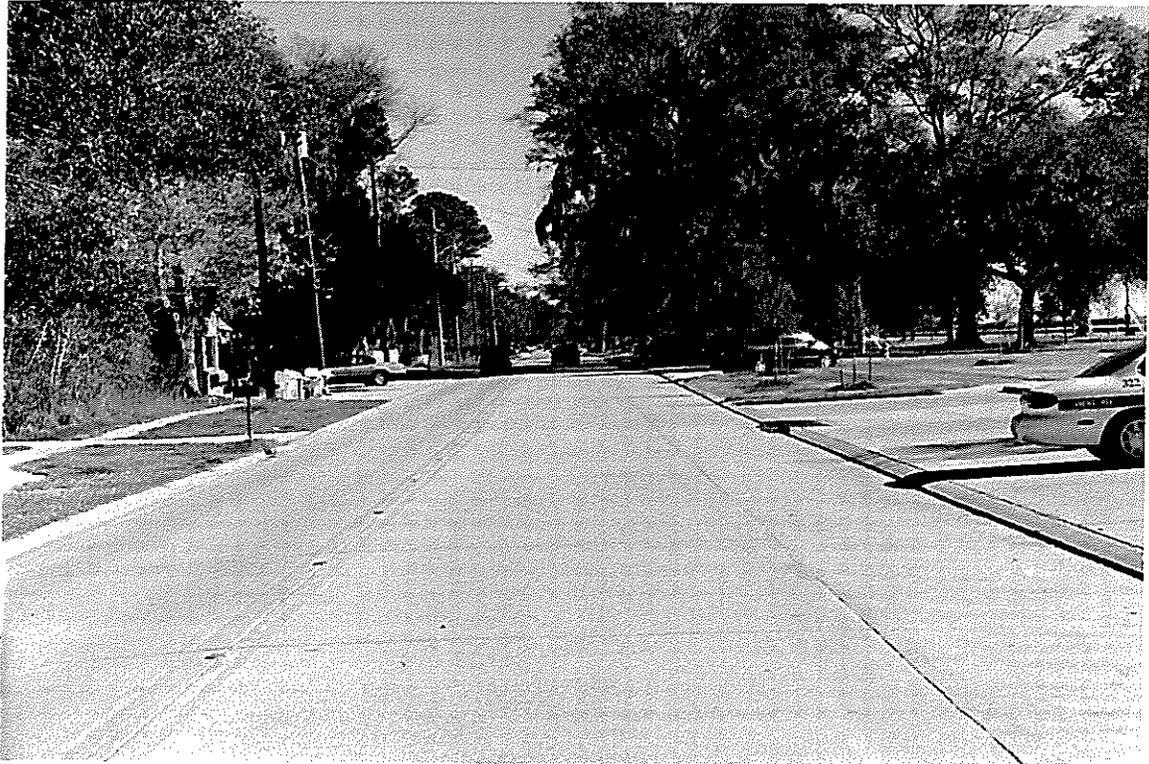
A field inspection of the project two years after completion indicated all pavement sections to be performing adequately. There is no evidence of any subgrade or base failures. Figure 10 shows the completed project.

Figure 13
Completed project two years after construction
