RDT 03-001

# **Determination and Prioritization of Geotechnical Problems for Missouri DOT**

RDT 03-001  
Research Investigation RI 99-029

**Determination and Prioritization of MoDOT Geotechnical Related Problems with  
Emphasis on Effectiveness of Designs for Bridge Approach Slabs and  
Pavement Edge Drains**

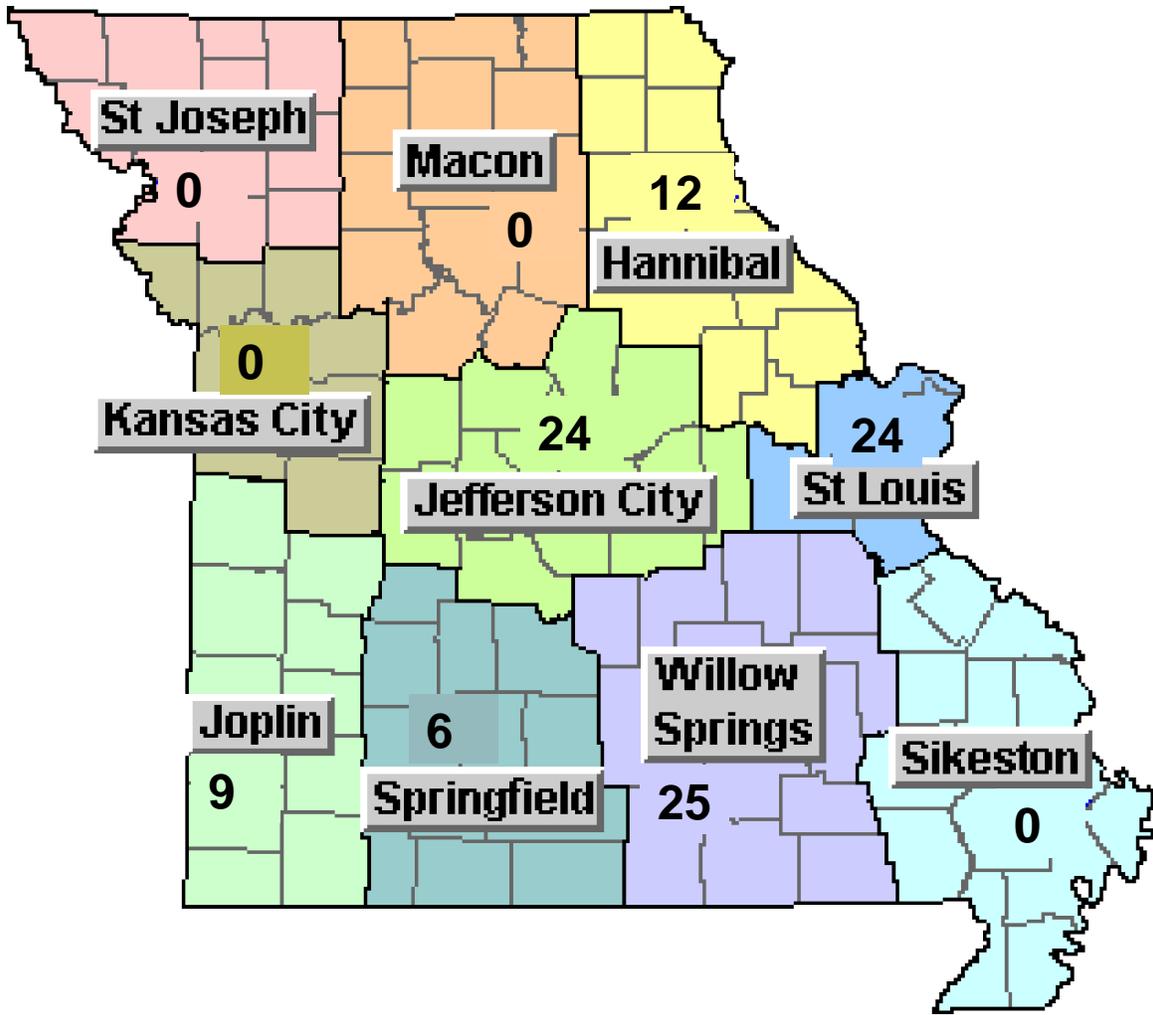
Figure 2 – Percentage of the Total Rock Slope Instability issues reported by District. Number is the percentage of statewide reported rock slope instabilities lying within the specific District.

Some observations on the location trends for the regional geotechnical issues (reported by 4 to 6 Districts) can be made. Consider rock slope instability (Figure 2). A general trend of rock instabilities extends from northeast to southwest across the state. The trend follows the significant rock outcrops and cuts within the Department's highway system. The locations of the bridge foundation problems are shown in Figure 3. These extend in a band trending from northwest to southeast across the State. Part of the band follows the Missouri River. The occurrence of earthquake foundations issues is shown in Figure 4. These sites are clustered in the southeastern quadrant of the State. This is the area impacted by the New Madrid and extended fault system. The percentage of the total reported bridge abutment and retaining wall issues are shown by District in Figure 5. These are generally located in the middle and eastern portions of the State. The data shown in Figures 2-5 have been normalized for the number of respondents in each District and provides a reasonable geographic location of the geotechnical issues cited in each figure.

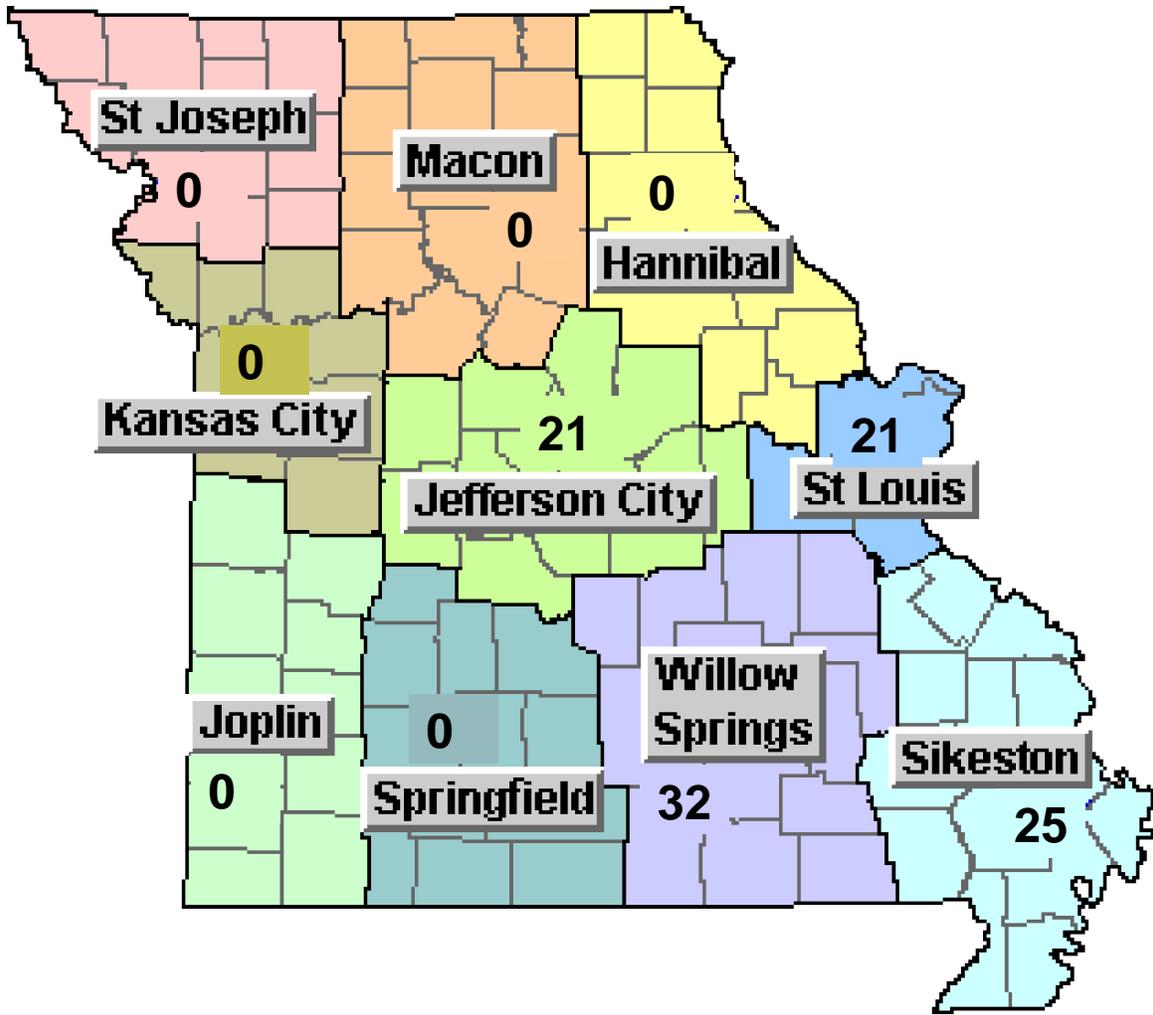
Figure 4. – Percentage of the Earthquake Foundation issues reported by District. Number is the percentage of statewide reported earthquake foundation issues lying within the specific District.

Rock slope instability, bridge foundations, earthquake foundations and bridge abutments/retaining walls were reported issues in four to six of the ten Districts. These should be considered regional issues. Inferior rock, freeze-thaw, problem soils, natural springs, culverts beneath high fills and mud-filled seams in rock cuts were reported in a single District.

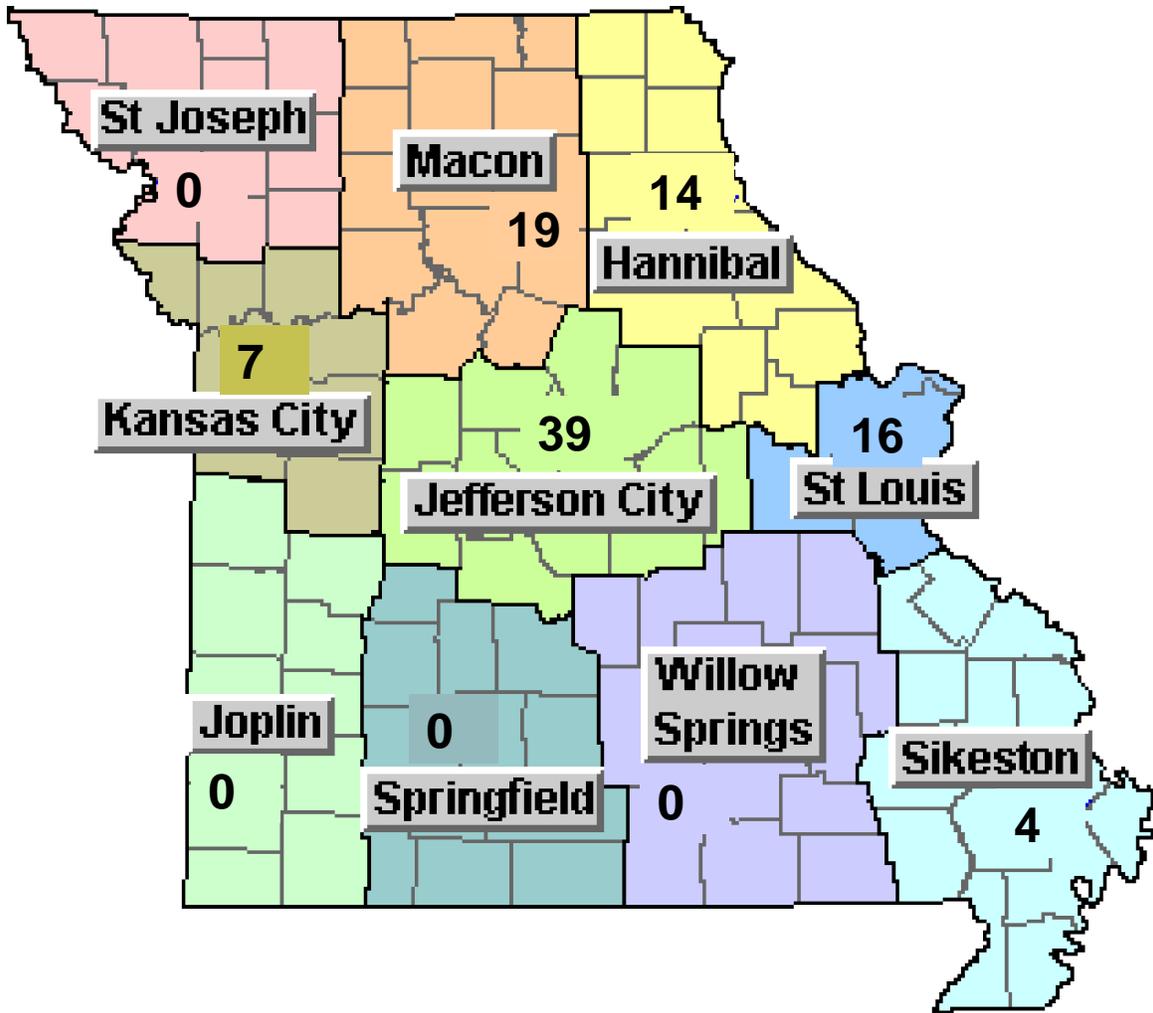
Figure 5. – Percentage of the Bridge Abutment and Retaining Wall issues reported by District. Number is the percentage of statewide reported bridge abutment and retaining wall issues lying within the specific District.

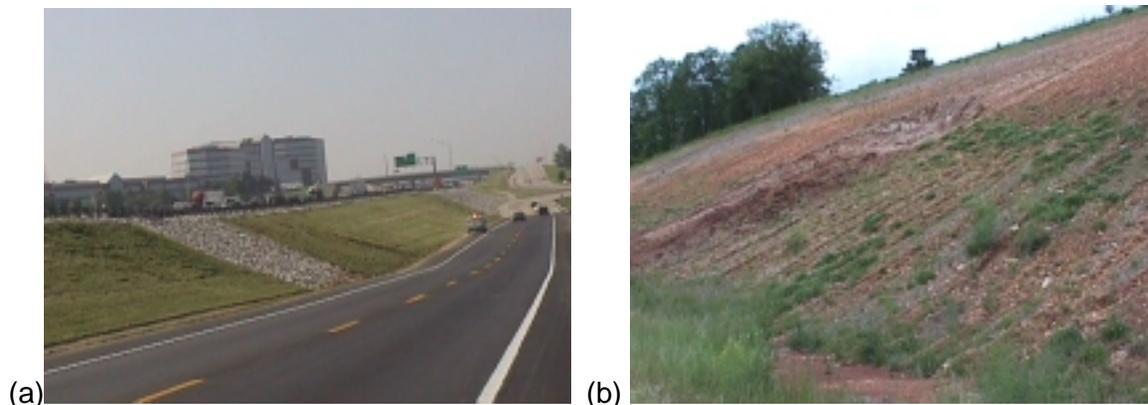
Figure 6 – (a) Repair embankment slide along I-270 and (b) Slide in a cut slope along US-65

Additionally, some cut slopes experienced slope stability problems, particularly the slopes in residual soils that lost strength with time and were exposed to high groundwater. An example of this condition was found in District 8 along US 65 between Springfield and Branson (Figure 6b).

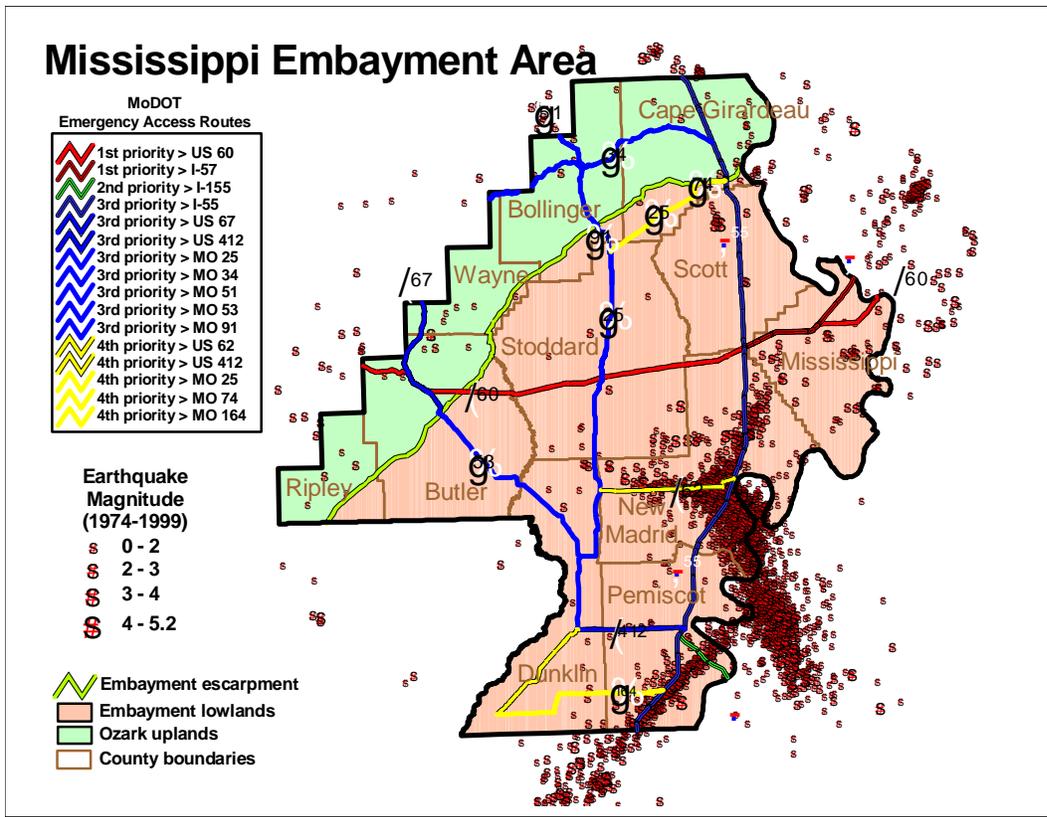
Figure 11 – The 1974-1999 earthquake epicenters and magnitudes (source: St. Louis University).

The southeast portion of the State of Missouri is considered an earthquake area due to its proximity to the New Madrid Seismic Zone (NMSZ). The NMSZ system of faults is located in a very unique setting with respect to hazards related to soil deposits. The areal extent of liquefiable soil deposits in the Mississippi Embayment is the largest in the North American continent. Additionally, these soil deposits are very deep and the anticipated behavior during dynamic loading is not well understood. Much is still to be learned about this high consequence seismic zone given that strong ground motion data is not available in recorded history. The paleoliquefaction features of this seismically active area are the evidence that strong ground motions occurred in the past, as well as the anecdotal data from the 1811 and 1812 earthquake events. Seismicity is currently being monitored by the USGS via a network of seismographs and records of small magnitude earthquakes are helping in defining the systems of faults. The Mississippi Embayment, seismicity events and Missouri roadways are shown in Figure 11. The awareness of earthquake problems in the MoDOT Districts near the NMSZ was evident in the survey responses

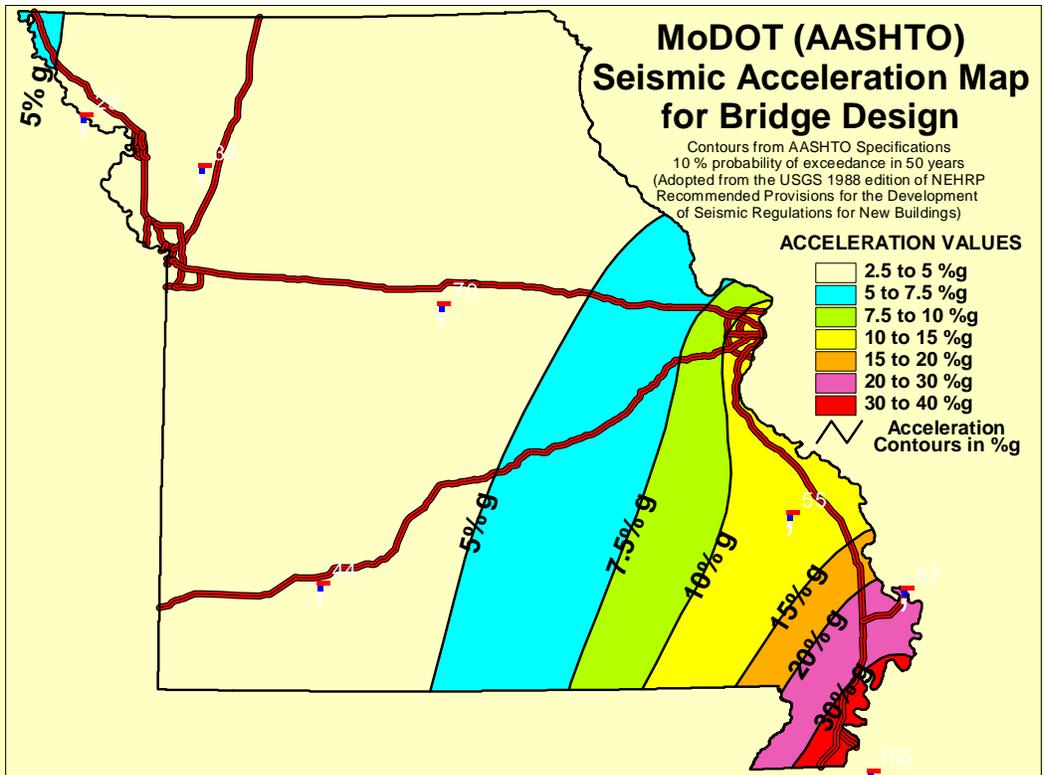
Figure 12 – AASHTO Seismic Accelerations based on USGS/National Earthquake Reduction Program Recommended 1988 Provisions.

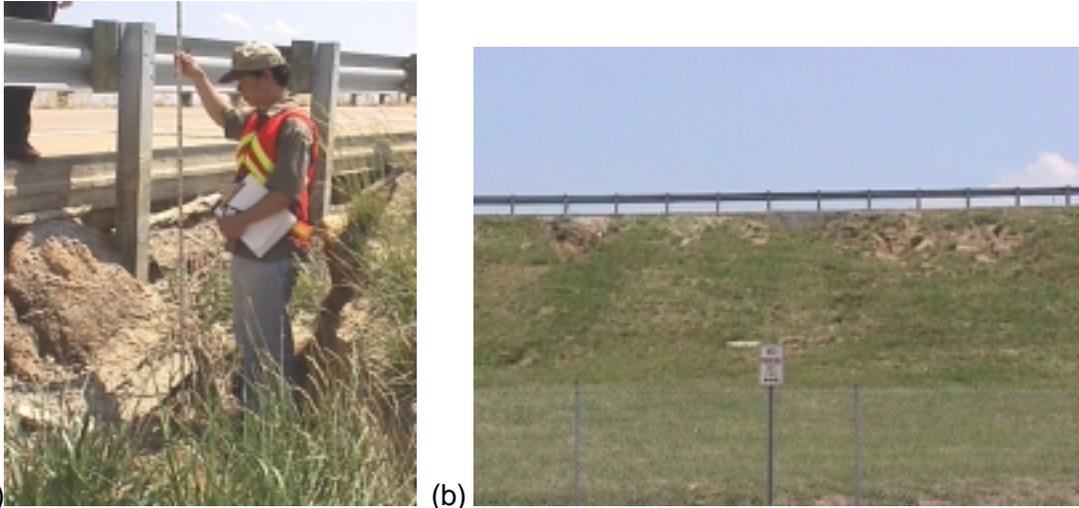
Figure 15 – (a) Erosion at the edge of shoulder concrete on Spencer road ramp on to Mo-370.  
(b) Erosion problem near I-170 and I-70 intersection.

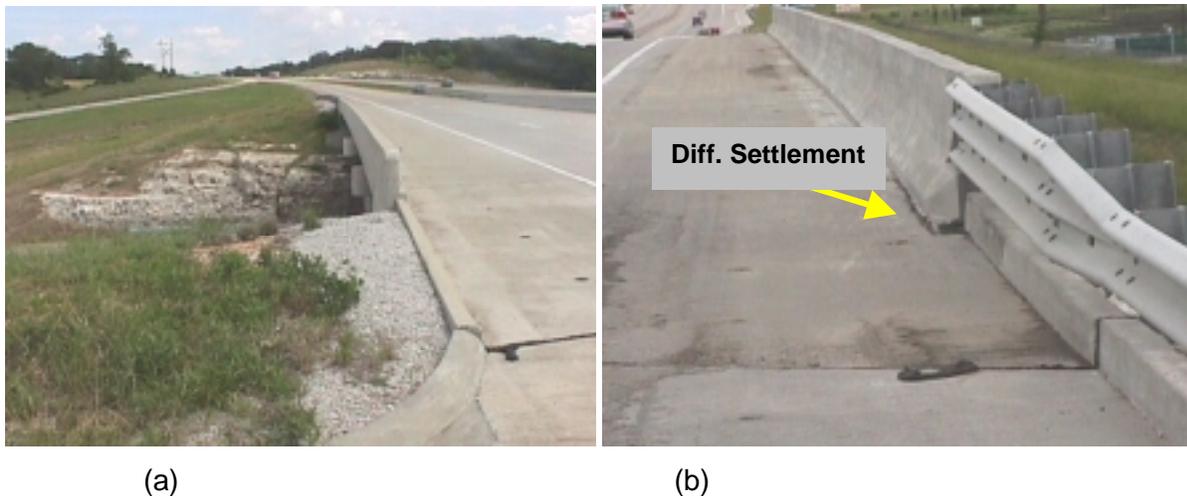
Figure 17 – (a) No settlement on BAS unused mudjack holes shown and (b) Differential settlement occurs on BAS

In some instances, differential settlement was noticed at the approach slab/bridge abutment contact. This likely indicates a failure (structural) of the bridge seat for the slab or of the slab itself. Careful analysis (destructive) and monitoring of such cases is required to correctly identify the failure mechanism(s). Additionally, since the presence of differential settlement appears to correlate positively with increasing height of embankment fill, it suggests that the length of the bridge approach slabs should vary according to the fill height in order to minimize the distortion (differential settlement/length of approach) in the approach.

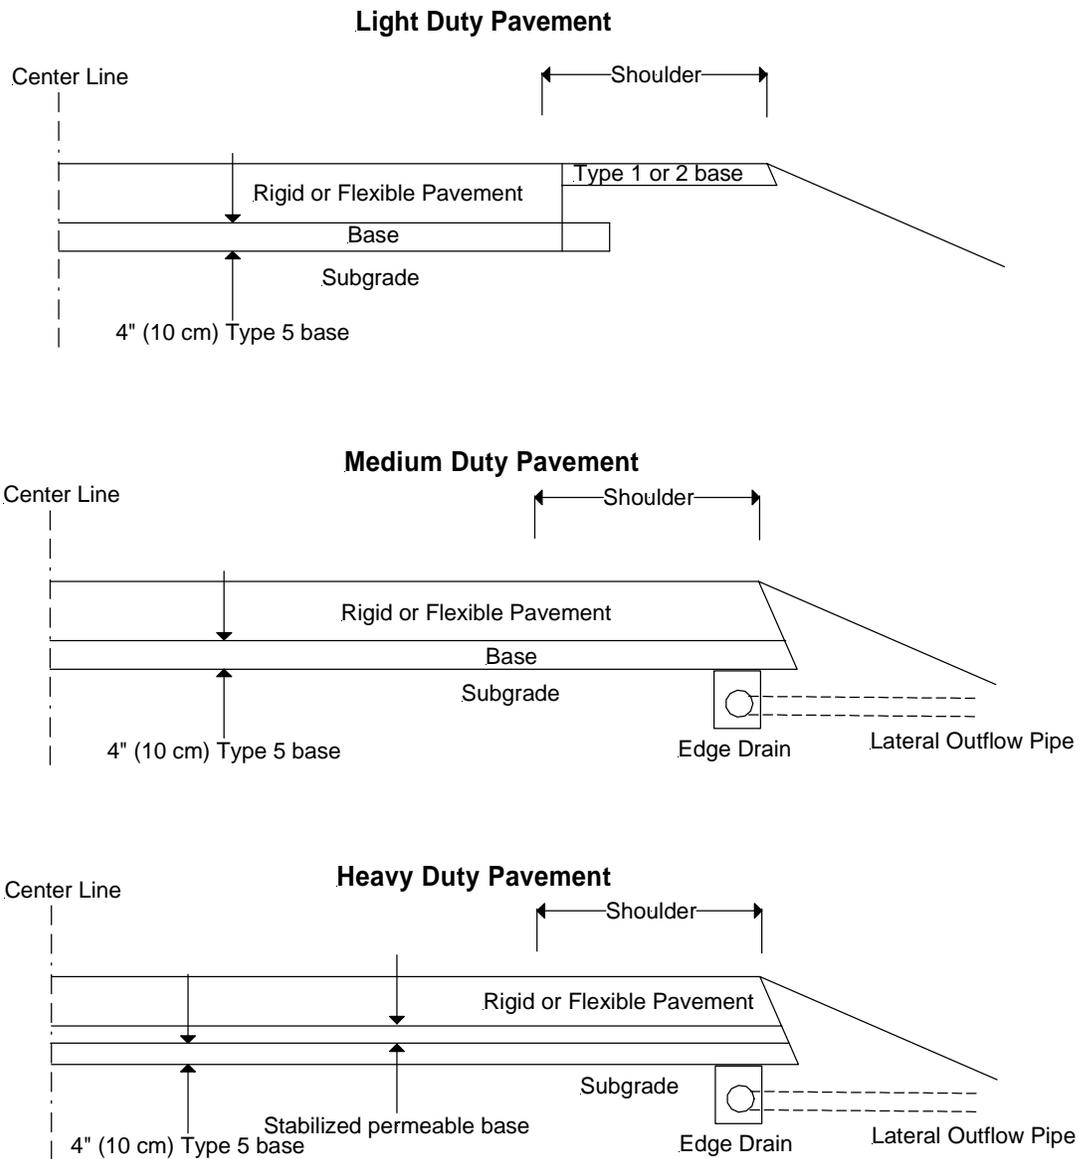
Figure 19 – The three pavement design cross sections used in MoDOT system (a) Heavy-duty, (b) Medium-duty, (3) Light-duty.

In Missouri, subsurface drainage of pavements is accomplished through use of drainable base courses and pavement edge drains (PED). Missouri DOT uses three standard pavement designs. These include light, medium and heavy-duty pavements (Figure 19). No subsurface drainage is supplied in light-duty pavements. Medium-duty pavements include a Type 5 base with edge drains, and heavy-duty pavements include an asphalt stabilized drainable layer with edge drains. Subsurface drainage is only provided for medium and heavy-duty pavements in the Missouri DOT system.

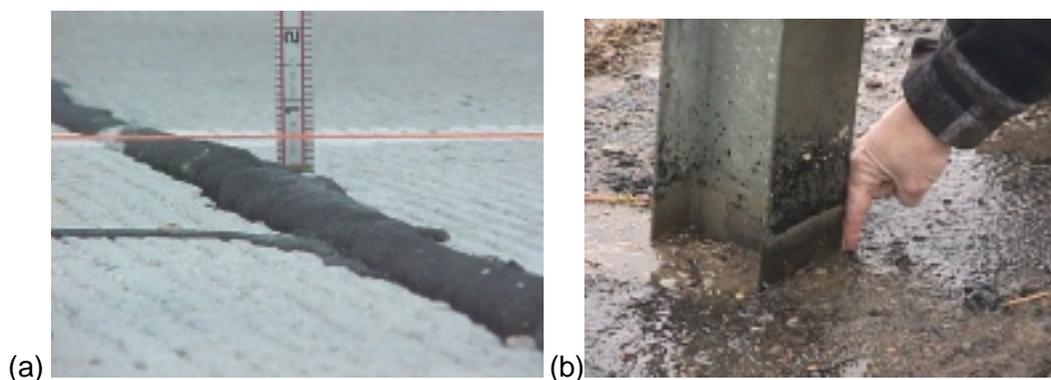
Figure 22 – (a) Settlement at bridge approach slab and concrete pavement joint (b) Settlement at bridge end illustrated at guard rail post, Bridge A-4811, District 10, Jackson, MO.

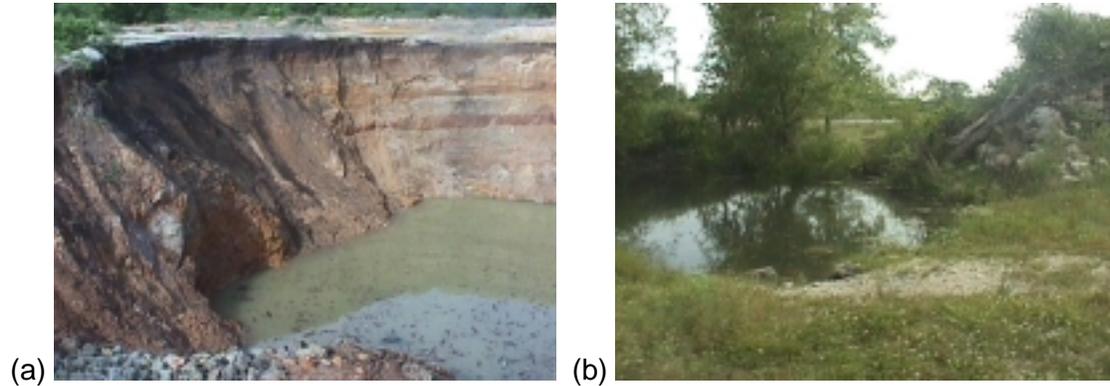
Figure 24 – (a) Recent and (b) Old sinkholes in District 7 NE of Joplin, MO

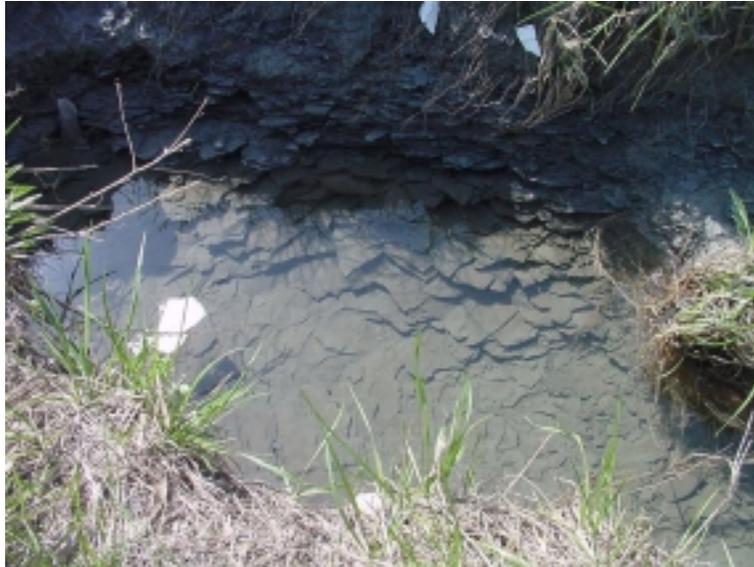
additional problem from the oxidation of pyritic shales is the production of sulfates which can attack the structure of concrete and accelerate its deterioration.

Figure 26 – Exposed area showing shale that is underlying highway in District 4.

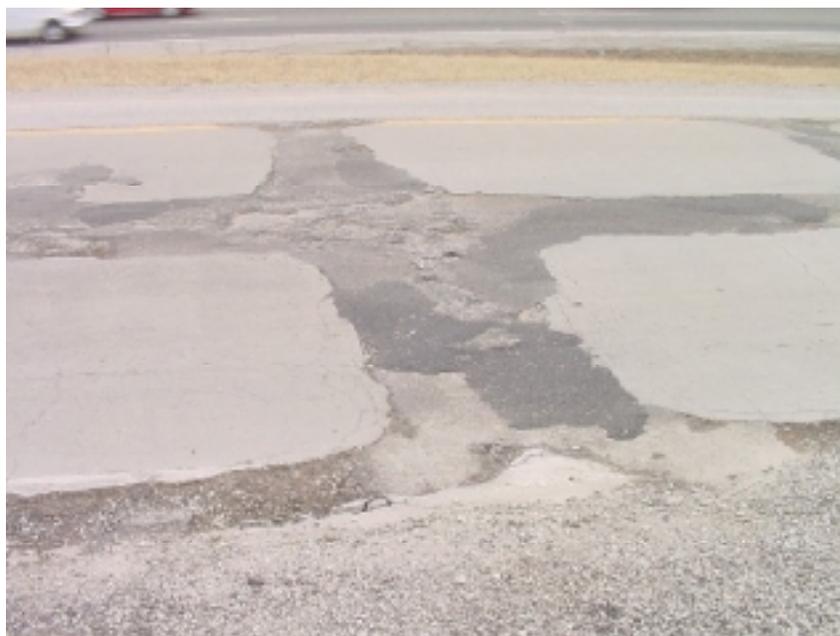
Figure 27 – Heave in I-435 due to underlying expansive shales.

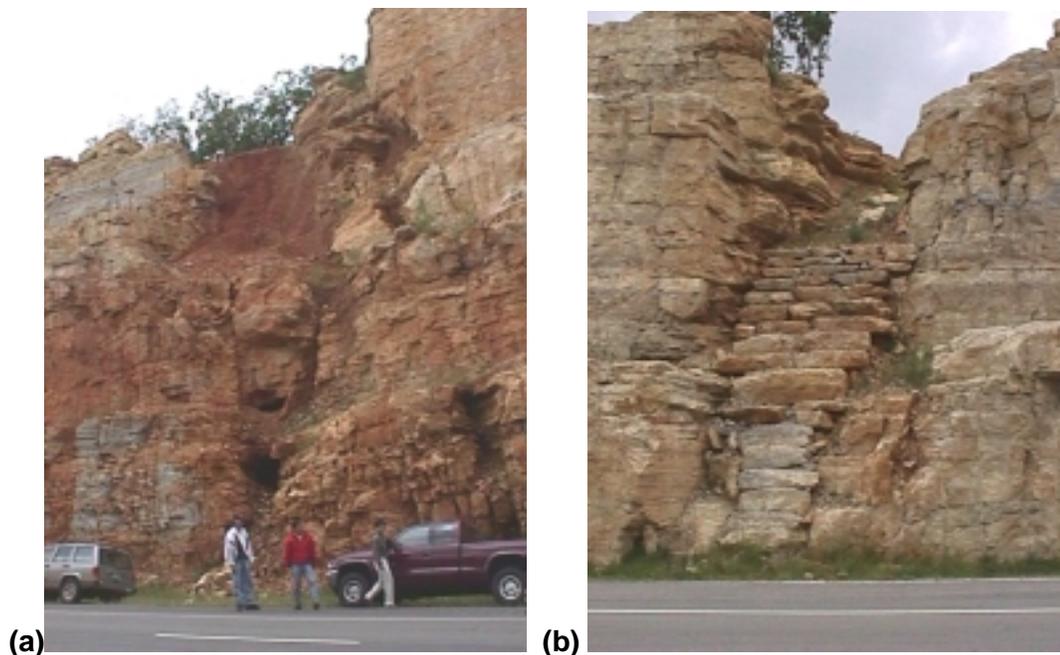
Figure 28 – (a) A full-scale view of the magnitude of a clay seam on US 65 and (b) A solution to the clay seam problem is the man-made wall of rock to cover the seam.

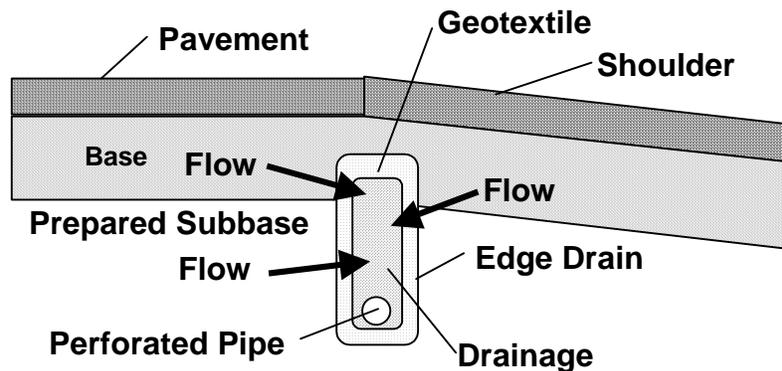
Figure 29 – Typical Pavement Edge Drain. Many variations on the design exist and can include aggregate or geocomposite drains.

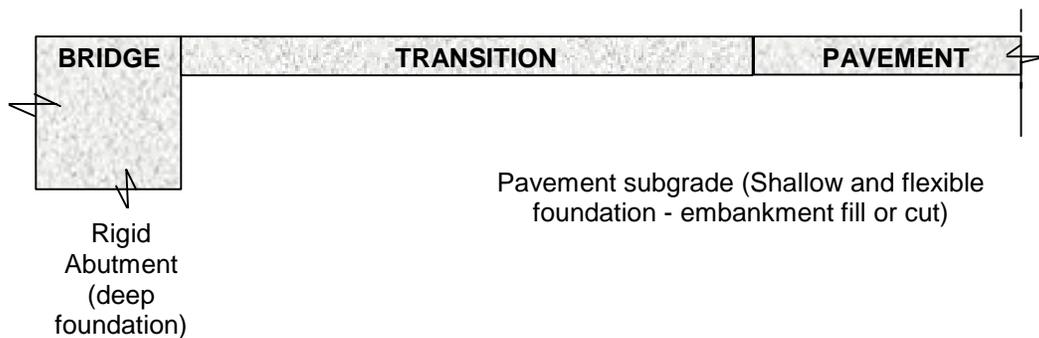
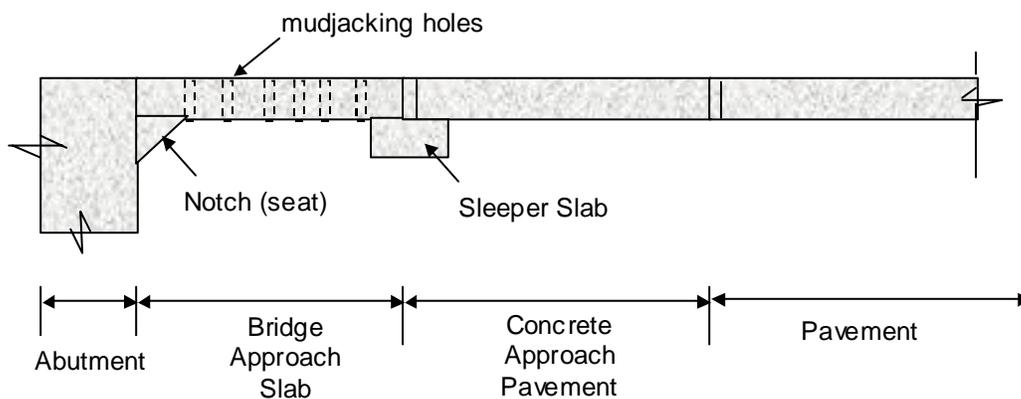
(a) General Concept

(b) MoDOT Design (1993)
