VIDEO ENFORCEMENT FOR HOV LANES: FIELD TEST RESULTS FOR THE I-30 HOV LANE IN DALLAS

Report 2901-S
Research Project Number 7-2901
Research Project Title: Use of Advanced Technology in HOV Lane Enforcement

July 1998

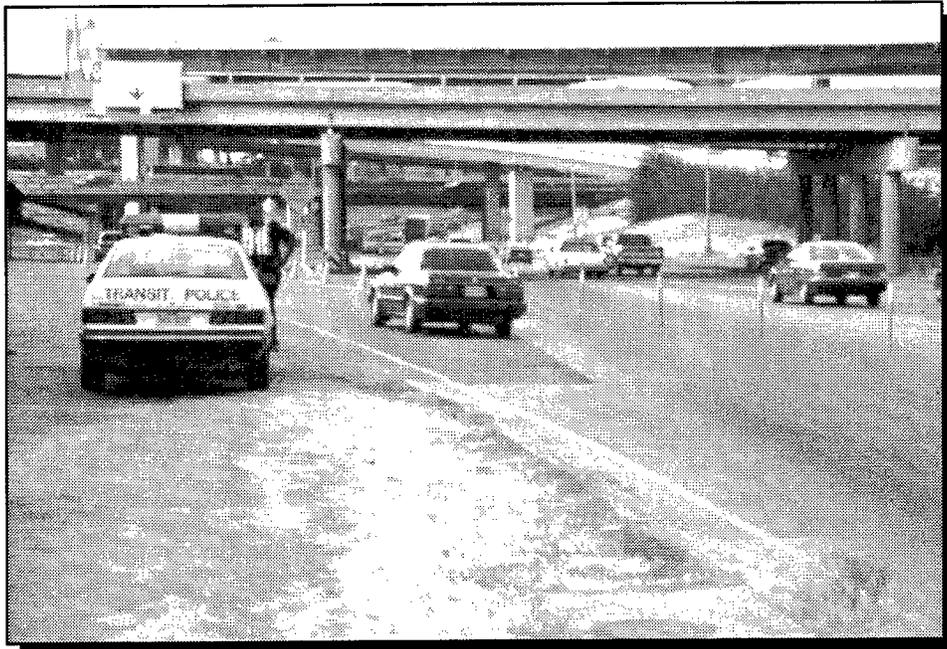
Figure 1. Manual Enforcement of East R.L. Thornton (I-30) HOV Lane (looking into lane entrance)

Current methods of HOV lane enforcement used in the Dallas area rely on DART transit police to position themselves near the HOV lane to observe vehicle occupancy compliance (Figures 1 and 2). To adequately view vehicle compartments to ensure occupancy compliance, most police officers must stand near the high-speed traffic lanes. The police officers patrolling the HOV lanes typically work in pairs, with a second officer downstream of the first officer to apprehend violators not stopping at the upstream officer. Alternatively, a single officer may pursue a violator along the HOV lane. These current enforcement methods have kept violation rates below 10 percent on the three existing HOV lanes, but safer, more cost-effective methods are being sought to improve the current state-of-the-practice in HOV lane enforcement.

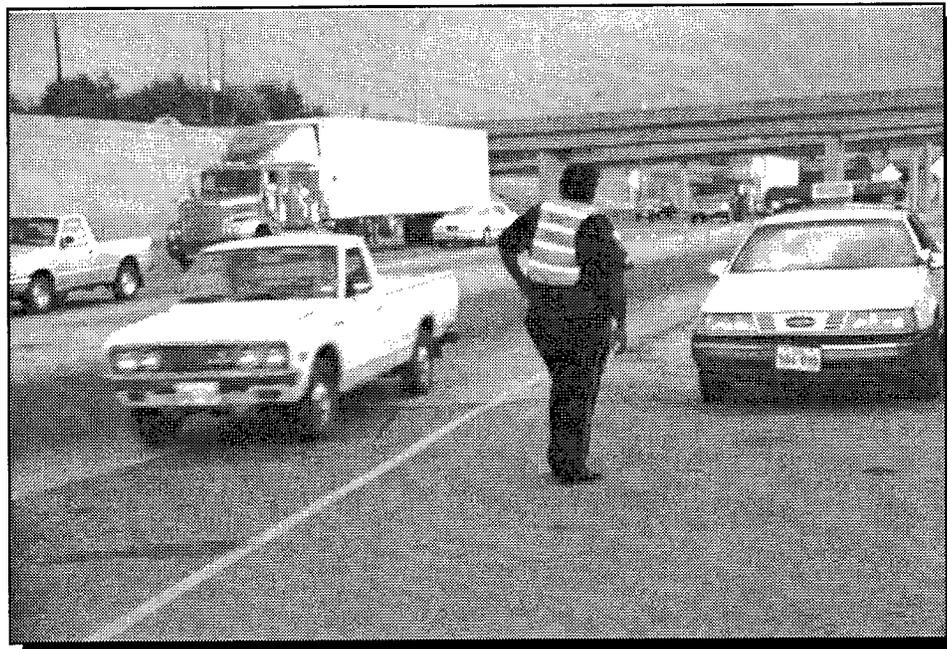
Figure 2. Manual Enforcement of East R.L. Thornton (I-30) HOV Lane (looking away from lane entrance)

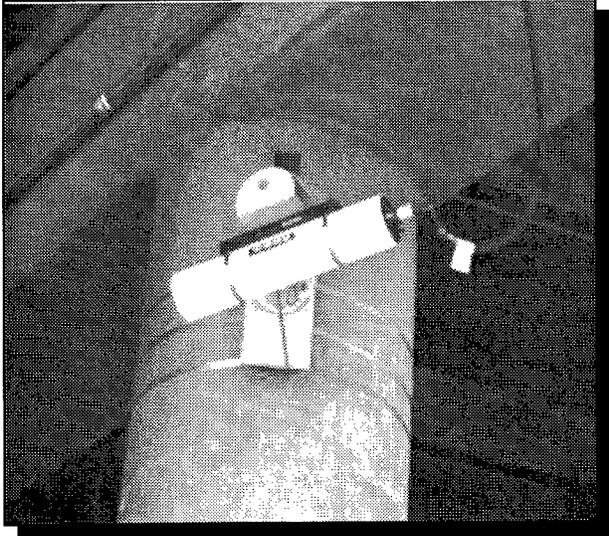
**Figure 3. Front View Video Camera,
HOVER System**

Two video cameras are used to capture front and side images of vehicle compartments (Figures 3 and 4). A third video camera collects synchronized images of the rear vehicle license plate (Figure 5). The cameras are capable of operating in low-light conditions with supplemental lighting (Figure 6) as required.

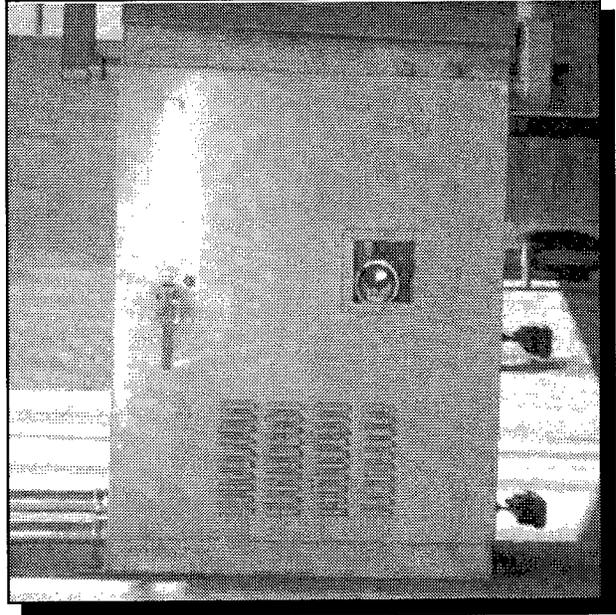
**Figure 4. Side View Video Camera,
HOVER System**

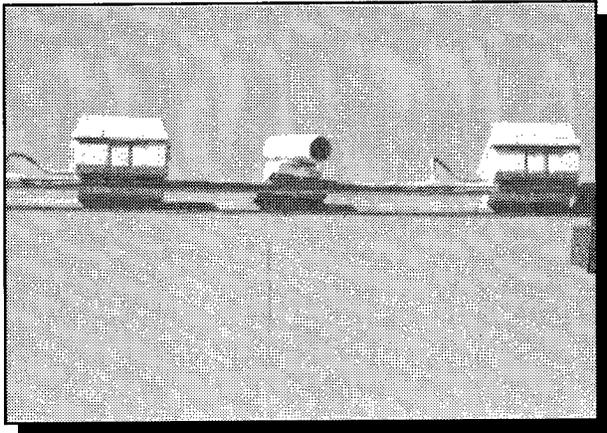
**Figure 5. License Plate Video Camera,
HOVER System**

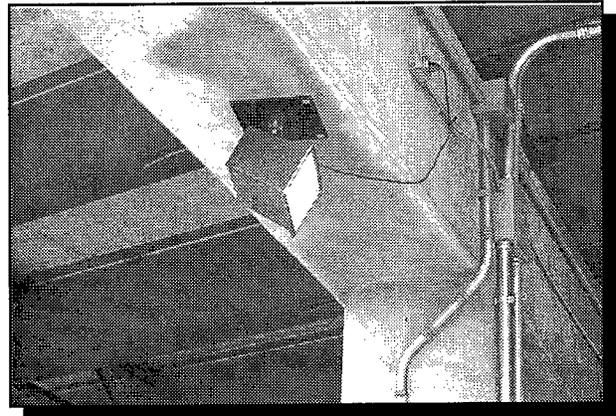
**Figure 6. Supplemental Lighting,
HOVER System**

- The lack of adequate supplemental lighting prevented the researchers from performing any evaluation tests in low light. Transfo supplemented the original low-powered lights with flood lights. Because the I-30 HOV lane operates only between 4 p.m. and 7 p.m. in the evening, low-light conditions are not able to be tested until later in the fall of 1998 when Central Standard Time returns.

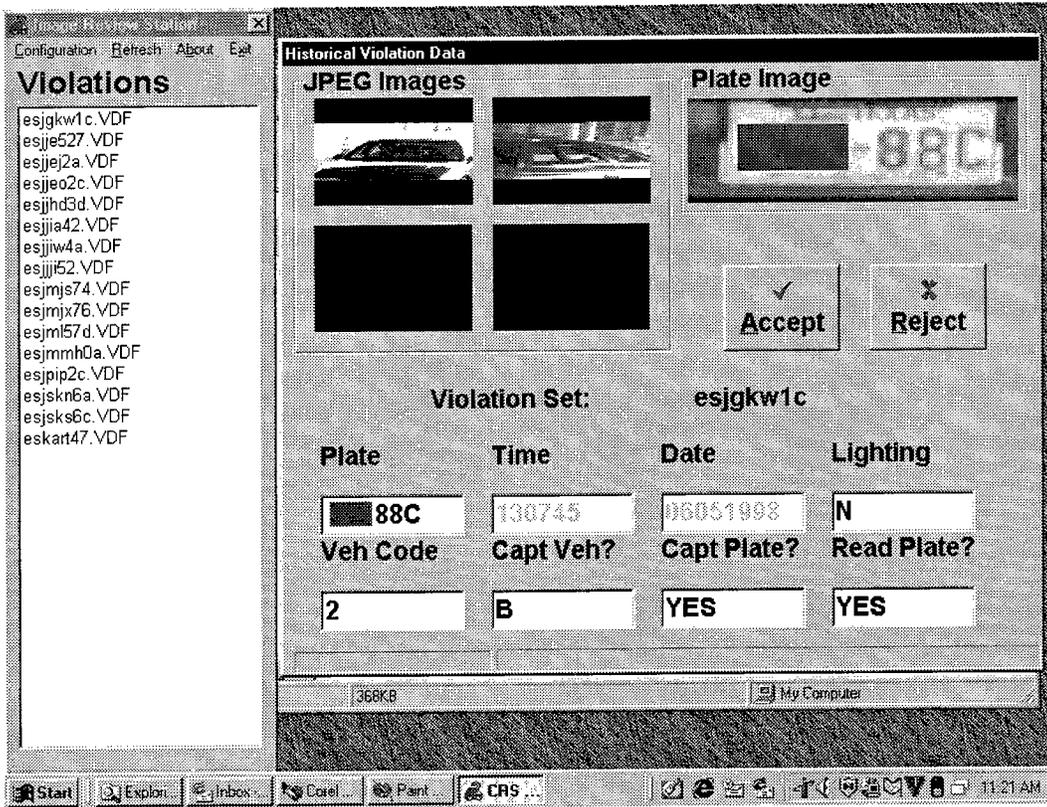
Figure 7. HOVER Enforcement Workstation Interface

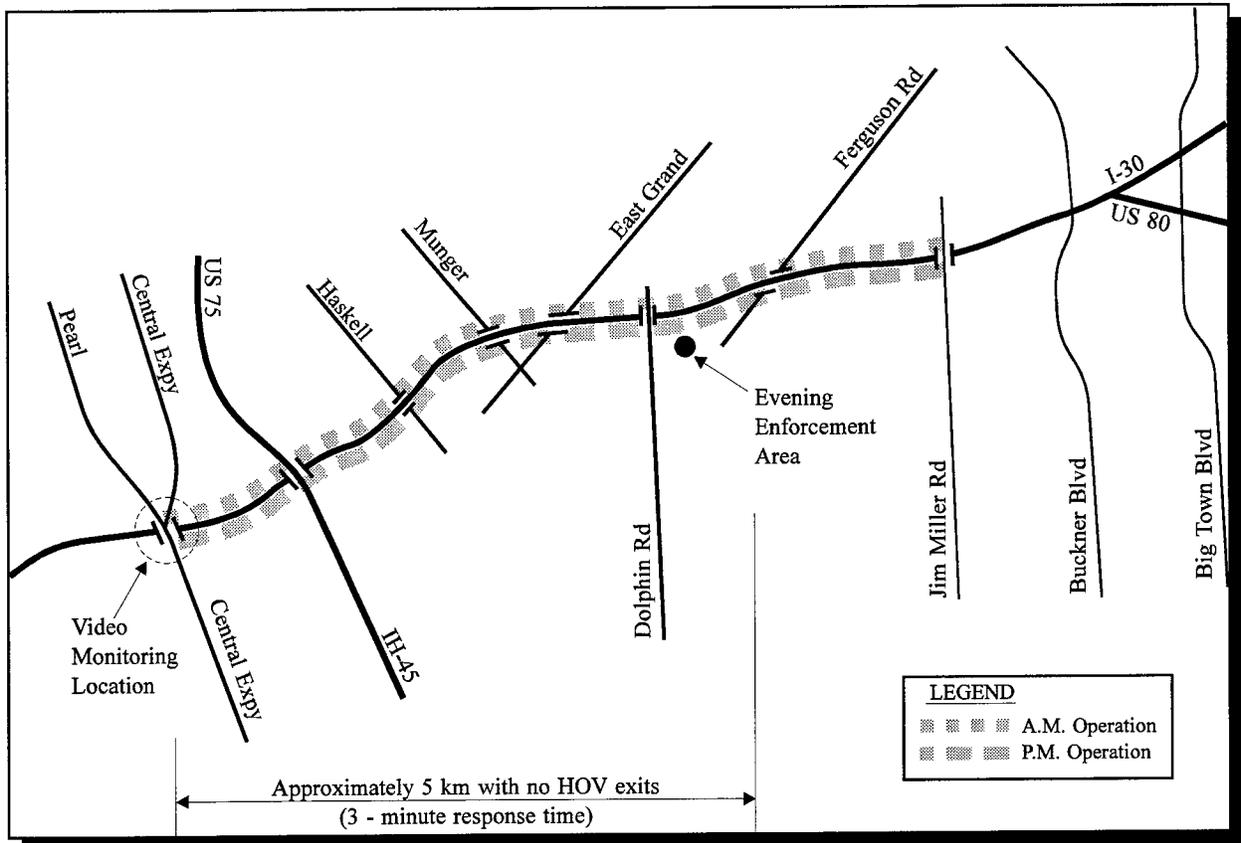
Figure 9. Operational Testing of the HOVER System
