Research Report  
KTC-98-23

## EVALUATION OF REFERENCE MARKERS (Interim Report)

**EVALUATION OF REFERENCE MARKERS**  
(Interim Report)

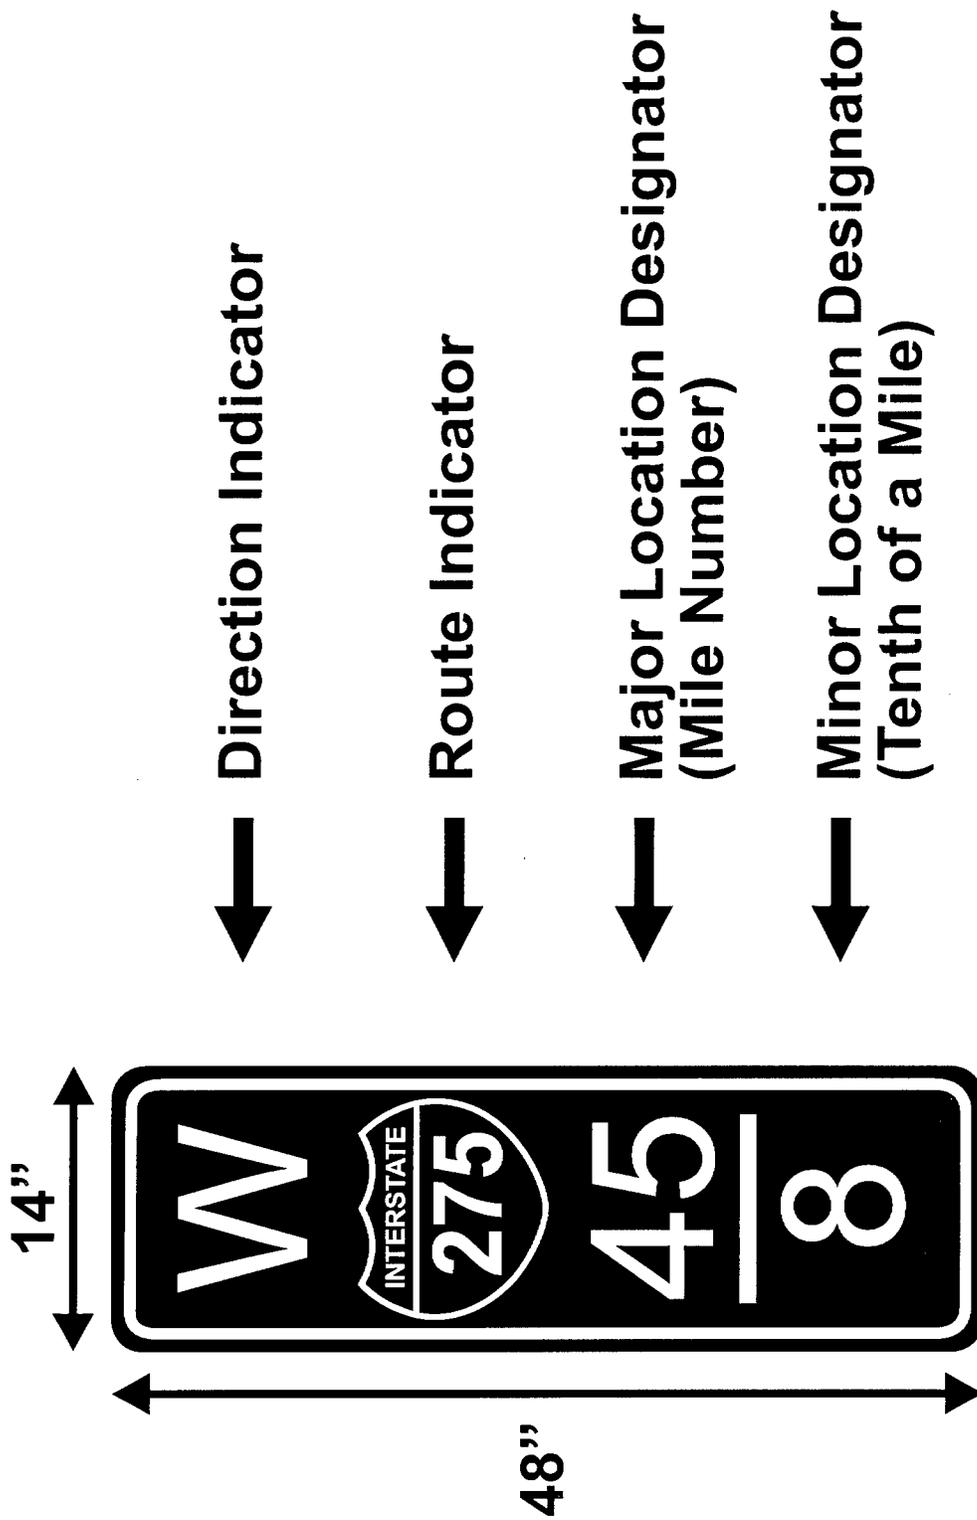
Figure 1. Schematic Showing Mainline Reference Marker Used in the ARTIMIS Project.

Installations to evaluate the use of “white on blue” versus “white on green” markers were completed in the fall of 1994 and the evaluation report was completed in the summer of 1995 (1). The reference markers were installed on the mainline and ramps for approximately three miles of I-275 (between Mosteller Road and US 42) east of I-75 in Cincinnati. The experimental mainline reference markers had white letters on blue background for westbound traffic on I-275; with the marker containing information related to direction of travel, interstate route number, milepost number, and a number representing the tenth of a mile segment between mileposts. The “white on blue” mainline reference marker was 14 by 48 inches and mounted in the median on the concrete barrier wall where practical. For eastbound traffic, the markers were white letters on green background, 12 inches by 48 inches in size and placement generally consistent with the standard milepost marker. The “white on green” reference markers had MILE in 4-inch letters at the top, with vertically stacked 8-inch numbers indicating the milepost and tenth of a mile segment. A schematic showing the mainline marker and message dimensions is presented in Figure 1. Ramp markers used in the test section were also white letters on blue background. The marker size was 30 by 30 inches, with the message RAMP at the top of the marker and the message indicating where the driver would be coming from and going to when using the ramp. A schematic showing the ramp marker used as part of ARTIMIS is shown in Figure 2.

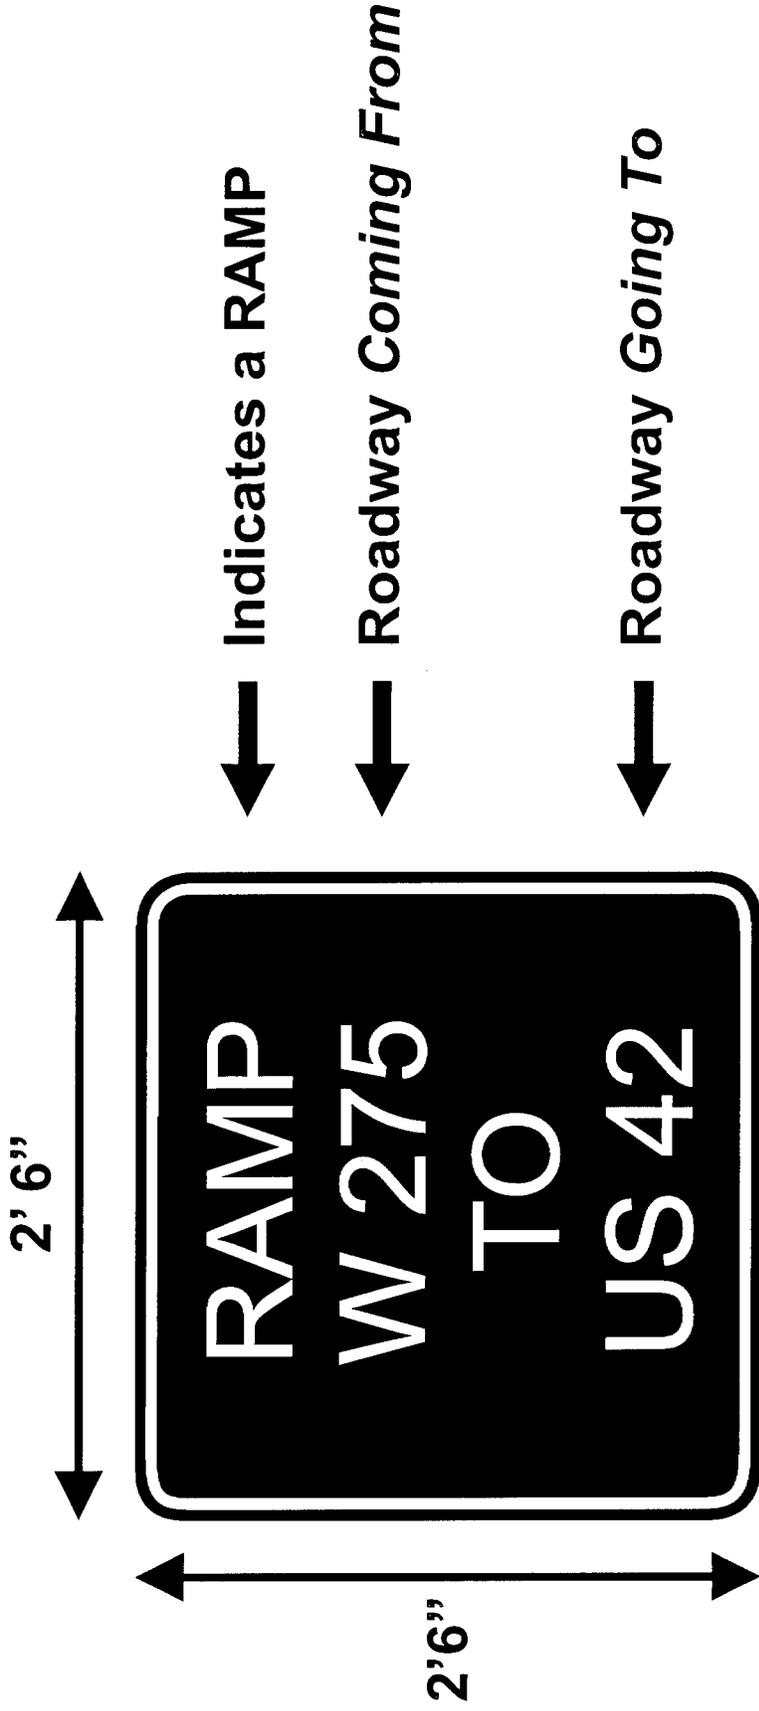
Figure 2. Schematic Showing Ramp Reference Marker Used in the ARTIMIS Project.

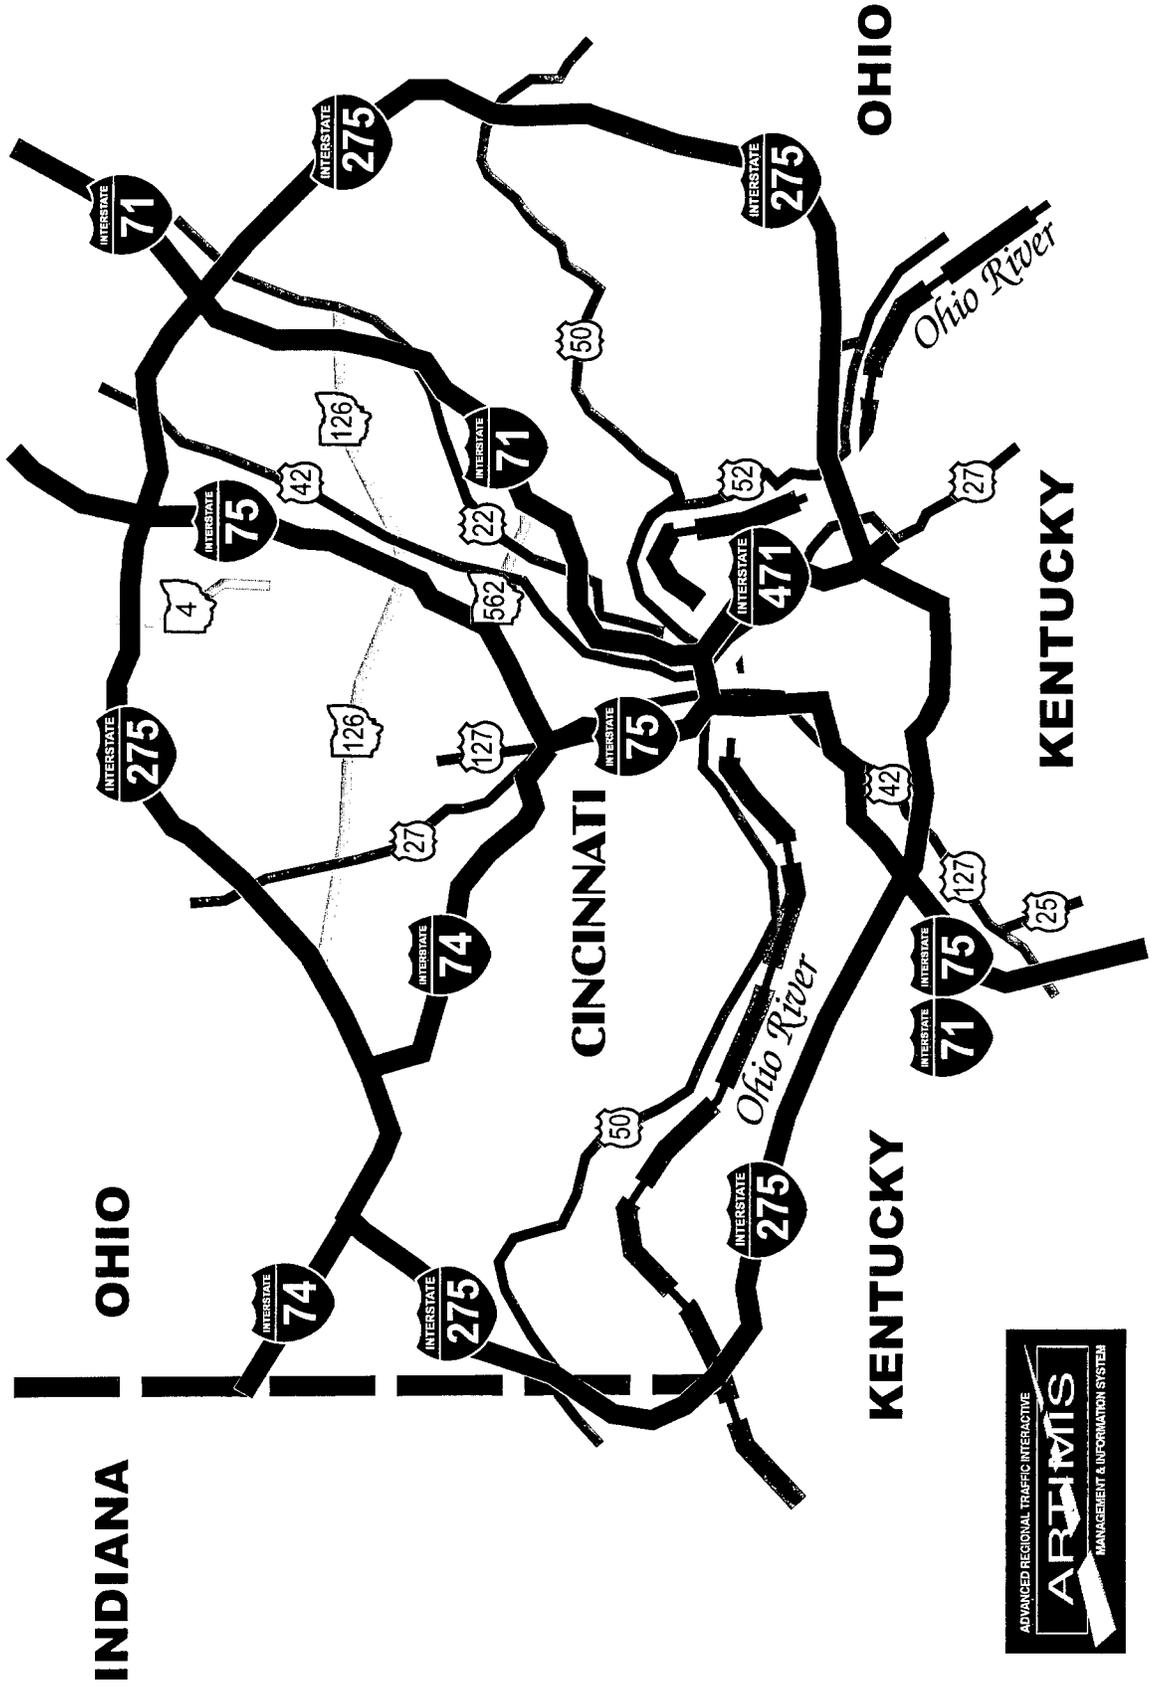
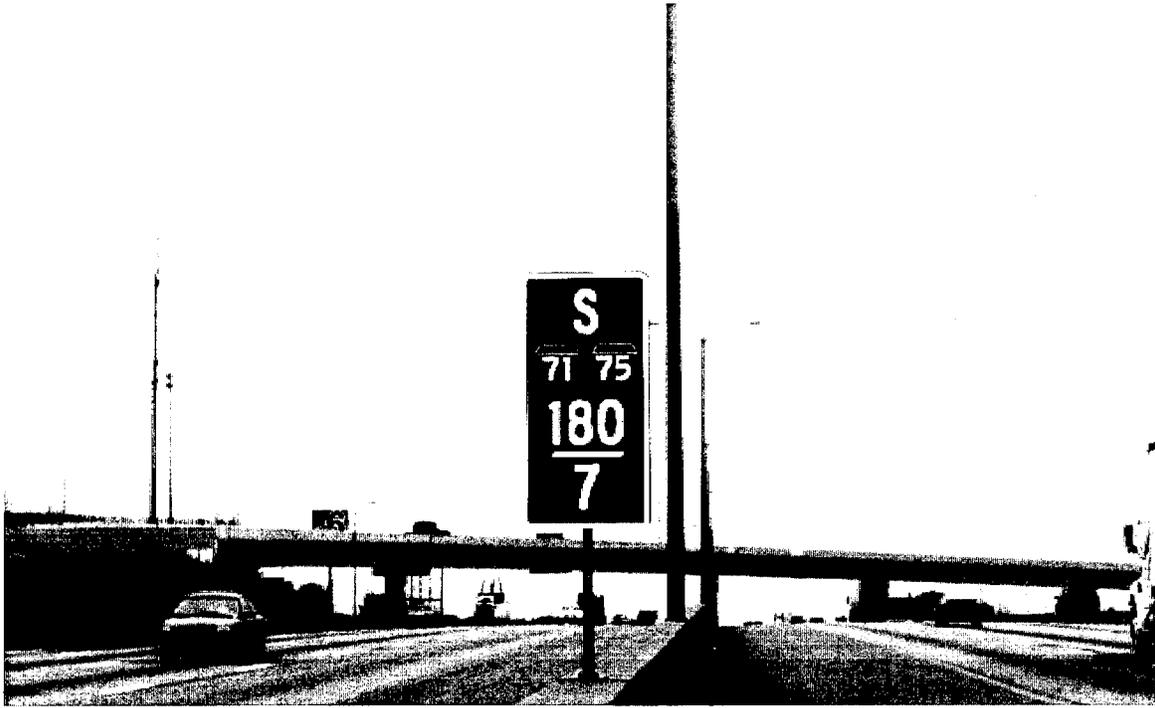
Figure 3. Map Showing Reference Marker Installations - ARTIMIS Project.

The primary installation of reference markers began in the summer of 1995 and all markers were installed in Ohio by June 1996. Installations were delayed for the Kentucky sections due to contract scheduling and were completed, with the exception of a few markers, in July 1997. Where concrete median barriers existed on the routes, the markers were installed on the barrier wall using a short post. On sections without median barrier walls, the markers were installed in the left median area on 2-inch square posts, and mounted back-to-back to allow viewing the markers from both directions. Highways on which reference markers have been installed include I-71, I-74, I-75, I-275, I-471, the Ronald Reagan Highway and the Norwood Lateral (OH Route 562). A map showing the locations where markers have been installed as part of the ARTIMIS project and other installations is presented in Figure 3. Examples are shown for

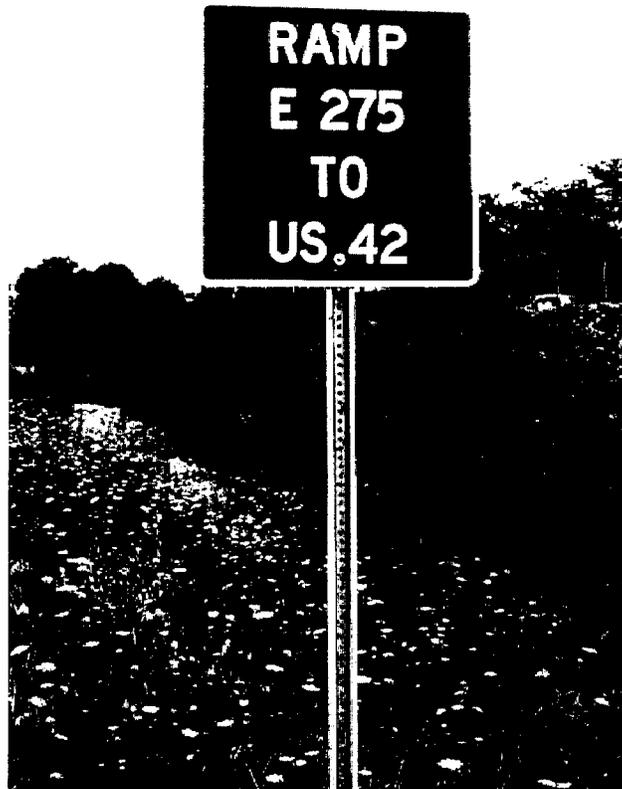
Figure 4. Photograph of Reference Marker Used in the ARTIMIS Project.

the ARTIMIS mainline markers in Figure 4 and the ramp markers in Figure 5.

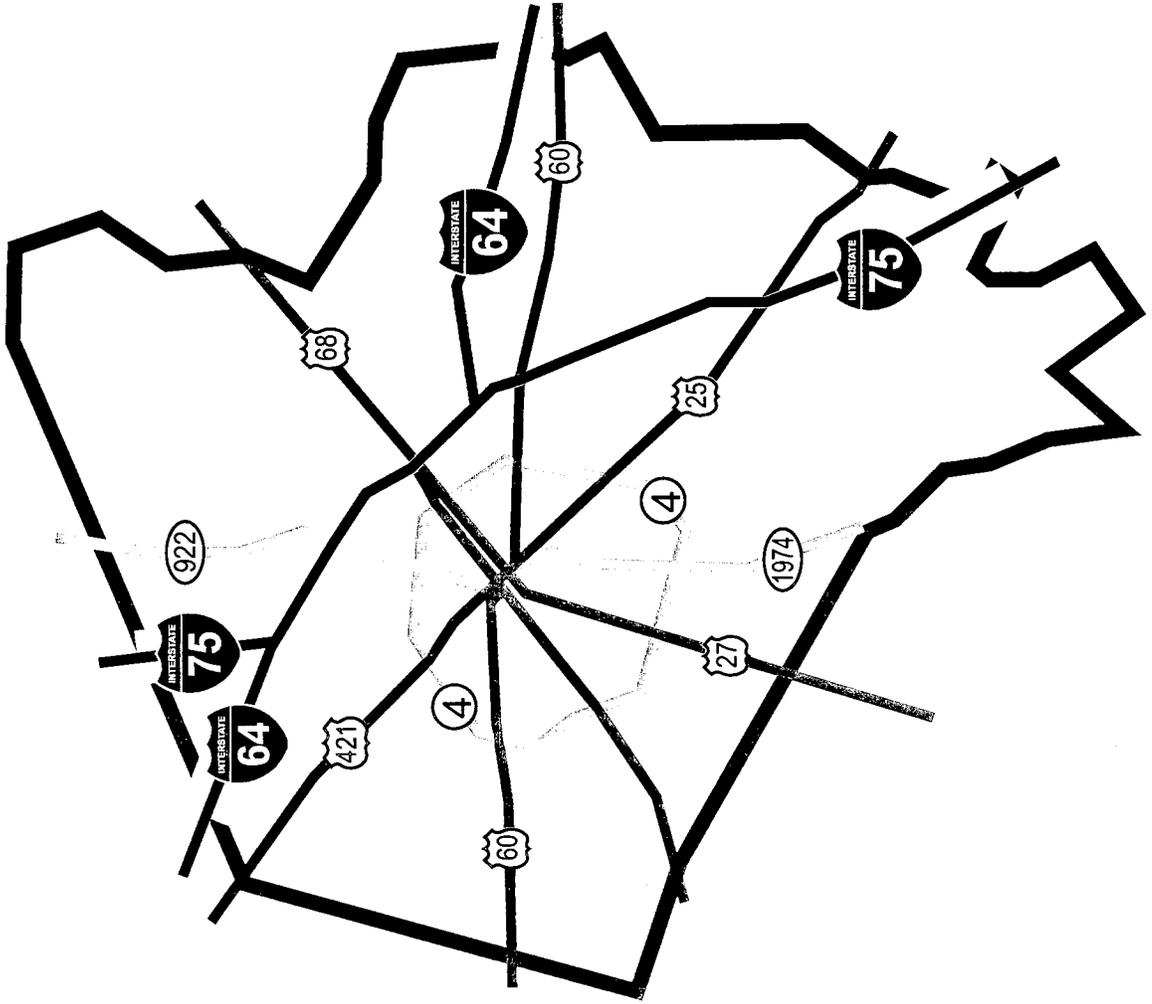
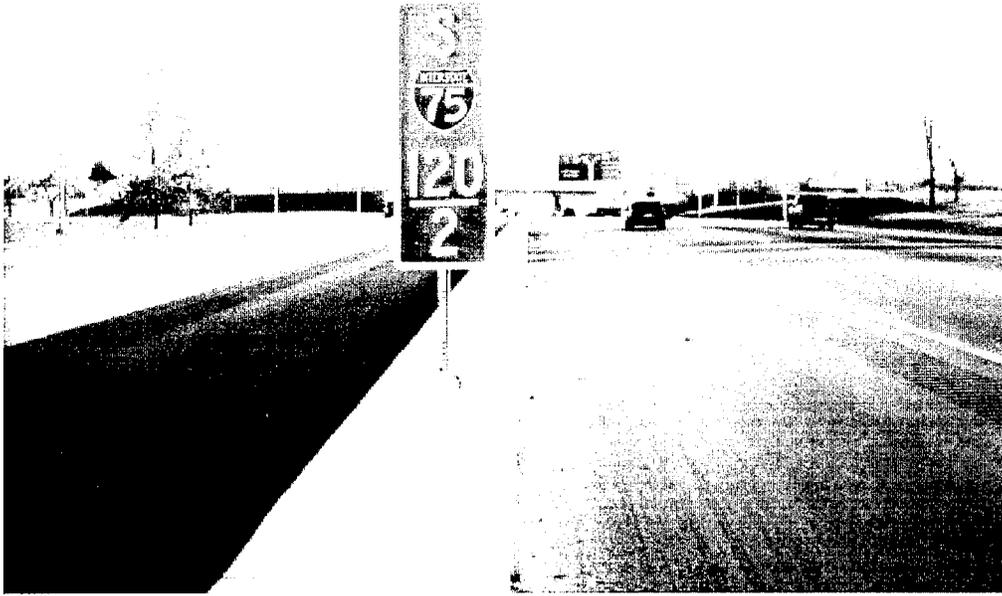
Figure 6. Map Showing Reference Marker Installations -- Lexington-Fayette County.

The reference markers in Lexington-Fayette County were installed on I-64 and I-75, the two interstates which traverse the county. Installation began in the summer of 1997 and was completed in October 1998. The first phase of installation included the section of I-75 between mileposts 105.6 and 120.0, and all interchanges except KY 418 which was being reconstructed. The second phase included the remaining sections of I-75 between mileposts 97.6 and 105.6, and all of I-64 in Fayette County. Materials were purchased and fabricated by the Lexington-Fayette Urban County Division of Traffic Engineering, and a separate contract was awarded for installation of the markers. A total of 322 mainline markers and 84 ramp markers were installed, with a materials cost of \$43,749 and an installation cost of \$15,220. This resulted in a cost per marker of approximately \$145. Excluded were the fabrication costs assumed by Lexington-Fayette Urban County Division of Traffic Engineering. Markers have been installed on the median barrier wall where possible, which includes most of I-75 in Fayette County except for a short section north of the Clays Ferry Bridge. On I-64, the markers have been installed on the right side rather than the median, apparently for the convenience of maintenance crews. A map showing locations of reference marker installations in Fayette County is presented in Figure 6. A photograph showing an example of the mainline reference marker used in Fayette County is shown in Figure 7 and a ramp marker is shown in Figure 8.

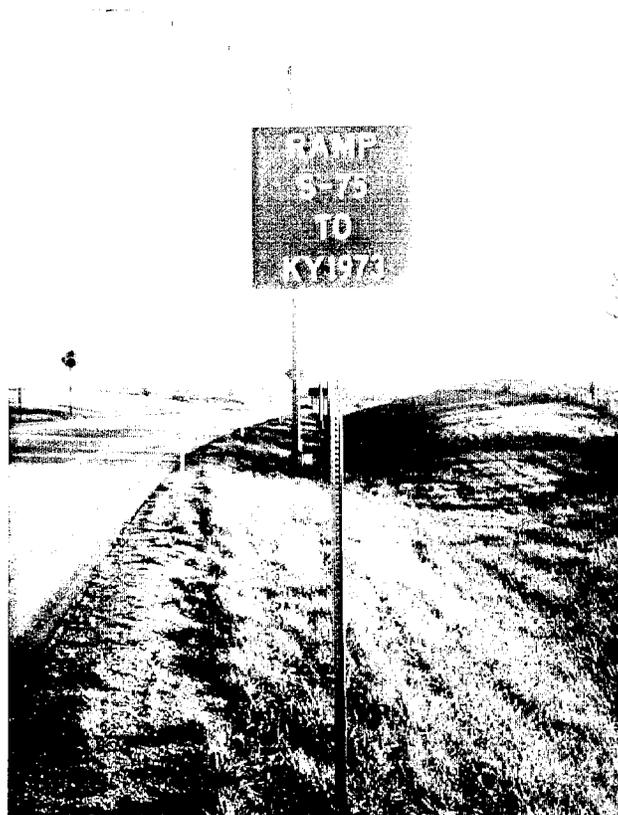
Figure 7. Photograph of Reference Marker Used in Lexington-Fayette County.

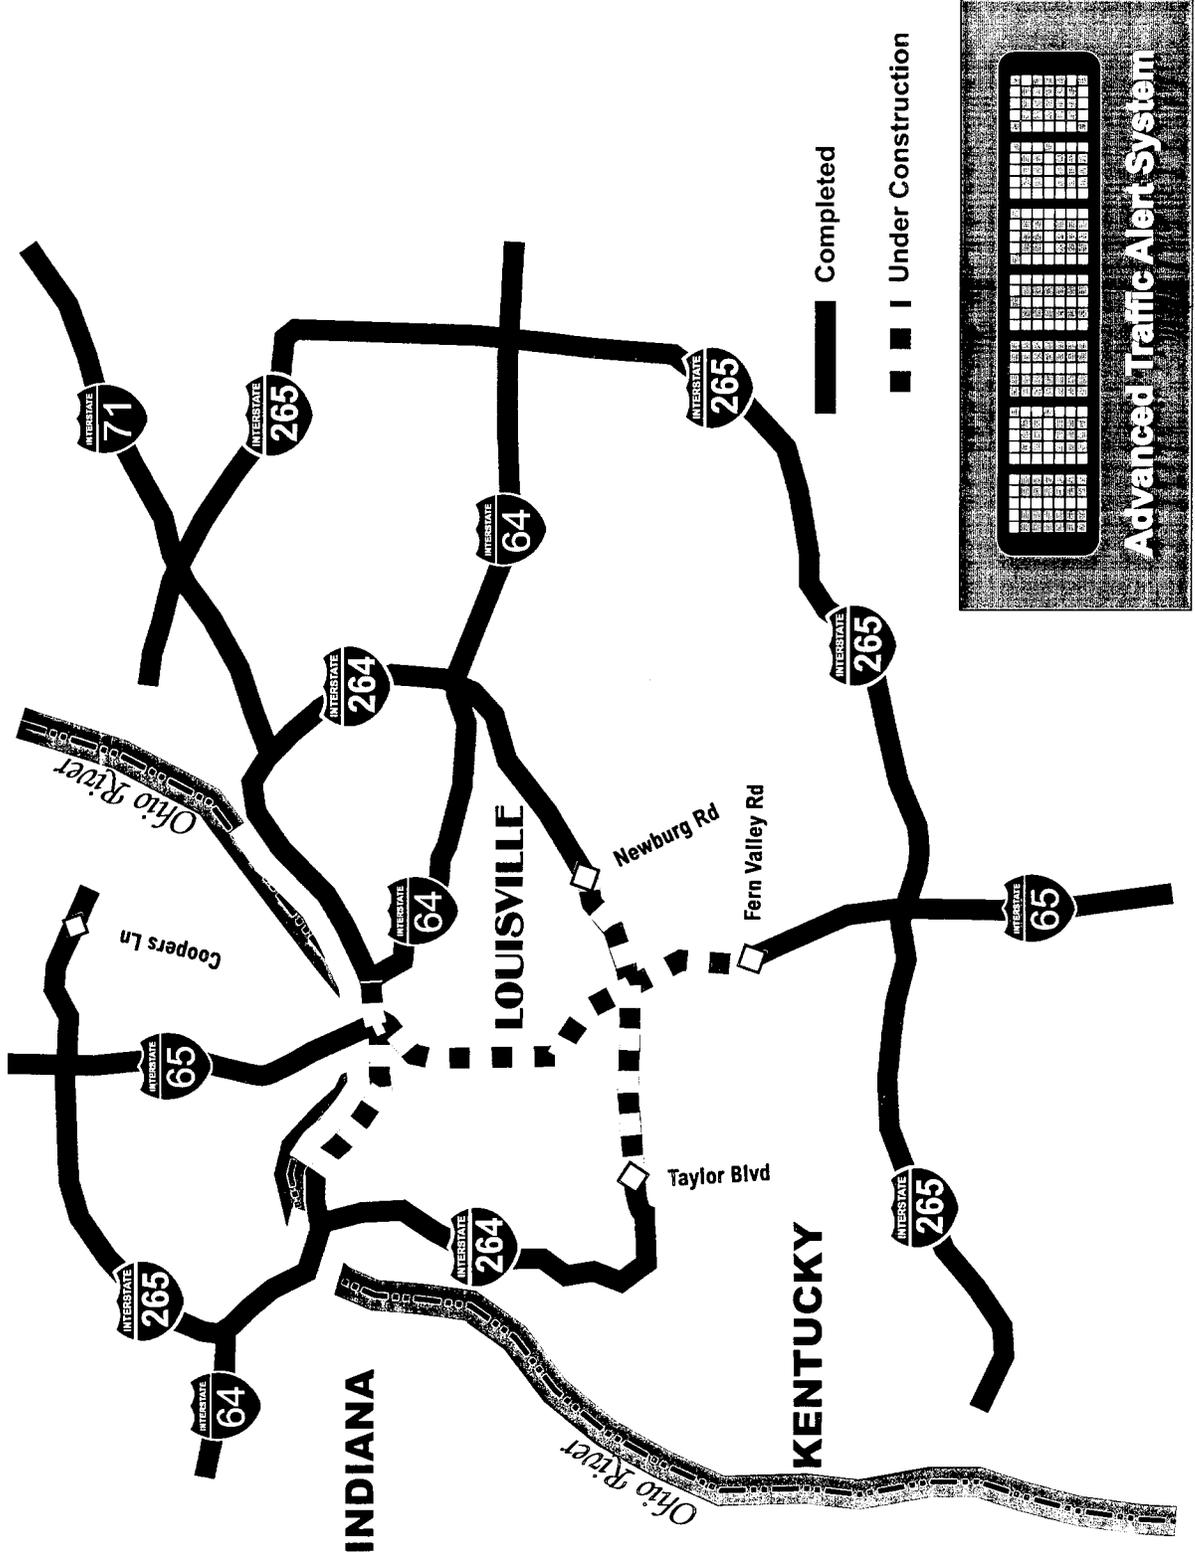
Figure 9. Map Showing Reference Marker Installations - TRIMARC Project.

The reference markers in Louisville and southern Indiana will be installed on sections of I-64, I-65, I-71, I-264, and I-265. A map showing the reference marker installations in the TRIMARC area is presented in Figure 9. As of December 1998, all markers had been installed in Indiana and in Kentucky on sections of I-64 between mileposts 6.0 and 9.0 and I-71 between mileposts 0.0 and 3.0. Sections where markers had not yet been installed in December 1998 included I-64 between mileposts 2.0 and 6.0, I-65 between mileposts 128.0 and 137.0, and I-264

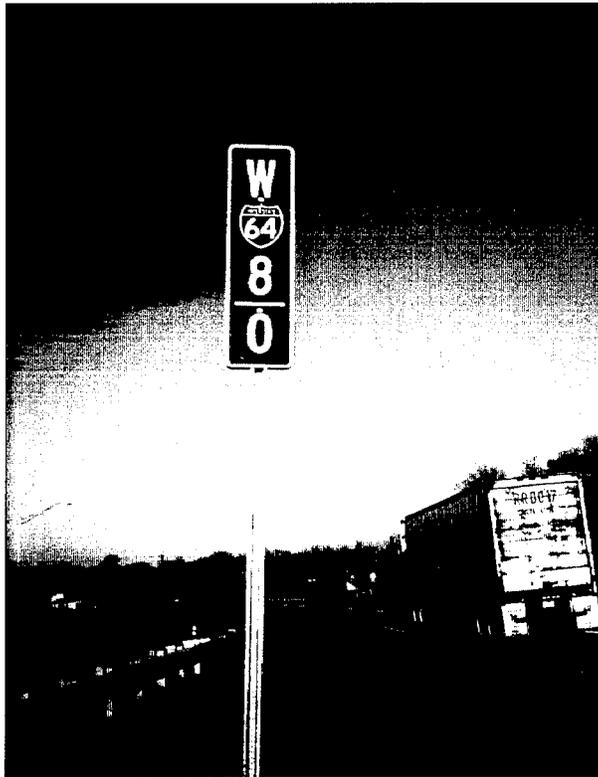
Figure 10. Photograph of Reference Marker Used in TRIMARC Project.

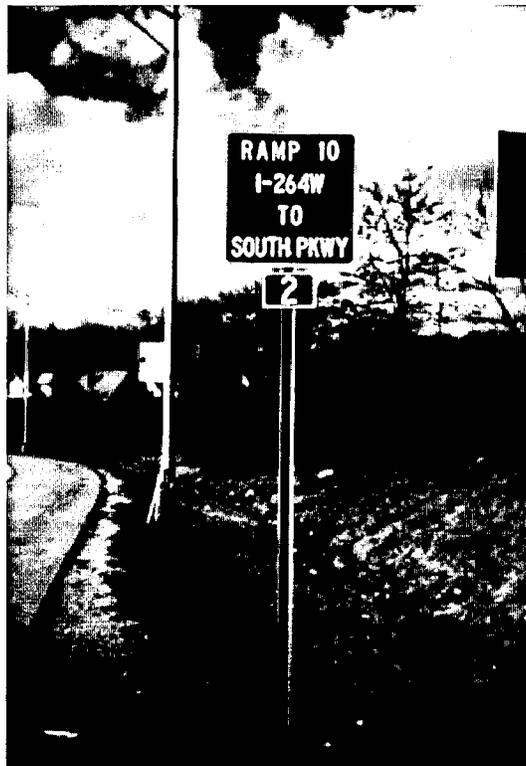
Figure 11. Photograph of Ramp Marker Used in TRIMARC Project.

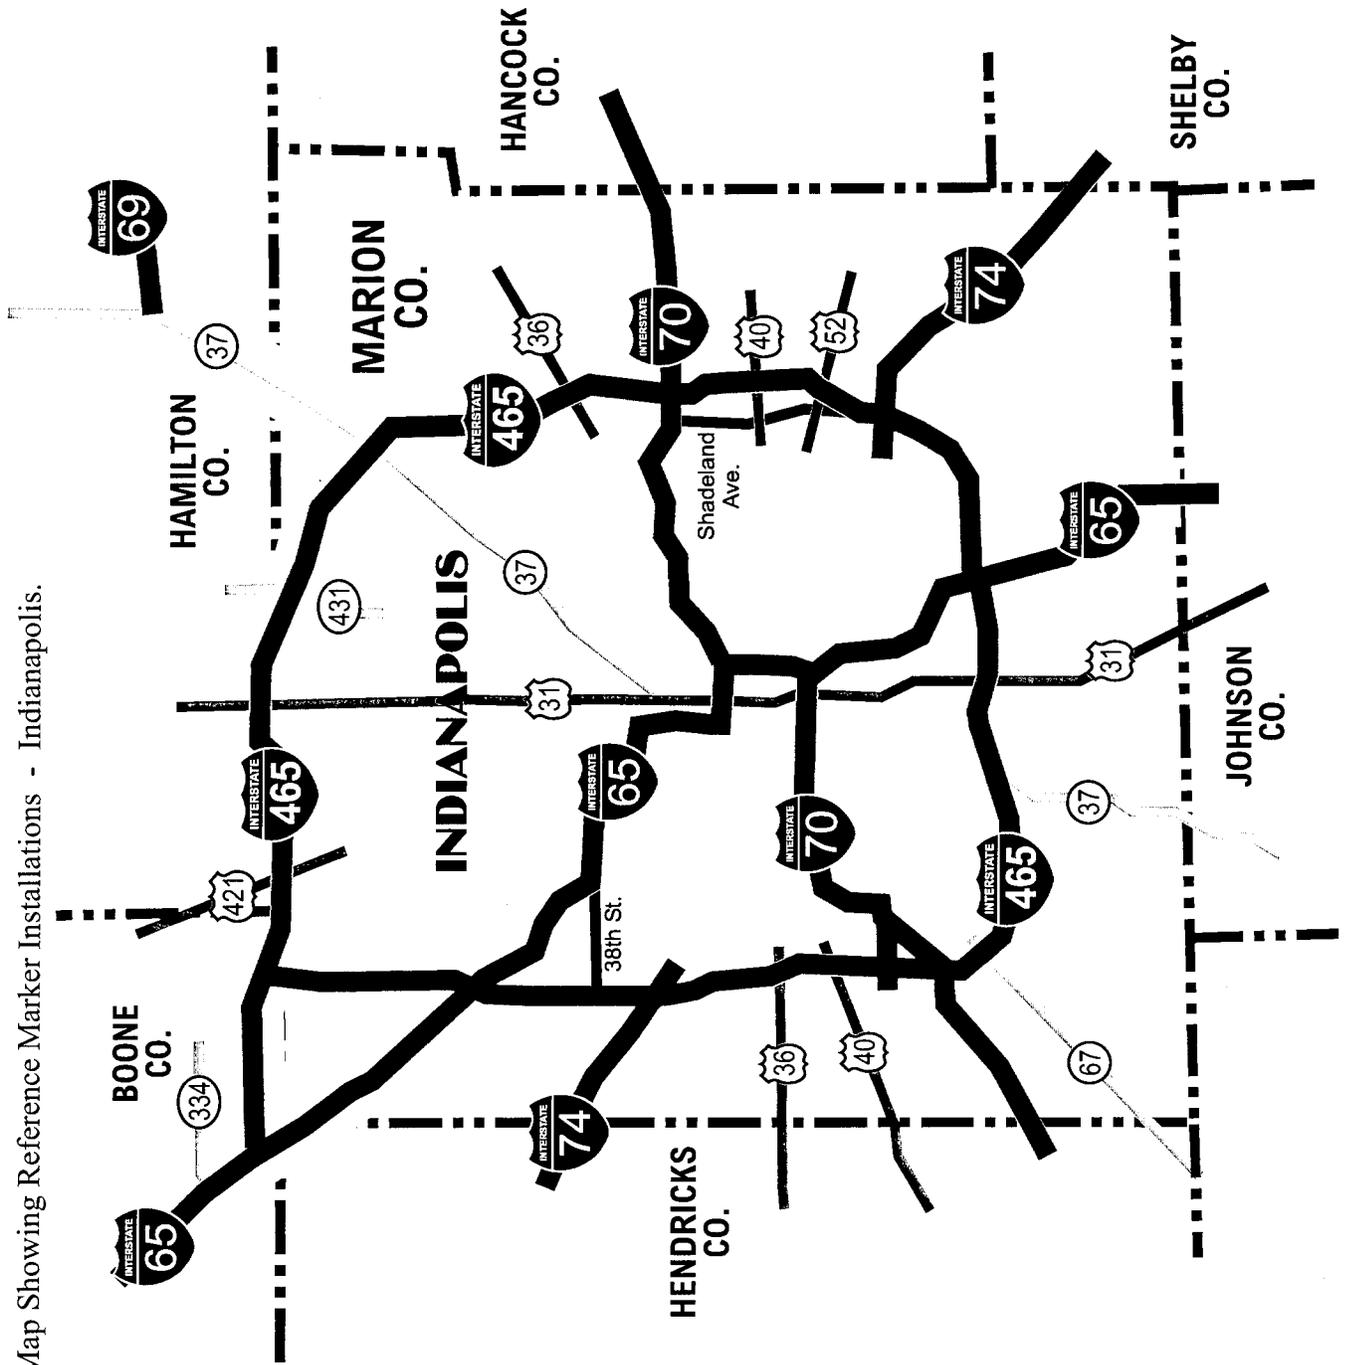
Figure 12. Map Showing Reference Marker Installations - Indianapolis.

The reference marker installations in the Indianapolis area were completed in the summer of 1998. The markers were installed on all interstates within the urban area, including I-65, I-69, I-70, I-74, and I-465. A map identifying routes where markers have been installed is shown in Figure 12. A numbering scheme similar to the TRIMARC project was used on ramp markers in the Indianapolis area to insure the uniqueness of routes which may intersect other routes at more than one point. There were 1,190 mainline markers and 320 ramp markers. This was a total of 1,510 markers which were installed at a cost of \$231,728; or an average cost of \$153 per marker. This cost did not include the contract bid items related to maintenance of traffic, mobilization, construction engineering, and the project field office. A summary on the status and experiences of the Indianapolis project as documented by the Indiana Department of Transportation is attached as Appendix A (3).
