ANALYTICAL AND EXPERIMENTAL EVALUATION OF AN ALUMINUM BRIDGE DECK PANEL

PART II: FAILURE ANALYSIS

1. Report No. FHWA/VTRC 00-R5		2. Government Accession No.		3. Recipient's Catalog No.	
4. Title and Subtitle Analytical and Experimental Evaluation of an Aluminum Bridge Deck Panel Part II: Failure Analysis				5. Report Date September 1999

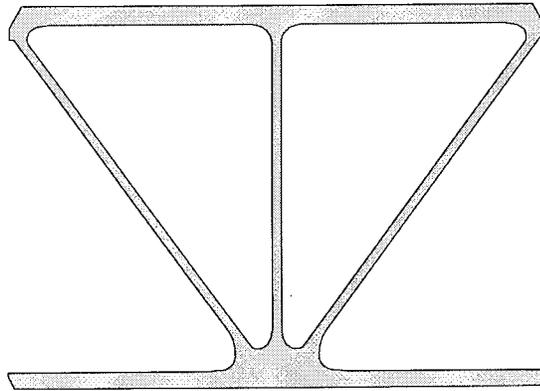
Figure 1. Extrusion Cross Section

As explained in the previous report (Dobmeier, et al., 1999), the aluminum bridge deck is a multi-voided structure. These voids arise from the hollow extrusions used to construct the deck. The system analyzed in this study consists of the two-voided extrusion shown in Figure 1. These extrusions are fabricated from 6063-T6 aluminum, which has a minimum tensile yield strength of 172.4 MPa (25 ksi) and a minimum ultimate strength of 206.8 MPa (30 ksi). A deck is formed by welding extrusions together at the top and bottom flanges.

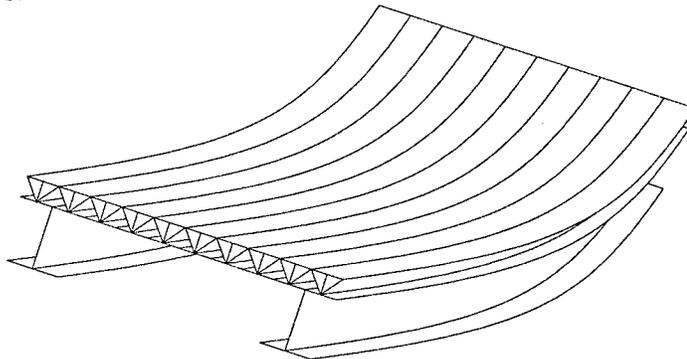
System I Stresses—Longitudinal Bending of the Composite Deck/Girder Section

System II Stresses—Transverse Bending of the Deck Between Girders

System III Stresses—Localized, Transverse Bending of the Top Deck Flange

Figure 2. Three Stress Systems Developed in the Deck

Although the resulting deck is nearly isotropic, the panel is typically oriented with extrusions parallel to the supporting girders and the flow of traffic. When installed in this manner, the stresses developed under loading can be categorized into the three stress systems shown in Figure 2. System I stresses are generated by longitudinal bending of the composite panel-girder unit. System II stresses result from the panel bending transversely between the supporting girders. Bending the top deck flange transversely between the stiffeners creates System III stresses. System III stresses are local effects present only in the vicinity of concentrated wheel loads.

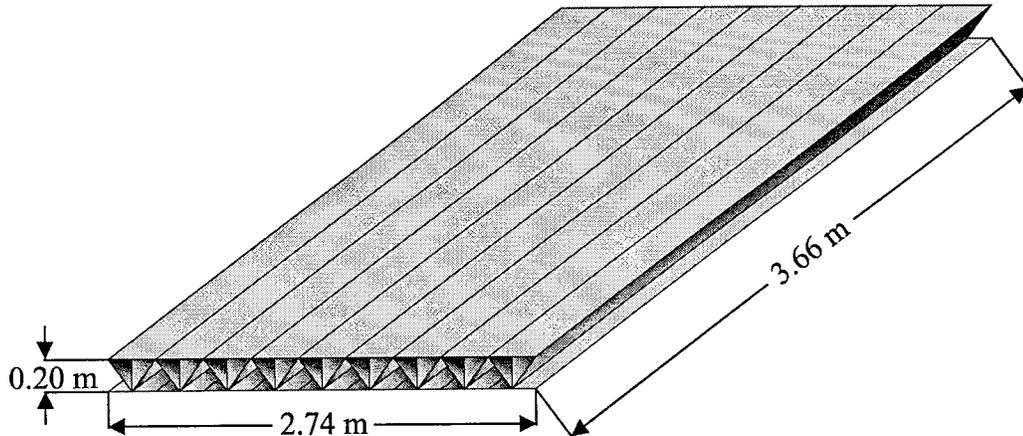
Figure 3. Dimensions of the Panel Tested in the Laboratory

The ultimate-load tests were conducted on the same deck panel used in the service-load tests. This panel consisted of nine extrusions, each measuring 0.30 m (1 ft) wide and 3.66 m (12 ft) long. These extrusions were welded together at the top and bottom flanges to form a deck section 2.74 m (9 ft) wide and 3.66 m (12 ft) long. An illustration of the system is provided in Figure 3.

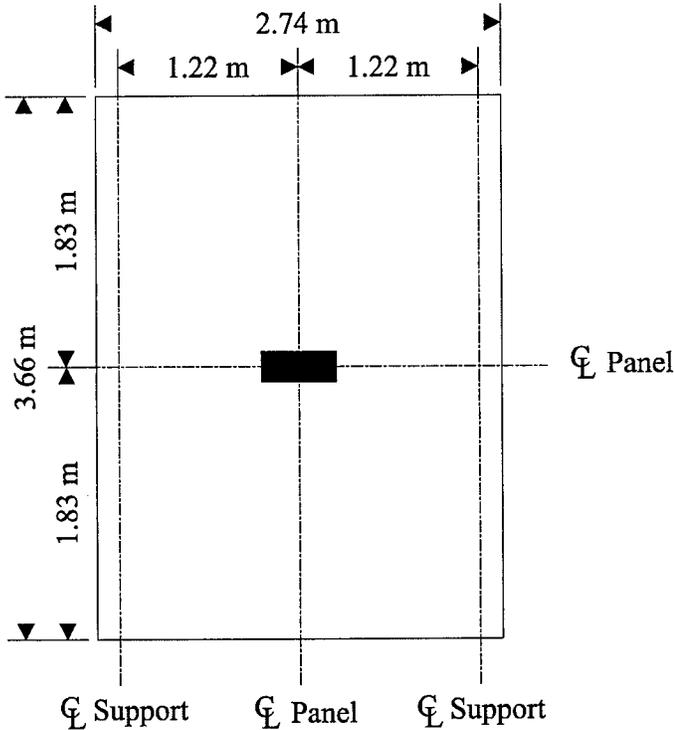
Figure 6. Experimental Setup for the First Ultimate-Load Test

The first ultimate-load test of the panel used the support conditions and loading configuration similar to that expected in the field. The panel was simply supported along the two 3.66 m (12 ft) sides and loaded in the center of the panel. Figure 6 illustrates the experimental setup. The applied load was distributed over a 50.80 cm x 21.59 cm (20 in x 8.5 in) neoprene patch, which was intended to simulate the contact area of dual tires on an AASHTO HS-20 truck. The load was initially applied at a rate of 222.41 N (50 lb) per second with gage readings taken every 4.45 kN (1 kip). Once the magnitude reached the 94.75-kN (21.3-kip) mark, the loading rate was increased to 444.82 N (100 lb) per second, and gage readings were taken approximately every 22.24 kN (5 kips). At a load of 556.03 kN (125 kips), loading was suspended while the load frame was stiffened, and then the testing was resumed. At a load of approximately 831.82 kN (187 kips), deck compliance changed, and the sustainable load dropped to 814.02 kN (183 kips). Testing was temporarily discontinued because a closer inspection revealed that the stiffeners near the load patch had buckled.

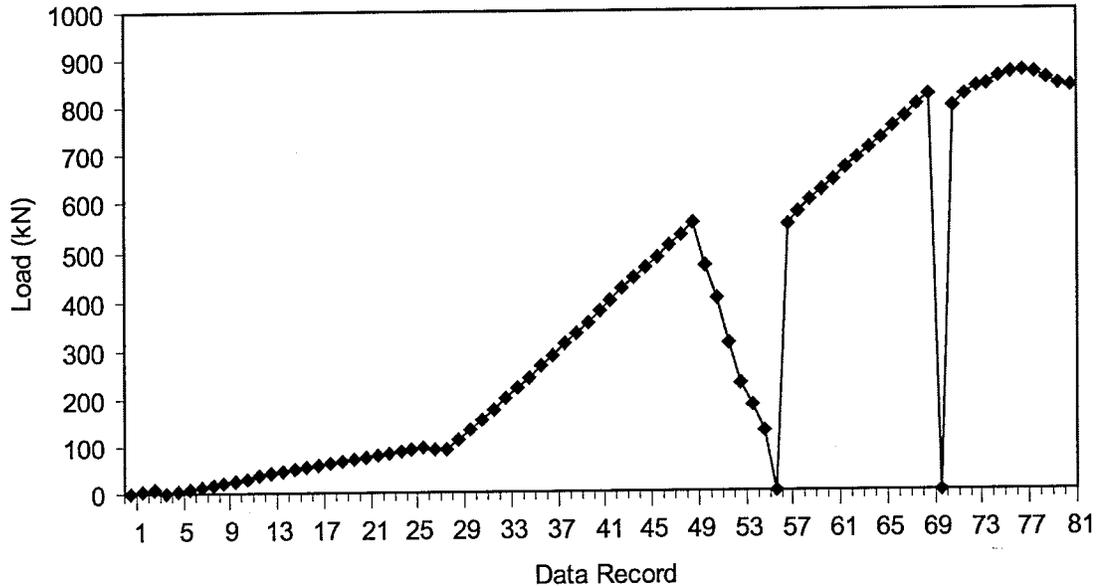
Figure 7. Load History of the First Ultimate Load-Test

To determine if the deck possessed additional capacity, loading was continued, and the load was immediately taken back to 800.68 kN (180 kips). From this value, loading increased at a rate of approximately 222.41 N (50 lb) per second, with data recorded every 4.45 kN (1 kip). The deck finally achieved a maximum load of 871.85 kN (196 kips), at which point local yielding occurred and the load patch began to punch through the top deck surface. The complete load history of the panel is given in Figure 7.

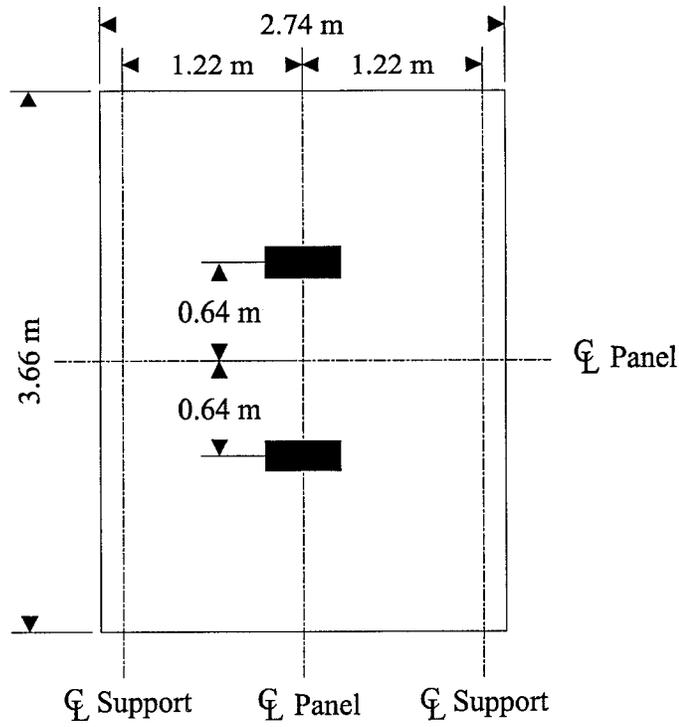
Figure 8. Experimental Setup for the Second Ultimate-Load Test

For the second ultimate-load test, the experimental procedure was similar to that of the first ultimate-load test. Figure 8 shows the configuration of the second test, which developed large stresses perpendicular to the welds. Each hydraulic jack increased the load at a rate of 556.03 N (125 lb) per second. Thus, the total deck load was applied at a rate of 1.11 kN (250 lb) per second. Data was recorded at every 44.48-kN (10-kips) increment of total deck load. A complete load history of the panel for this test is given in Figure 9.

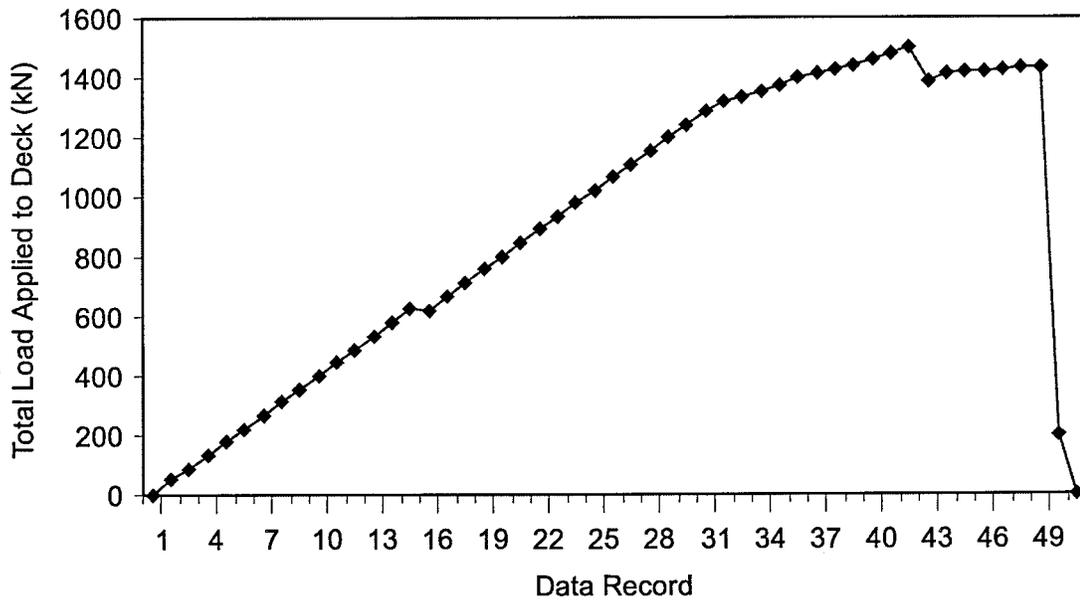
Figure 9. Load History of the Second Ultimate-Load Test

In the second ultimate load test, the panel was loaded incrementally until failure occurred in the same manner as in the first ultimate-load test. As the load history in Figure 9 illustrates, the deck successfully supported a total load of 1512.40 kN (340 kips). The stiffeners began to distort at 622.75 kN (140 kips) of total deck load. At 1512.40 kN (340 kips), a “pop” was heard as a weld on the bottom surface began to fracture. The total deck load immediately dropped to 1387.85 kN (312 kips). Although the deck was damaged, it still possessed substantial capacity. Loading of the structure continued from the 1387.85-kN (312 kip) plateau. At 1441.22 kN (324 kips) of total deck load, another loud “pop” was heard as a bottom weld fractured completely, resulting in total deck failure.

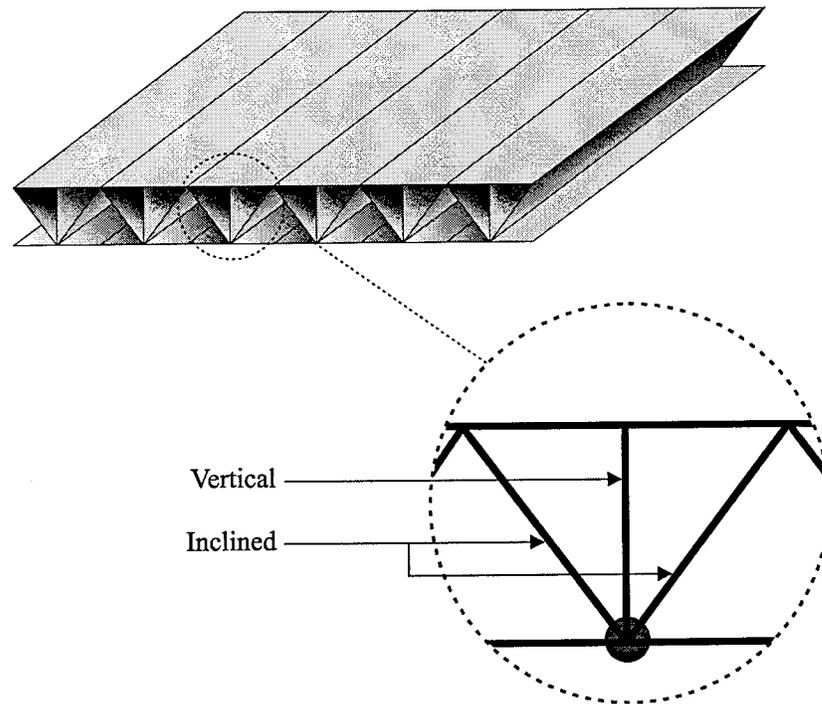
Figure 10. Nomenclature of Stiffeners

To facilitate discussion, the following terminology is used to identify structural members and directions on the panel. The *web stiffeners* are classified by their orientation. The stiffeners with no incline are called *vertical stiffeners*, whereas the inclined stiffeners are identified as simply *inclined stiffeners*. Figure 10 illustrates this notation. Another identification scheme is used to identify the top and bottom plates that bound the stiffeners. The top member is referred to as the *top deck surface* or the *top chord*, and the bottom member is called the *bottom deck surface* or the *bottom chord*. These designations arise from the truss-style design of each extrusion. Figure 11 depicts the various members and their locations.

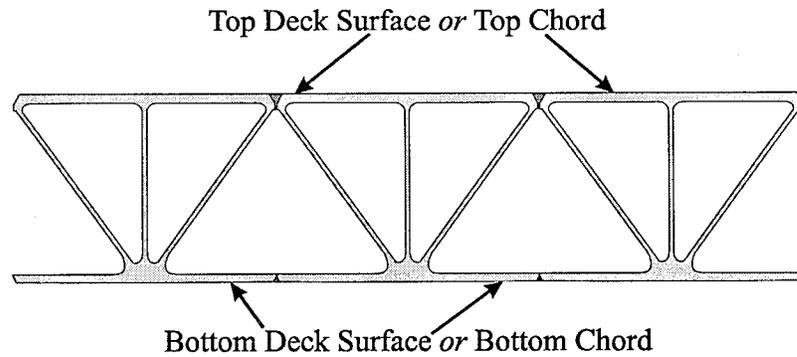
Figure 11. Nomenclature of Top and Bottom Deck Surfaces

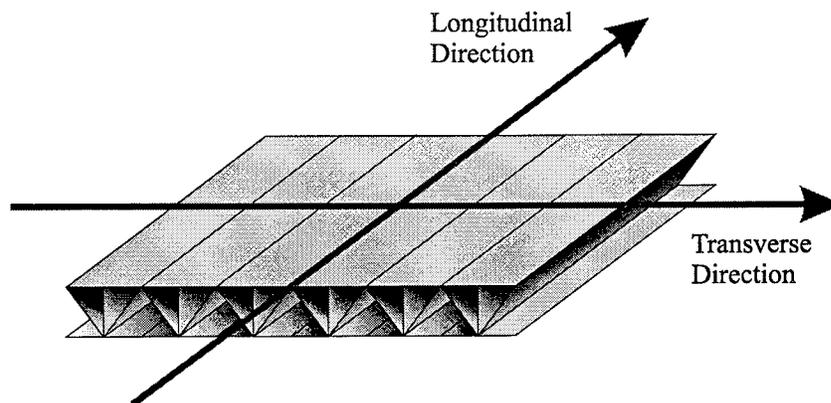
Figure 12. Direction Nomenclature

Directions on the panel are specified with respect to two mutually perpendicular axes where the origin coincides with the geometric center of the panel. Regardless of the support conditions, the direction parallel to the extrusions is called the *longitudinal direction* and the direction perpendicular to the extrusions is referred to as the *transverse direction*. This convention system arises from the orientation of the panel in an actual bridge. The illustration in Figure 12 clarifies this directional system.

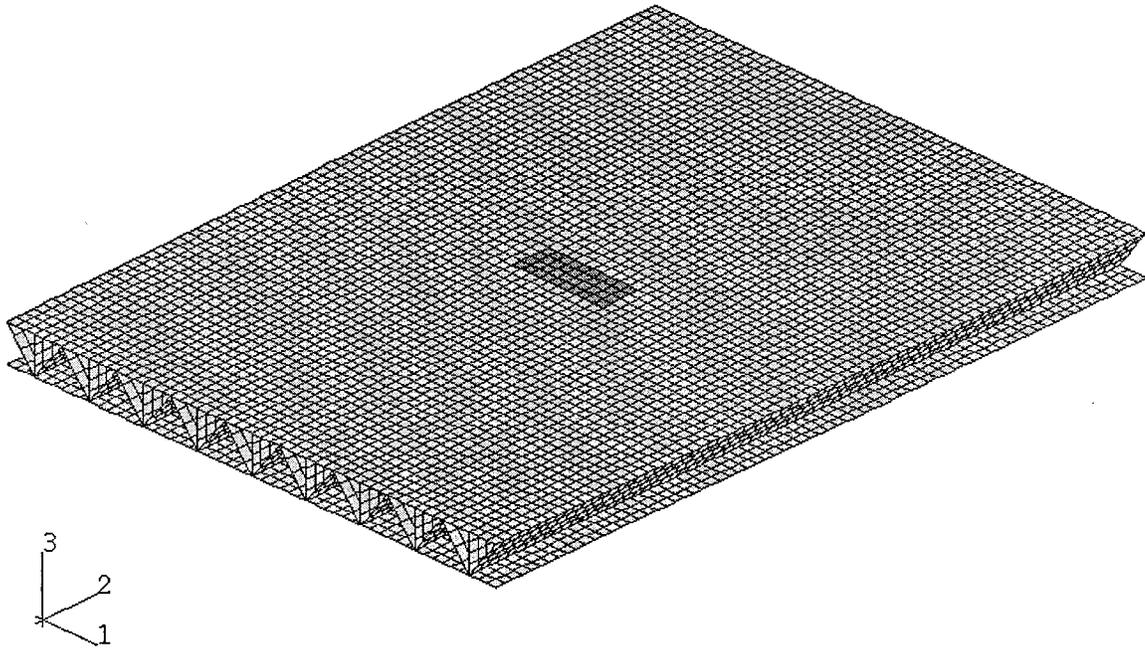
Figure 13. Model Used to Simulate the First Ultimate-Load Test

The loading configuration and boundary conditions of the first ultimate-load test were the same as those used in load case 7 of the service-load tests (Dobmeier et al., 1999). Therefore, the mesh and shell elements used in the service load simulation are still applicable. A sketch of the model is shown in Figure 13. Because the stresses developed during this simulation will easily exceed the yield stress of aluminum, the constitutive theory had to be modified to account for inelastic behavior.

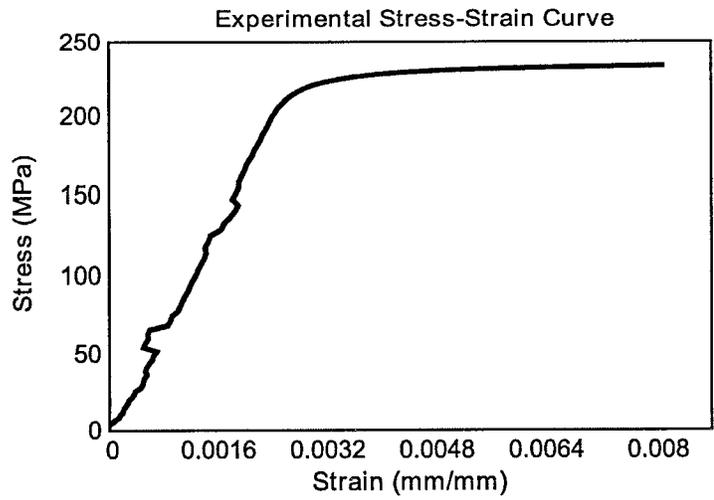
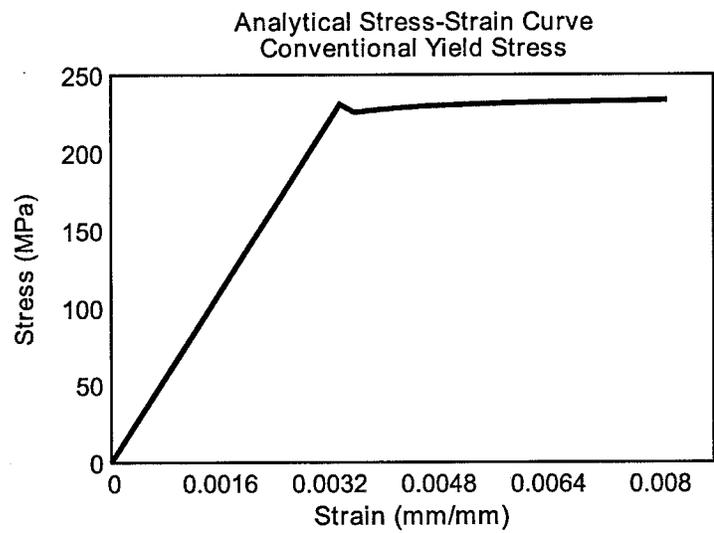
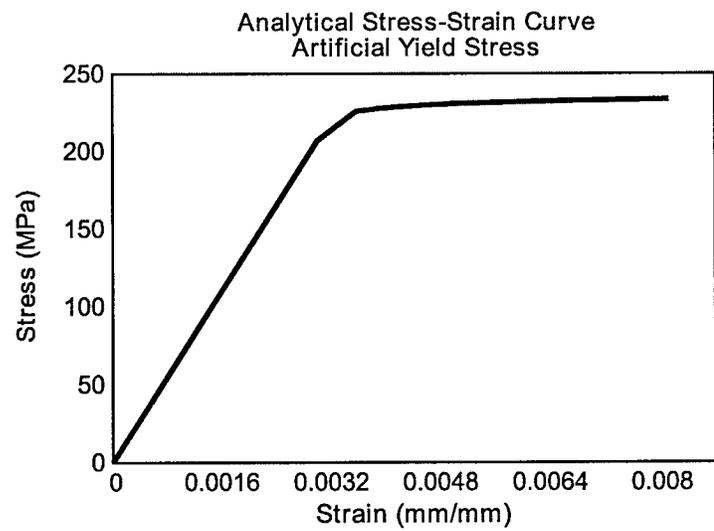
Figure 14. Advantage of Using an Artificial Yield Stress to Approximate the Stress-Strain Curve

The stress-strain data points used to define this plastic response were obtained from a uniaxial tension test conducted by Reynolds. The constitutive relationship for the model assumed a yield stress of 206.84 Mpa (30 ksi). Beyond this point, fifty-nine data pairs of stress and strain were used to define material behavior. The last pair that was inputted corresponded to the maximum engineering stress, beyond which ABAQUS assumed perfect plasticity. The experimental data, together with the analytical stress-strain curve, are shown in Figure 14.

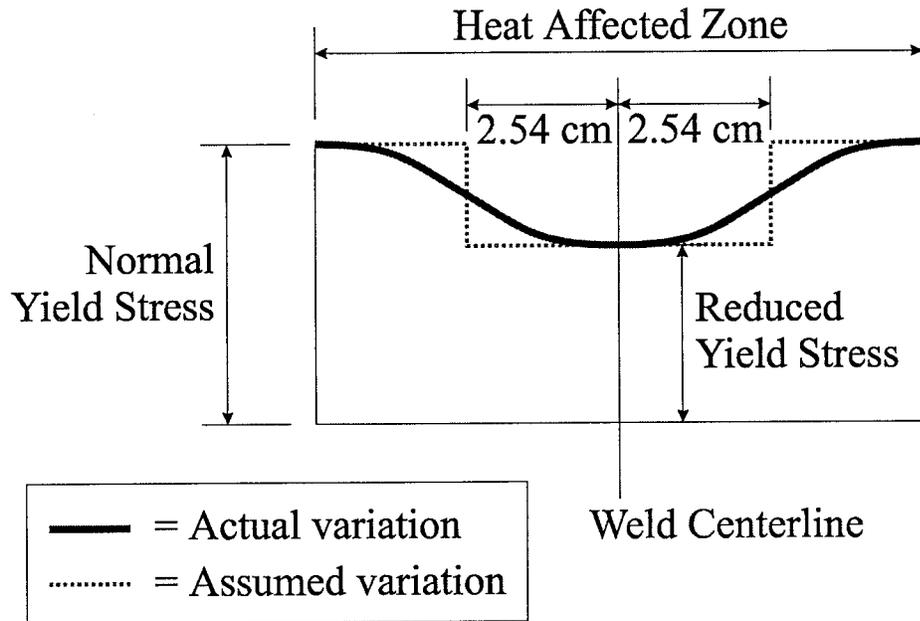
Figure 15. Variation of Properties Across the HAZ

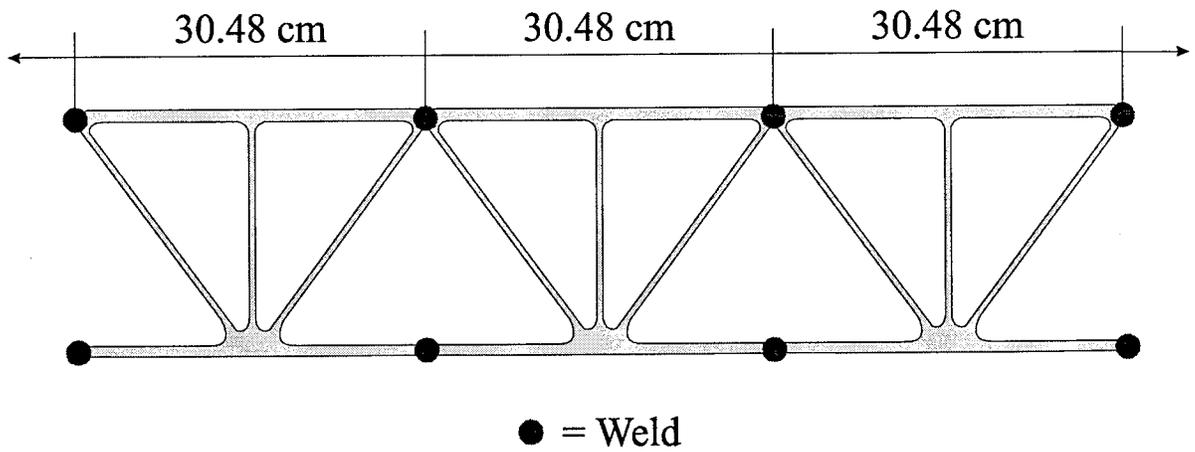
Figure 16. Location of Welds in the Aluminum Deck System

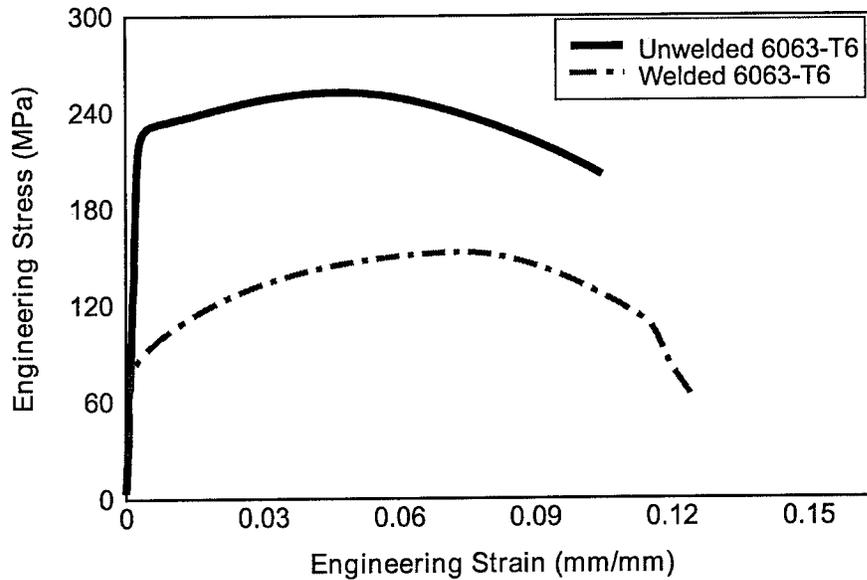
Figure 17. Differences in Mechanical Properties of Welded and Unwelded Aluminum

The constitutive relationship for unwelded aluminum was defined with the same data used in the model for the first ultimate-load test, and the constitutive relationship for welded aluminum was implemented in a similar fashion. Plastic response ensues once the stress exceeds the specified yield stress of 75.84 MPa (11 ksi). Beyond this yield stress, behavior is defined by strain hardening. One hundred and five data points from a uniaxial tension test on welded aluminum were used to define this hardening region. The last value entered corresponded to the maximum engineering stress, beyond which ABAQUS assumes perfect plasticity.

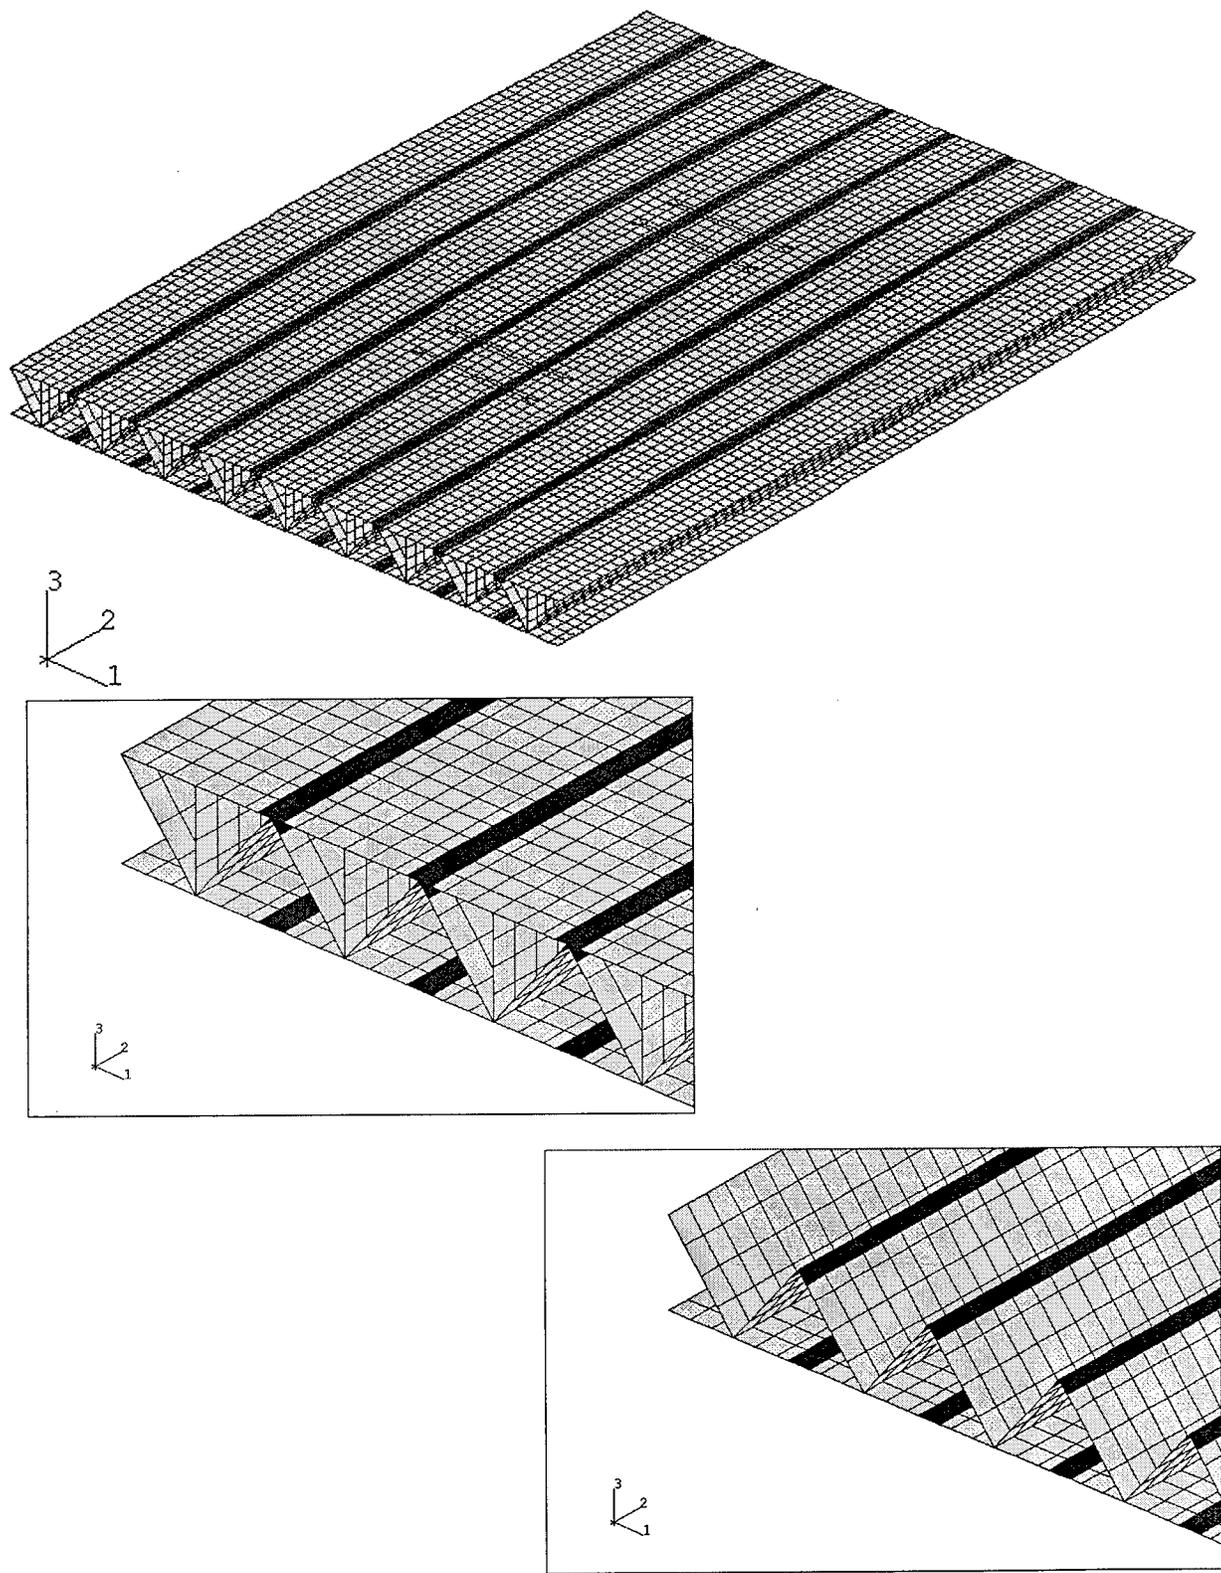
Figure 18. Model Used to Simulate the Second Ultimate-Load Test

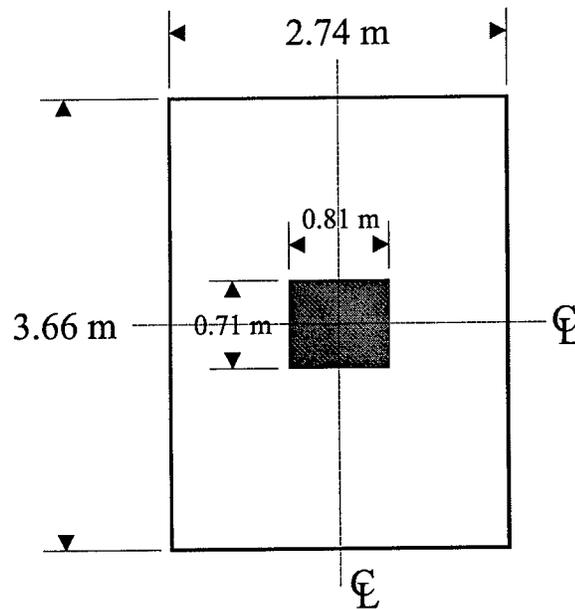
Figure 19. Region of the Panel Analyzed in the First Ultimate-Load Test

After validating the models, the graphical post-processor was used to identify the onset and progression of failure by analyzing the von Mises stress throughout the model. Specific element sets were analyzed one at a time to ensure that the maximum values were successfully located. This graphical evaluation showed that only elements on the top deck surface in the vicinity of the load patch were experiencing von Mises stresses greater than the yield stress. With this knowledge, when analyzing the panel, one could concentrate on a small region of the top surface. Examination of the output files indicated that a rectangular region centered on the load patch would provide the data necessary to analyze panel failure. This rectangle is illustrated in Figure 19.

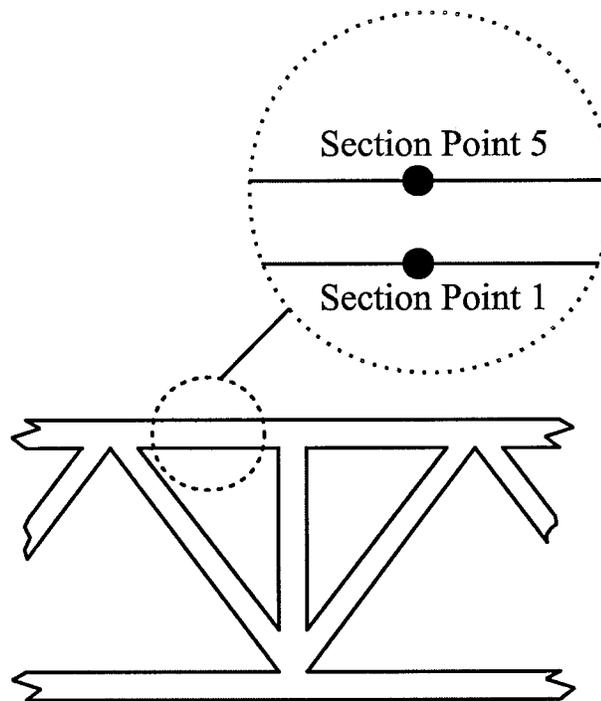
Figure 20. Location of Section Points on the Top Deck Surface

Due to localized bending effects (System III stresses), both the upper and lower sides of the top deck surface were analyzed. Output for these extreme fibers is obtained by requesting data from the appropriate section point in ABAQUS: section point 5 for the upper side and section point 1 for the lower side. These points are illustrated in Figure 20. As the results will show, examining both surfaces is crucial for fully understanding the failure mechanisms of the deck.

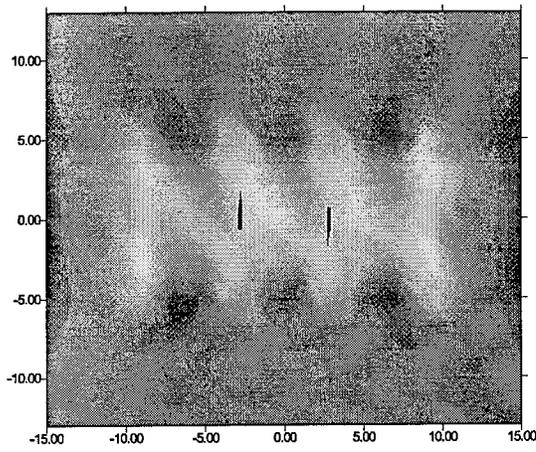
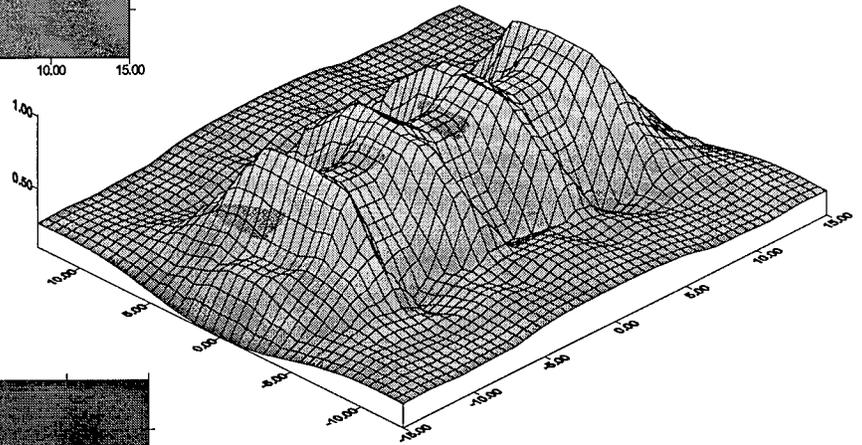
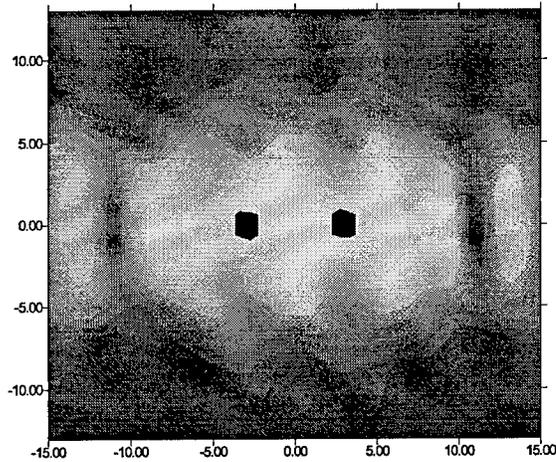
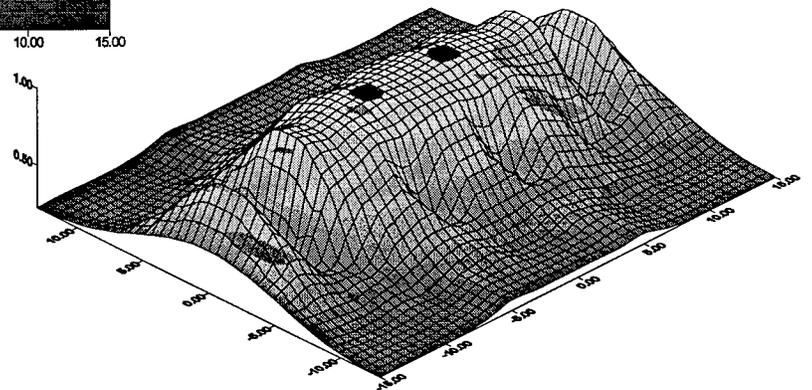
Top Fiber

Note: Black area equals failure by von Mises Theory

Bottom Fiber

Figure 21. Ratio of von Mises Stress to Yield Stress. Load = 731.6 kN

Based upon the sizes of the failure regions, predictions on failure load were made. At a load of 889.64 kN (200 kips), 20 of the 40 elements in the load patch were failing on the top fiber. Simultaneously, 28 of the 40 elements were failing on the bottom fiber. At a load of 911.89 kN (205 kips), 28 of the 40 elements were failing at both extreme fibers. Based on this behavior, the panel was considered to have failed by yielding under the load patch at a load of 911.89 kN (205 kips).

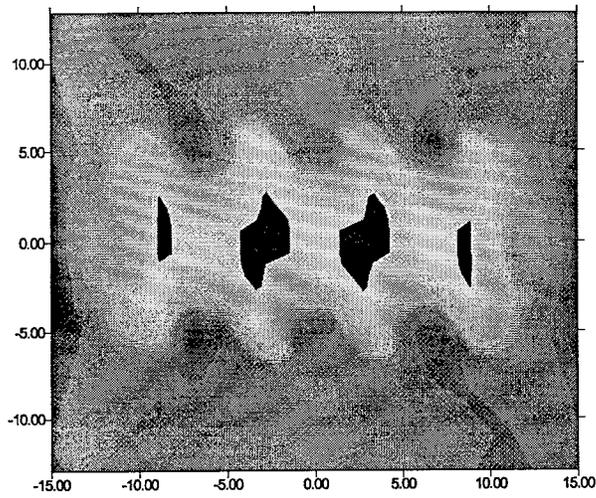
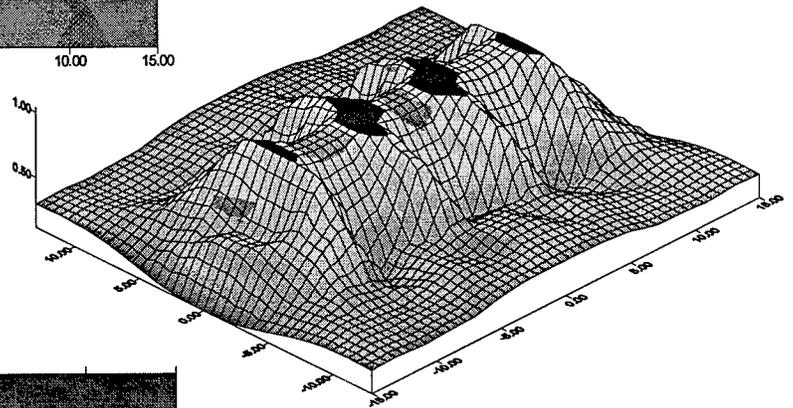
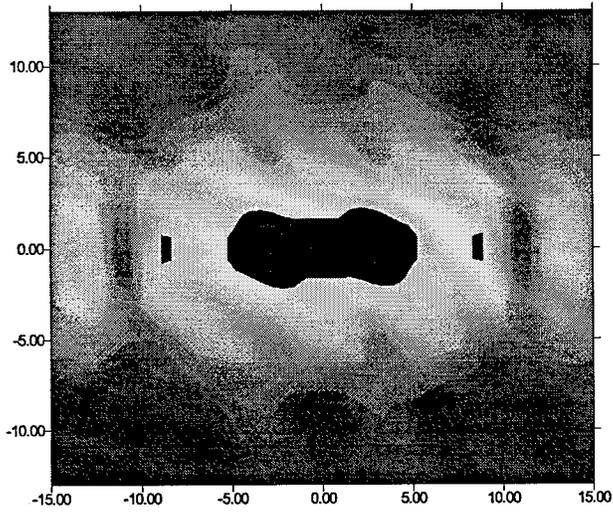
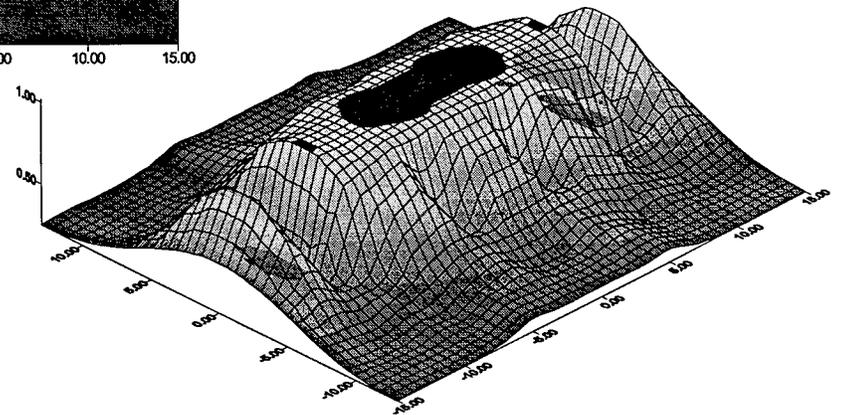
Top Fiber

Note: Black area equals failure by von Mises Theory

Bottom Fiber

Figure 22. Ratio of von Mises Stress to Yield Stress. Load = 822.34 kN

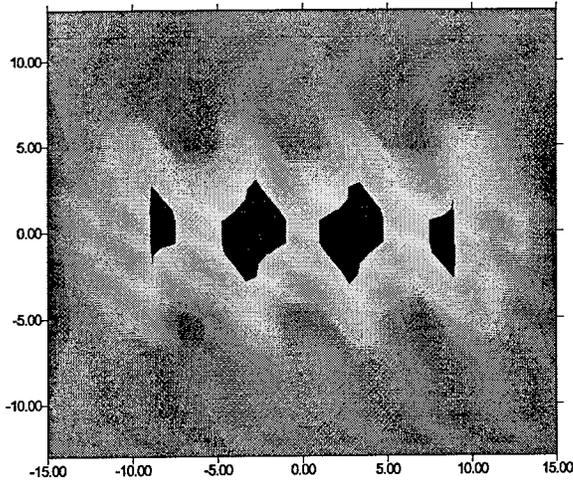
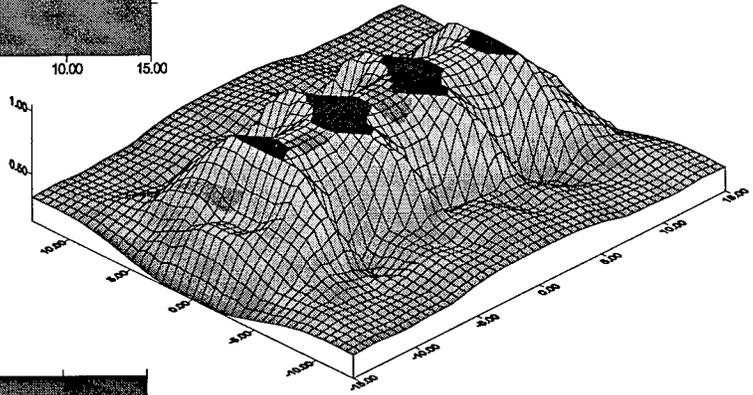
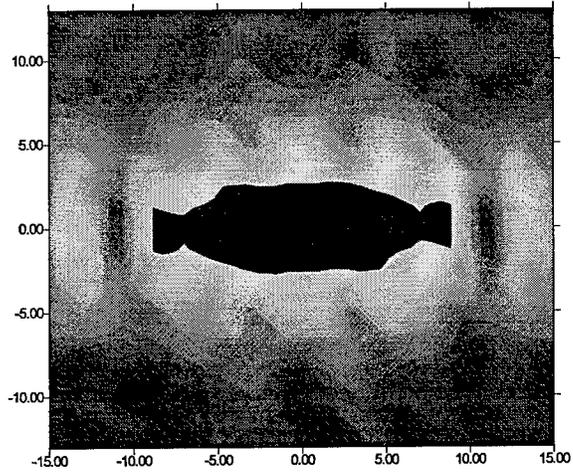
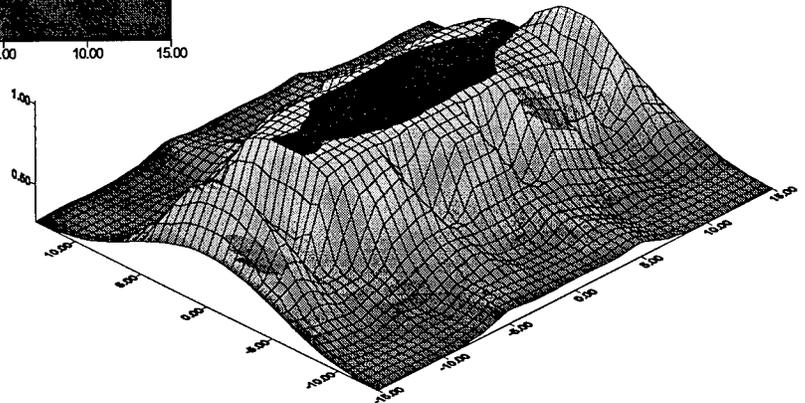
Top Fiber

Note: Black area equals failure by von Mises Theory

Bottom Fiber

Figure 23. Ratio of von Mises Stress to Yield Stress. Load = 889.64 kN

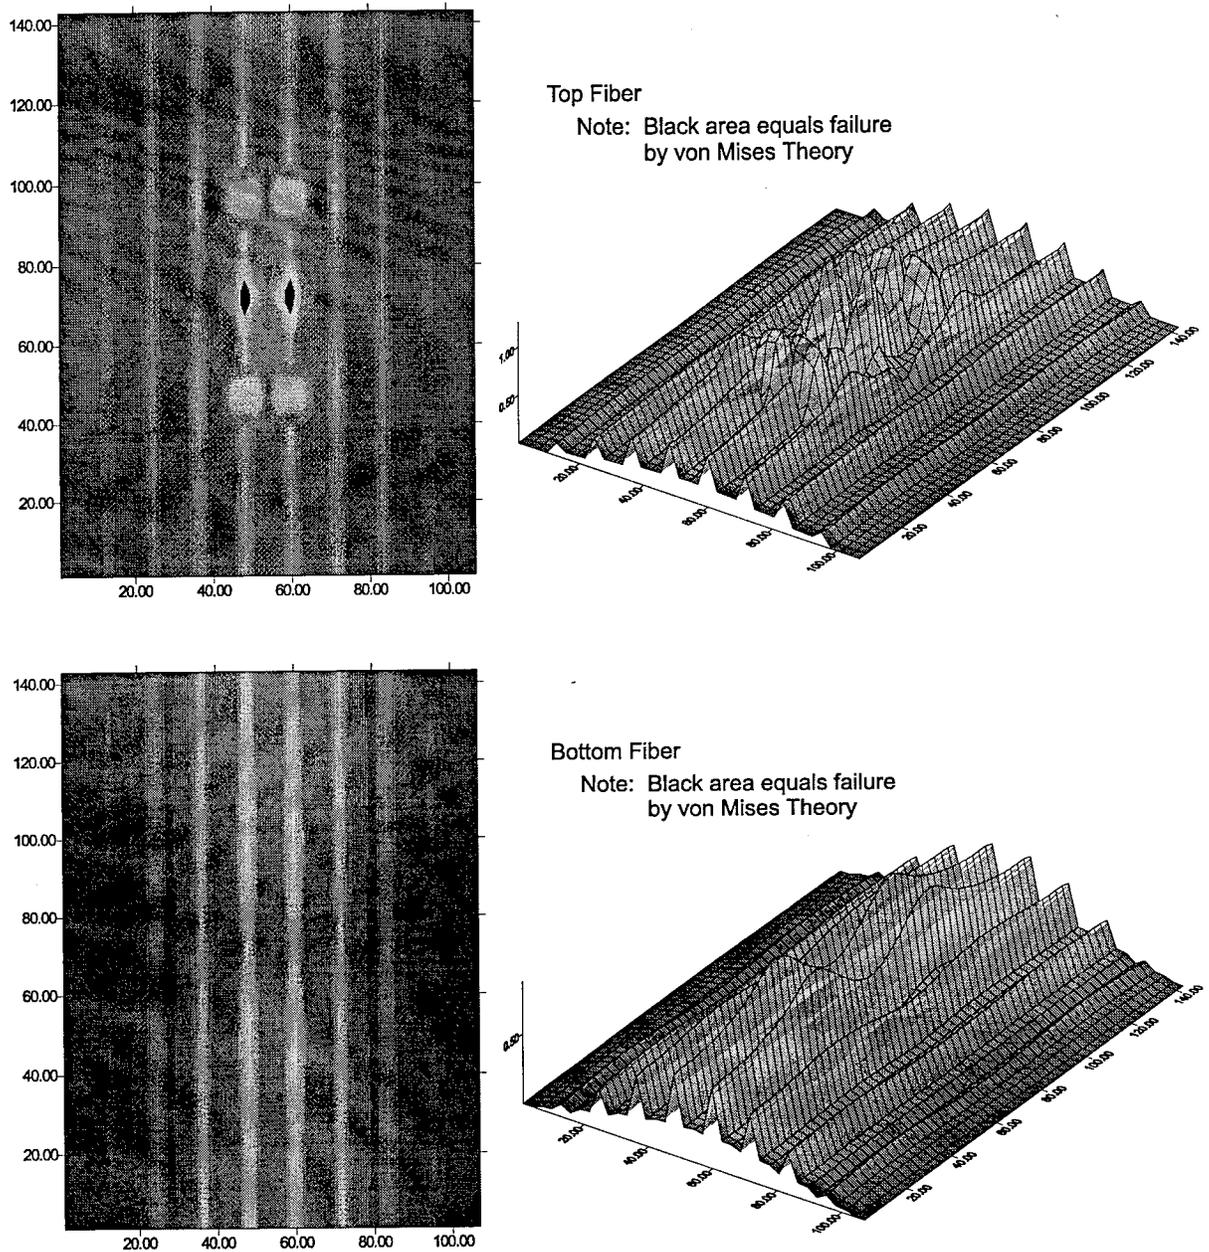
Figure 24. Ratio of von Mises Stress to Yield Stress. Load = 757.64 kN

The general characteristics of panel response during lower loads are illustrated by the plots in Figure 24 that correspond to a load of 757.64 kN (170 kips). Again, black areas correspond to regions where failure is occurring. One interesting feature of these plots is the series of parallel ridges running in the longitudinal direction. These eight ridges, present in graphs of both the top and bottom deck surfaces, correspond in location to the eight welds in the deck panel. The factors creating these ridges will be explained in the next section. The graph for the top deck surface contains two small failure zones in the center of the panel, which occur in elements in the HAZ.

Failure of these two small zones is caused by the stresses developed during the first ultimate-load test. The 872.07-kN (196-kip) load applied to the deck during this test creates extremely high stresses in elements under the load patch using weld-affected properties. Even after the load is removed, the residual value of the von Mises stress still exceeds the failure stress. Examination of the von Mises data from the second step of the analysis verifies this. Thus, before any loads are even applied from the second ultimate-load test, two small failure zones already exist.

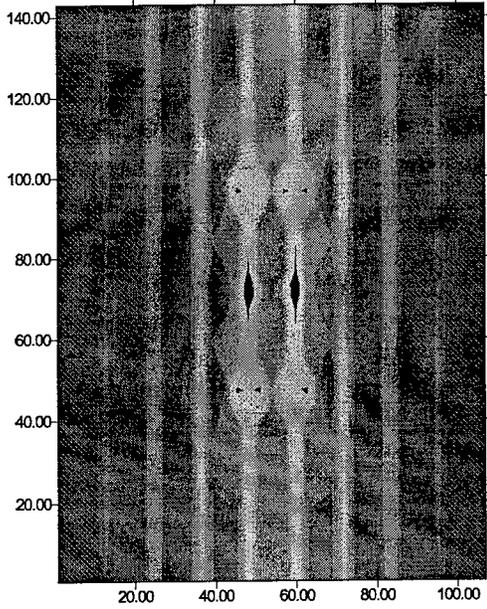
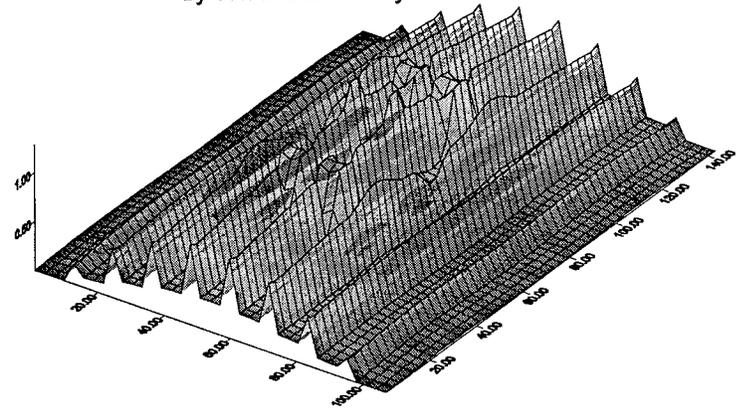
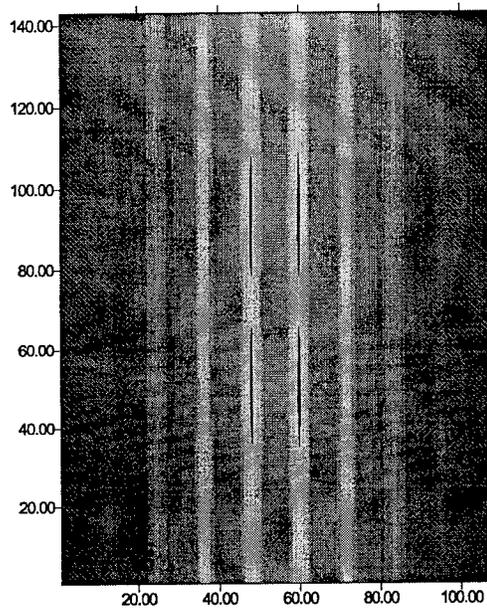
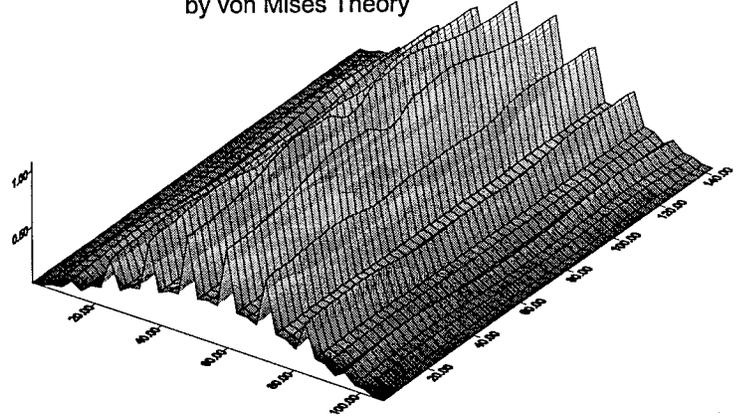
Top Fiber
 Note: Black area equals failure
 by von Mises Theory

Bottom Fiber
 Note: Black area equals failure
 by von Mises Theory

Figure 25. Ratio of von Mises Stress to Yield Stress. Load = 1,022.82 kN

Failure zones created by loads applied during the second ultimate-load test initially occur on the bottom deck surface at a total deck load of 1022.82 kN (229.94 kips). As Figure 25 shows, four tiny failure zones developed on the bottom deck surface. These four failure regions develop in the HAZ at points located below the load patches. The plots of the top deck surface are essentially the same as the residual values that are still causing zones of failure.

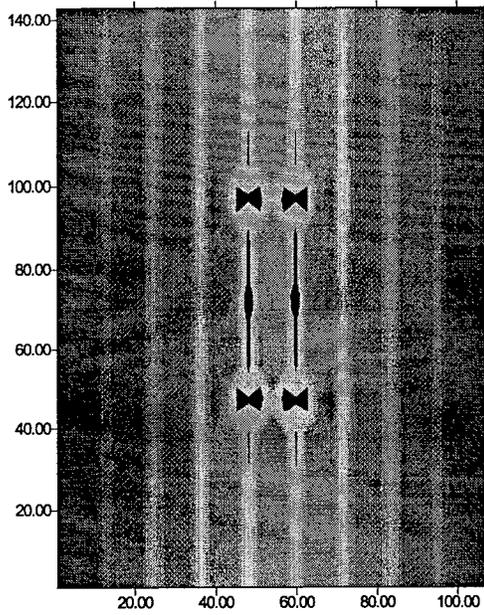
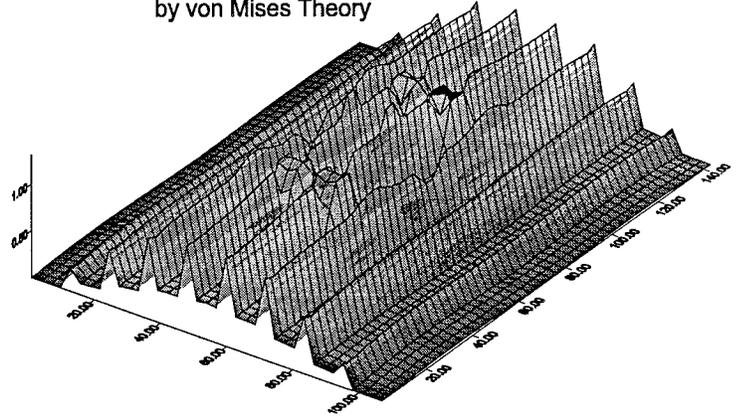
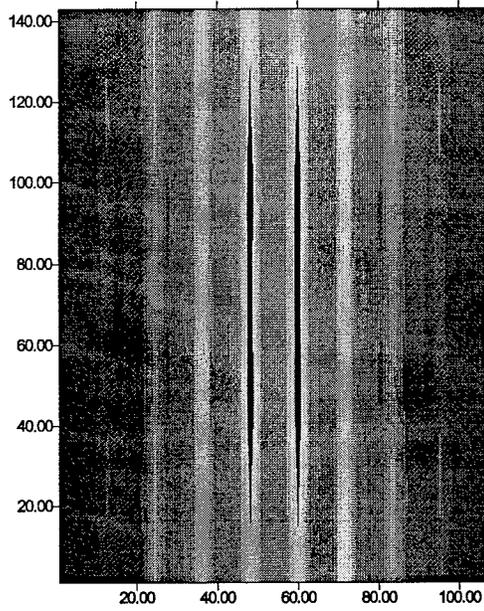
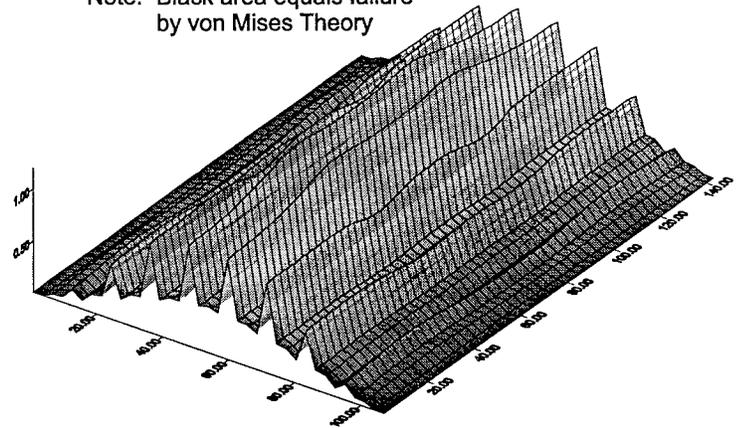
Top Fiber

Note: Black area equals failure by von Mises Theory

Bottom Fiber

Figure 26. Ratio of von Mises Stress to Yield Stress. Load = 1,198.31 kN

The four individual failure zones on the bottom surface connect when the deck is subjected to a total load of 1198.31 kN (269.39 kips). As depicted in Figure 26, the two resulting strips are approximately 2.13 m (84 in) in length. This length implies that nearly 60 percent of the two welds are failing. On the top deck surface, additional stresses have caused the failure zones between the load patches to grow in the longitudinal direction. The widths of the failure areas under the load patches have also increased in the transverse direction because local bending stresses continue to rise.
