ANALYTICAL AND EXPERIMENTAL EVALUATION OF AN ALUMINUM BRIDGE DECK PANEL

PART II: FAILURE ANALYSIS

1. Report No. FHWA/VTRC 00-R5		2. Government Accession No.		3. Recipient's Catalog No.	
4. Title and Subtitle Analytical and Experimental Evaluation of an Aluminum Bridge Deck Panel Part II: Failure Analysis				5. Report Date September 1999

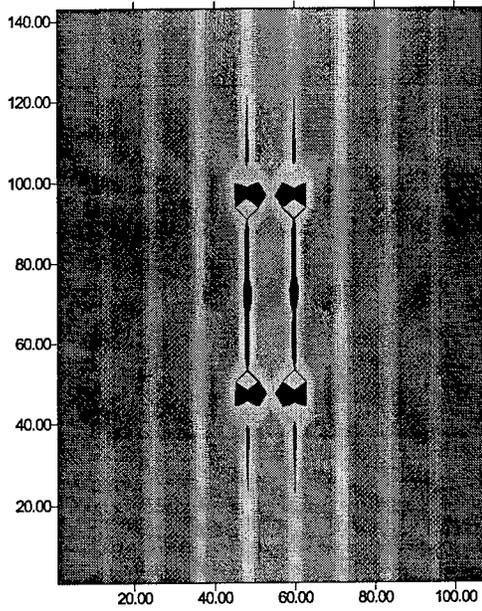
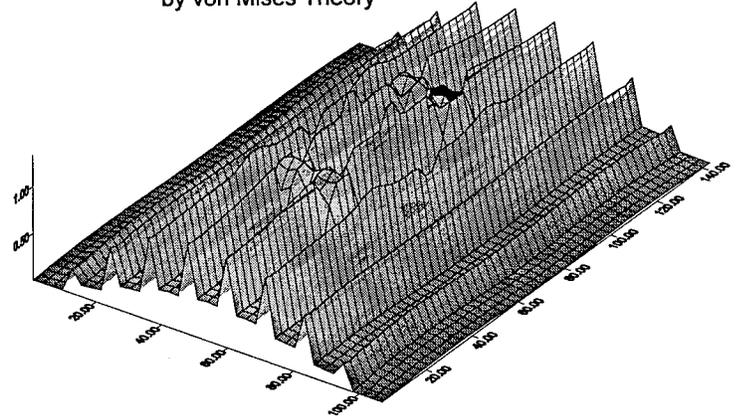
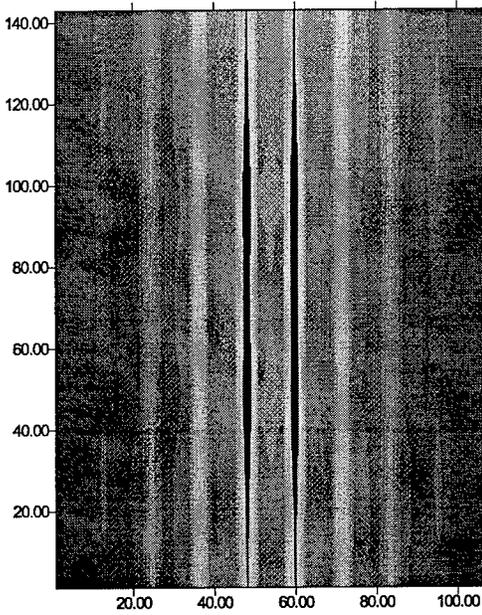
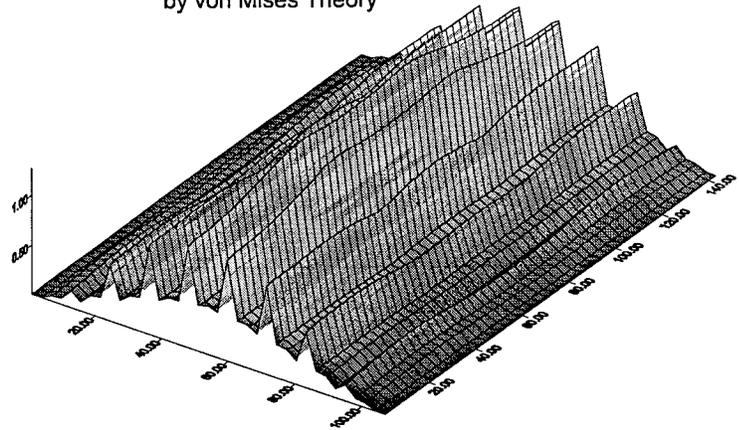
Top Fiber
 Note: Black area equals failure by von Mises Theory

Bottom Fiber
 Note: Black area equals failure by von Mises Theory

Figure 27. Ratio of von Mises Stress to Yield Stress. Load = 1,373.17 kN

Under a total deck load of 1373.17 kN (308.70 kips), failure zones on the bottom deck surface have reached critical levels. As depicted in Figure 27, the two failure strips now extend the entire length of the deck. A closer examination of model output shows that all of the elements on both sides of the weld centerlines have failed. This response indicates total weld failure and failure of the deck structure. To ensure that this was the first mode of failure produced, top data were checked as well. Although the longitudinal failure zones elongated, a critical state still was not attained. Locally driven failure zones also increased in size; however, they did not correspond to the sizes of the load patches. Thus, the deck failed by fracture of the bottom two welds.
