Improving Safety for Slow Moving Vehicles on Iowa's High-Speed Rural Roadways

Final Report
May 2009

Sponsored by
the Iowa Highway Research Board
(IHRB Project TR-572)
and the Iowa Department of Transportation
(InTrans Project 07-291)

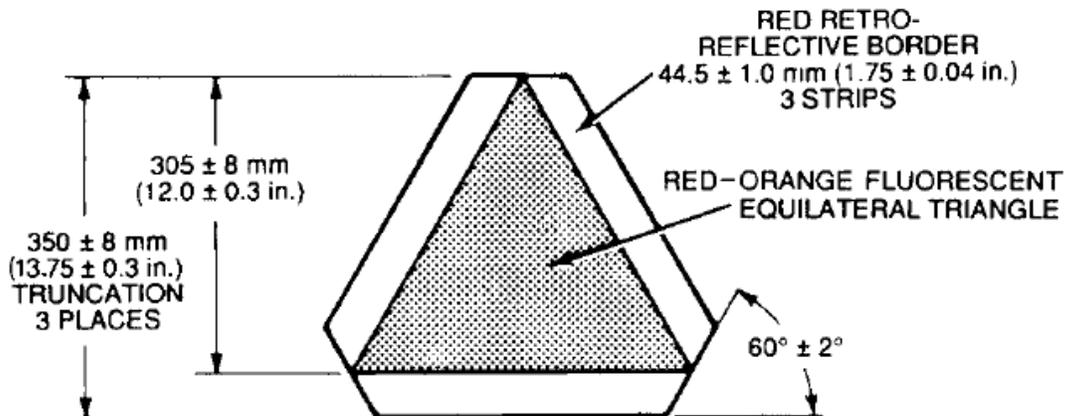
Figure 3-1. Dimensions for SMV identification emblem

The SMV emblem was developed to identify slower vehicles on the roadway. According to the Farm Safety Association (2002), an SMV is considered any vehicle that cannot keep a constant speed of 25 mph or greater. However, different states define a SMV differently for the purposes of requiring a SMV emblem. Iowa requires an SMV emblem on vehicles traveling 35 mph or less, while Minnesota has a speed requirement of 30 mph or less. One other state requires vehicles traveling 25 mph or less to use SMV emblems. The SMV emblem is identified as a “fluorescent, orange equilateral triangle with a red retroreflective tape.” The red-orange fluorescent triangle provides for daylight identification. The red retroreflective border “appears as a hollow red triangle in the path of motor vehicle headlights at night” (ASAE, 2005). Dimensioning and other specifics of the emblem are shown in Figure 3-1, and the emblem’s coloring is shown in Figure 3-2.

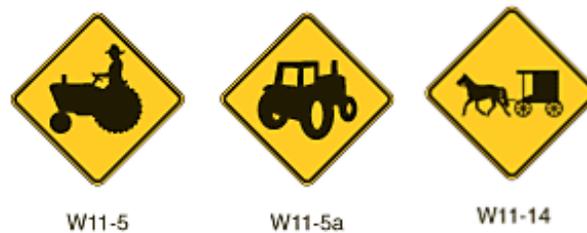
Figure 3-4 shows the most recent MUTCD SMV-related advanced warning signage. The W11-5 is shown as a diamond-shaped sign with a symbol of a left-facing tractor and driver. The W11-5a is shown as a diamond-shaped sign with an oblique symbol of a tractor. The W11-14 is shown as a diamond-shaped sign with a symbol of a left-facing horse and closed buggy.

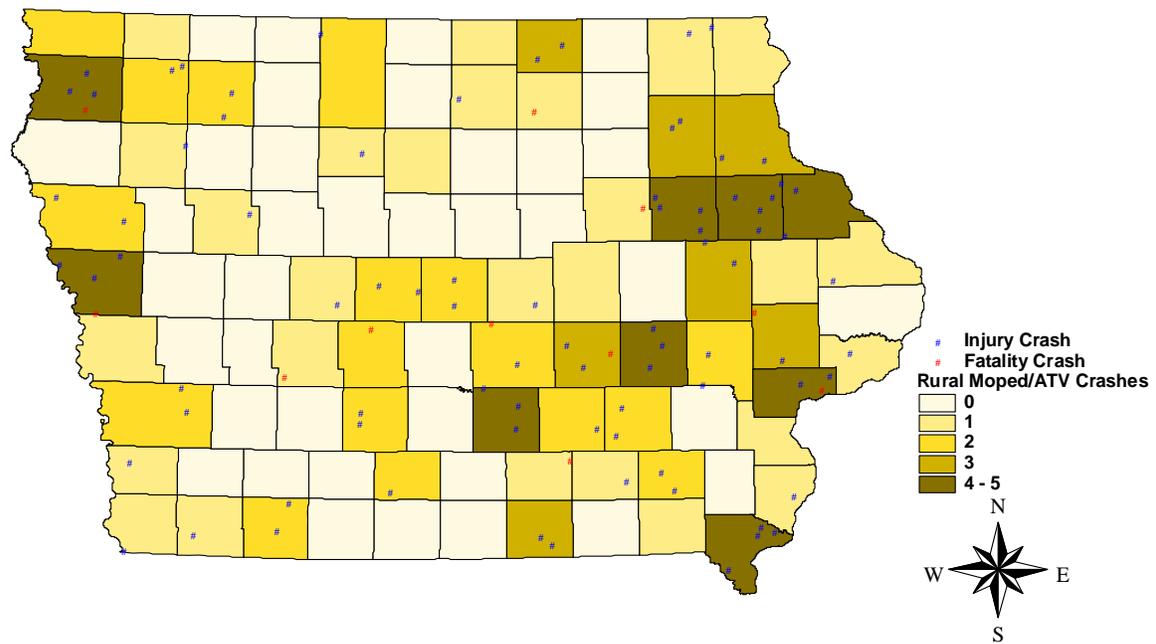
Figure 4-5. Rural moped/ATV SMV, frequency and severity (2004–2006)

Figure 4-5 maps SMV crashes for Moped/ATV vehicles. Sioux, Monona, Marion, Iowa, Muscatine, Lee, Buchanan, Delaware, and Dubuque Counties had the highest number of crashes, and Buchanan and Delaware Counties had the highest number of injury crashes.

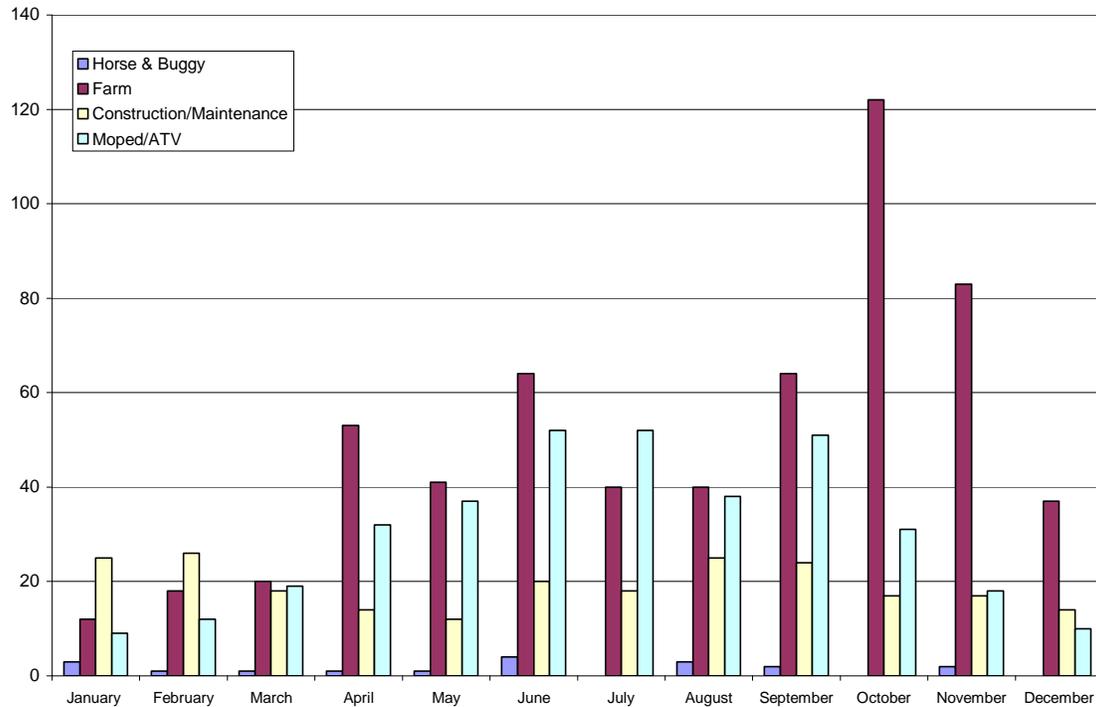
Figure 4-6. Overall rural SMV crash by month (2004–2006)

Rural SMV crashes were analyzed by month, as shown in Figure 4-6. As anticipated, the majority of Farm Vehicle crashes occurred during the month of October (harvest season). The adjacent months of November and September follow with the next highest crash volumes, respectively. June and July are the most prominent months for Moped/ATV vehicle crashes, followed by May and October. Construction/Maintenance vehicle crashes occurred more frequently in September and August than during any other month.

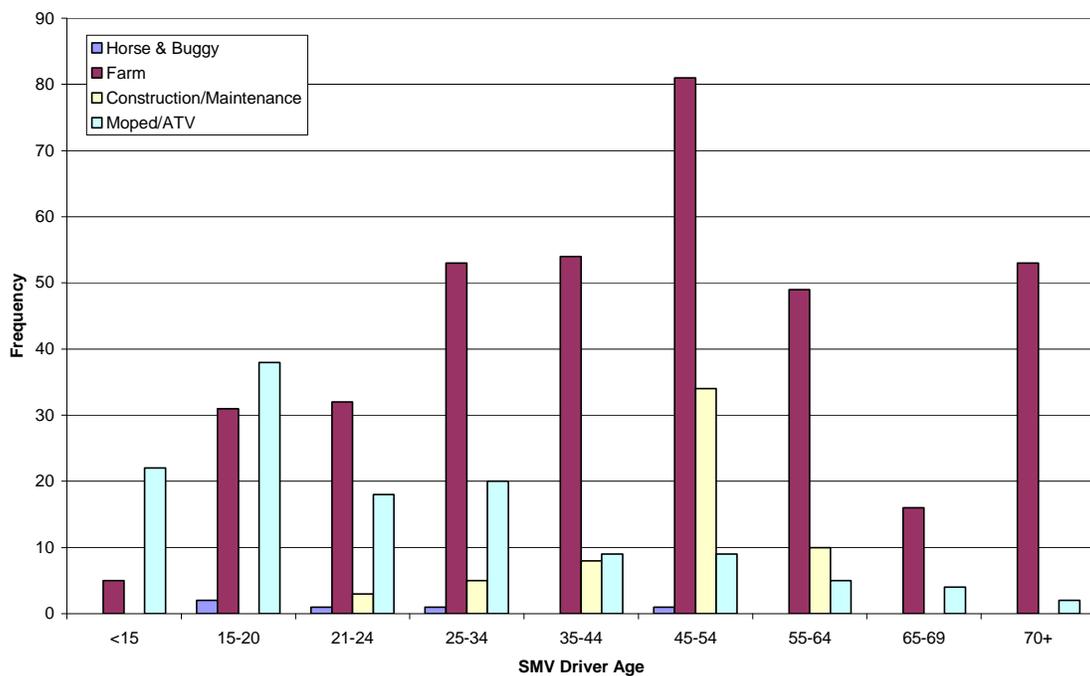
Figure 4-7. Crash frequency by SMV driver age (rural)

Figure 4-7 provides a visual comparison of crash frequency by SMV driver age. When the age of the driver was known, the most common age group for rural horse and buggy crashes was 15–20 years old (few data points). Farm vehicle crashes involving drivers between the ages of 45 and 54 were the most common, representing 21%, and drivers over 70 years of age represented 16% of the rural farm vehicle crashes. Construction/maintenance vehicle crashes involving drivers between the ages of 45 and 54 were the most common, representing 57% of the drivers. Moped/ATV vehicle crashes involving drivers between the ages of 15 and 20 were the most common, representing 30% of the drivers, and 77% of the drivers involved in a crash were less than 34 years of age.

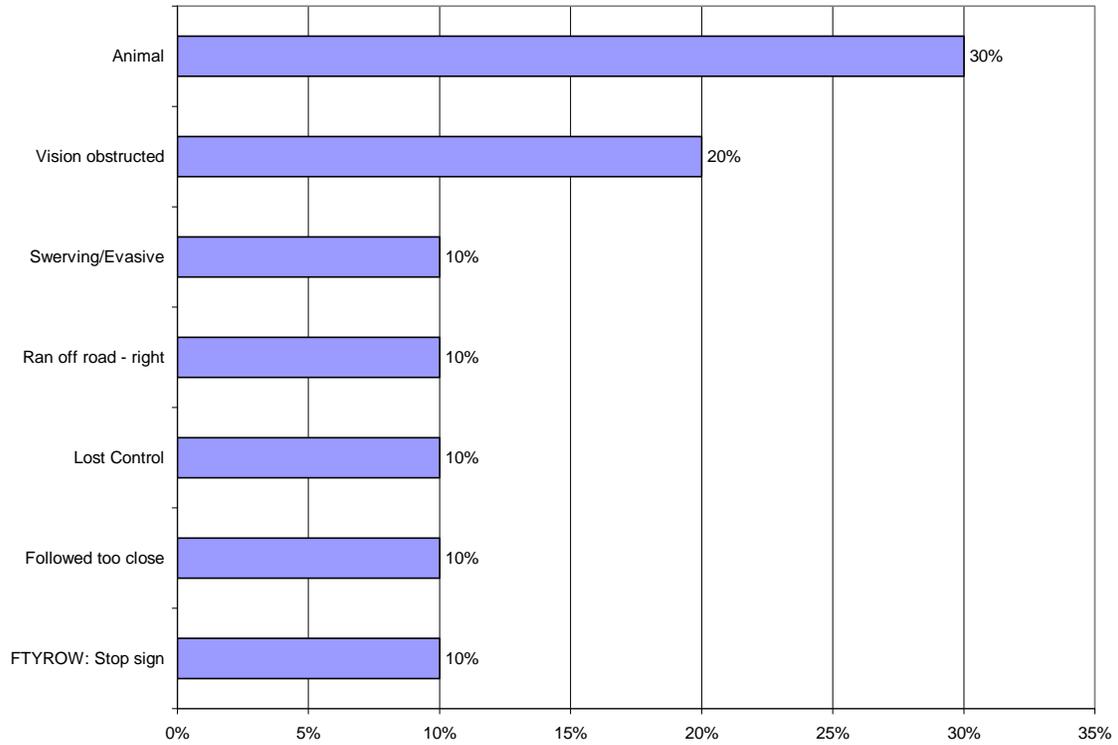
Figure 4-8. Major cause for SMV crash, horse and buggy

Figure 4-8 shows the major causes for rural Horse and Buggy crashes, where “animal” was the most common cause (30%), followed by vision obstructed at 20%. Figure 4-9 shows Farm Vehicle major cause. The graphic only shows the 18 most frequent causes out of a total of 31. The most common major cause was swerving/evasive action (12.8%). Figure 4-10 shows major cause for Construction/Maintenance SMV crashes, where there were 18 different categories, with the most common major cause being failure to yield (13%). Figure 4-11 shows major cause for Moped/ATV crashes, where there were 28 different categories, with the most common major cause was swerving/evasive action (13%).

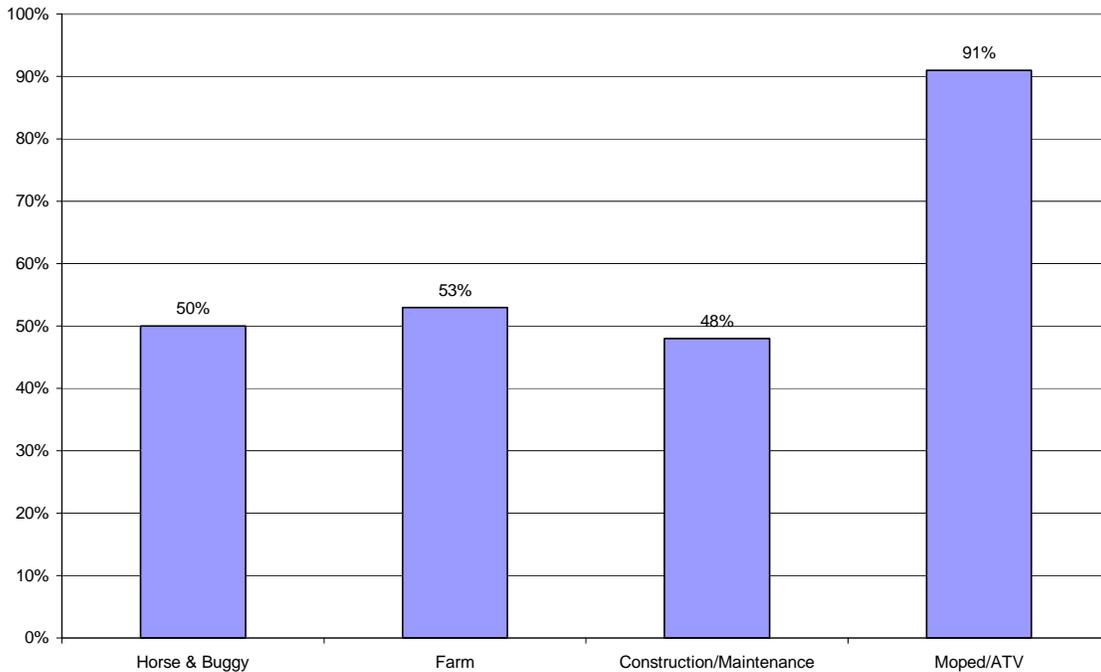
Figure 4-12. Percentage of crashes, SMV driver most likely at fault

Crash responsibility was determined by matching the major cause for the crash with the contributing circumstances or sequence of events for the individual vehicle. The major cause derivation used by the Iowa DOT was used to determine the contributing circumstance, or sequence of events, most likely to be responsible for each rural crash. Figure 4-12 shows the percent of instances in which different SMV drivers were most likely to be responsible for the multi-vehicle crash. Moped/ATV drivers were significantly higher than other vehicle types at 91%, in contrast to all the other categories, at around 50% at fault.

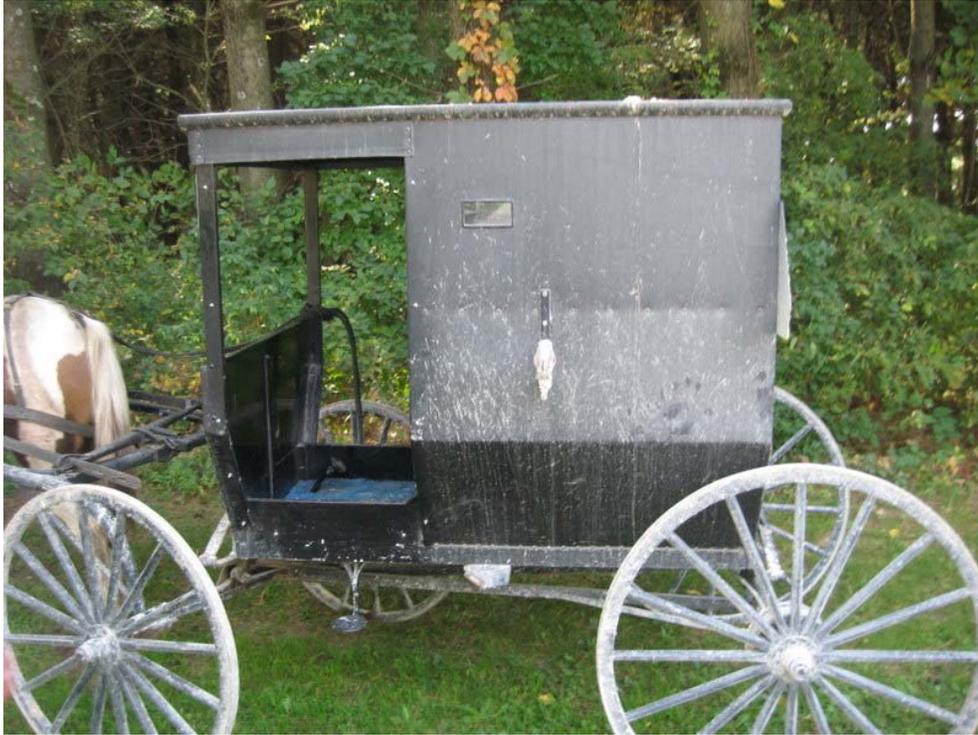
Figure 5-3. Profile view of a one-horse buggy

Figure 5-3 is a photo of a single-horse buggy, which is a common means of transportation within Buchanan County. Figure 5-4 shows other buggy features, including the left side windows (which are small rectangles), the SMV emblem, the battery operated side reflector (left side only), and rear strip of grey conspicuity or reflective tape (bottom left), with right and top reflectorized tape strips (not shown). Note that mud and gravel are commonly found on the SMV emblems (two out of the three are visible within the photo).

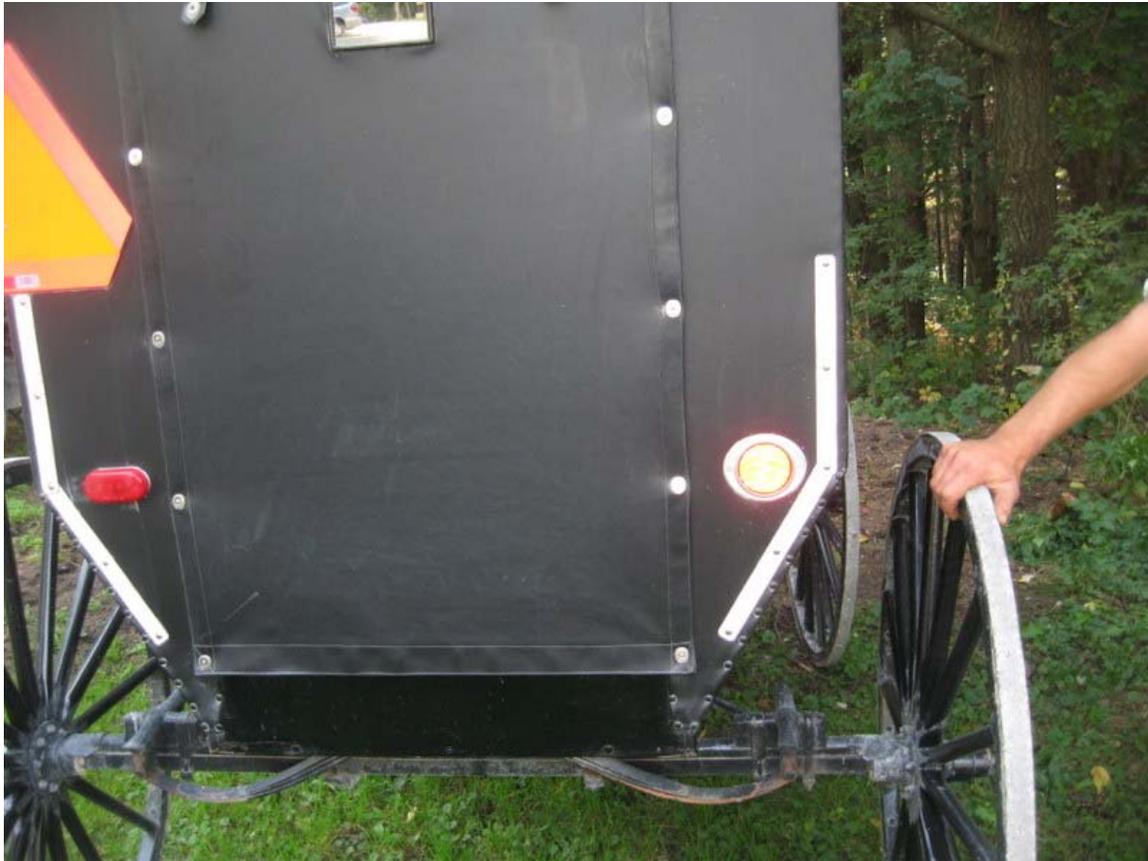
Figure 5-5. Rear view of a one-horse buggy

Figure 5-5 shows the rear view window, lighted reflector (left), non-lighted reflector (right), reflective tape (reflecting from the camera flash), and SMV emblem. Figure 5-6 shows a side and interior view of the floor-board brake pedal.

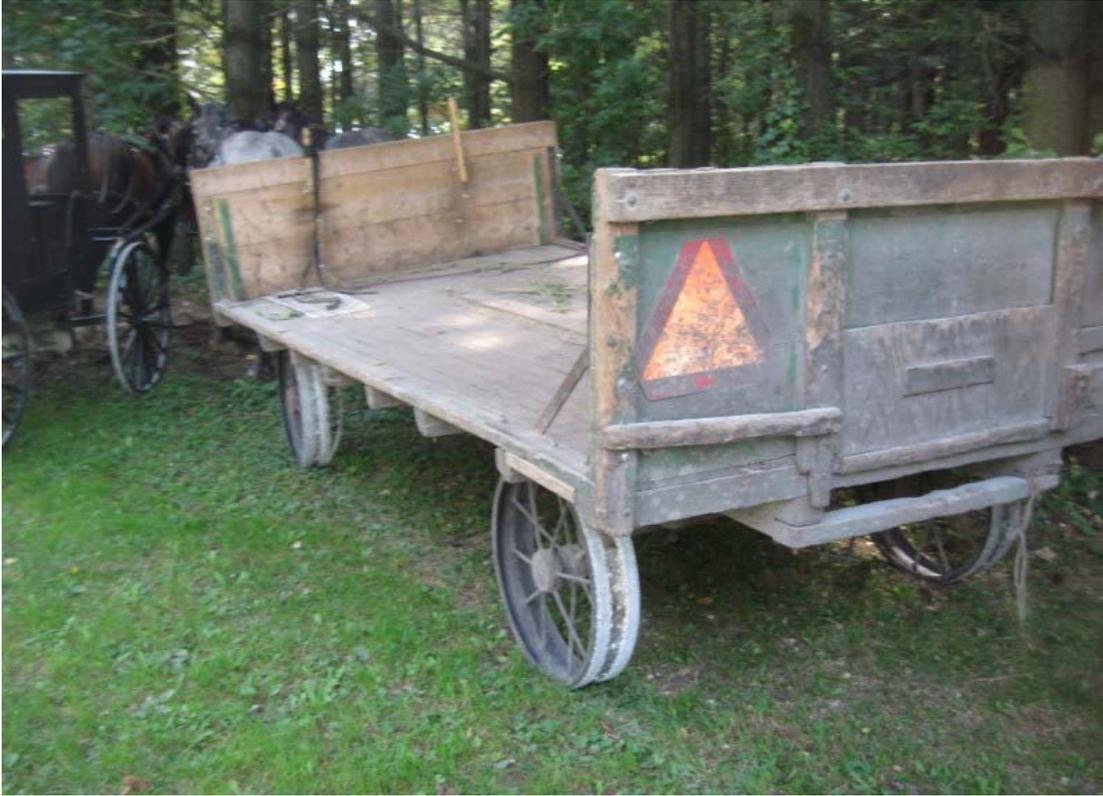
Figure 5-7. Rear view of a two-horse wagon

Figure 5-7 shows a two-horse wagon with SMV emblem and steel wheels. Figure 5-8 is a side view of a one-horse buggy when leaving the meeting.

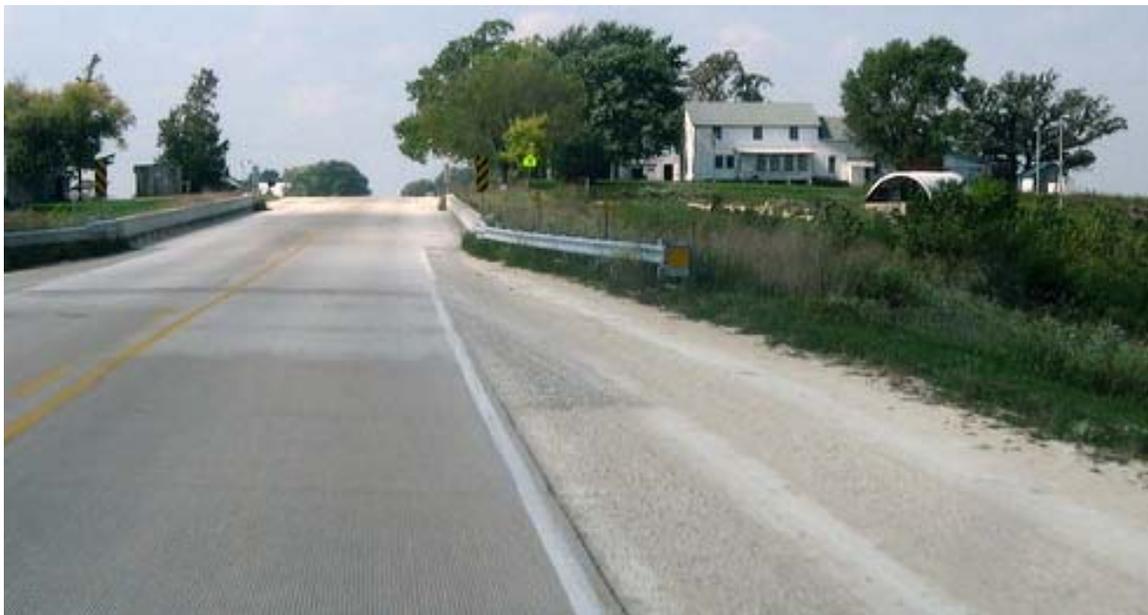
Figure 5-11. Bridge requiring buggies to merge into the vehicle lane

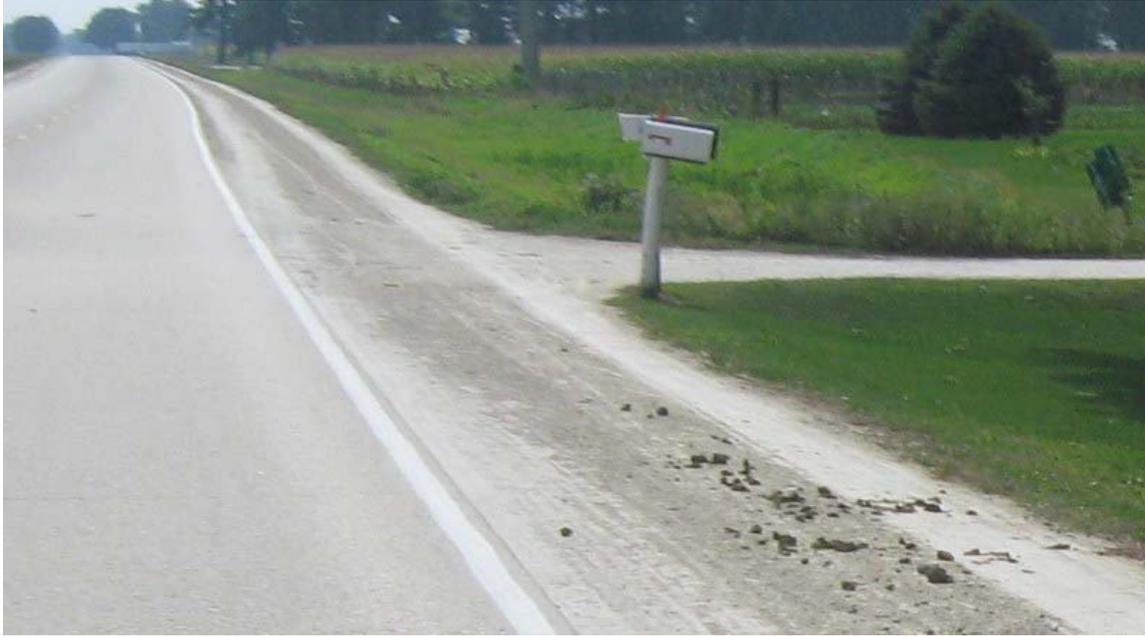
Figure 5-12 shows another example where buggies have to merge into the travel lane due to a roadside mailbox.

Figure 5-12. Roadside obstacles for buggies

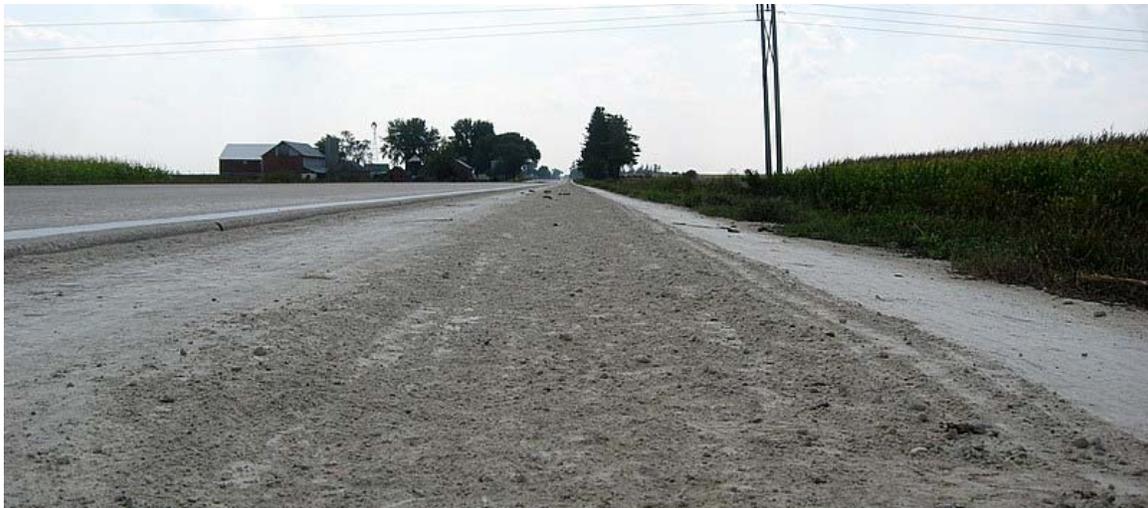
Figure 5-13 shows the horse and buggy impact on a roadway gravel shoulder. As shown, the buggies' wheels pack down the gravel on the shoulder edges, and the horse hoofs pulverize the area between the wheel tracks. The end result is a low spot near the center of the shoulder where water does not drain. The lack of drainage negatively impacts shoulder stability. The packed buggy wheel paths can also accelerate pavement edge drop off distances, which is a safety issue for both vehicles and buggies.

Figure 5-13. Drainage problem on non-paved shoulders caused by horse and buggy tracks: horse hooves create a low spot that retains water

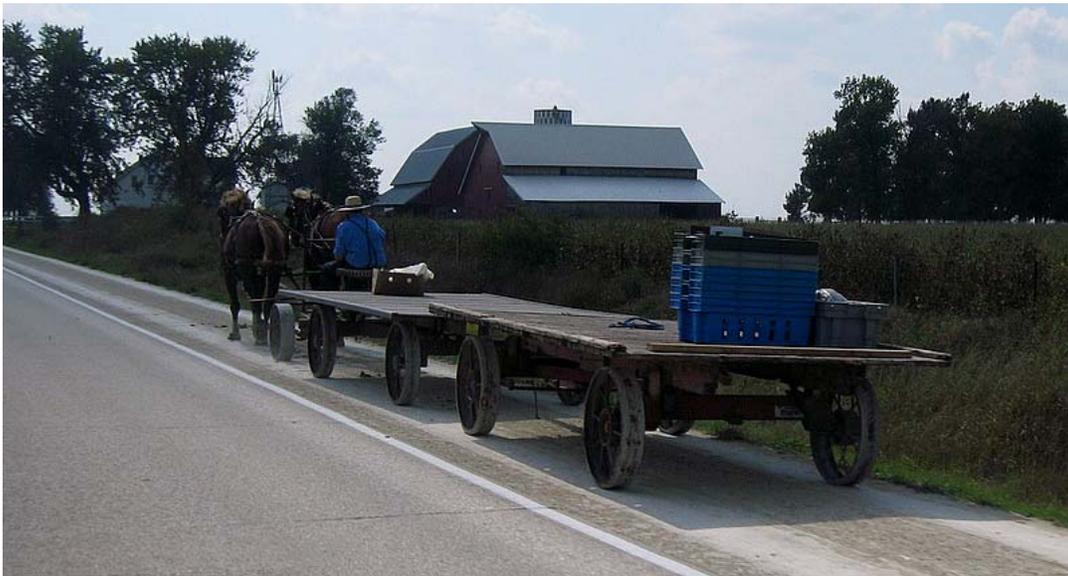
Figure 5-14 shows how the steel-wheeled wagons can pack down the edges of a gravel shoulder (also notice the lack of SMV signage on the wagon).

Figure 5-14. Steel-wheeled wagons, Buchanan County, Iowa

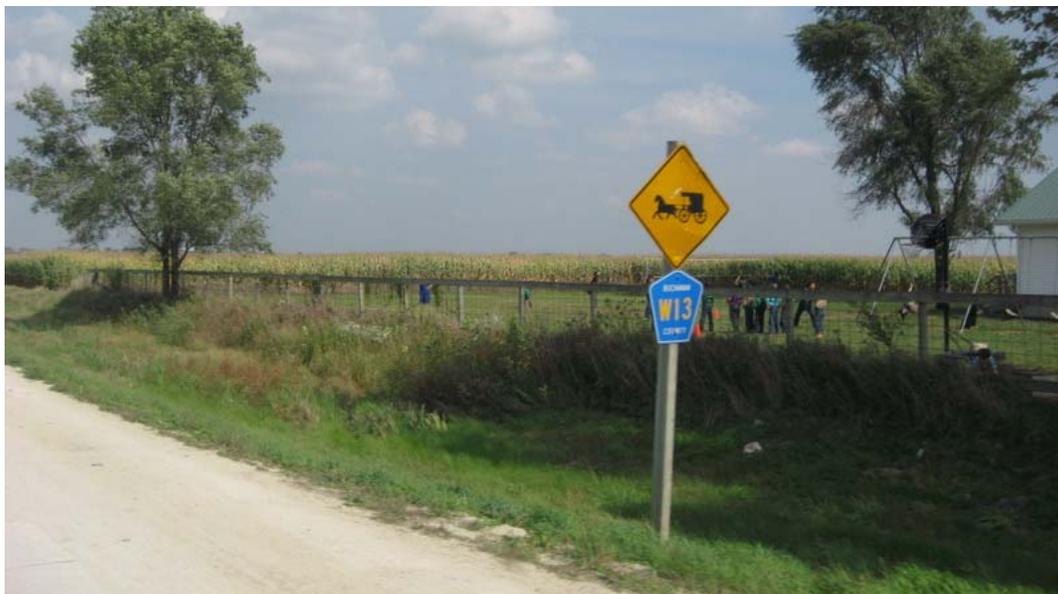
Figure 5-15 shows typical signage near one of several Amish community schools. The schools are spaced roughly one per mile, given that children all walk to school. It was noted that the Amish families are concerned with the safety of their children when walking along these busy roadways.

Figure 5-15. Signage for horse and buggy SMV, Buchanan County, Iowa

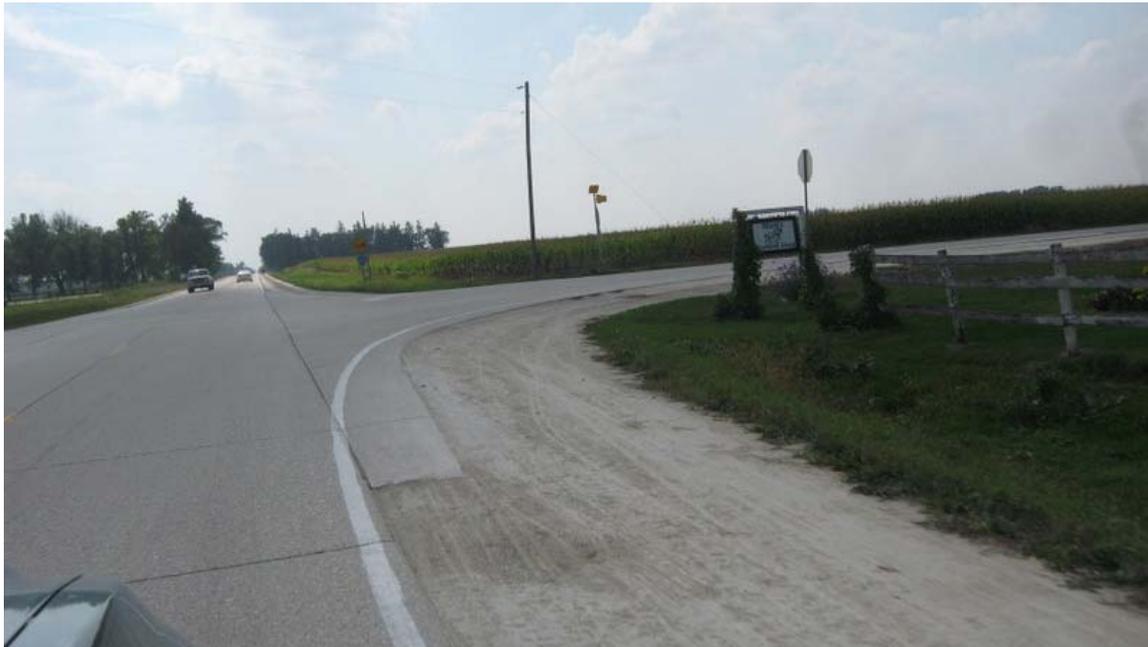
Figure 5-16 shows a typical intersection and the location for potential conflicts between vehicular and horse and buggy traffic. The Amish community also noted that when pulling up to a side-street stop sign, buggy drivers are at a disadvantage in trying to view gaps in traffic. Buggy drivers often pull forward well ahead of the stop location, and this can position the horse uncomfortably close to high-speed traffic. The seasonal issue also varies by crop. Corn presents much more of a problem than soy beans.

Figure 5-16. Typical county intersection, Buchanan County, Iowa

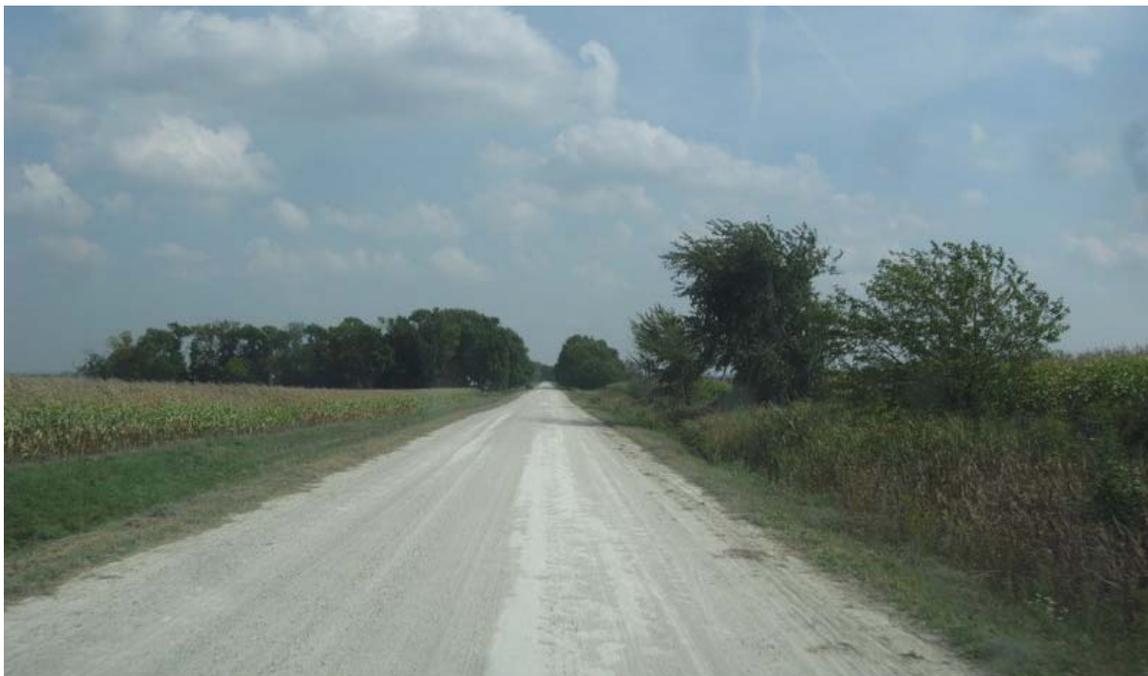
Figure 5-18 shows a typical non-paved roadway that has daily horse and buggy traffic. The Amish community felt much safer traveling on these types of roadway, given the lower vehicular speeds and volumes, the ability to hear oncoming traffic, and the convenience of traveling on the road as opposed to the shoulder.

Figure 5-18. Gravel roadway, Buchanan County, Iowa

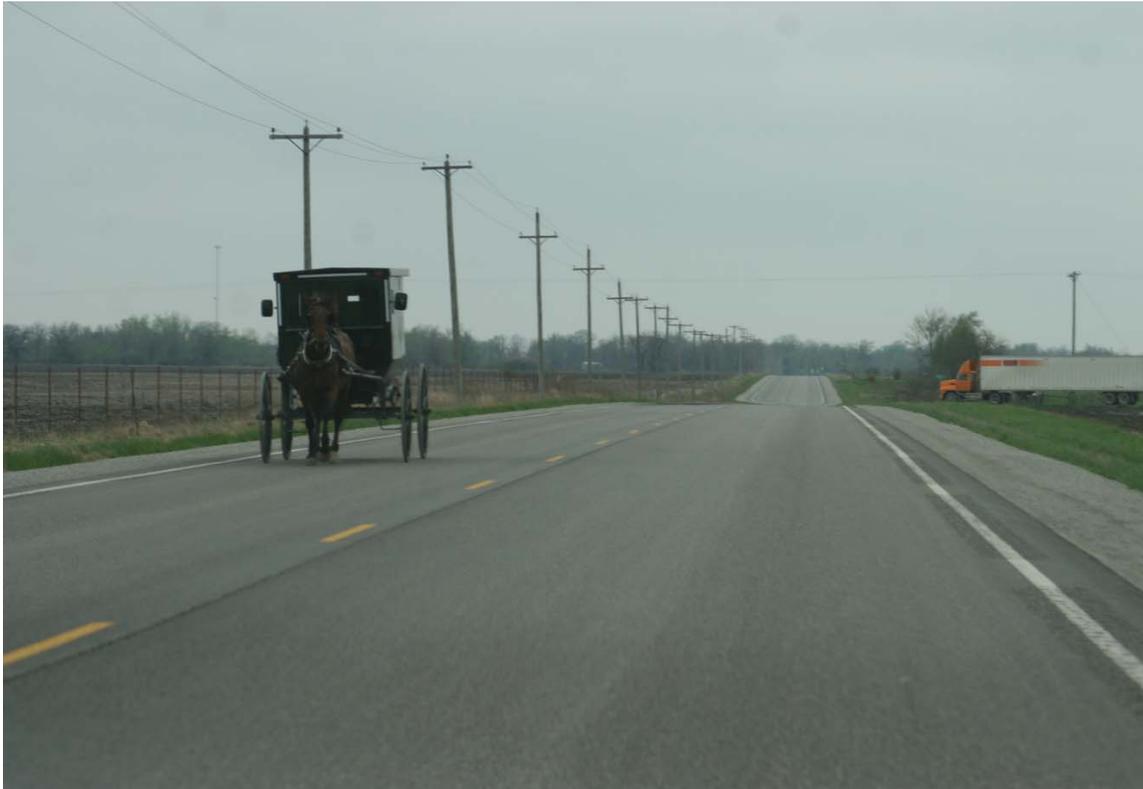
On April 28, 2009, a meeting was held with members of the horse and buggy (Amish) community within Davis County, Iowa. The meeting was organized by the Iowa DOT in response to some expressed concerns over recently installed pavement marking rumble strips within the area (see Figure 5-19).

Figure 5-19. Rumble strips on IA 2, Davis County, Iowa

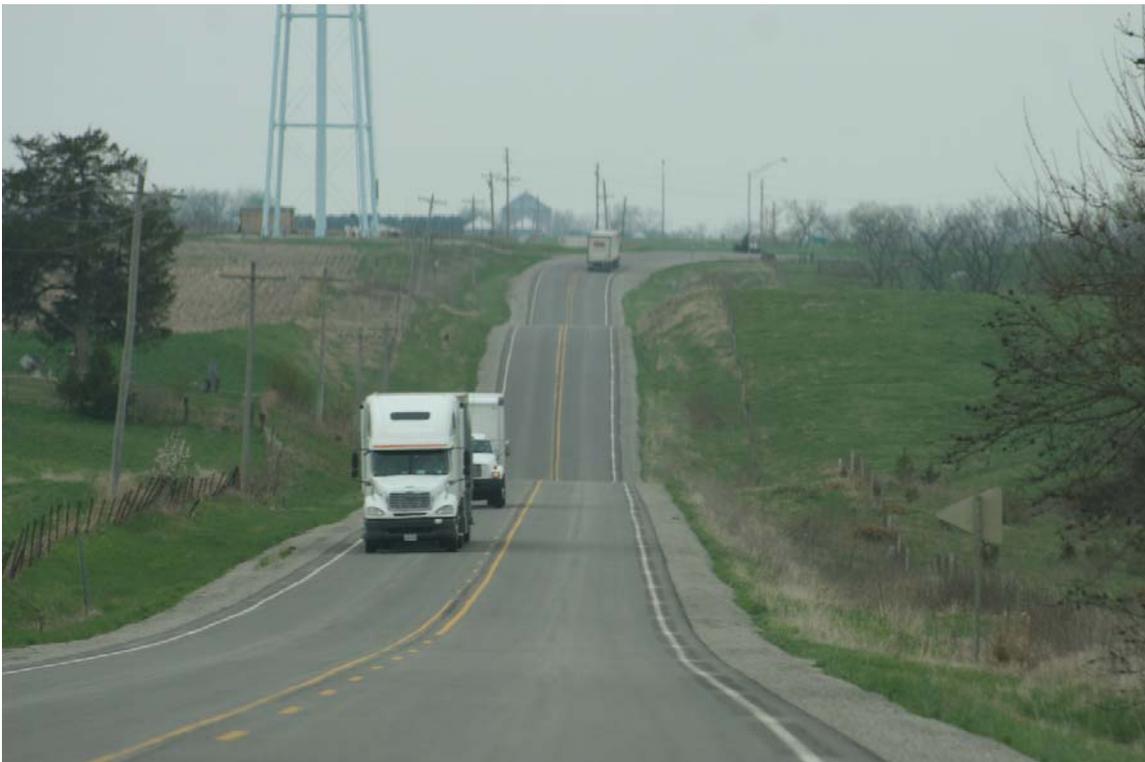
The group would also prefer more shoulder room, if possible, to further separate the horse from large trucks (see Figure 5-23).

Figure 5-23. Narrow shoulder, trucks, rumble strips, and vertical grade on IA 2, Davis County, Iowa
