Flexible Overlays for Rigid Pavements

FINAL REPORT
February 2010

1. Report No. FHWA-NJ-2009-014		2. Government Accession No.		3. Recipient's Catalog No.	
4. Title and Subtitle Flexible Overlays for Rigid Pavements				5. Report Date February, 2010

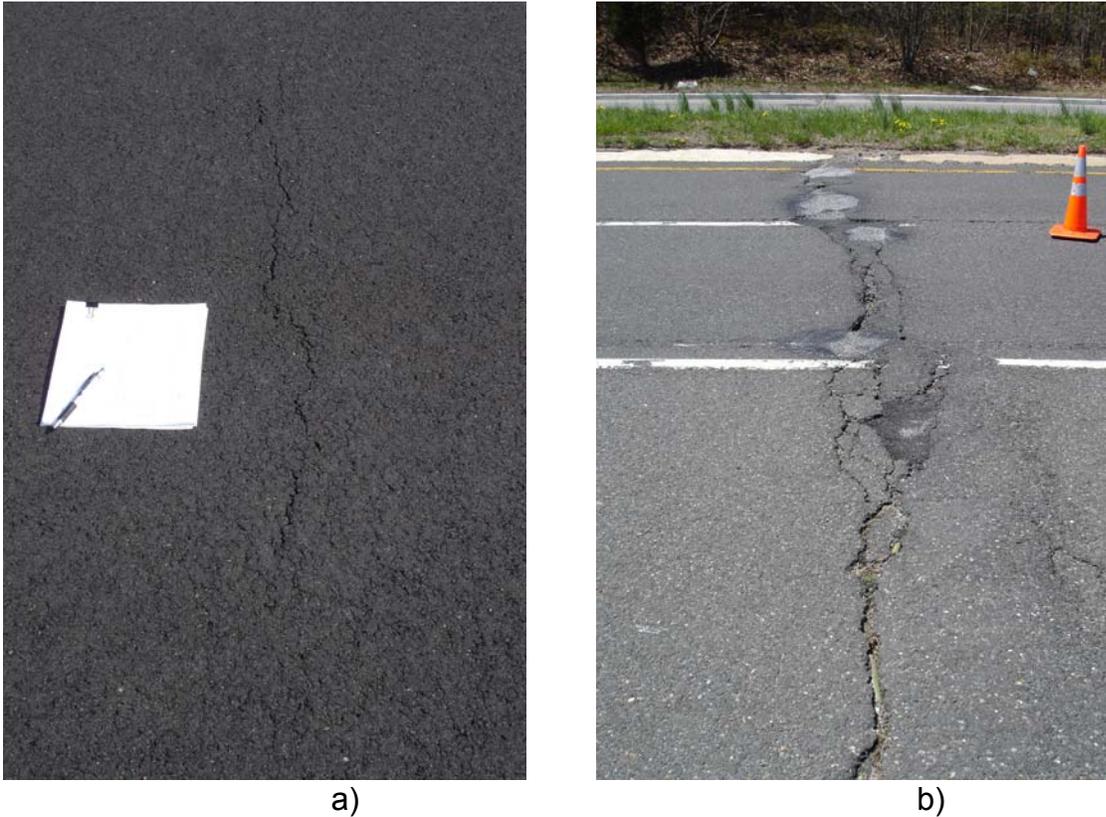
Figure 1 – Reflective Cracking on Existing Composite Pavement, a) Early Reflective Cracking and b) Reflective Cracking After 8 Years of Service

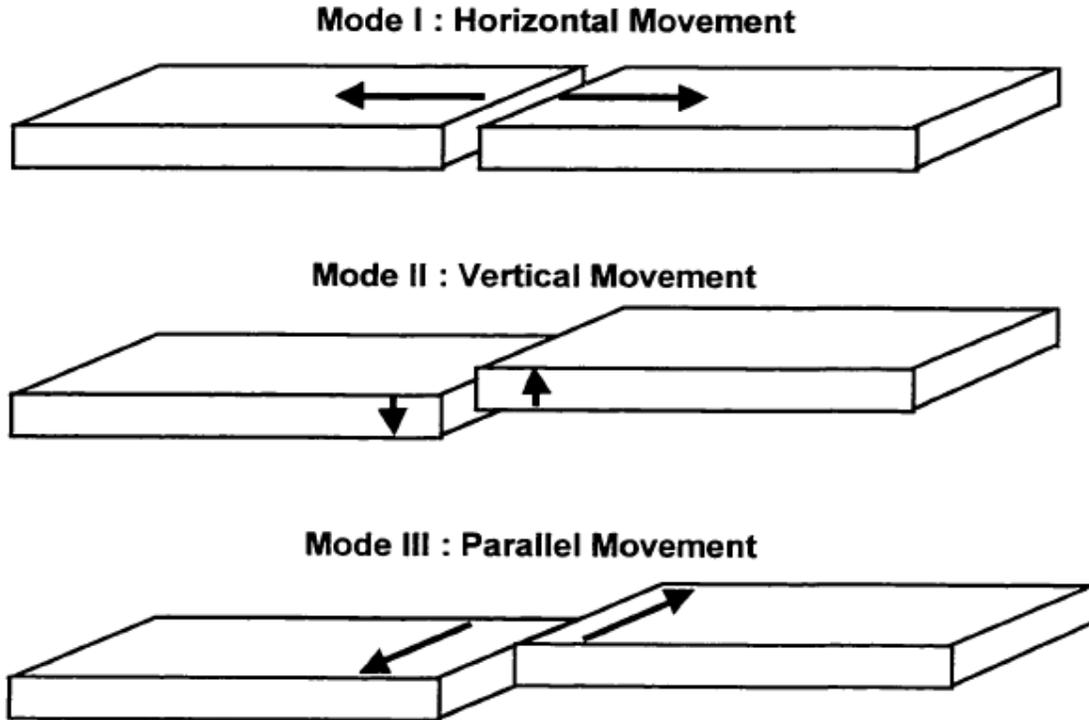
Figure 2 – Movements in Underlying Pavement Layers that Contribute to Reflective Cracking (After Mukhtar and Dempsey, 1996)

Any type of movement taking place within the vicinity of the joint/crack will produce stress and strains in the overlay that can cause it to physically tear. This is purely based on the magnitude of the applied stress being higher than the overlay's resistance to fracture. There are generally three common modes of failure movements associated with reflective cracking (Figure 2):

- Horizontal Movement of Slab – Usually temperature associated and causes tensile and bending stresses to develop in the overlay.
- Vertical Movement at the Joint/Crack Area – Primarily load induced and creates shear and tensile stresses within the overlay.
- Parallel Movement of the Slab – Not common, however, the parallel movement may occur if the slab is structurally unstable with minimal frictional resistance.

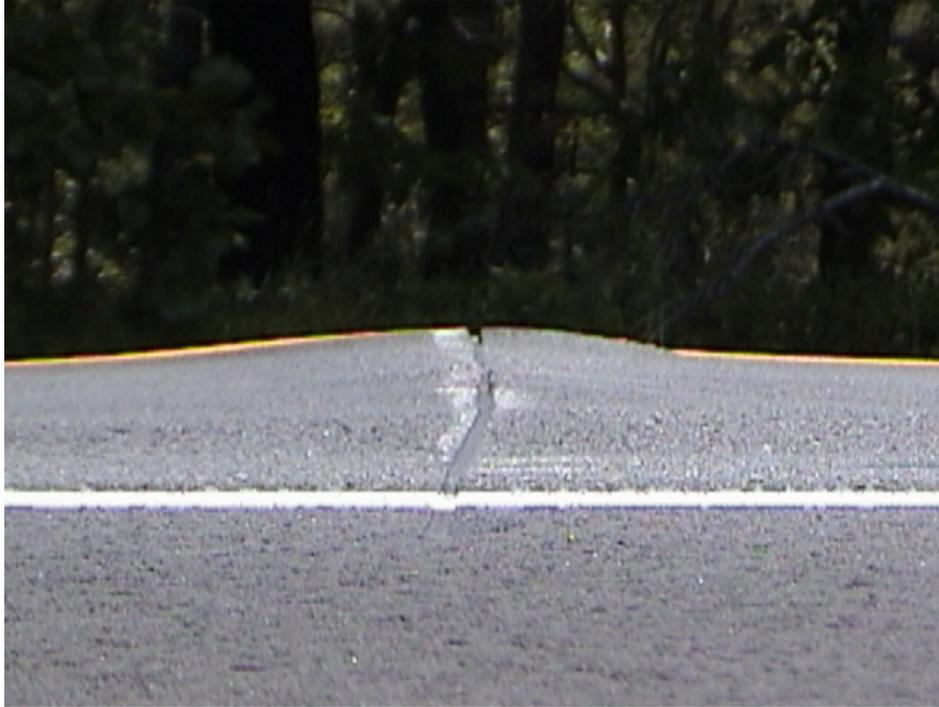
Figure 5 – HMA Overlay Failure at Joint Area Due to Excessive Curling Forces (Route 34 MP 11.5 Southbound)

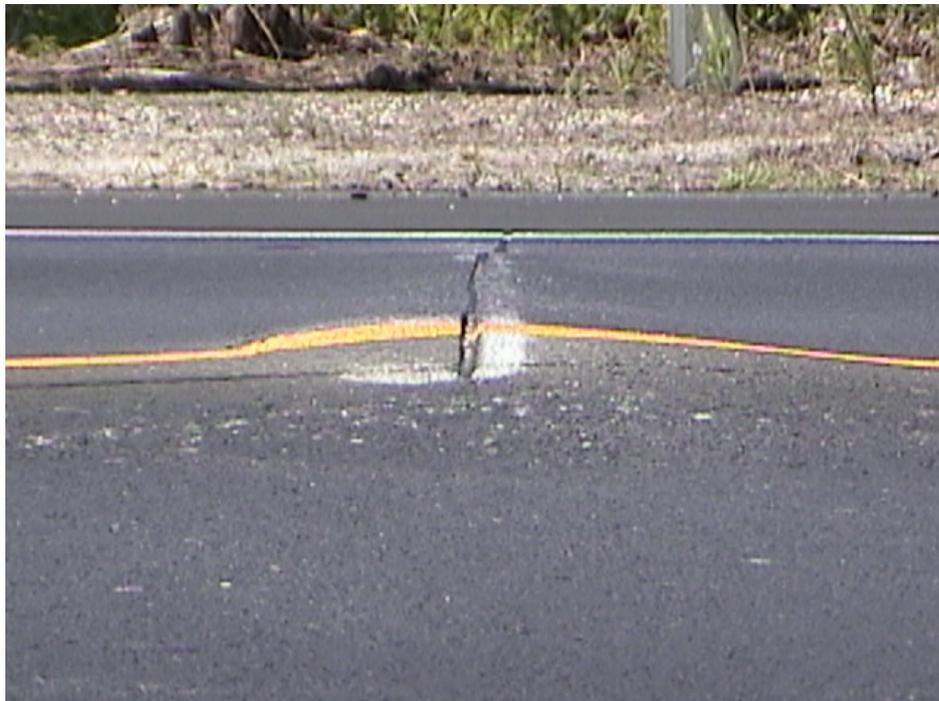
Figure 6 – HMA Overlay on Route 34 (Picture taken from Northbound Side showing the joint was only sawed and sealed on the Southbound Side)

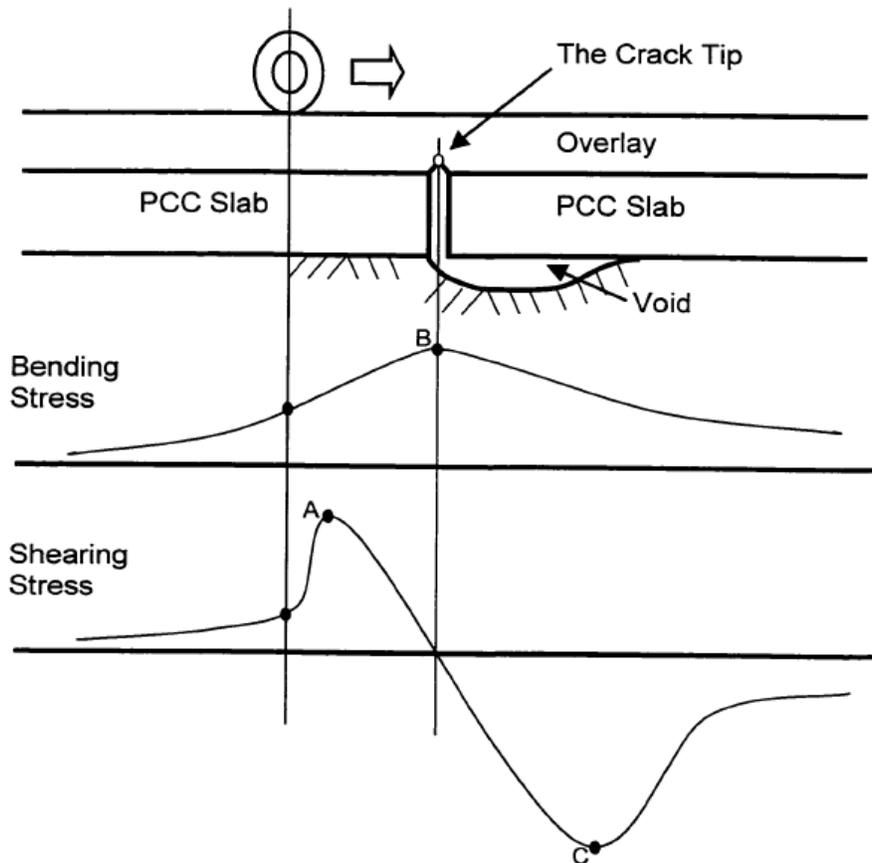
Figure 8 – Stresses Developed in the Joint/Crack Area Due to Traffic Loading (After Kohale and Lytton, 2000)

As the wheel load moves across the PCC joint/crack, three high stresses pulses are developed in the HMA overlay, shown in Figure 8 (After Lytton, 2000). The stress pulse at points A and C occur as shear stress, with point B occurring as a bending stress. The shear stress at point C can potentially be greater than point A if a void exists under

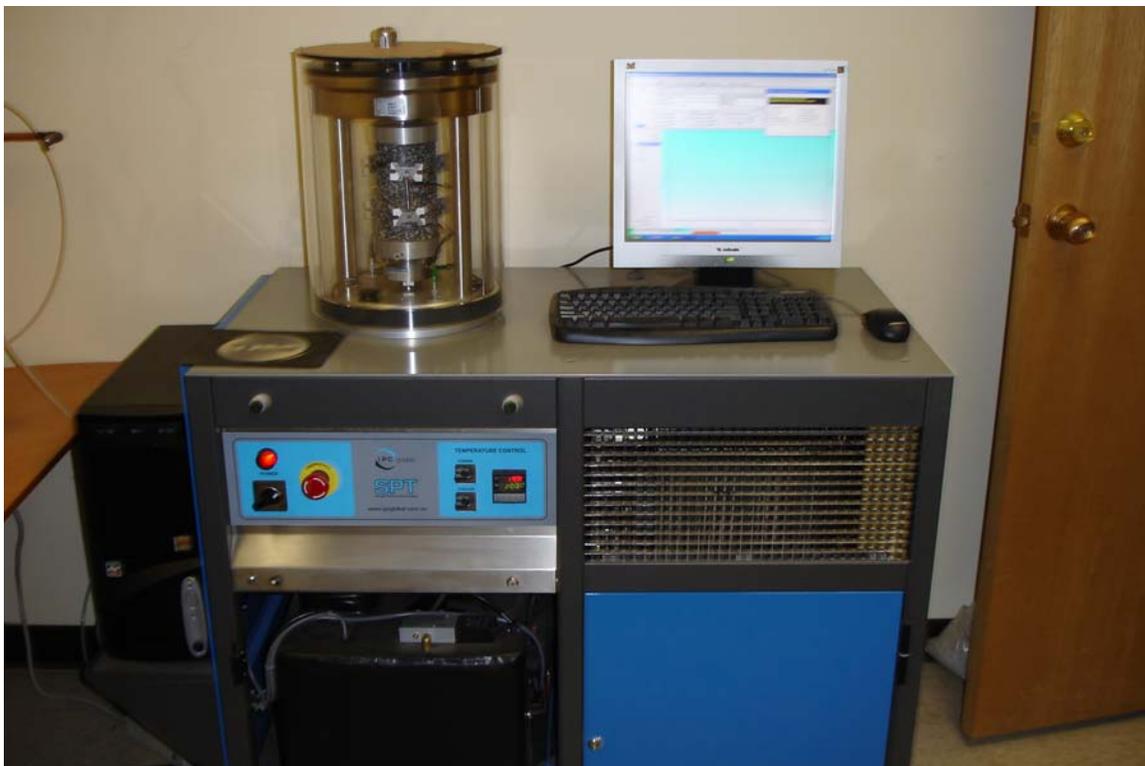
Figure 22 – Dynamic Modulus Test Device

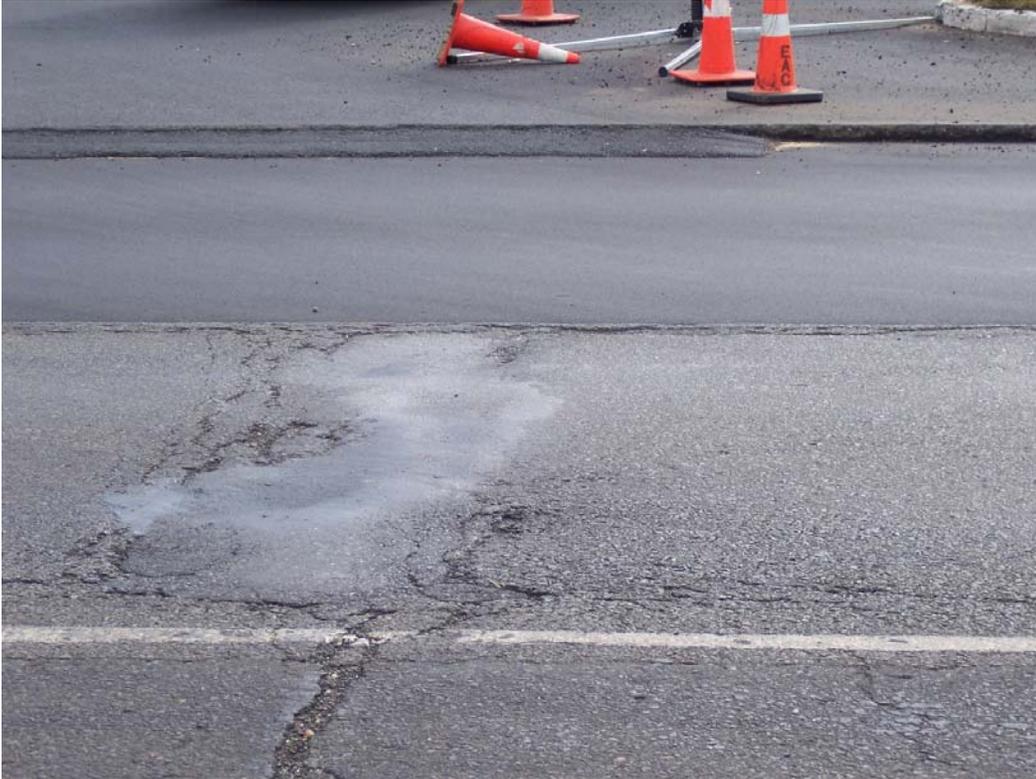
Figure 27 – Photo of Reflective Crack Relief Interlayer (RCRI) Mix, shown in far lane, and Existing HMA Patch Over Deteriorated Reflective Crack

In the summer of 2006, a maintenance resurfacing program consisting of using a reflective crack interlayer mix (RCRI) was specified. The project limits of the resurfacing project were from milepost 0.2 to milepost 7.6. The pavement design recommendation consisted of milling to a constant depth of 76.2 mm (3 inches) prior to the overlay. Photos of some of the construction are shown in Figures 27 and 28.

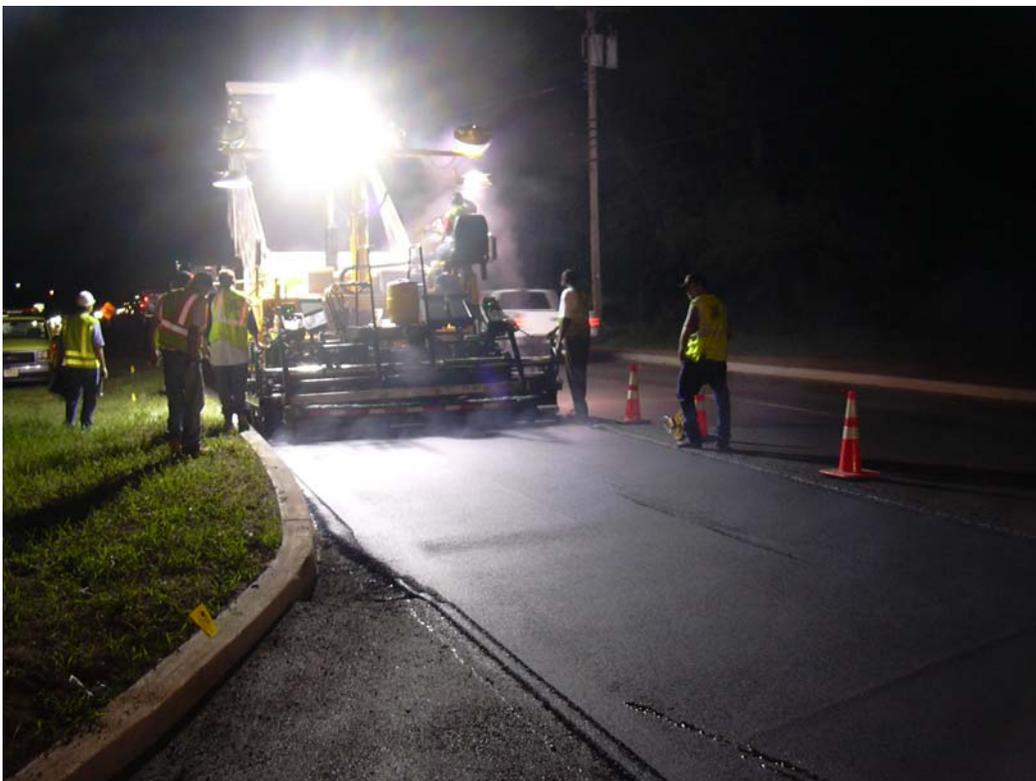
Figure 28 – Paving RCRI Mixture on Rt 34N in New Jersey

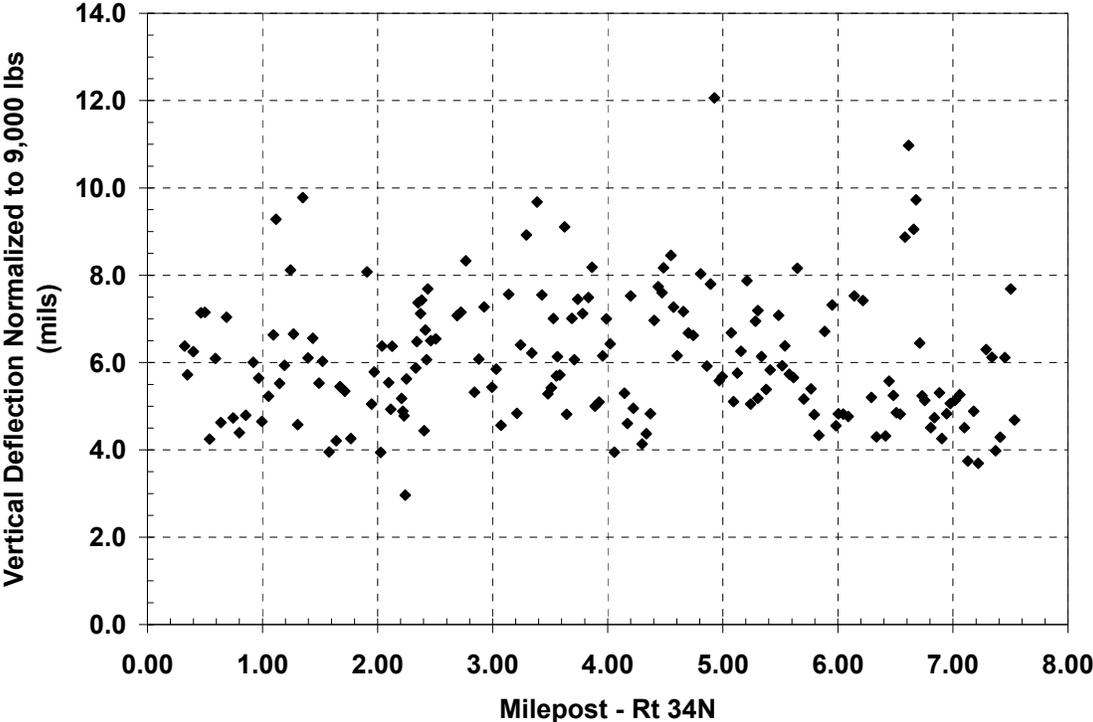
Figure 32 – Vertical Deflections at PCC Joint/Crack

The measured vertical deflections at the PCC joint/crack, normalized to 9,000 lbs for comparison purposes, are shown in Figure 32. On average, the vertical deflection normalized to 9,000 lbs was 6.08 mils with a standard deviation of 1.47 mils.

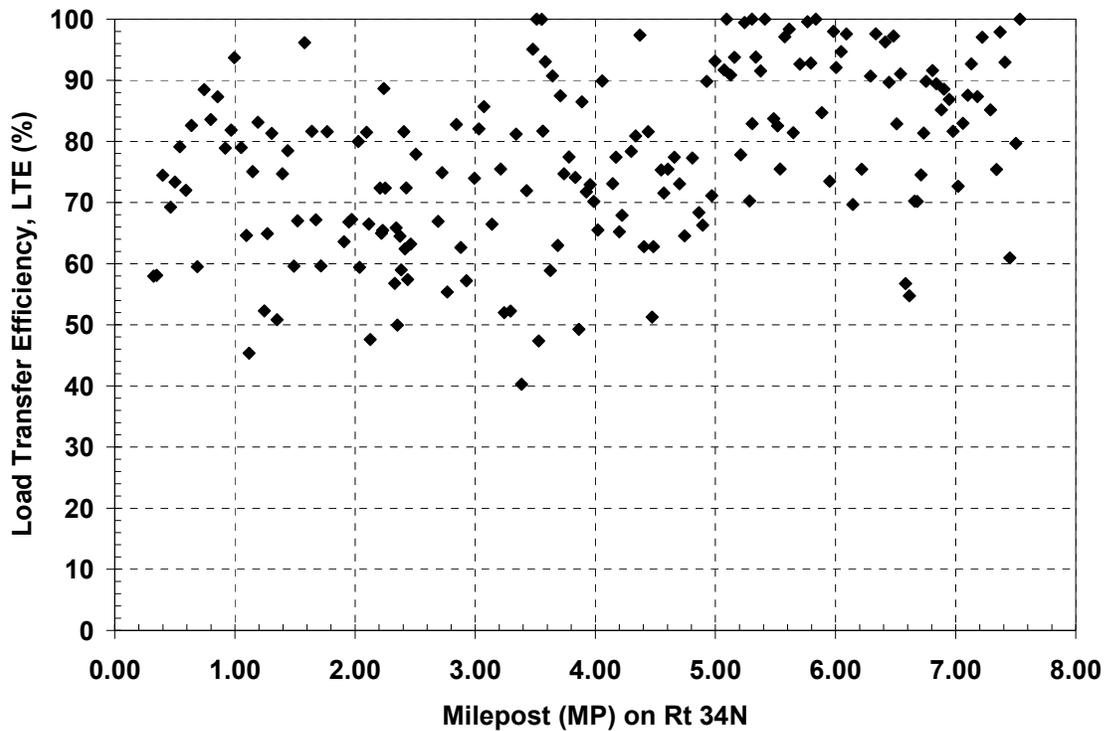
Figure 33 – Load Transfer Efficiency for Rt 34N in New Jersey

Since there are three test sections located on Rt 34N, the test results were calculated and compared for each test section. The Falling Weight Deflectometer (FWD) measured parameters for the different test sections were as follows:

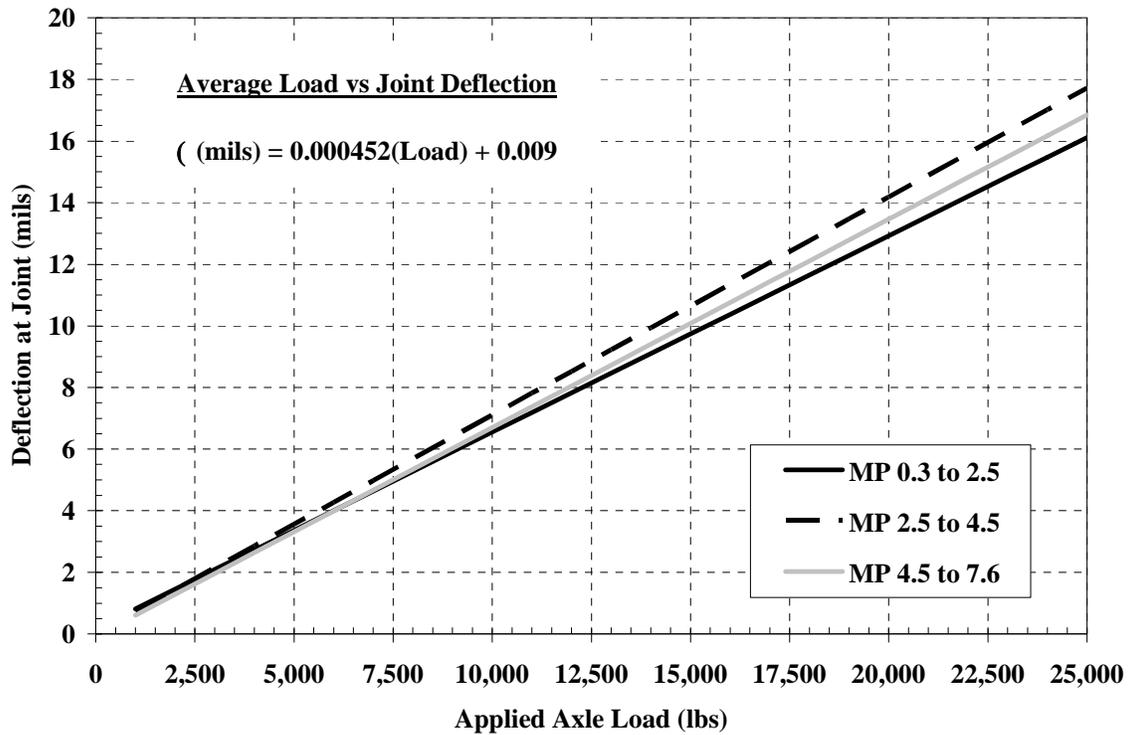
Figure 34 – Applied Load vs Resultant PCC Joint/Crack Vertical Deflection

When conducting FWD testing at different load magnitudes, the relationship between the vertical deflection at the joint (measured immediately under the load) and the applied load can be represented by a linear regression, thereby, allowing for the direct substitution of any known applied axle load to determine the resultant deflection at the joint. The relationship for each Test Section, along with the average, is shown as Figure 34.

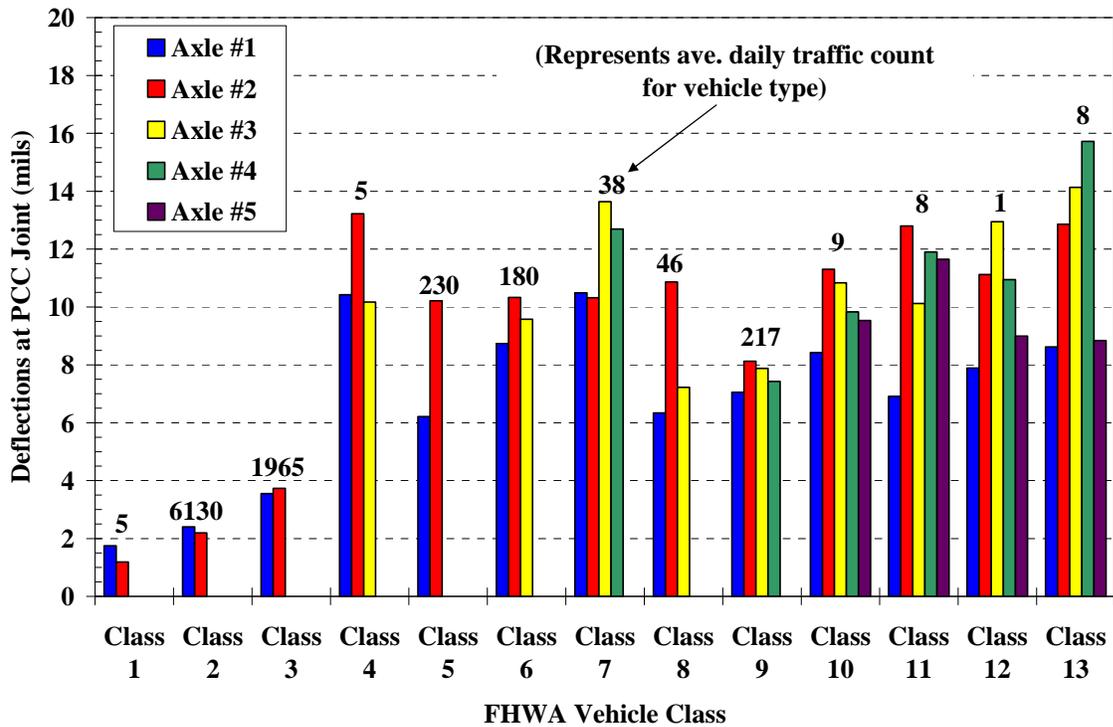
Figure 35 – PCC Vertical Joint Deflection Spectra for Test Section #1

Once the relationship between applied load and vertical joint deflection is established, the axle load measurements recorded by the WIM/AVC sensors can be directly inputted into the regression equation to generate a PCC Vertical Joint Deflection Spectra. In this research, a PCC Vertical Joint Deflection Spectra is defined as the amount and magnitude of vertical deflections that are assumed to occur due to daily traffic volumes. The PCC Vertical Joint Deflection Spectra developed for Test Section #1 is shown as Figure 35. Figure 35 provides valuable information regarding the magnitude of the vertical deflection due to the individual axle load. More detail on the use of the PCC Vertical Joint Deflection Spectra and how it can be applied to laboratory testing is discussed later in this report.

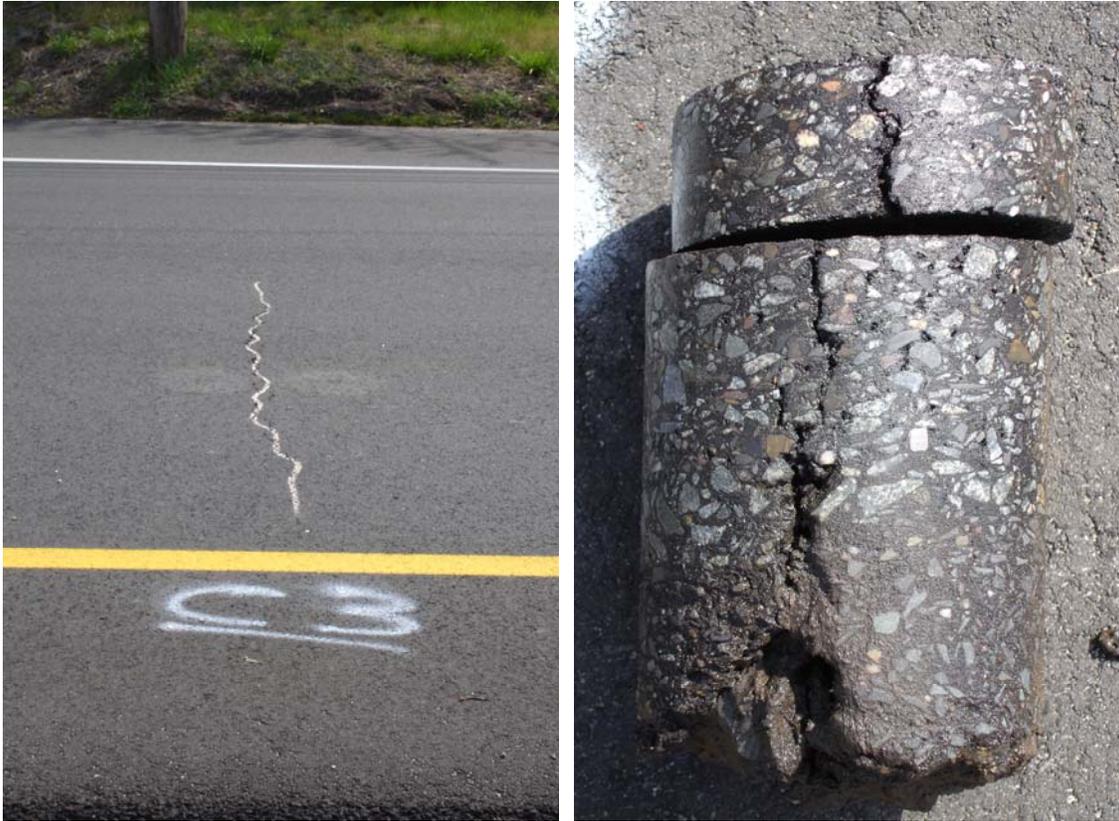
Figure 39 – Early Reflective Cracking in Test Section MP 2.5 to 4.5

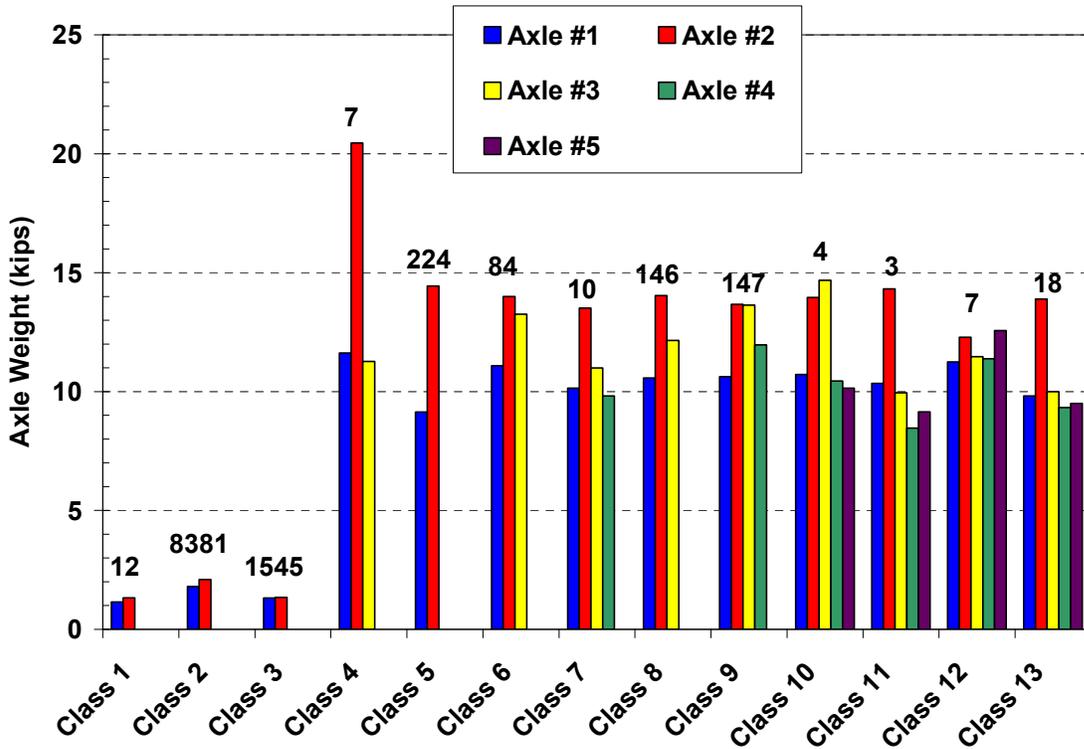
Figure 43 – Axle Load Spectra for Rt 202S

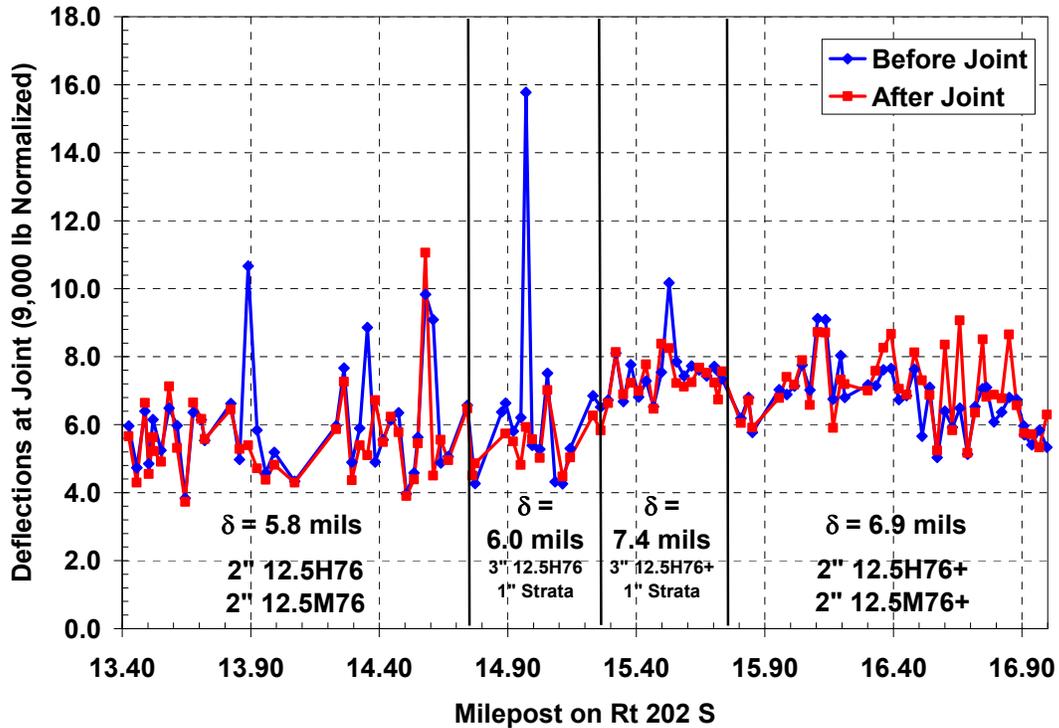
Figure 44 – Vertical Deflection at the PCC Joint/Crack Normalized to 9,000 lbs

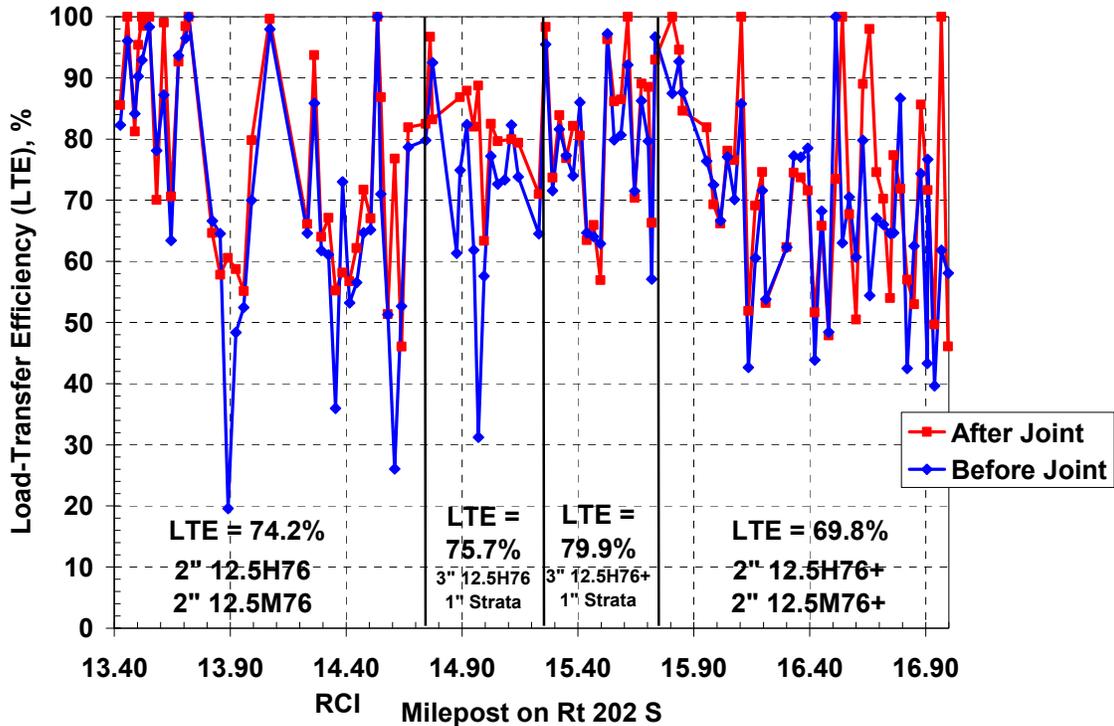
Figure 45 – Load Transfer Efficiency (LTE) of the Different Test Sections on Rt. 202S

- Test Section #1 (2" 12H76 over 2" 12M76) = 74.2%
- Test Section #2 (3" of 12H76 over 1" RCRI) = 75.7%
- Test Section #3 (3" of 12H76+ over 1" RCRI) = 79.9%
- Test Section #4 (2" 12H76+ over 12M76+) = 69.8%

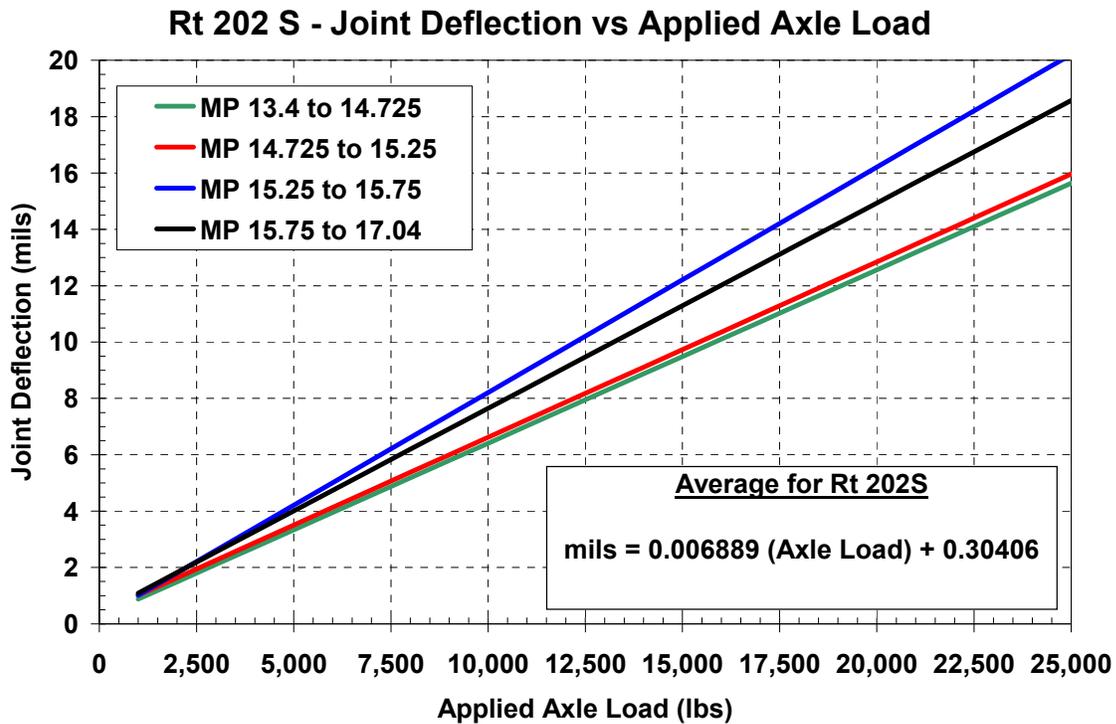
Figure 46 – PCC Joint Deflection vs Applied Axle Load for Rt 202S in New Jersey

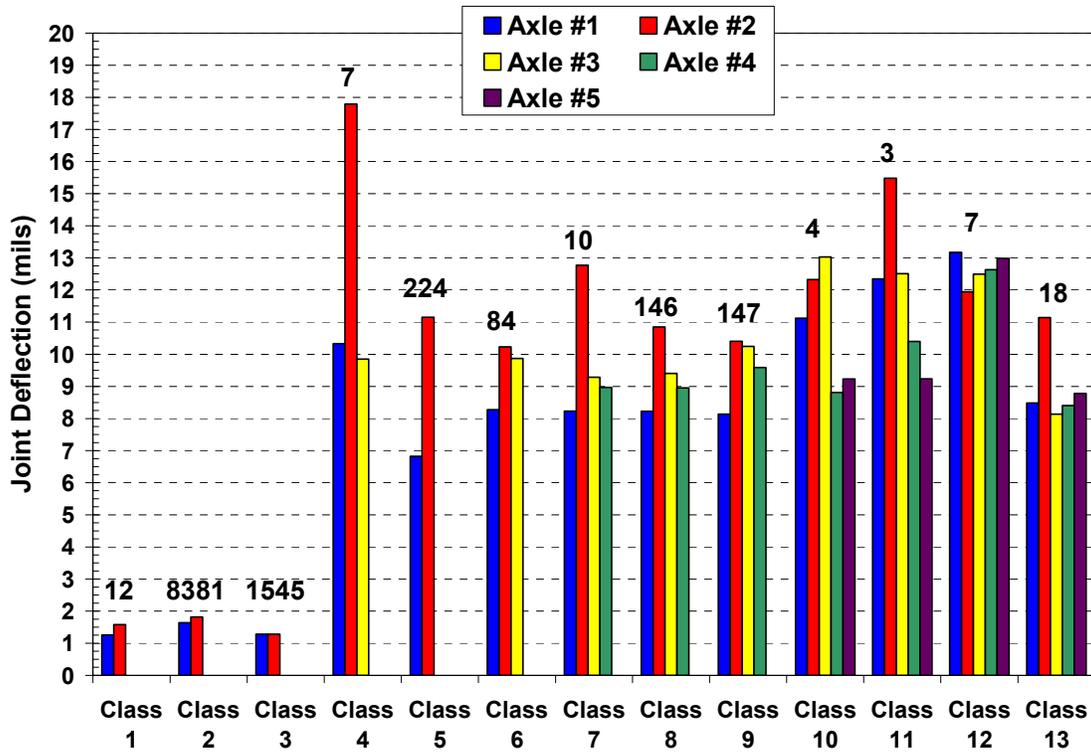
Figure 47 – PCC Vertical Joint Deflection Spectra for Test Section #2 (Rt 202S)

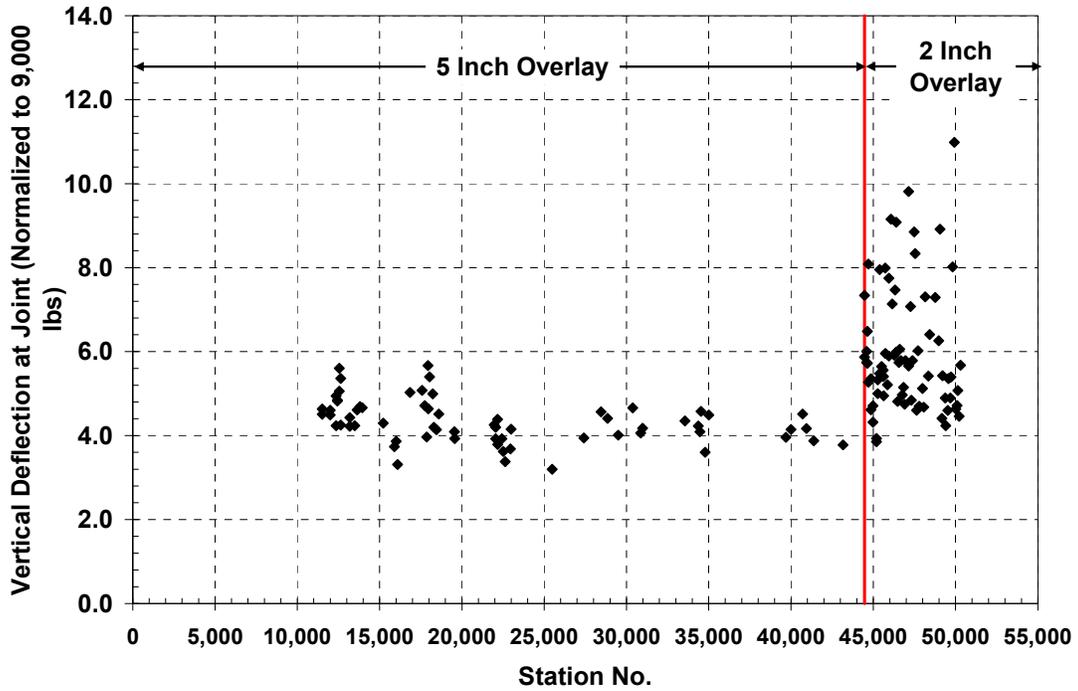
Figure 53 – Vertical Deflection at PCC Joint/Crack Normalized to 9,000 lbs

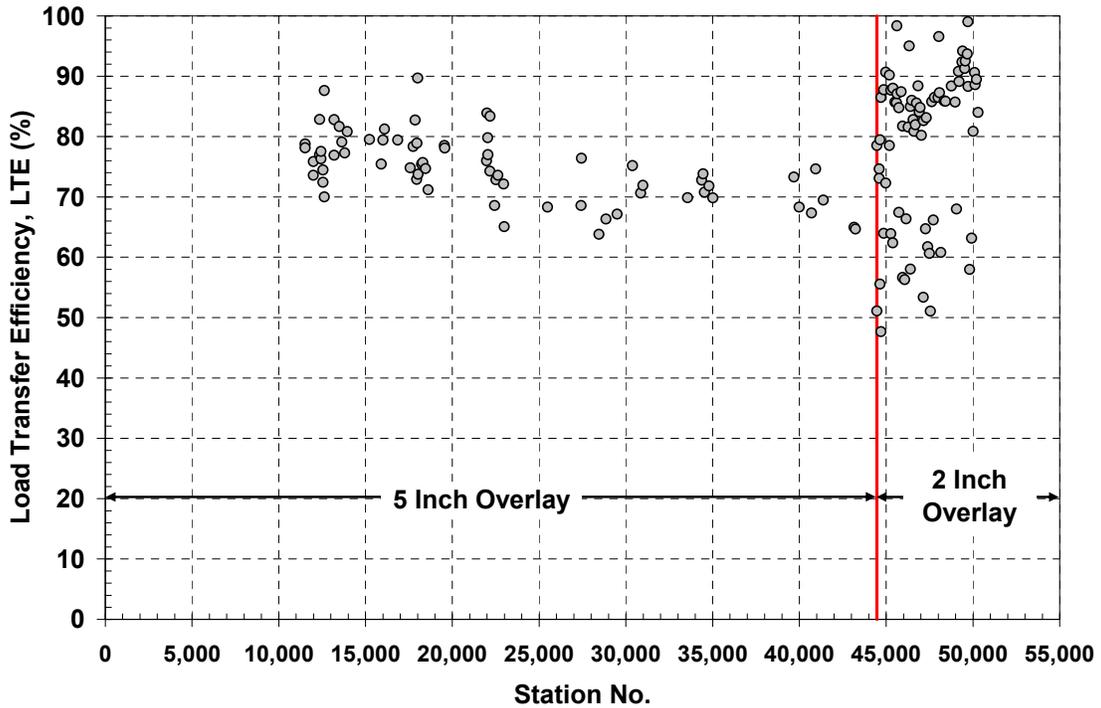
Figure 54 – Load Transfer Efficiency (LTE) at PCC Joint/Crack

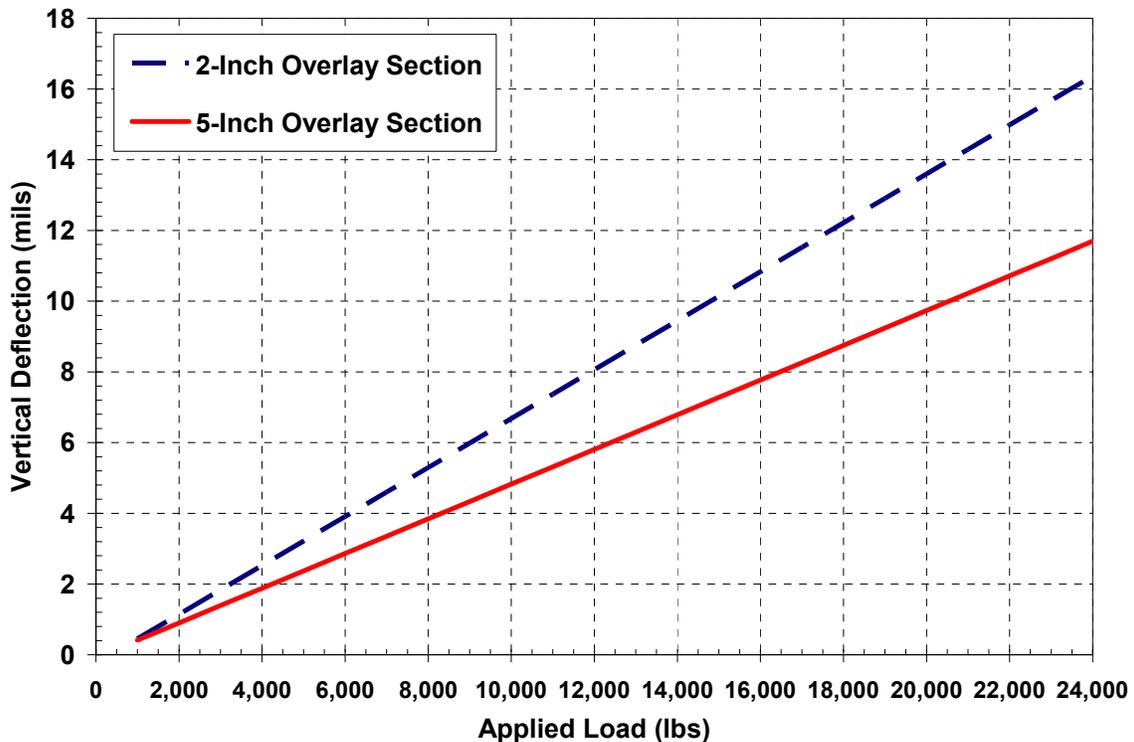
Figure 55 – Applied Load vs PCC Vertical Deflection Relationship for Interstate 495

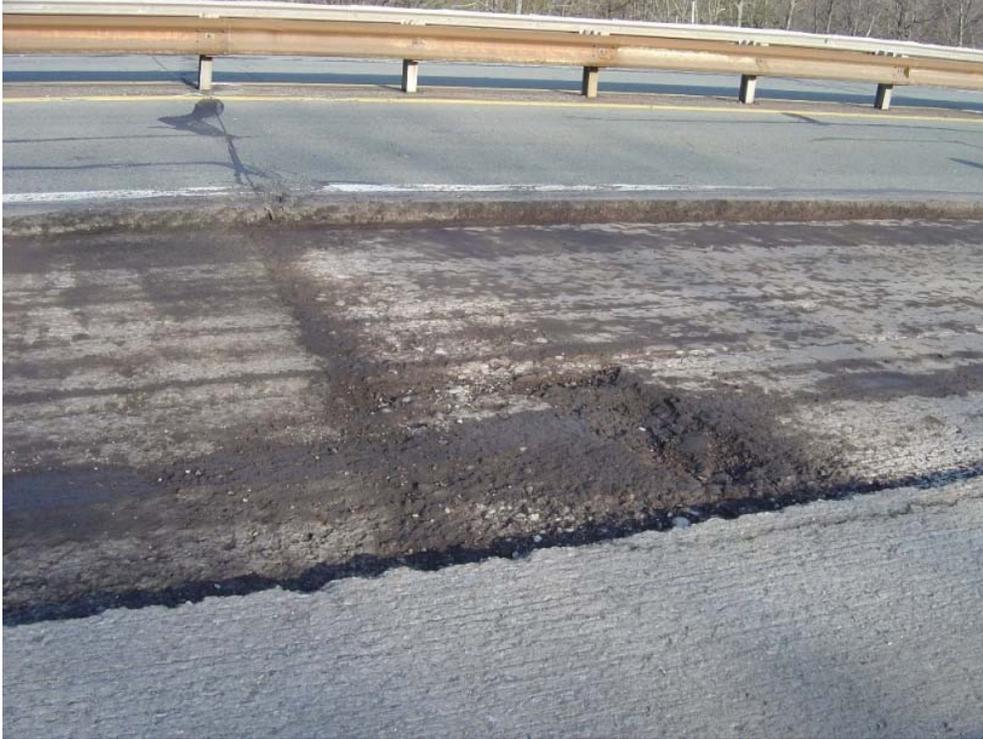
Figure 60 – Milled and Unmilled Surface of Interstate 476 in Pennsylvania

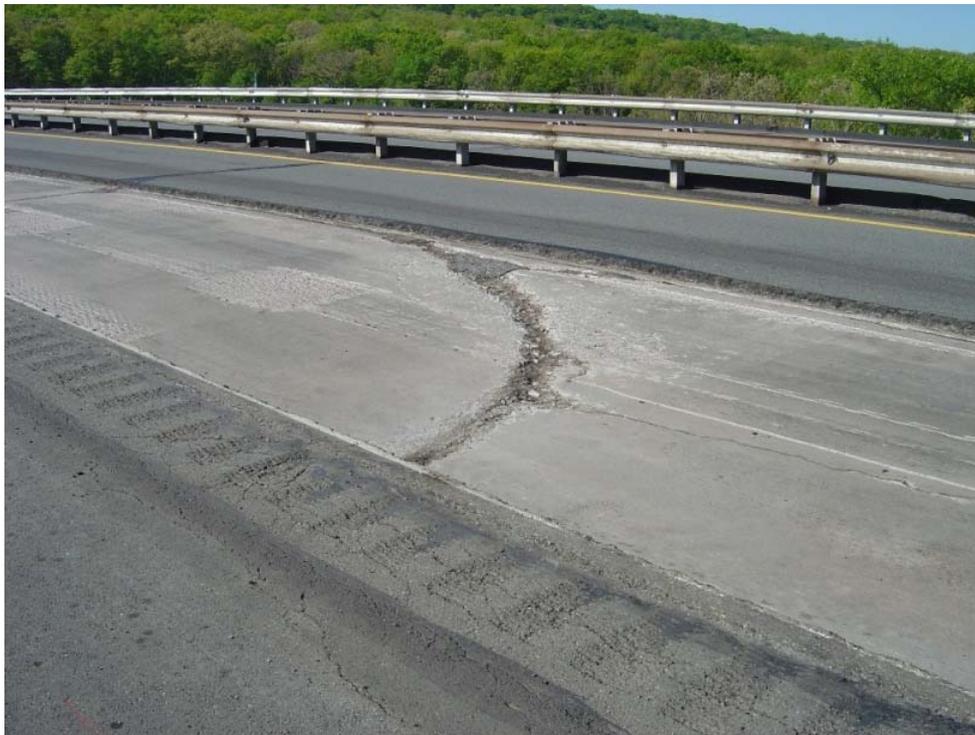
Figure 61 – Exposed Surface of Underlying PCC Pavement on Interstate 476 in Pennsylvania

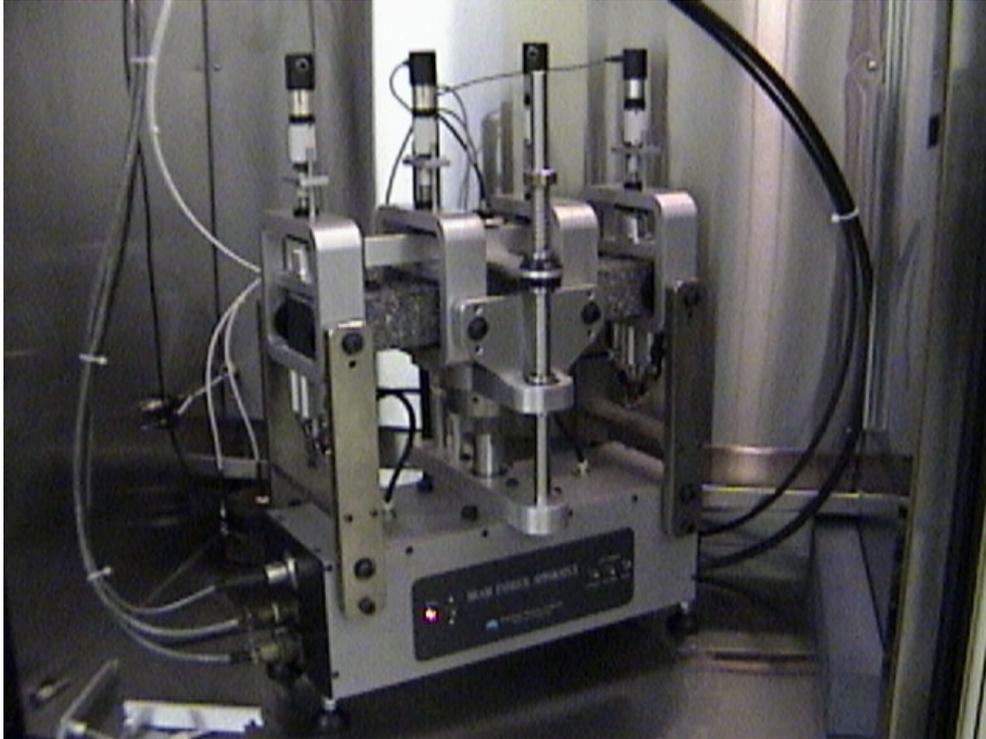
Figure 62 – Flexural Beam Fatigue Device for AASHTO T321

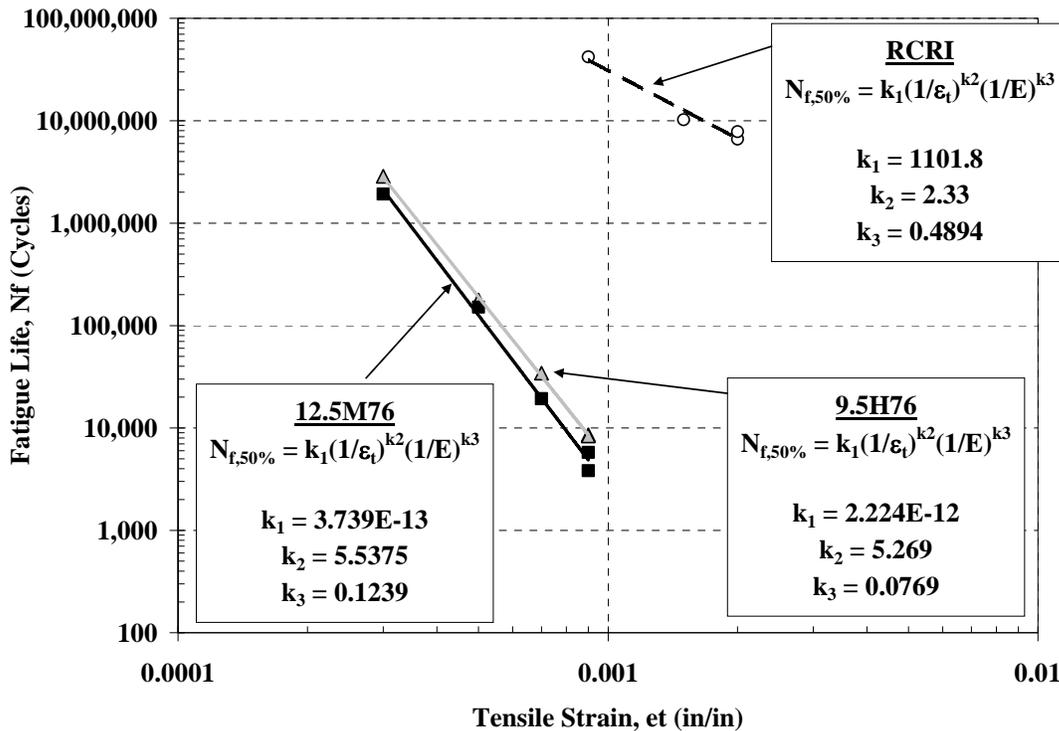
Figure 63 – Flexural Beam Fatigue Life of Asphalt Mixture from Rt 34N, New Jersey

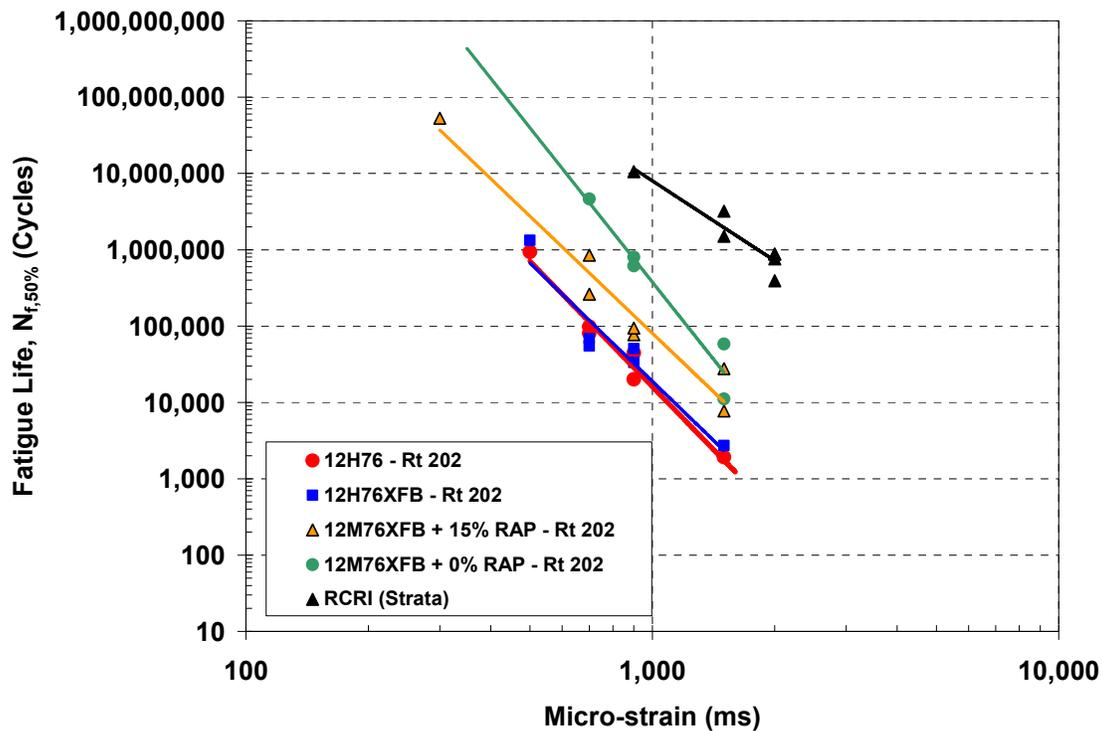
Figure 64 – Flexural Beam Fatigue Life of Asphalt Mixture from Rt 202S, New Jersey

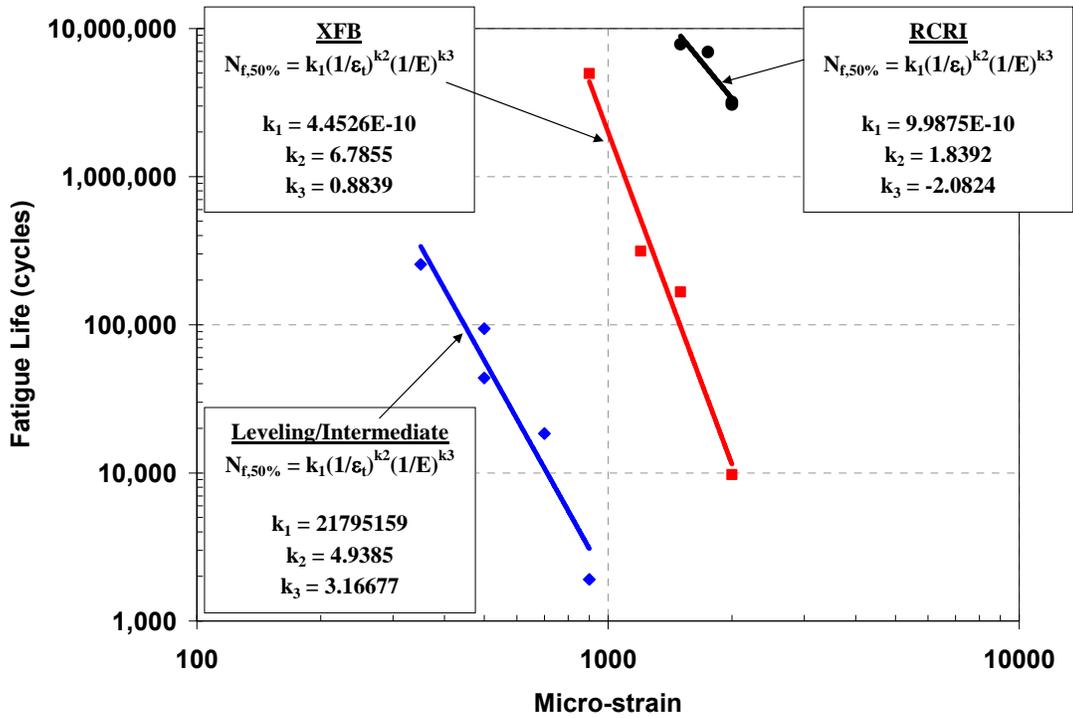
Figure 65 – Flexural Beam Fatigue Life of Asphalt Mixture from I495, Massachusetts
