Flexible Overlays for Rigid Pavements

FINAL REPORT
February 2010

1. Report No. FHWA-NJ-2009-014		2. Government Accession No.		3. Recipient's Catalog No.	
4. Title and Subtitle Flexible Overlays for Rigid Pavements				5. Report Date February, 2010

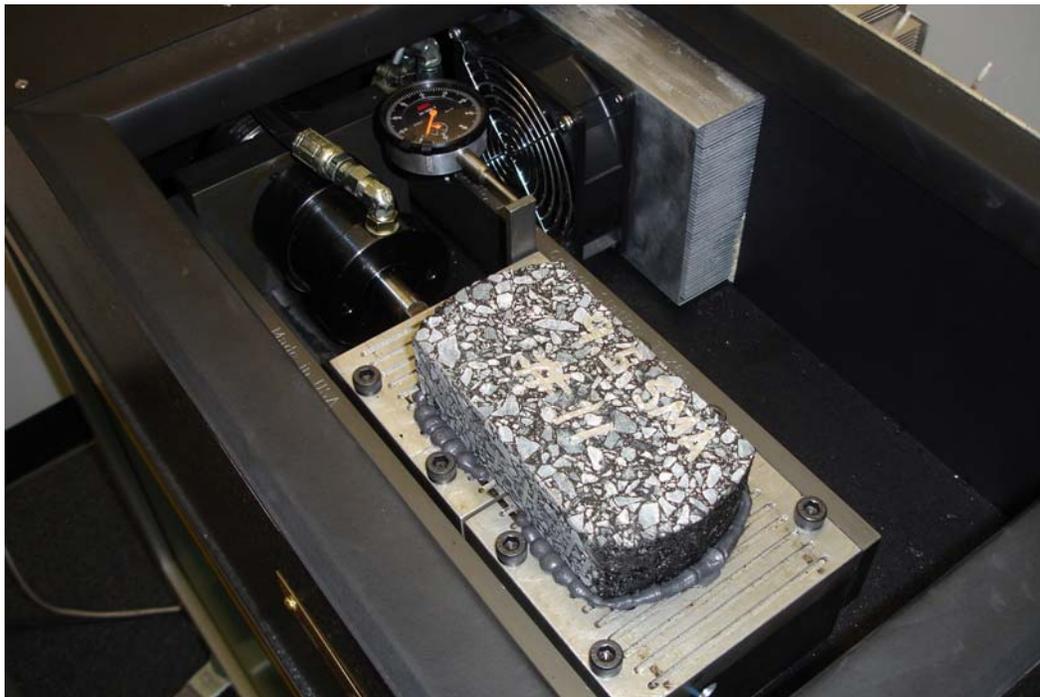
Figure 67 – Photo of the TTI Overlay Tester

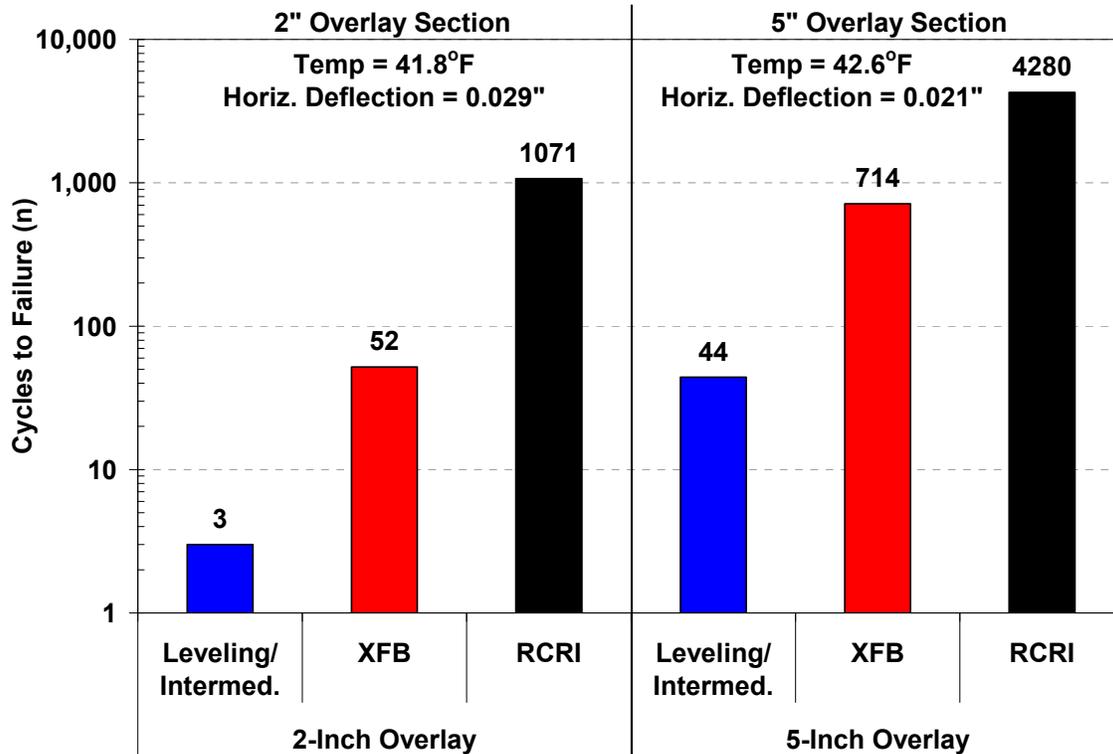
Figure 70 – Overlay Tester Test Results for 2” and 5” Overlay Sections

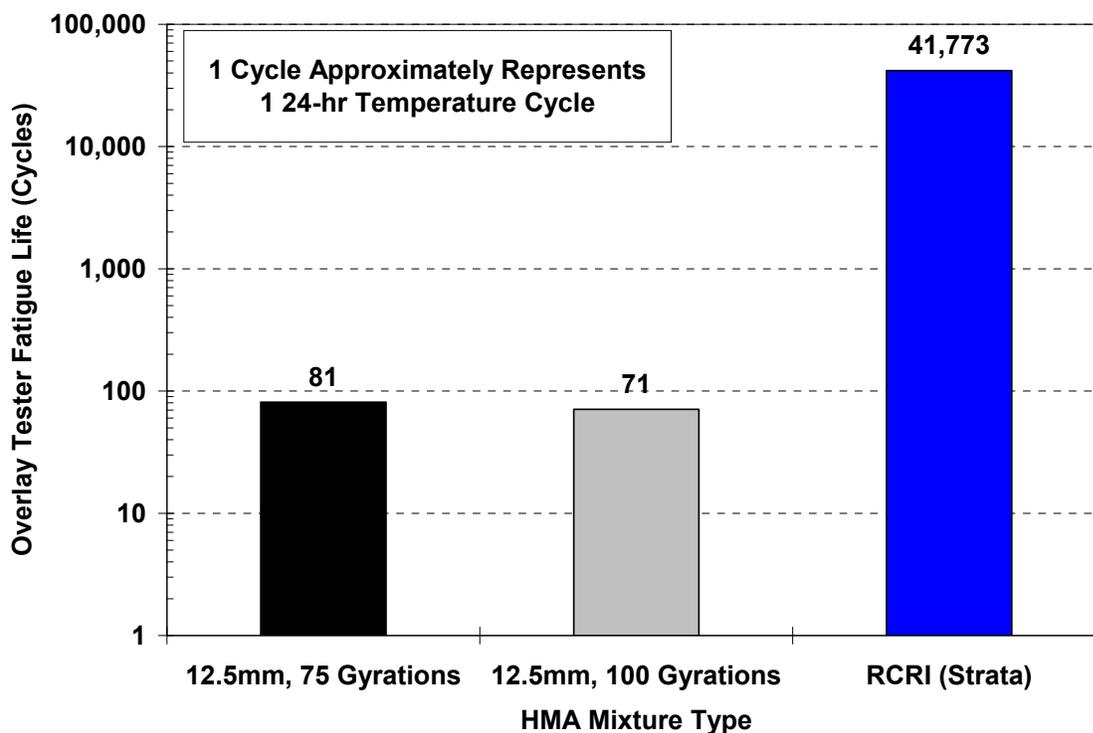
Figure 71 – TTI Overlay Tester Results for HMA Mixtures on I476, Pennsylvania

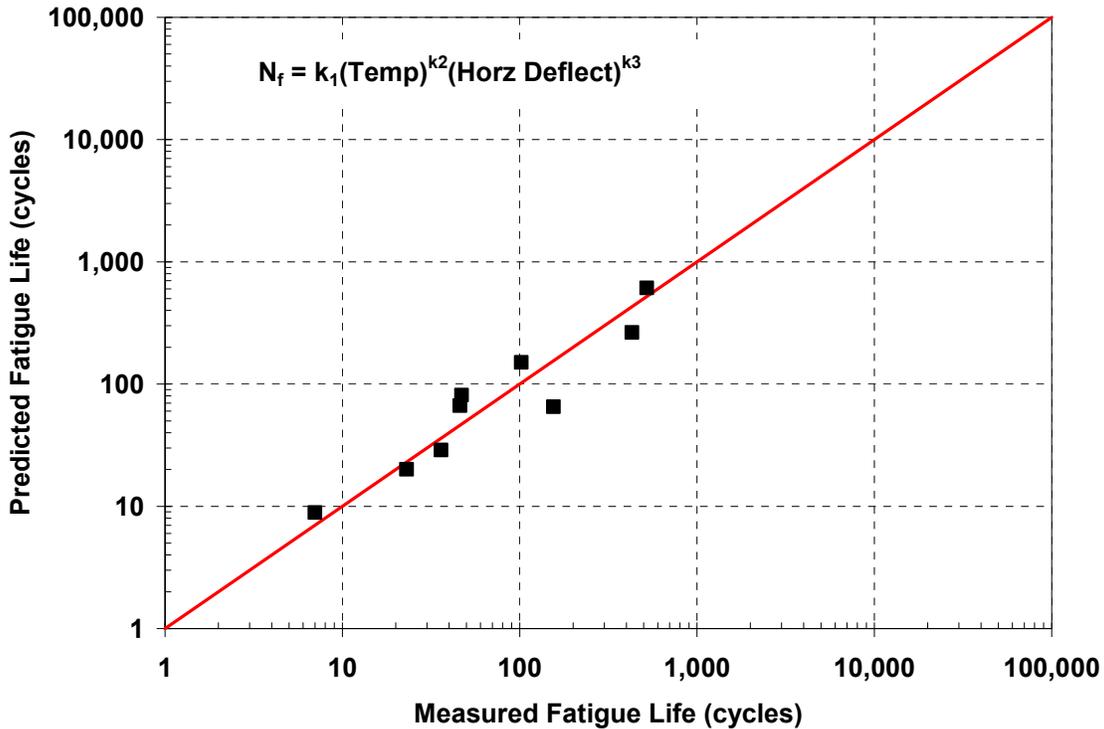
Figure 72 – Example of Horizontal Fatigue Life Determined in the TTI Overlay Tester

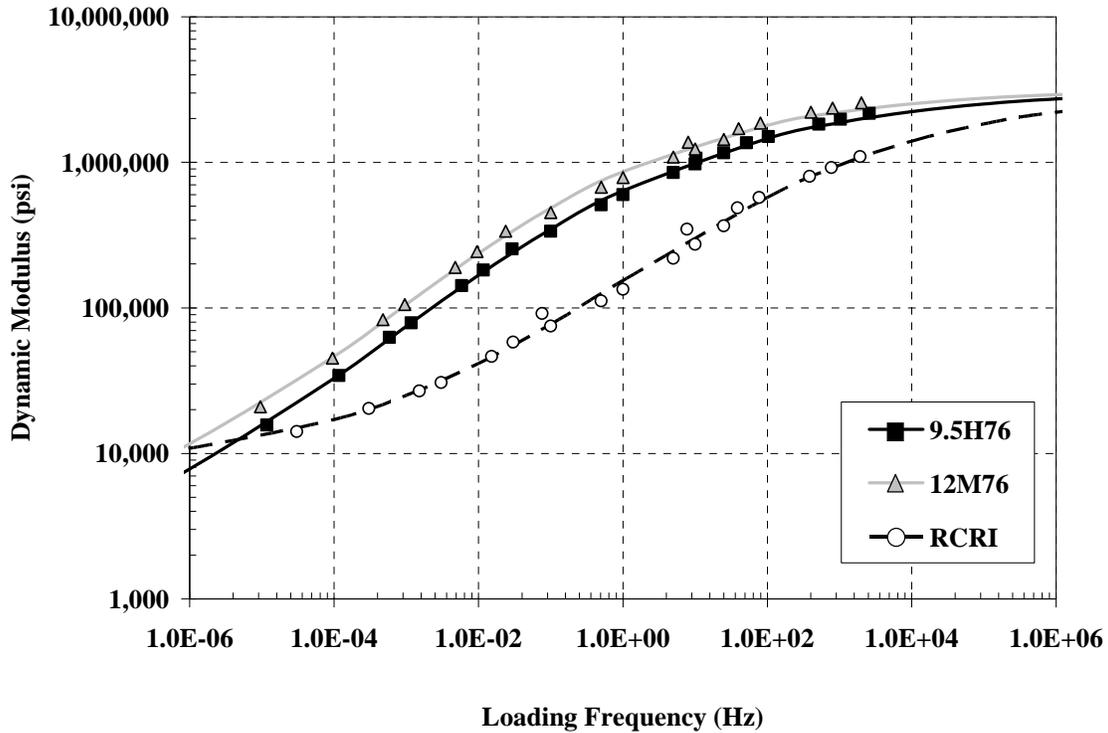
Figure 73 – Dynamic Modulus Test Results of Asphalt Mixtures on Rt 34N, New Jersey

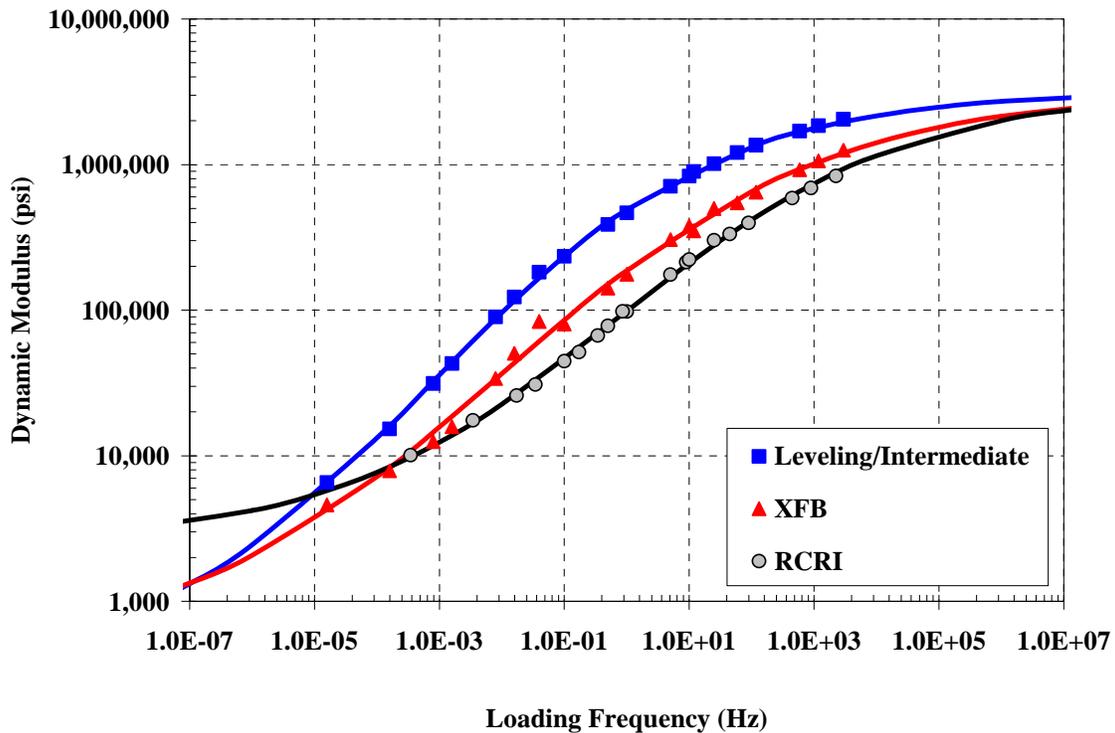
Figure 74 – Master Stiffness Curves of the Asphalt Mixtures from I495 Massachusetts Test Section

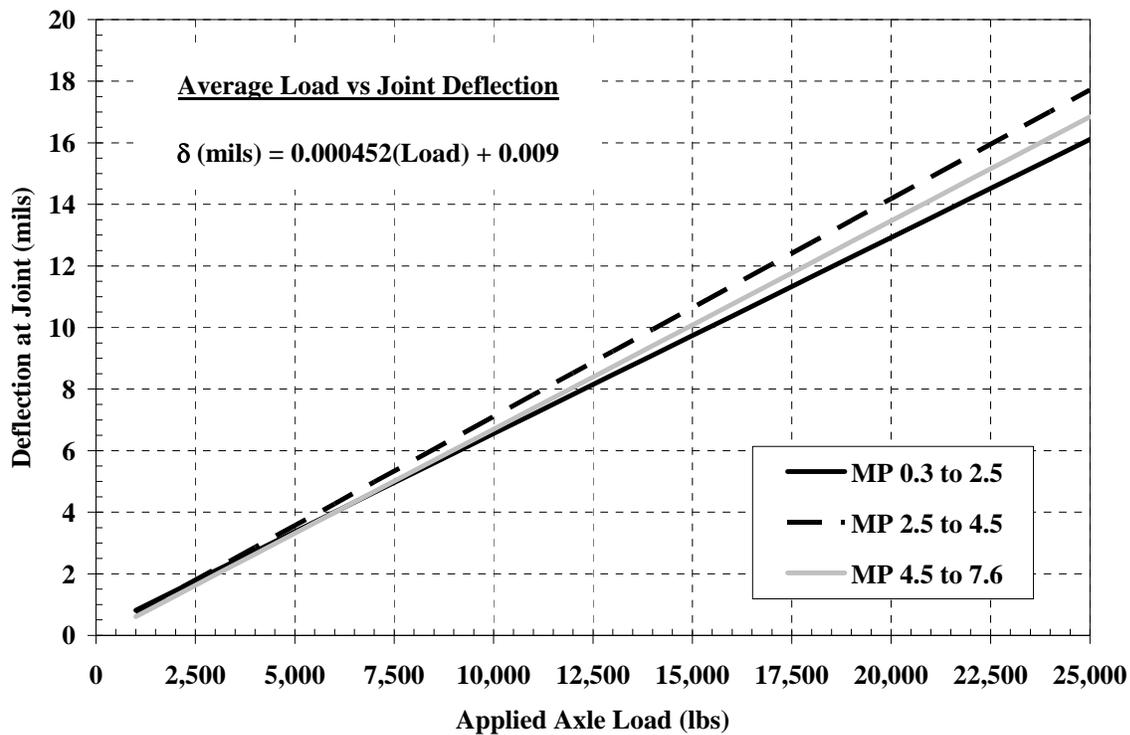
Figure 76 – Relationship Between FWD Load Magnitude and Vertical Deflection at PCC Joint for Rt 34N New Jersey Test Section

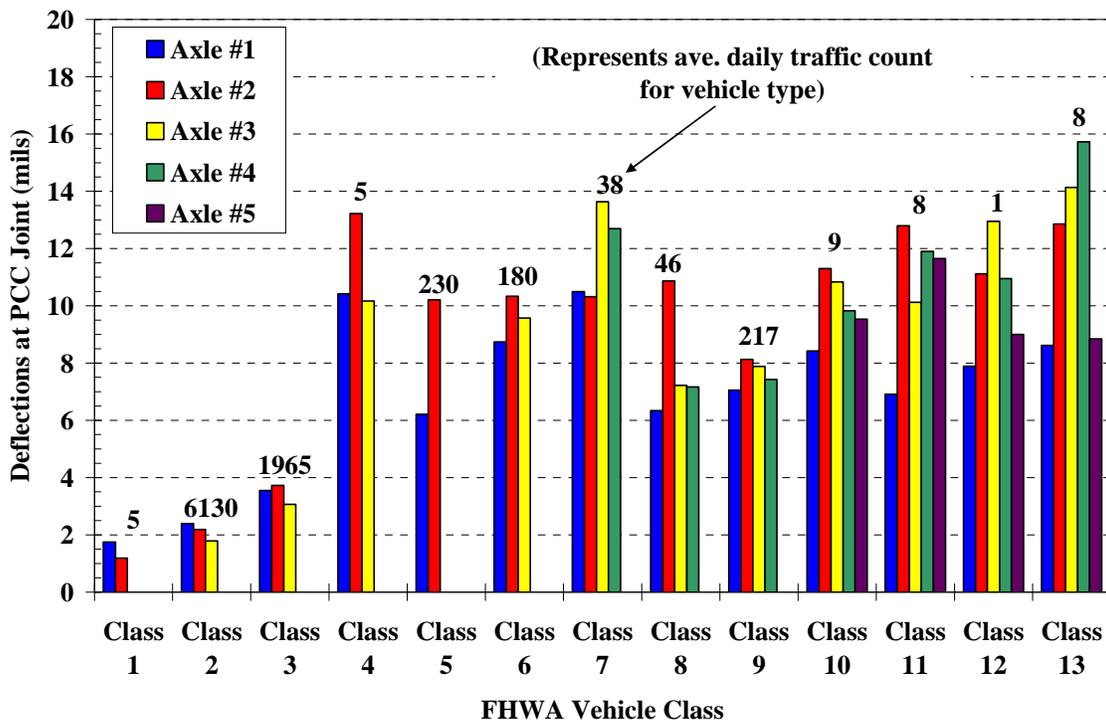
Figure 77 – PCC Vertical Joint Deflection Spectra for Test Section #1

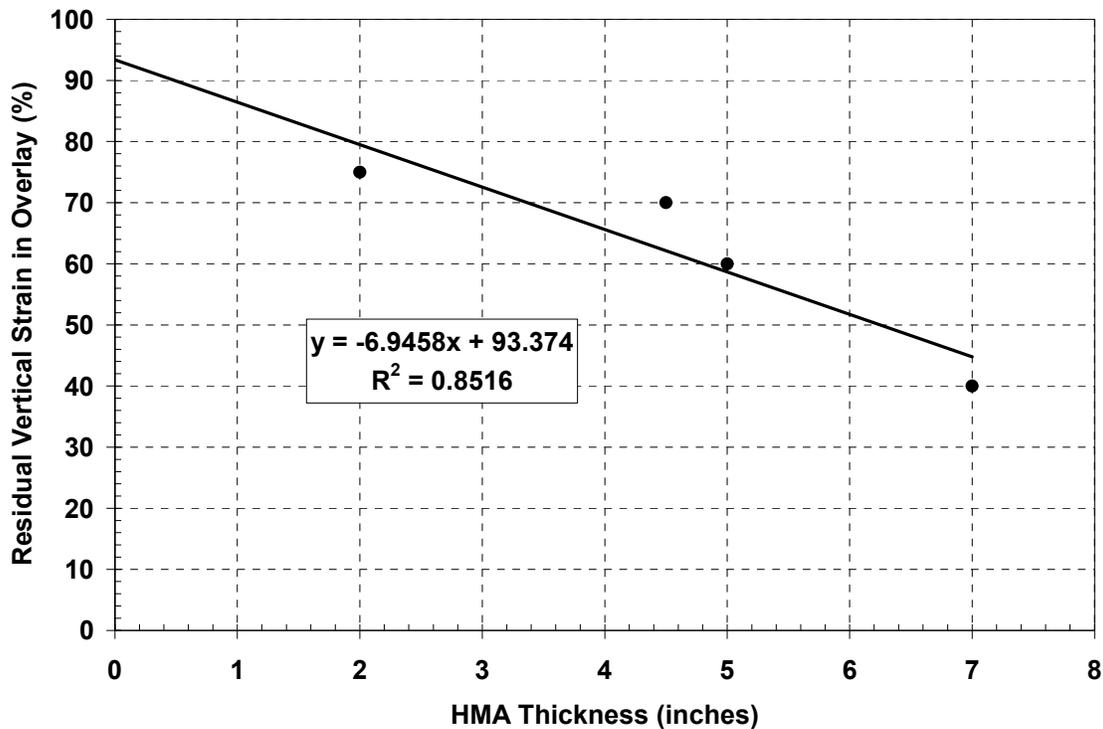
Figure 78 – Determination of Residual Vertical Strain from FWD Field Testing

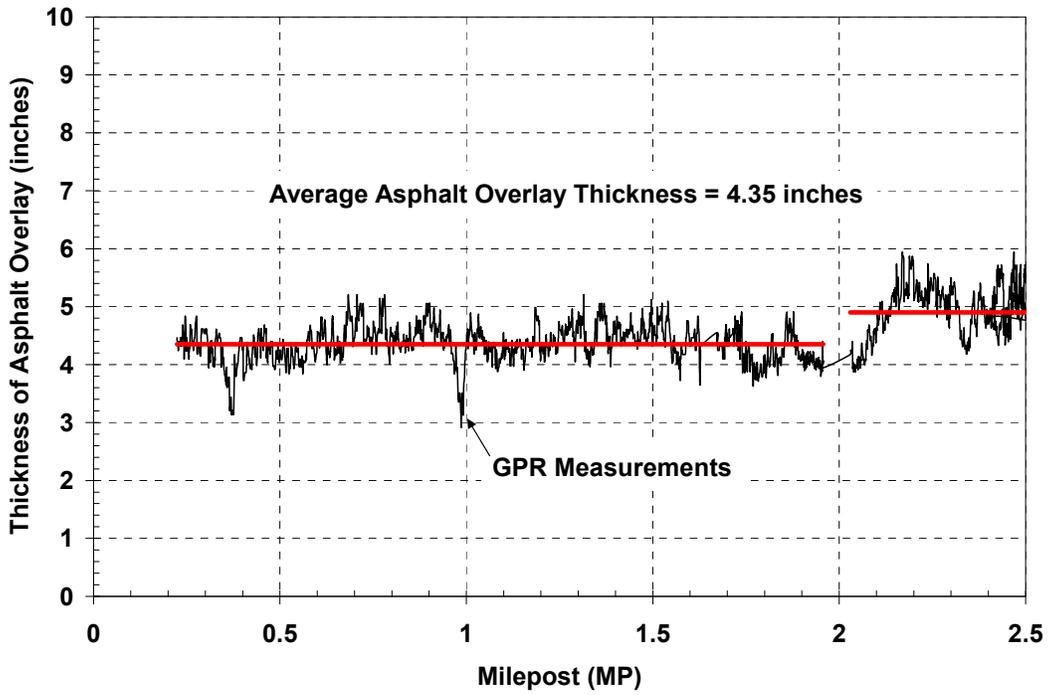
Figure 79 – Ground Penetrating Radar (GPR) Test Results for Section #1 of Rt 34N New Jersey

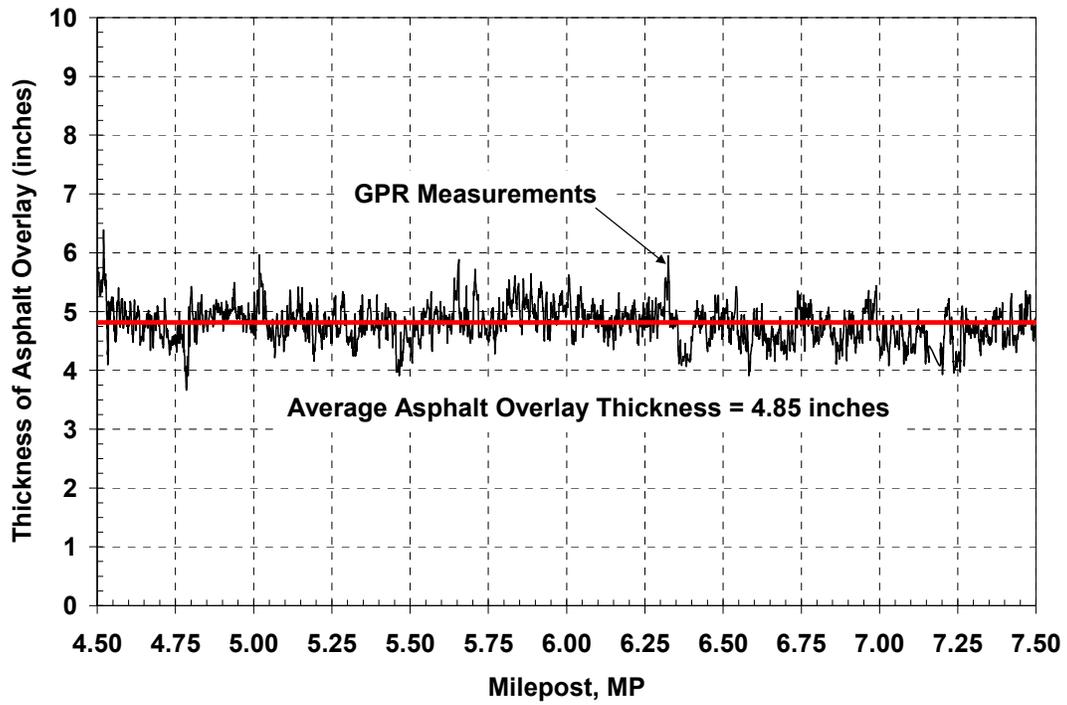
Figure 81 – Ground Penetrating Radar (GPR) Test Results for Section #3 of Rt 34N
New Jersey

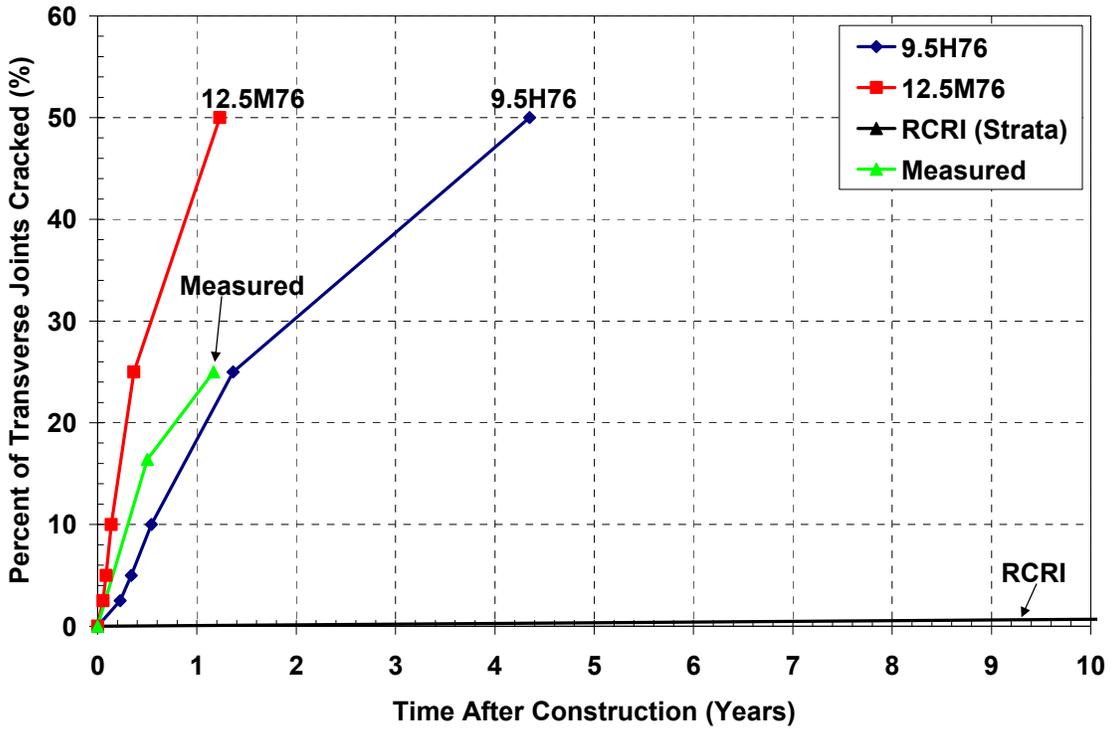
Figure 83 – Predicted versus Measured Reflective Cracking of Test Section #1 on Rt 34N New Jersey

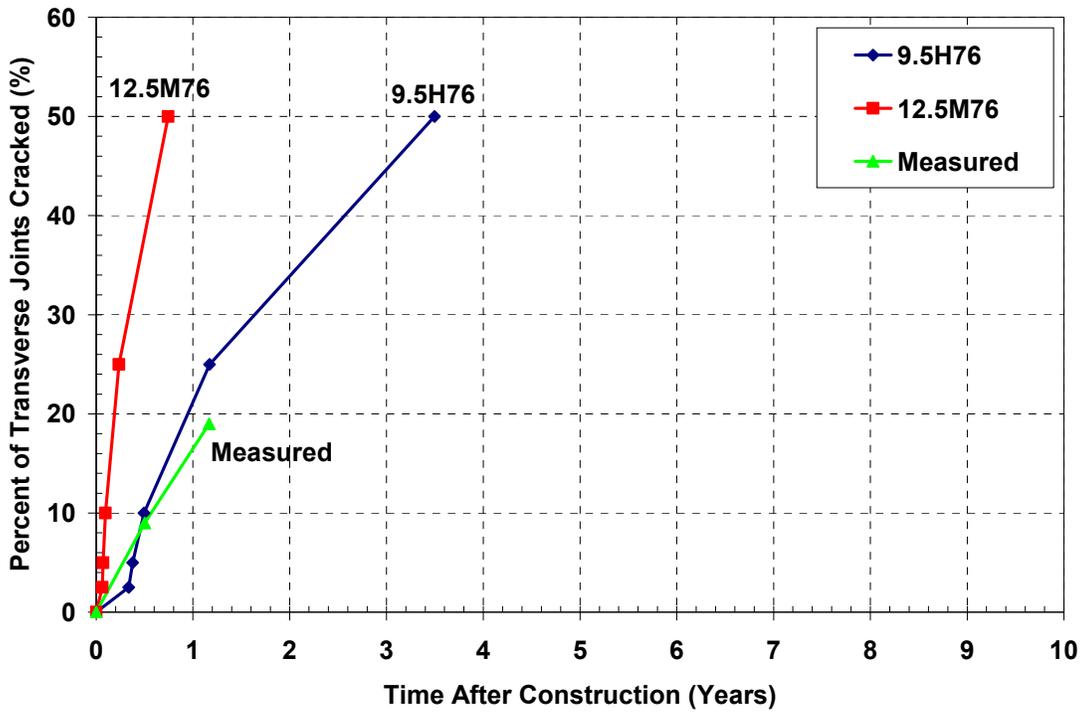
Figure 84 – Predicted versus Measured Reflective Cracking of Test Section #2 on Rt 34N New Jersey

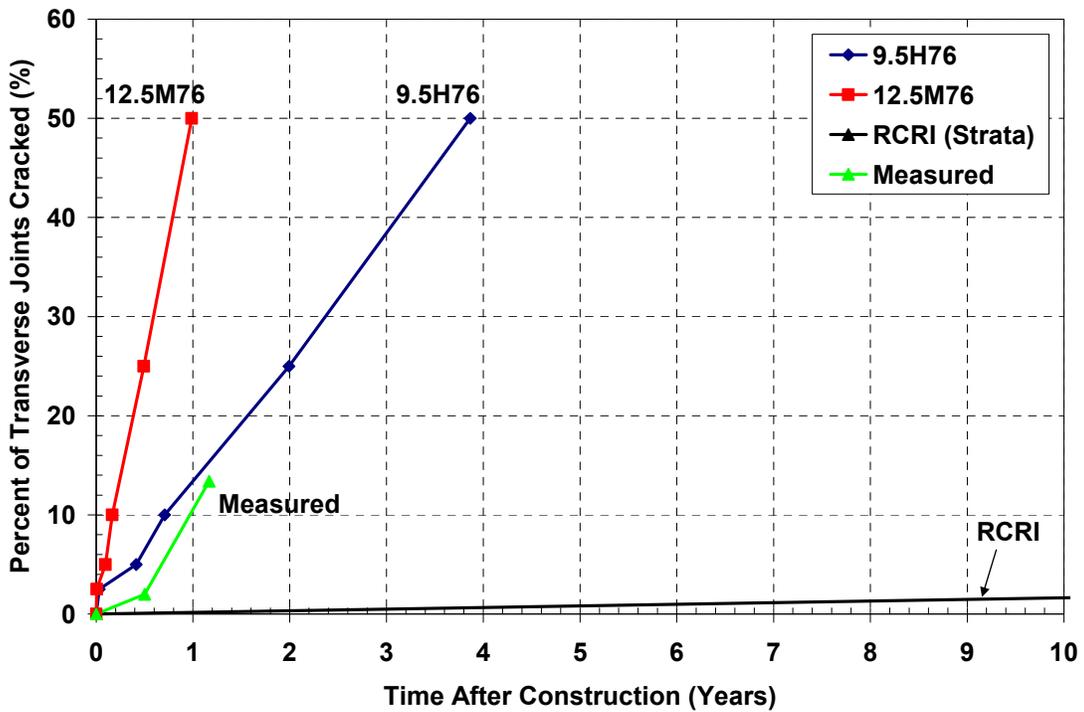
Figure 85 – Predicted versus Measured Reflective Cracking of Test Section #3 on Rt 34N New Jersey

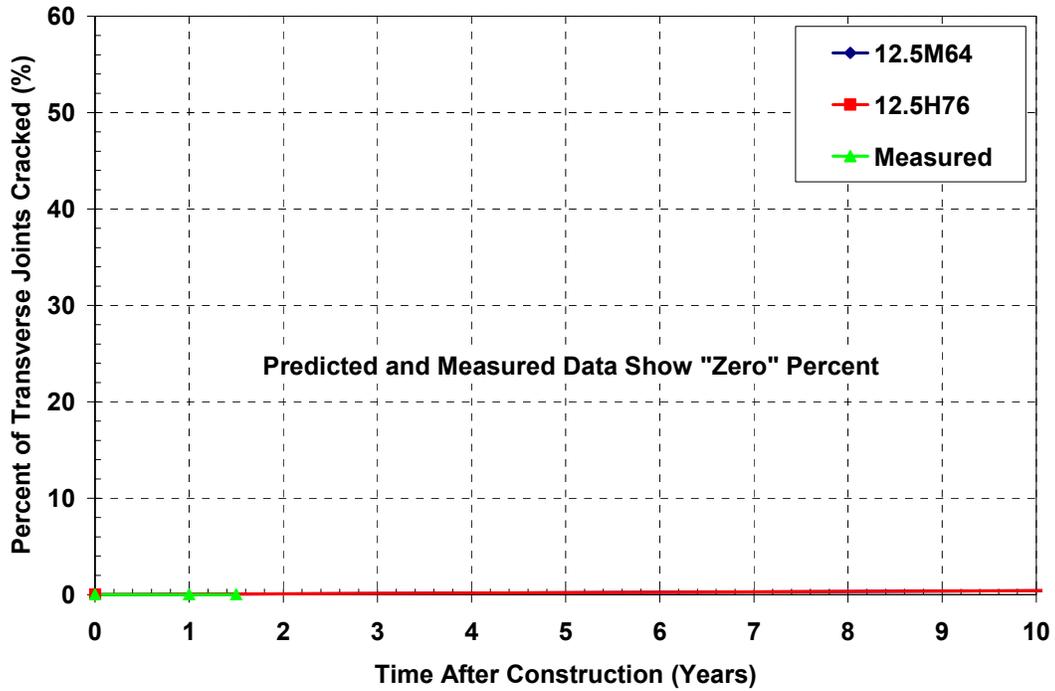
Figure 88 - Predicted versus Measured Reflective Cracking of Test Section mp 13.4 to 14.75 of Rt 202S New Jersey

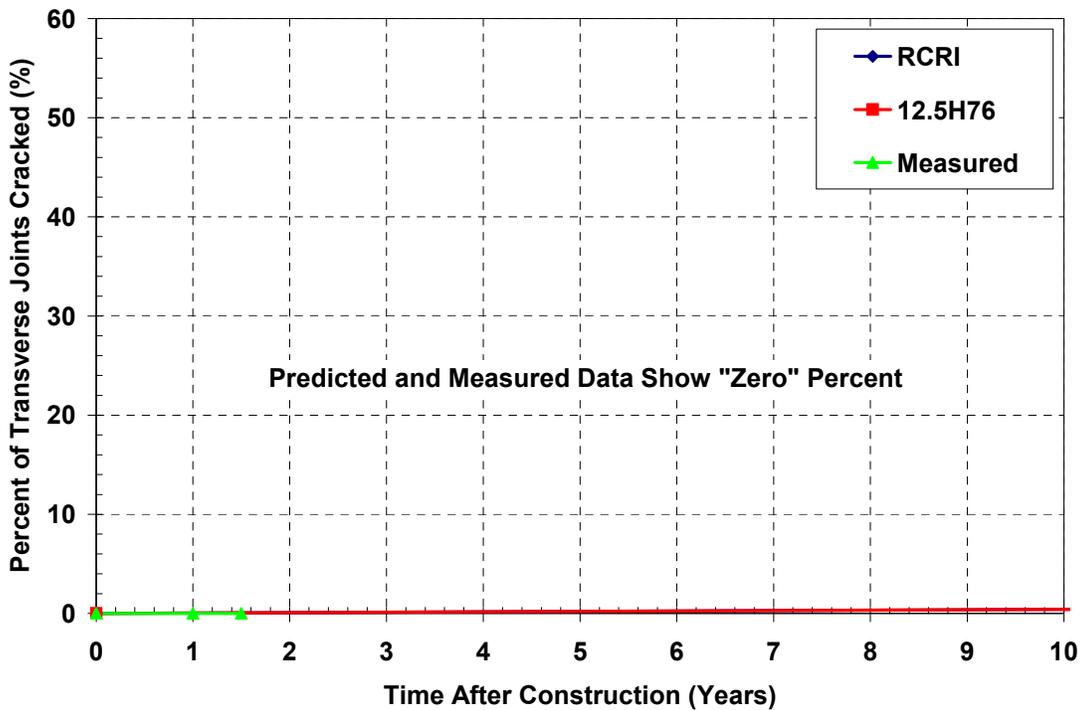
Figure 89 – Predicted versus Measured Reflective Cracking of Test Section MP 14.75 to 15.25 of Rt 202S New Jersey

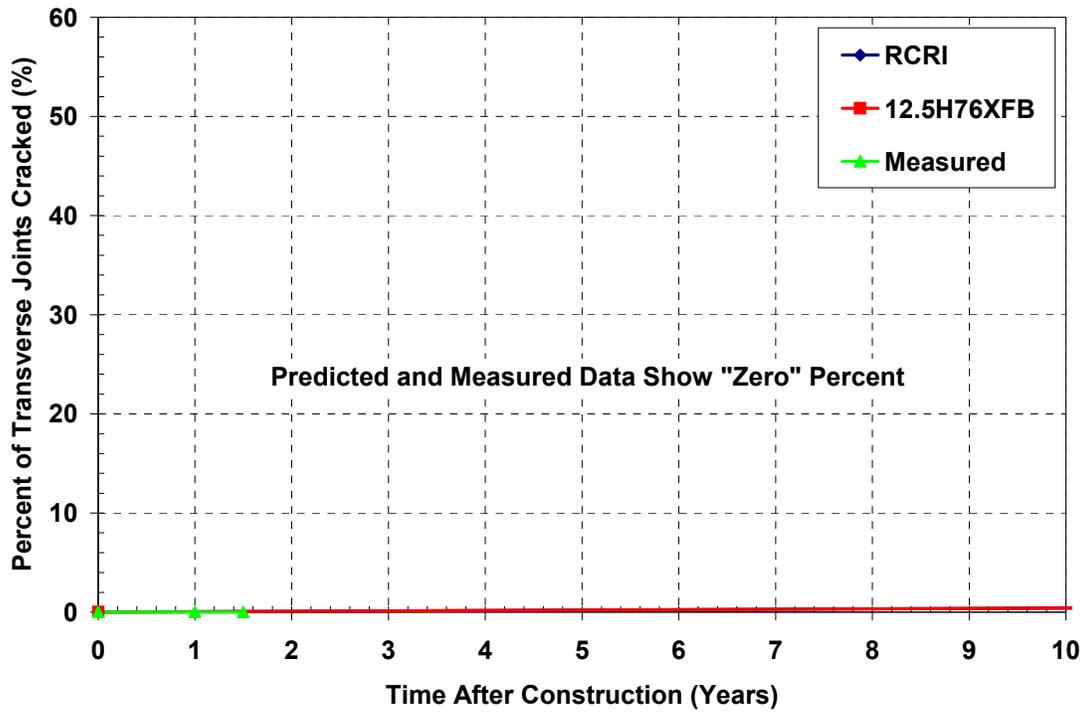
Figure 90 – Predicted versus Measured Reflective Cracking of Test Section MP 15.25 to 15.75 of Rt 202S New Jersey

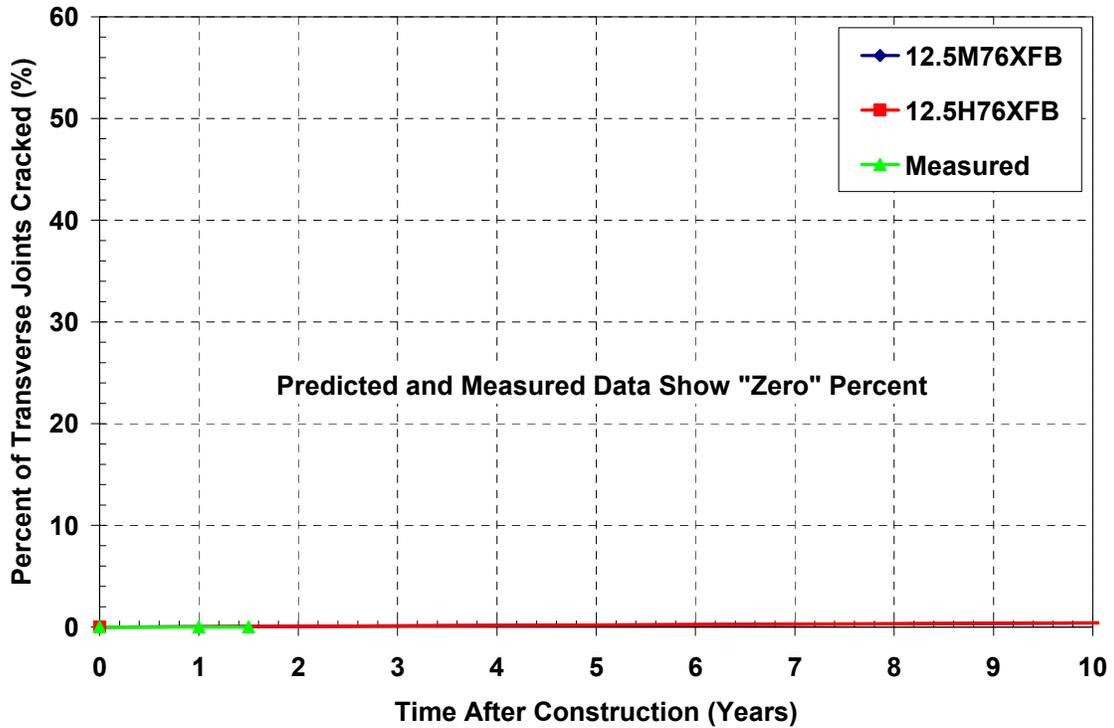
Figure 91 – Predicted versus Measured Reflective Cracking of Test Section MP 15.75 to 17 of Rt 202S New Jersey

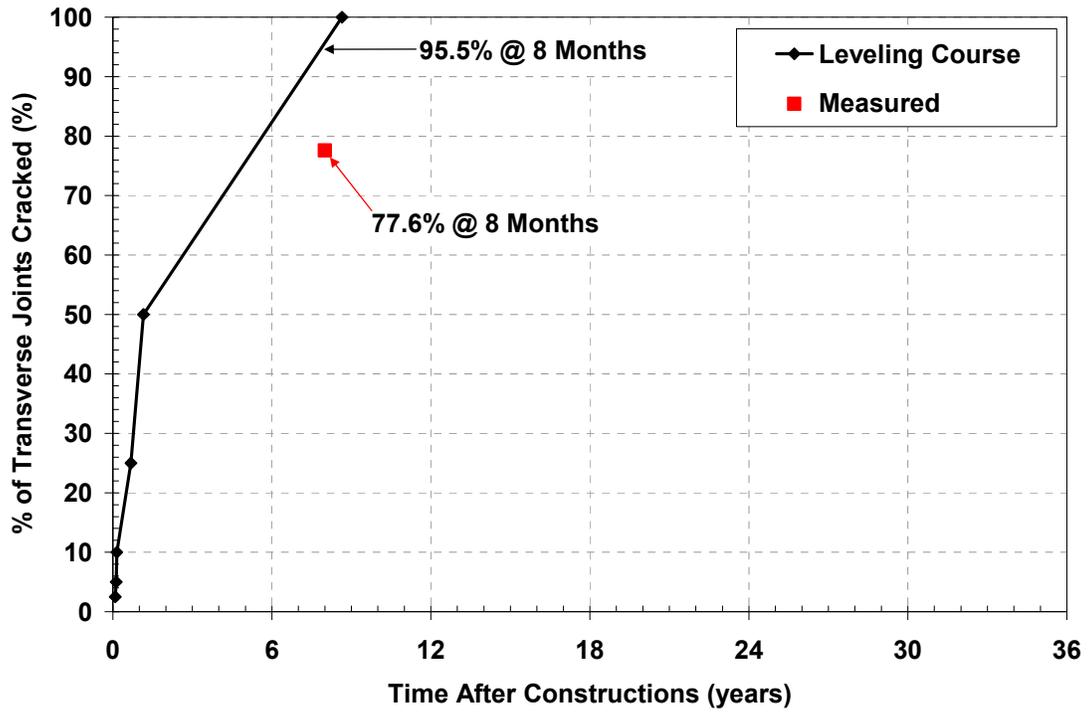
Figure 92 – Predicted versus Measured Reflective Cracking of the 2-Inch Overlay Test Section on I495 in Massachusetts

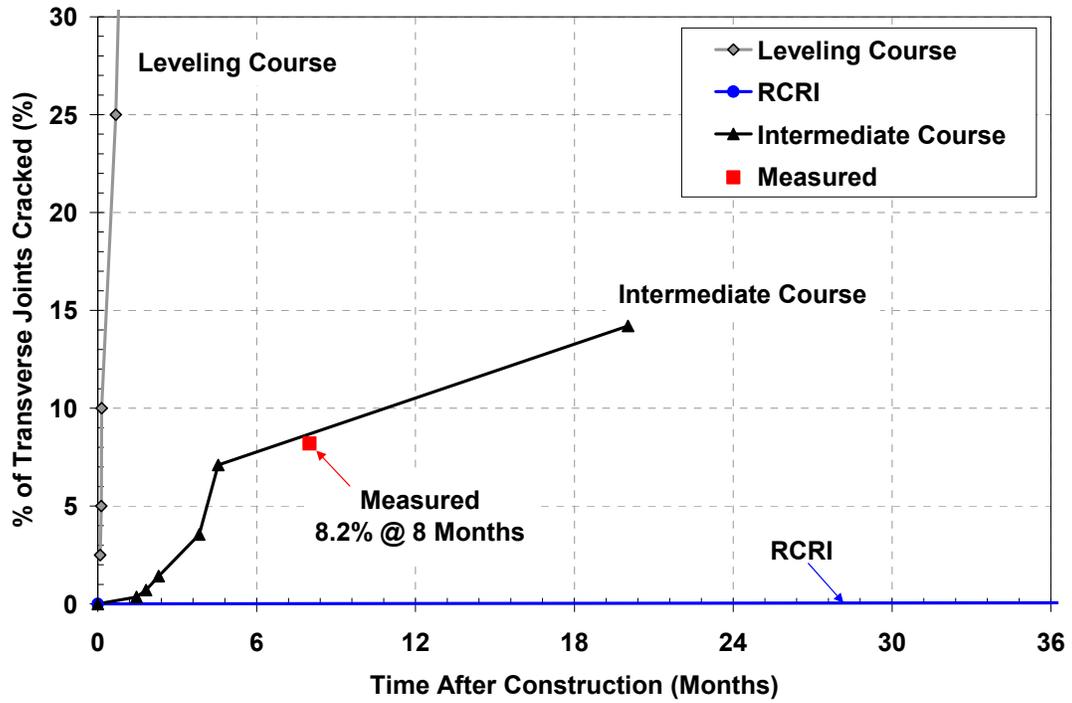
Figure 93 – Predicted versus Measured Reflective Cracking of the 5-Inch Overlay Test Section on I495 in Massachusetts

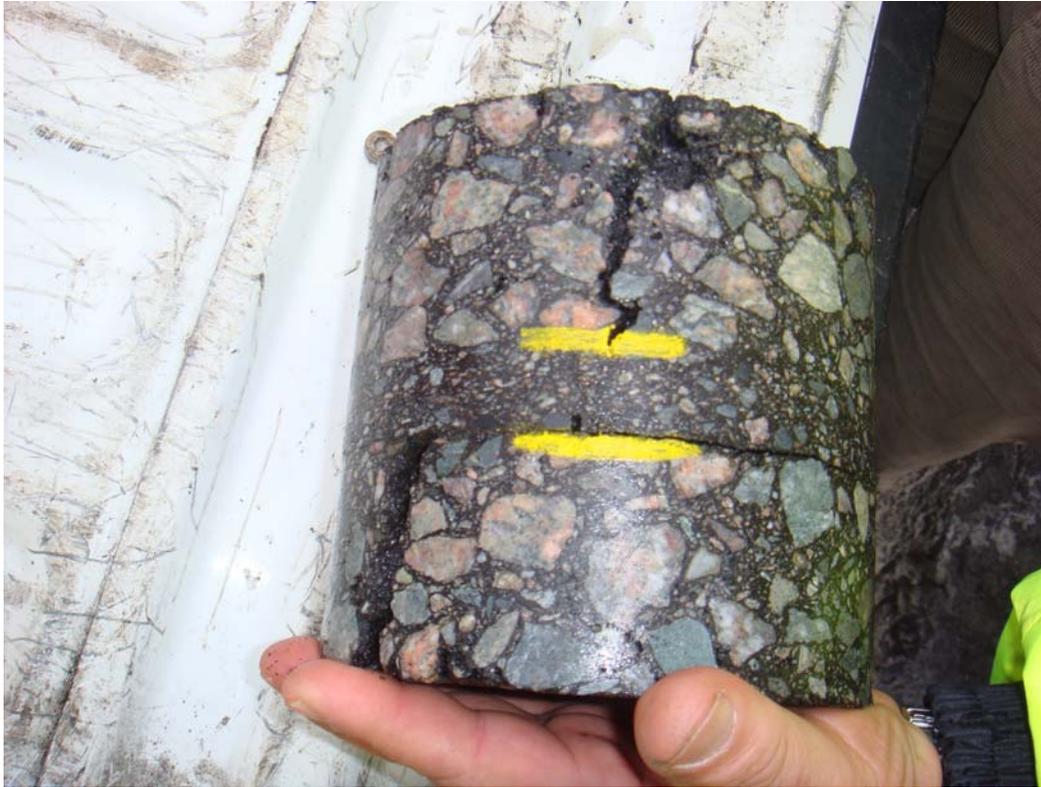
Figure 94 – Photo of Core Taken Through Surface Crack on I495 in Massachusetts

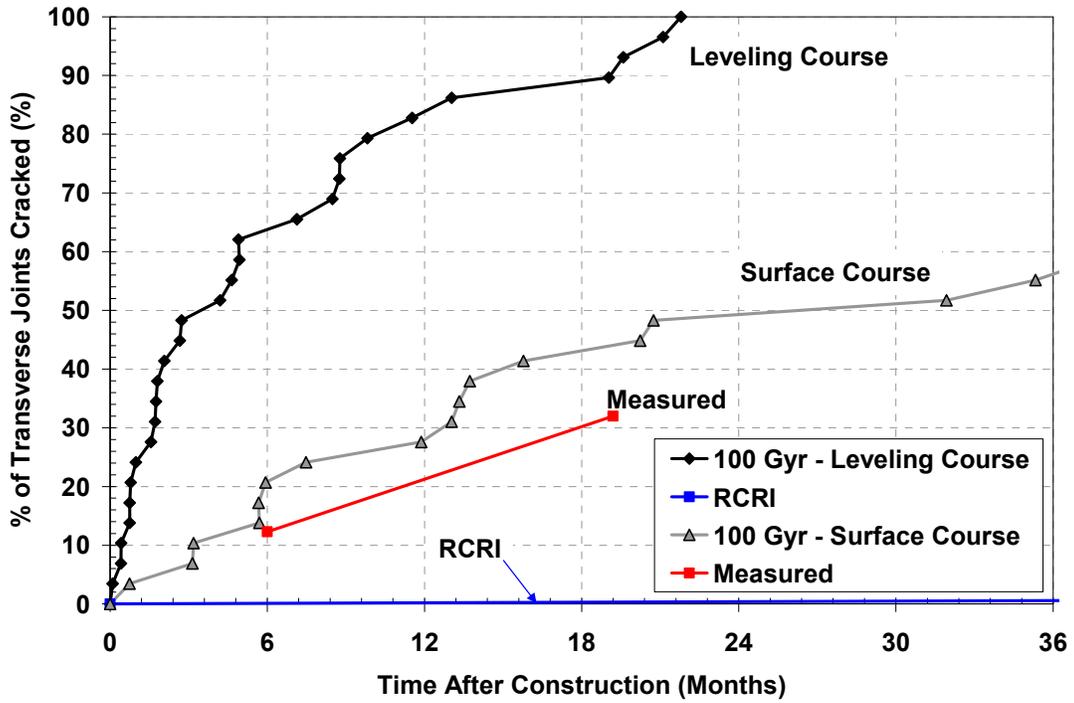
Figure 95 – Predicted versus Measured Reflective Cracking of the 100 Gyr Surface Course Mix on I476 in Pennsylvania

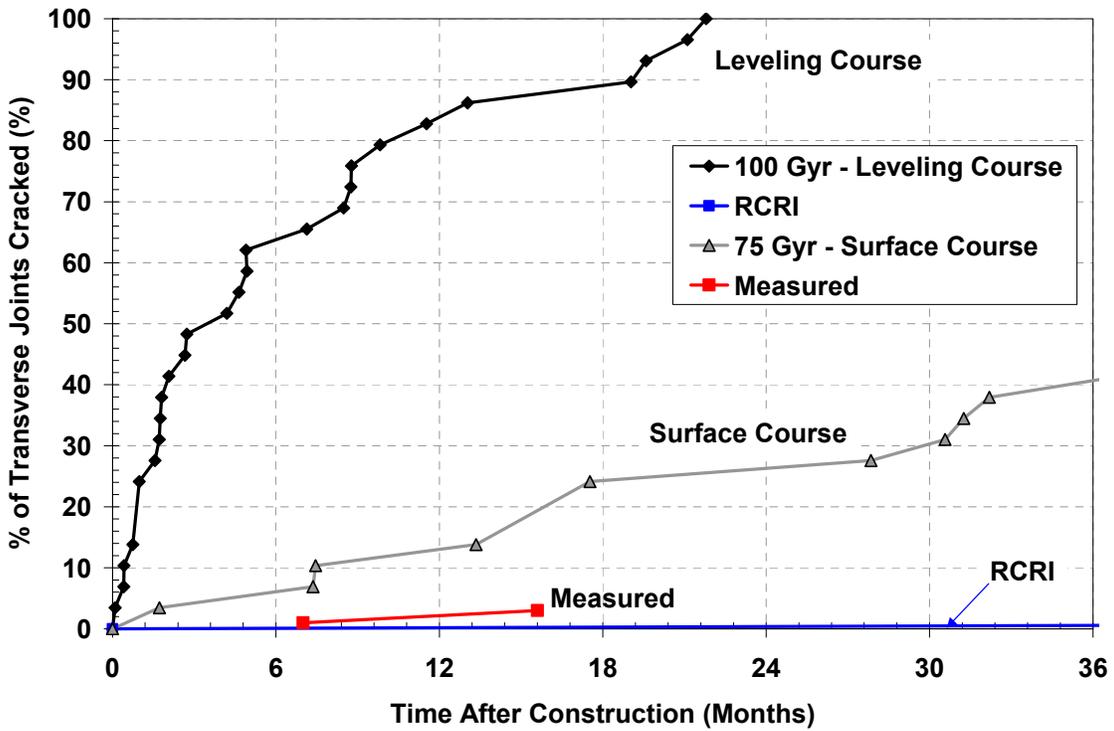
Figure 96 – Predicted versus Measured Reflective Cracking of the 75 Gyr Surface Course Mix on I476 in Pennsylvania

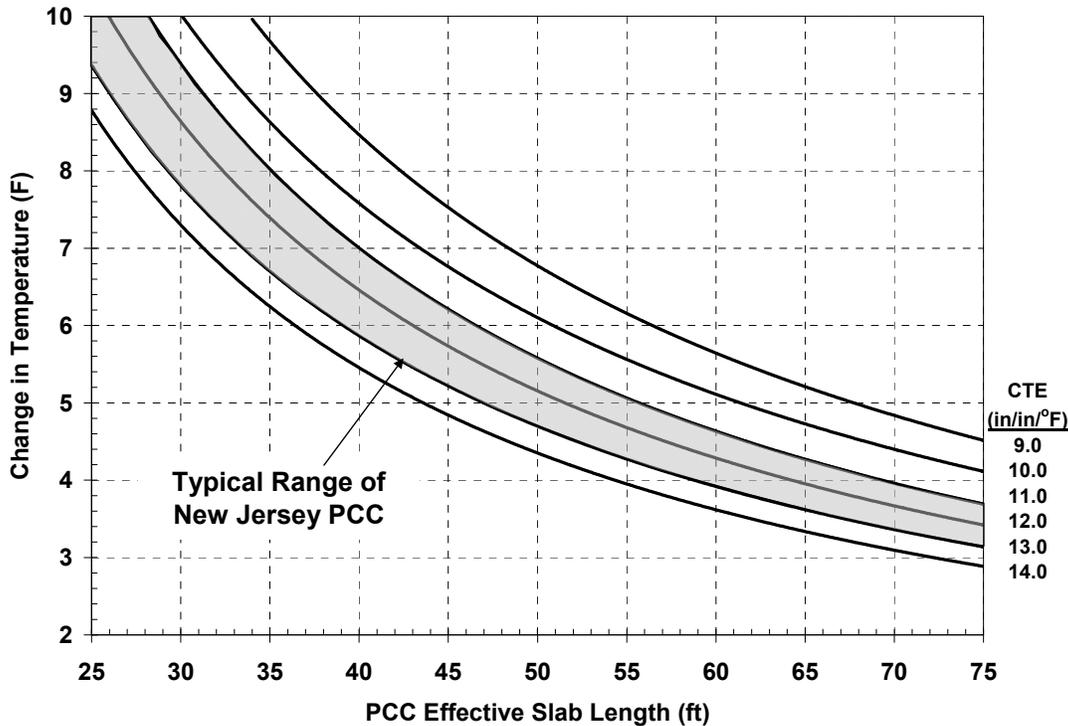
Figure 98 – Proposed Guideline to Limit Horizontal Deformation-Related Fatigue Cracking

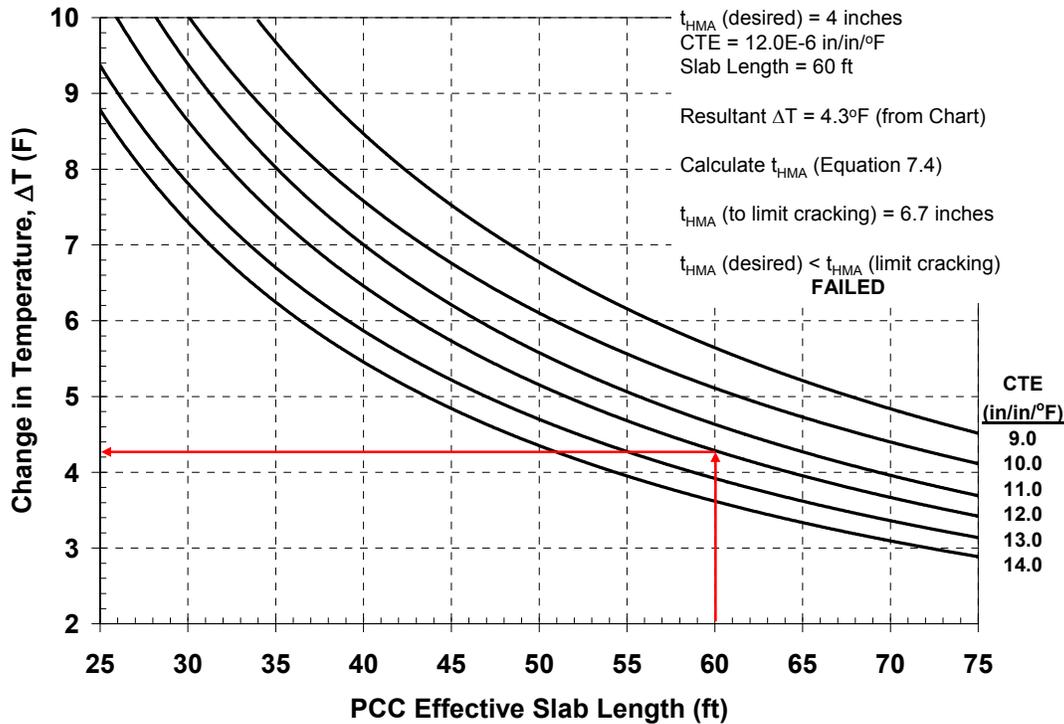
Figure 99 – Example of Using Proposed Guideline to Limit Horizontal Deformation-Related Fatigue Cracking – Required Asphalt Overlay Thickness

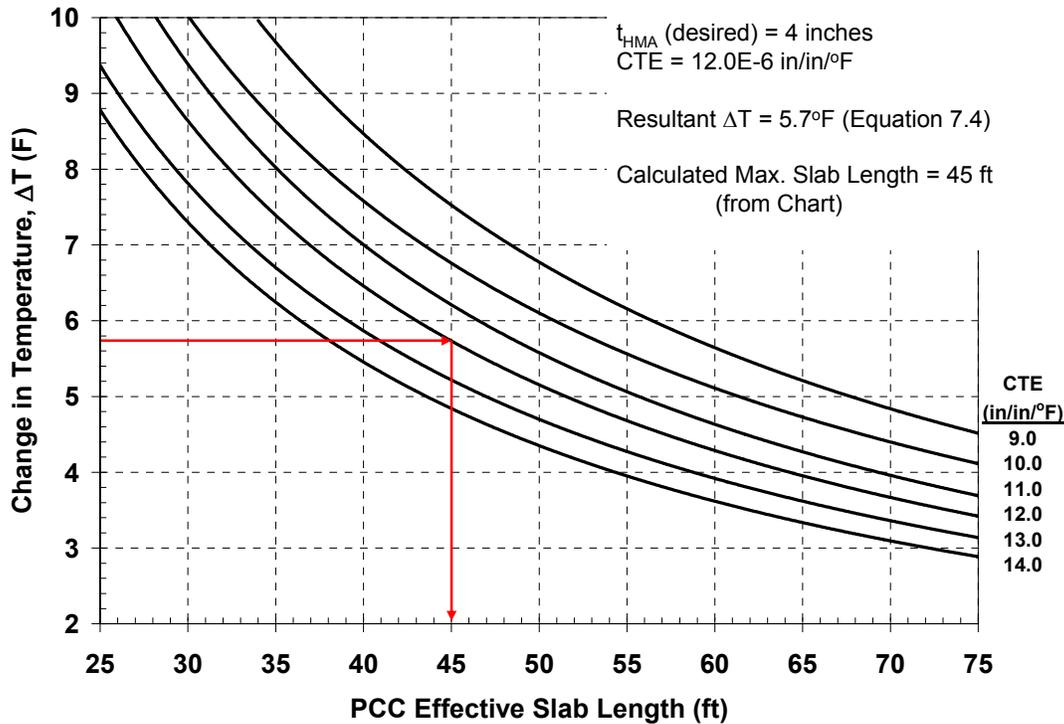
Figure 100 – Example of Using Proposed Guideline to Limit Horizontal Deformation-Related Fatigue Cracking – Determining Maximum Slab Length

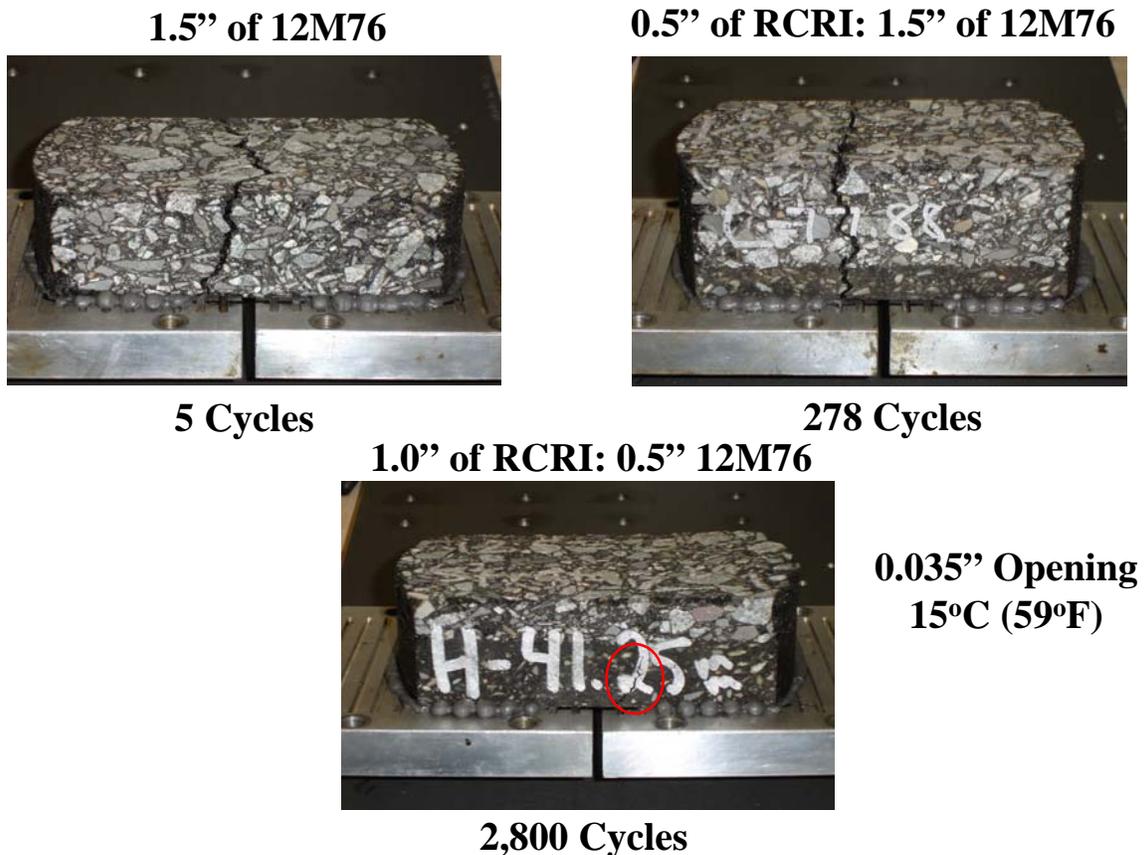
Figure 101 - Assessing RCRI Horizontal Strain Absorption and Thickness Impact on Fatigue Life Using the TTI Overlay Tester
