Report # MATC-KU: 363

Final Report

Performance of Geogrid Reinforced Ballast under Dynamic Loading

July 2012

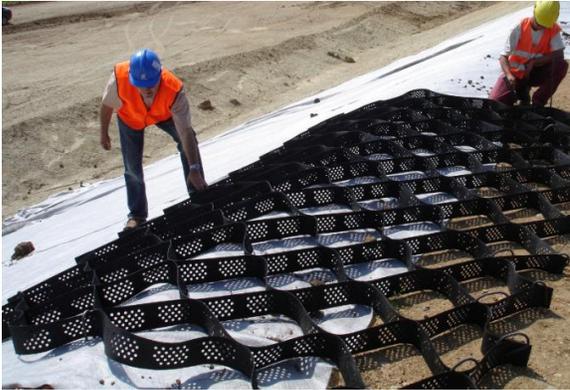
Figure 1.1 Placing geocell in the field

Geocells are a three-dimensional, honeycomb-shaped product made of high-density polyethylene (HDPE). The United States Army Corps of Engineers used geocells for providing lateral confinement to the granular material during the 1970s (Webster 1979). Examples of geocells are shown figures 1.1 and 1.2.

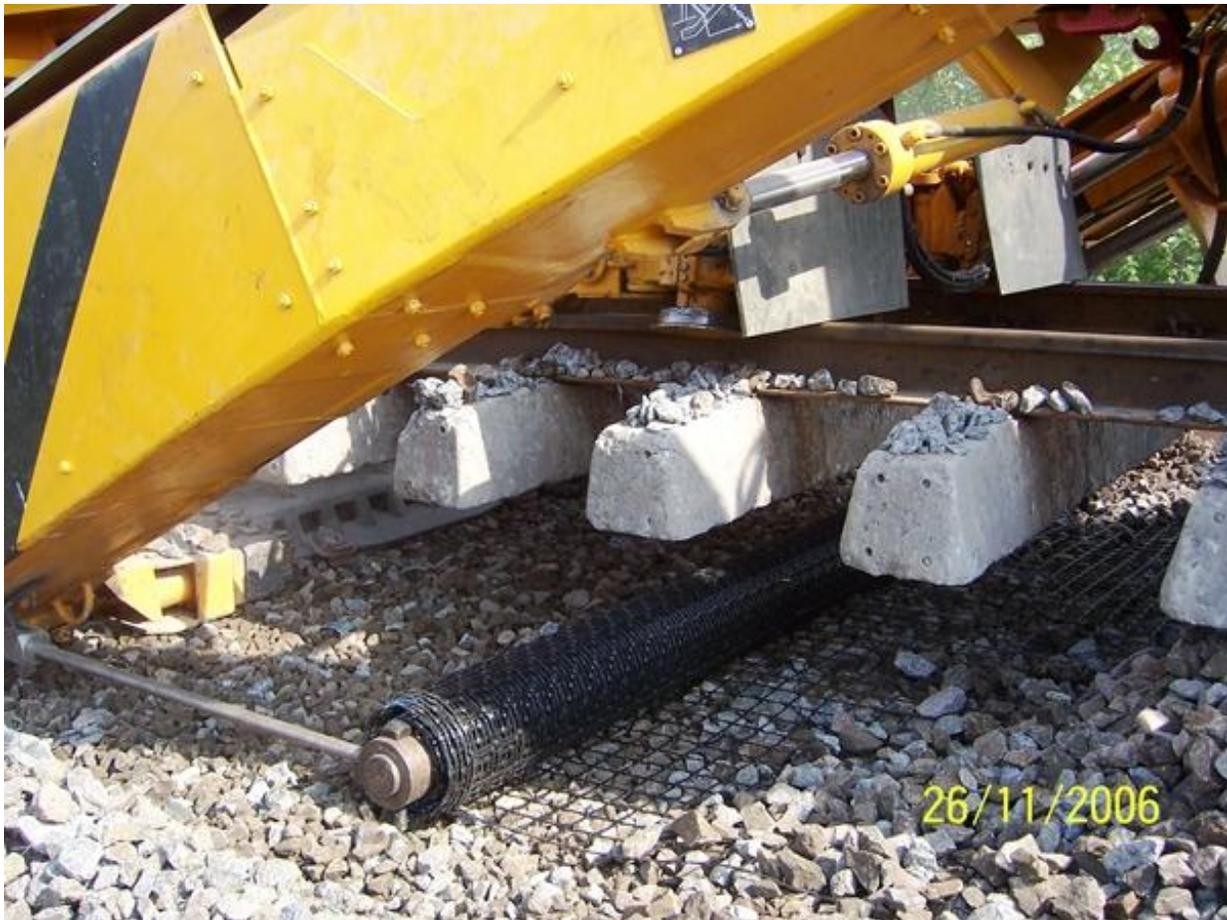
Figure 1.3 Placement of geogrid under railroad track (Tensar International 2012)

While both geocells and geogrids have the potential to extend the life of ballast and the time between maintenance cycles, geogrid has the additional advantage of being less expensive and easier to install during a maintenance action, as shown in figure 1.3. For these reasons geogrid was selected as the reinforcement product to be used in this study.

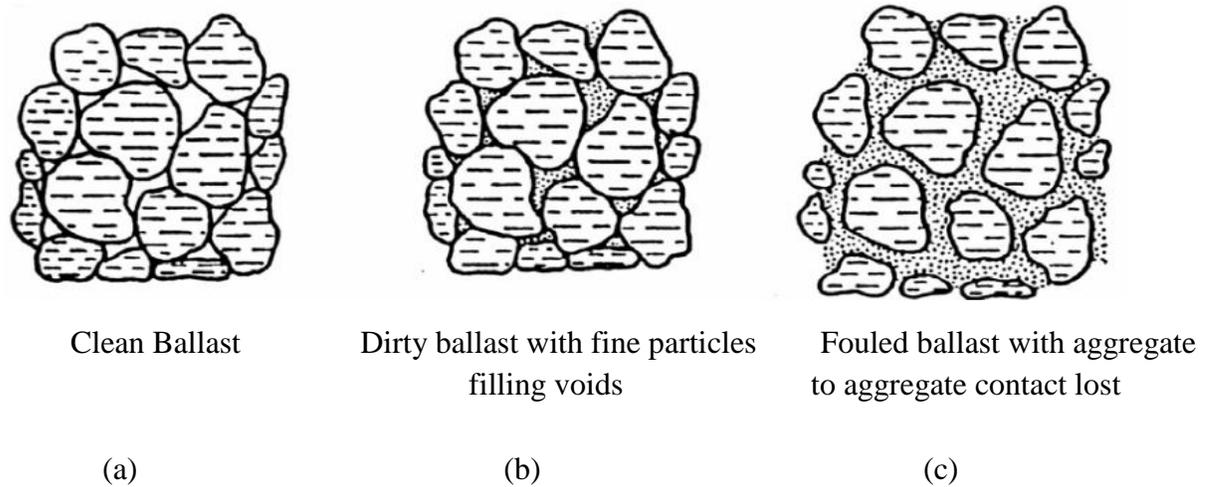
Figure 2.1 Critical ballast fouling and illustration of loss of aggregate to aggregate contact (Tutumluer et al 2008)

Tutumluer et al. (2008). Fouling of ballast in the railroad industry occurs as the voids within the ballast are filled with finer particles. Accumulation of coal dust in ballast is a primary concern for railroad engineers. In this paper, several tests, such as Atterberg limits, specific gravity, moisture-density relationships (Proctor), and shear strength, were conducted to determine coal dust's mechanical and physical properties. After mixing ballast with coal dust at a series of different moisture contents and coal dust weight percentages, it was found that it takes about 25% coal dust by weight to fill up all the voids in ballast, given a void ratio for the ballast of 43%. Also, when the ballast was fully fouled with coal dust with 35% moisture content, it was determined that the friction angle of ballast was approximately the same as the friction angle of coal dust. The study found that under this condition the ballast particles will be separated by coal fines, as shown in figure 2.1, which can result in track misalignment.

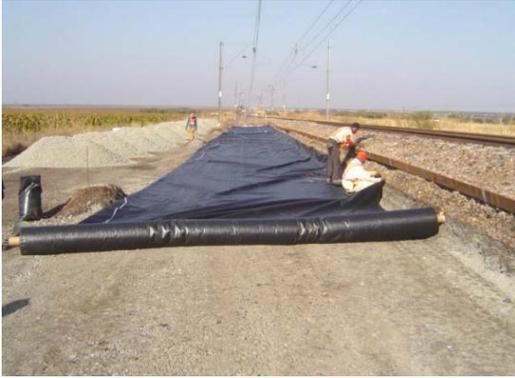
Figure 2.3 Placing geotextile sheet

Kea et al. (2007) showed that shrinkage and swelling of a clay subgrade would result in both upward and downward movement of the rail profile. Geocell reinforcement provides tensile strength as well as shear strength. It also has a major effect on increasing the bearing capacity of the subgrade. Geotextiles were also used to prevent migration of fine particles into ballast. Figures 2.3 through 2.6 show the construction process:

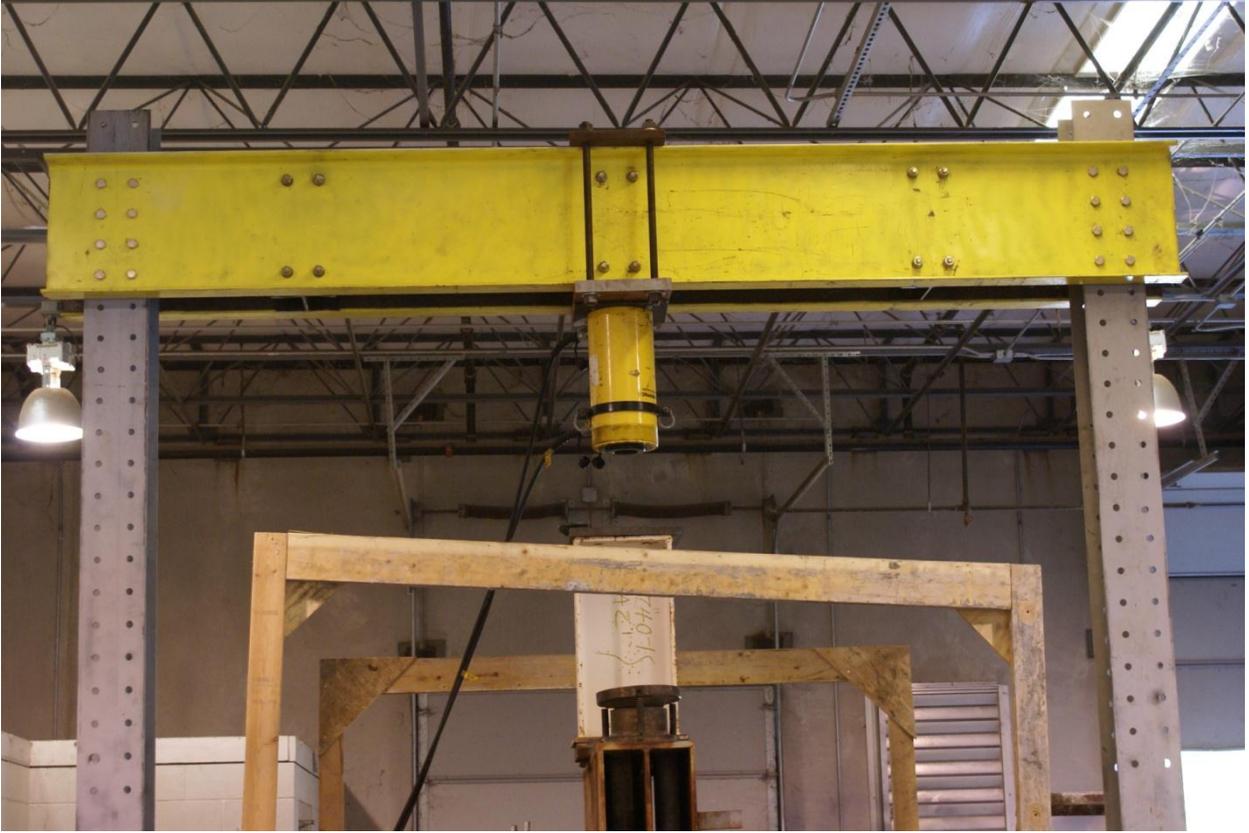
Figure 3.5 Loading cylinder

A self-reacting loading frame with a 100,000 lb capacity was constructed and is shown in figure 3.4. The inside column spacing is 9.5 ft, and the clearance between the bottom of the overhead beam and slab is 13 ft. Three reinforced 3 ft by 5 ft concrete slabs were built and post-tensioned together to construct the self-reacting loading frame. Figure 3.5 shows the loading cylinder with maximum capacity of 104,000 lb.

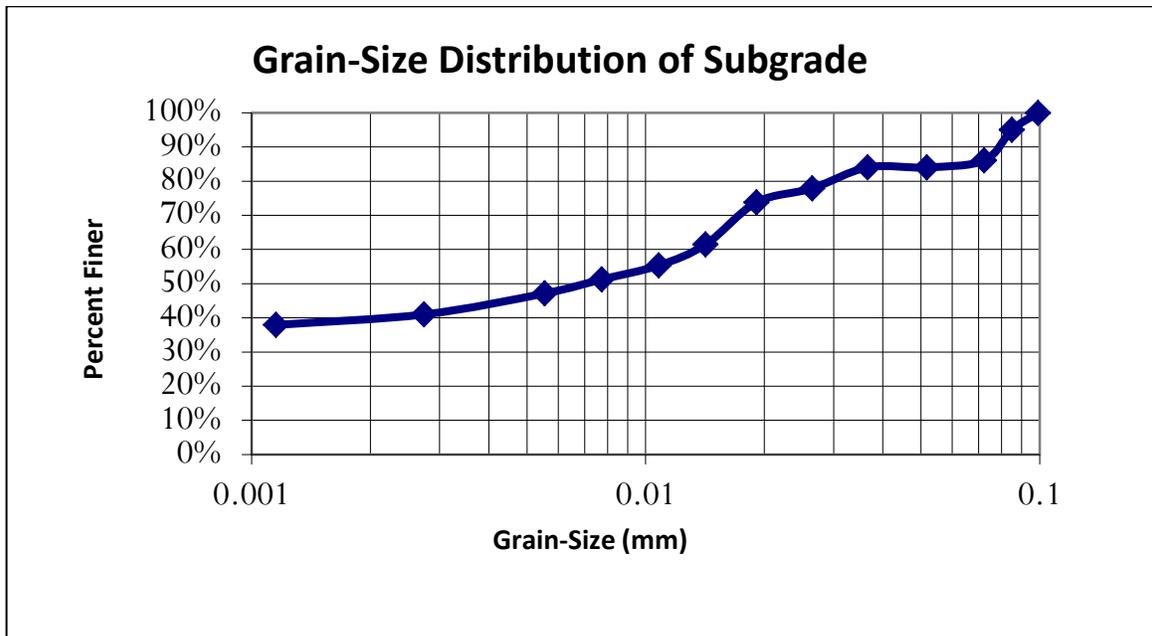
Figure 3.7 Grain size distribution for subgrade

The sub-grade had an optimum moisture content of 23% and maximum dry density of 99.5 lb/ft³. Figure 3.8 shows the compaction test curve. Results of Atterberg limits testing are shown in figure 3.9 and table 3.2. Based on the Atterberg limits and grain size distribution the soil was classified as fat clay (CH).

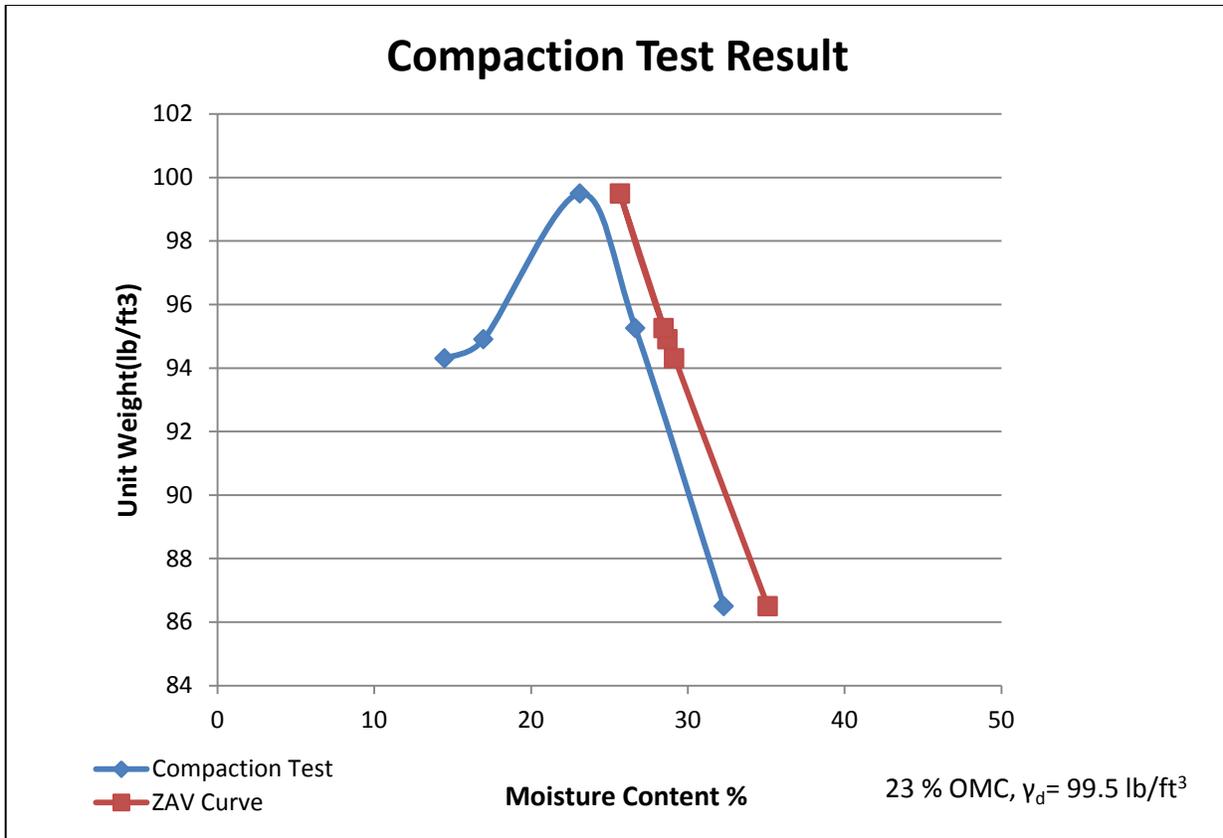
Figure 3.8 Standard proctor compaction curve of the subgrade

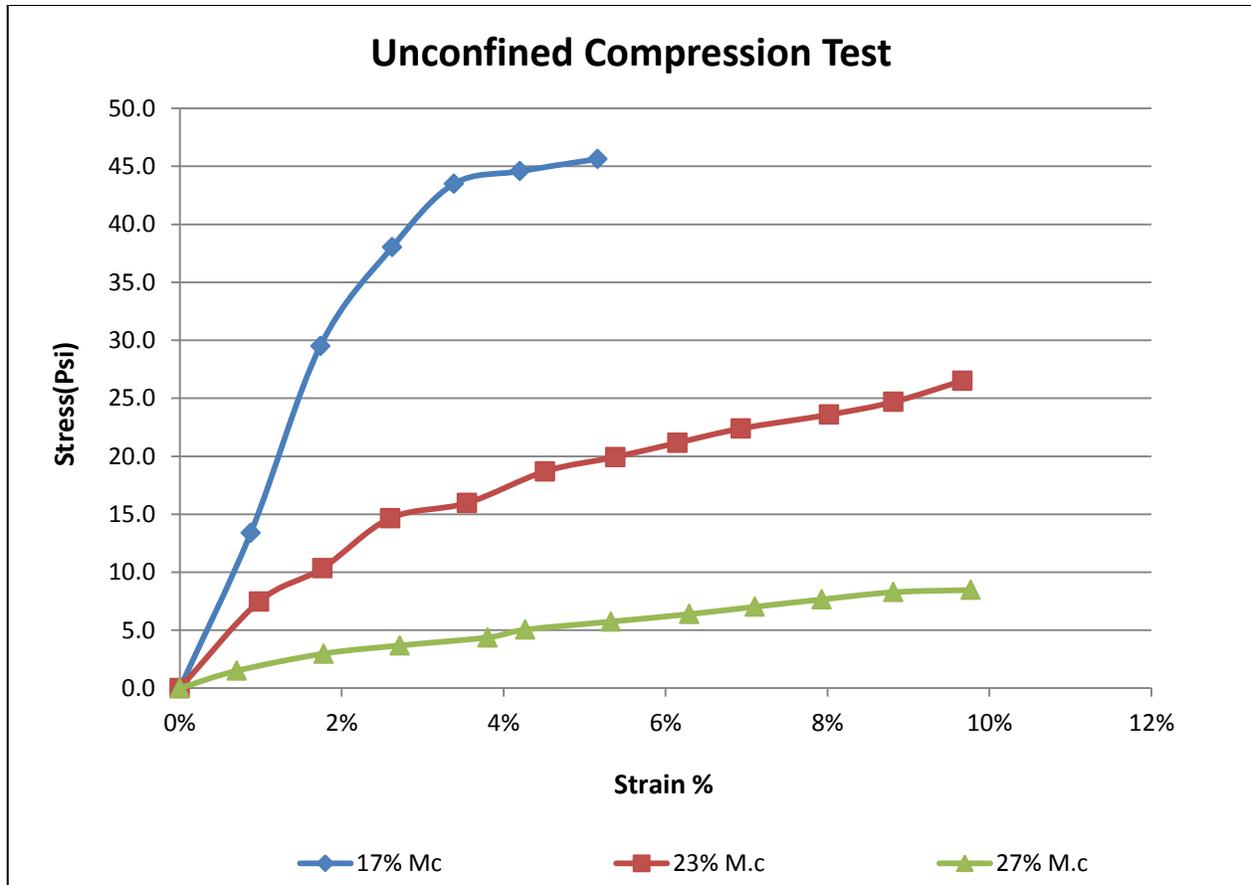
Figure 3.10 Unconfined compression test curves

Unconfined compression tests were conducted to determine the undrained shear strength (S_u) of the subgrade. The results are presented in figure 3.10.

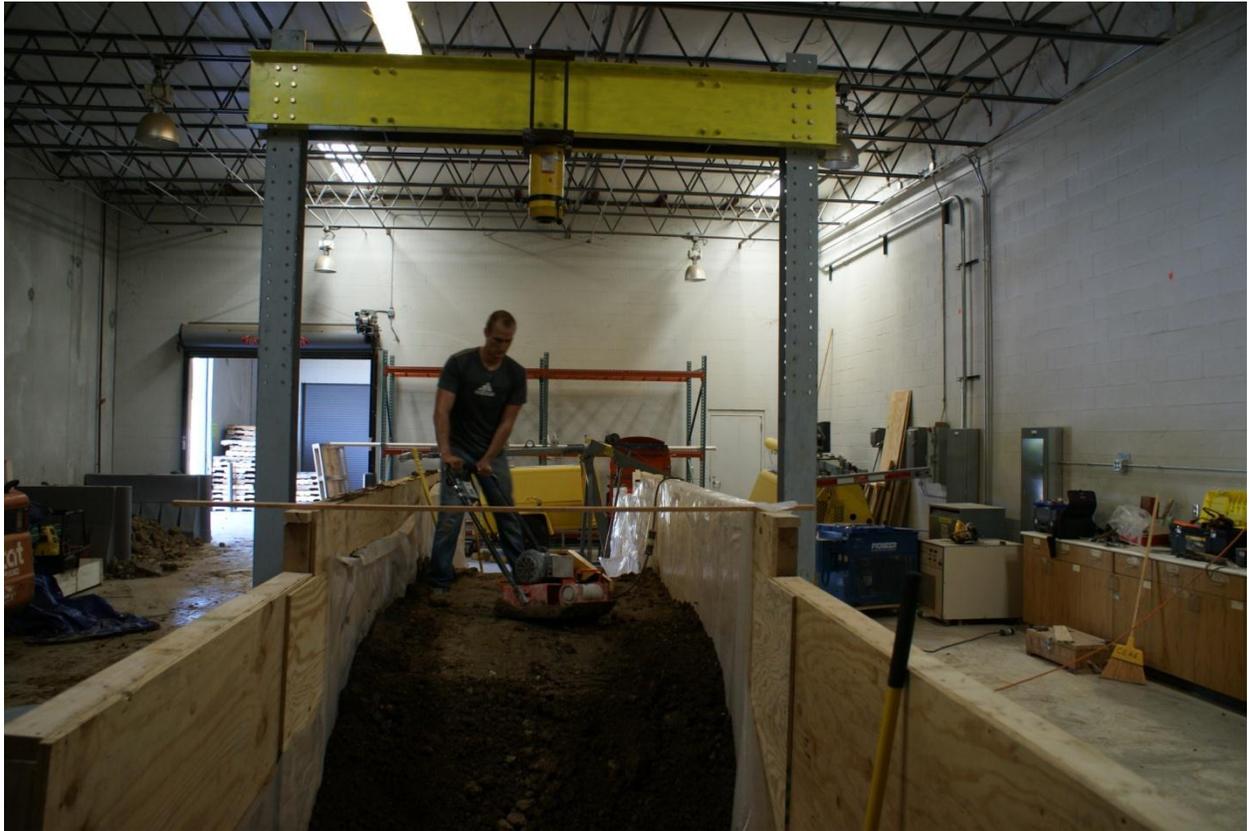
Figure 3.11 Placing subgrade and compaction

As shown in figure 3.11, the subgrade was placed with a skid loader in 6 in. lifts. Each lift was compacted with a vibratory plate compactor, as shown in figure 3.11. Unreinforced and reinforced sections were compacted at 26% moisture content and densities of 91.5 lb/ft³ dry density and 93 lb/ft³ dry density, respectively.

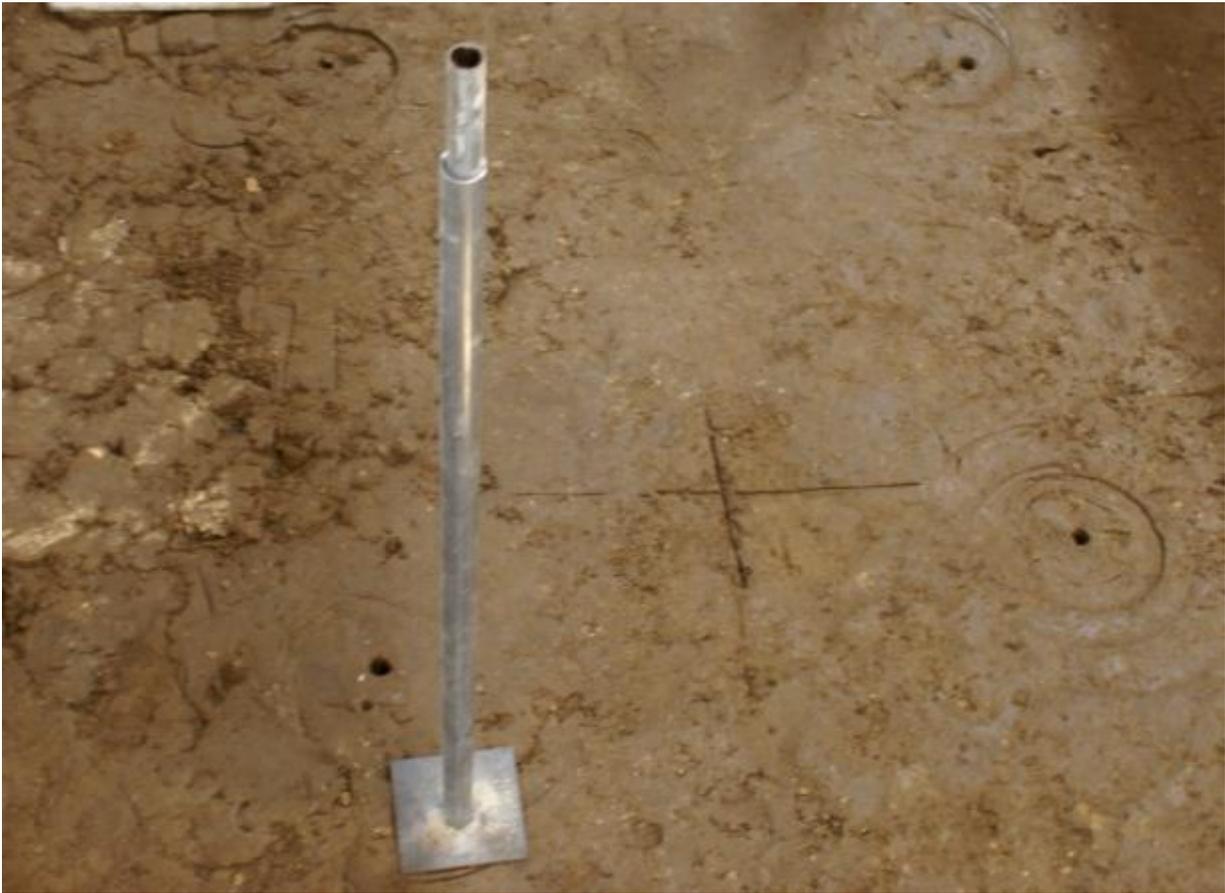
Figure 3.12 Tell-tale

Tell-tales are used to measure vertical deformation in soil profiles at selected depths. As the load is applied to the section, the base plate and the interior pipe move with the soil at the base plate elevation.

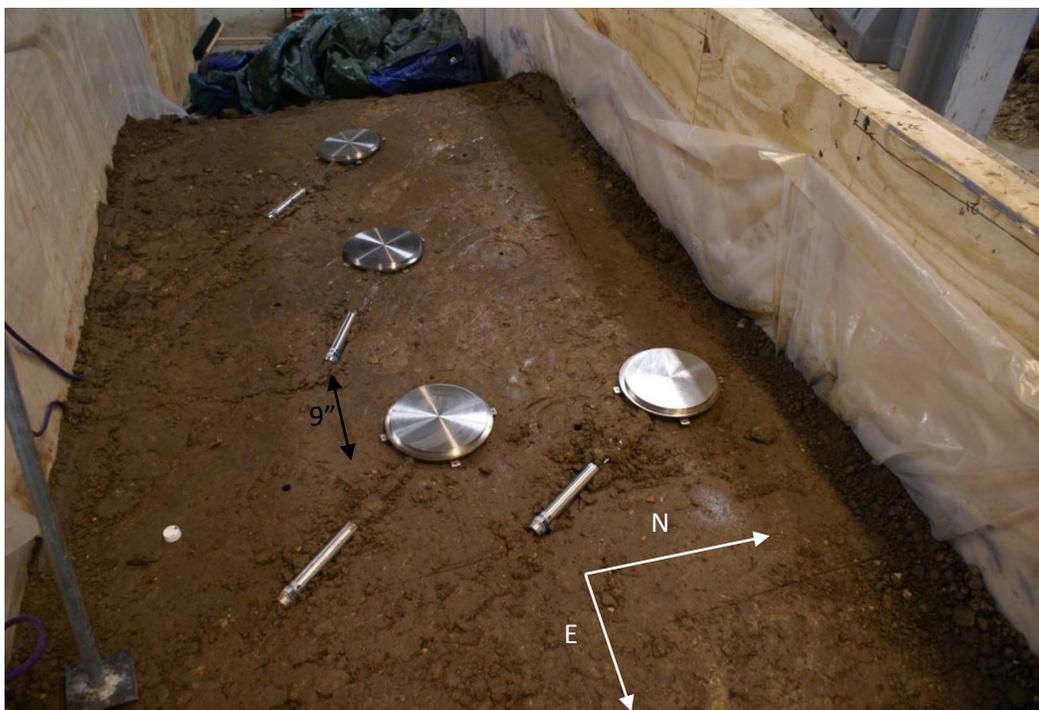
Figure 3.14 Model 3515 circular earth pressure cells during placement

Model 3515 Geokon pressures cells are heavy duty cells and are recommended for railroad applications. Five pressure cells were placed between the subgrade and ballast directly beneath the railroad ties as shown in figures 3.14 and 3.15. These earth pressure cells have a diameter of 9 in. and a capacity of 58 psi.

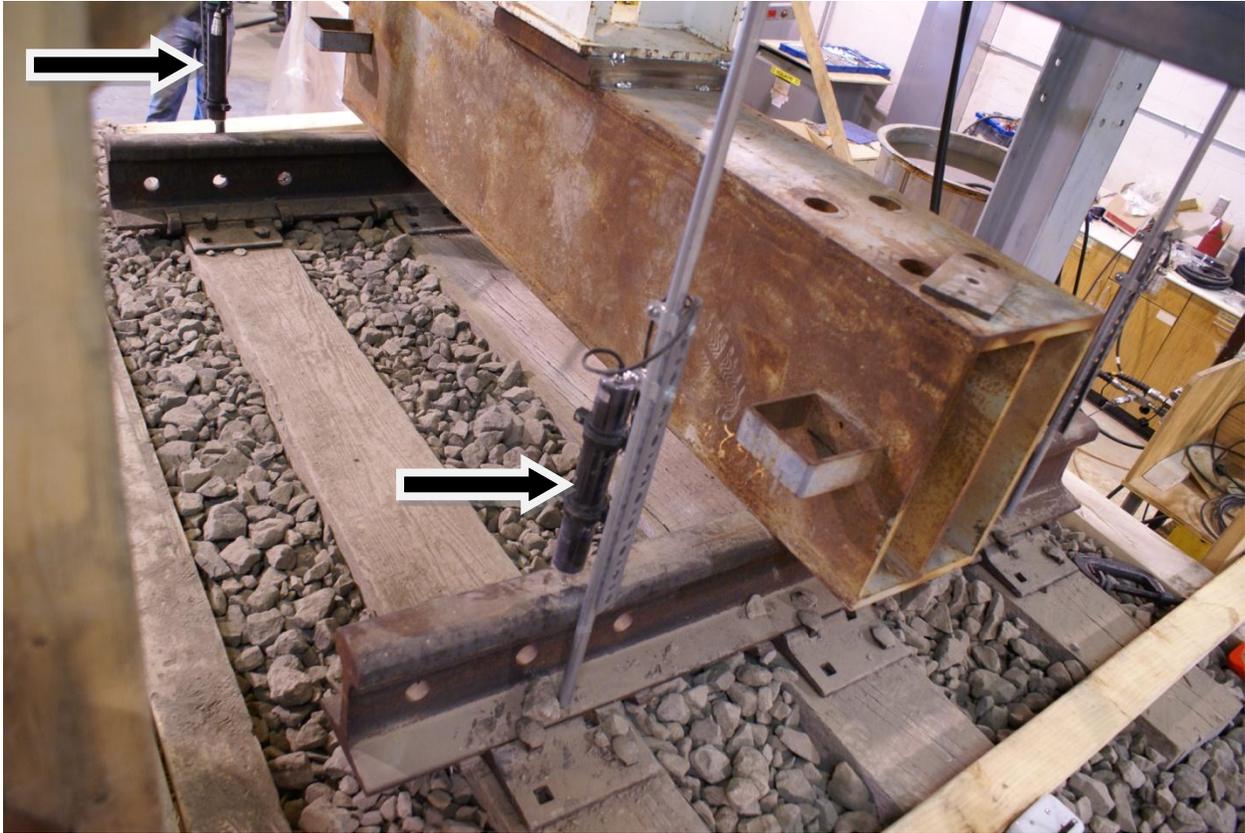
Figure 3.16 Displacement transducer placement

A total of four displacement transducers were used to instrument the corners of the track panel, as shown in figure 3.17. The displacement transducers were manufactured by Tokyo Sokki Kenkyujo, Co., Ltd., Japan. Two types of displacement transducers, the CDP-100 (100 mm capacity) and CDP-50 (50 mm capacity), were used to measure the surface displacement of railroad track.

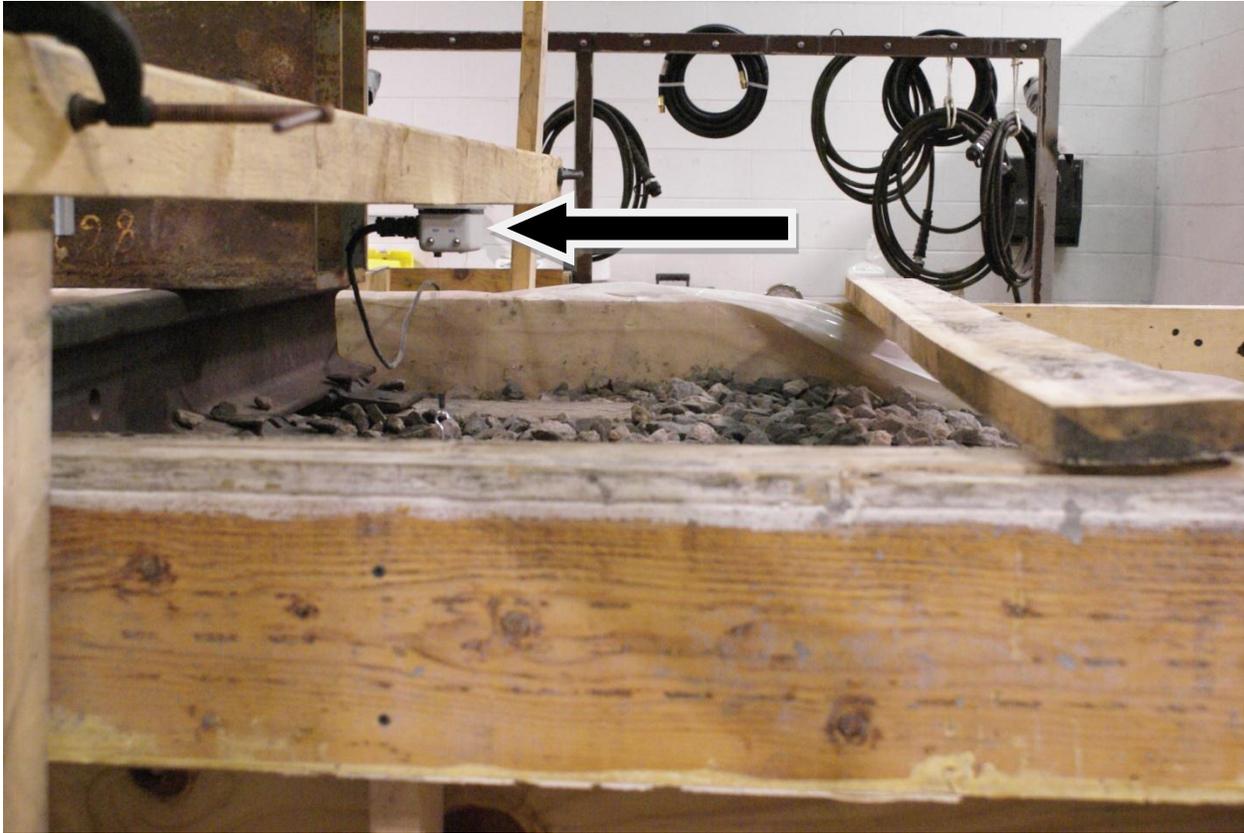
Figure 3.17 String pot

Two string potentiometers (string pots) with a maximum range of 20 in. were used to measure the displacement of center ties in the railroad section, as shown in figure 3.18.

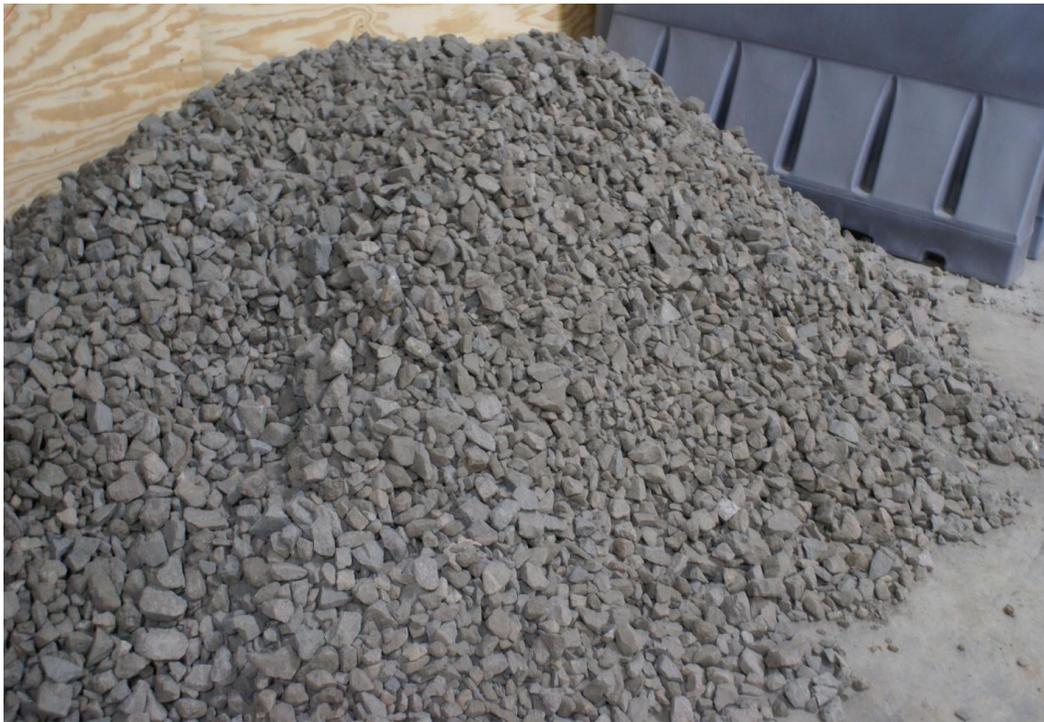
Figure 3.18 Recycled ballast after sieve

Recycled ballast was provided by BNSF and came from track undergoing maintenance in Gardner, Kansas. It was sieved to remove fouling material and to meet the gradation size of BNSF specification limits (class 1), reported in table 3.4. A picture of the sieved material is shown in figure 3.19. This ballast is composed of heterogeneous igneous rock. Samples of the washed rock are shown in figure 3.20. The grain size distribution is shown in figure 3.21, and table 3.5 contains the sieve analysis data. The recycled ballast was sieved with a sieve shaker provided by BNSF, as shown in figure 3.22.

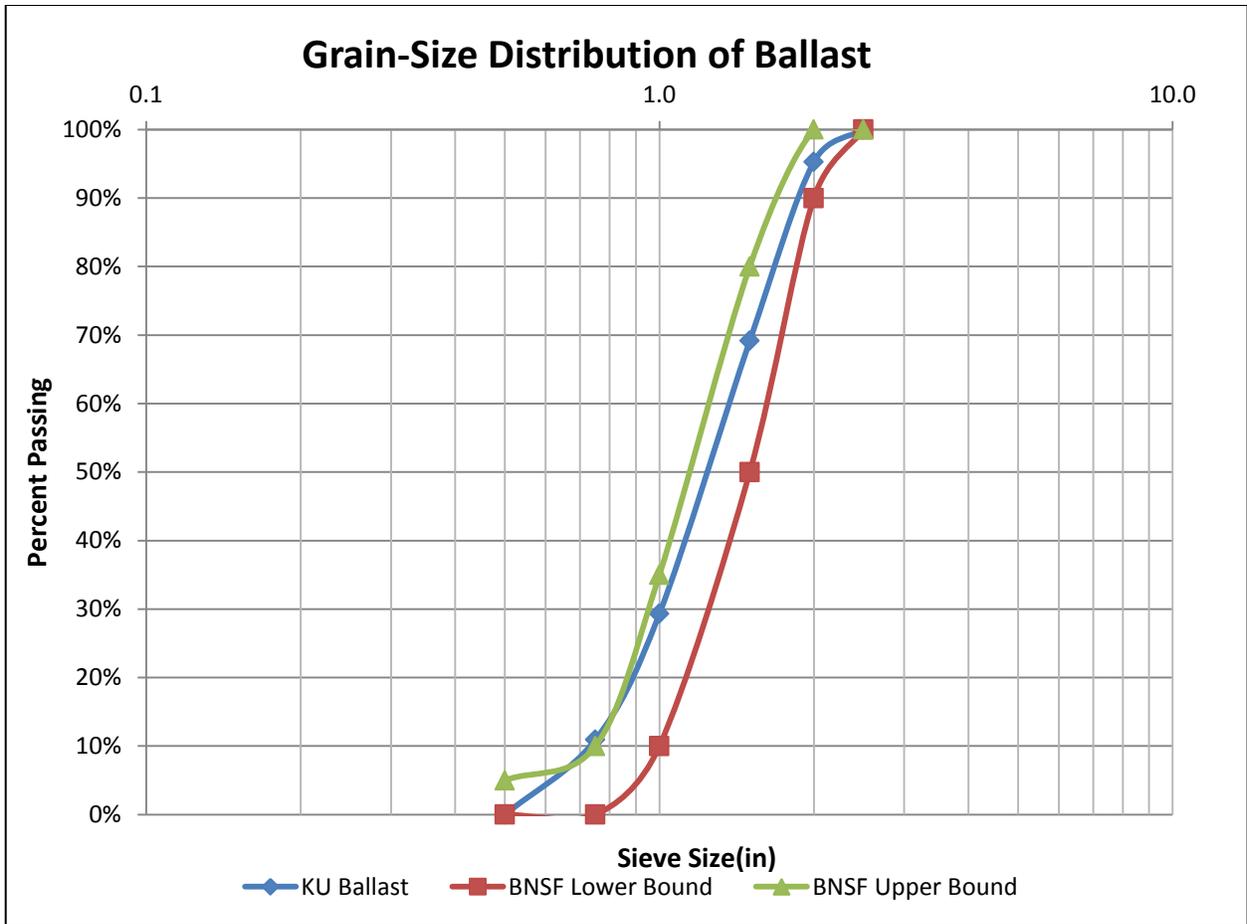
Figure 3.20 Sieve analysis for ballast

All sizes were within the range gradation sizes recommended by BNSF except for the 0.75 in. material, which exceeded the limit by 1%. After review, it was the judgment of KU and BNSF that the sieved ballast was essentially consistent with their specifications and would be accepted for use.

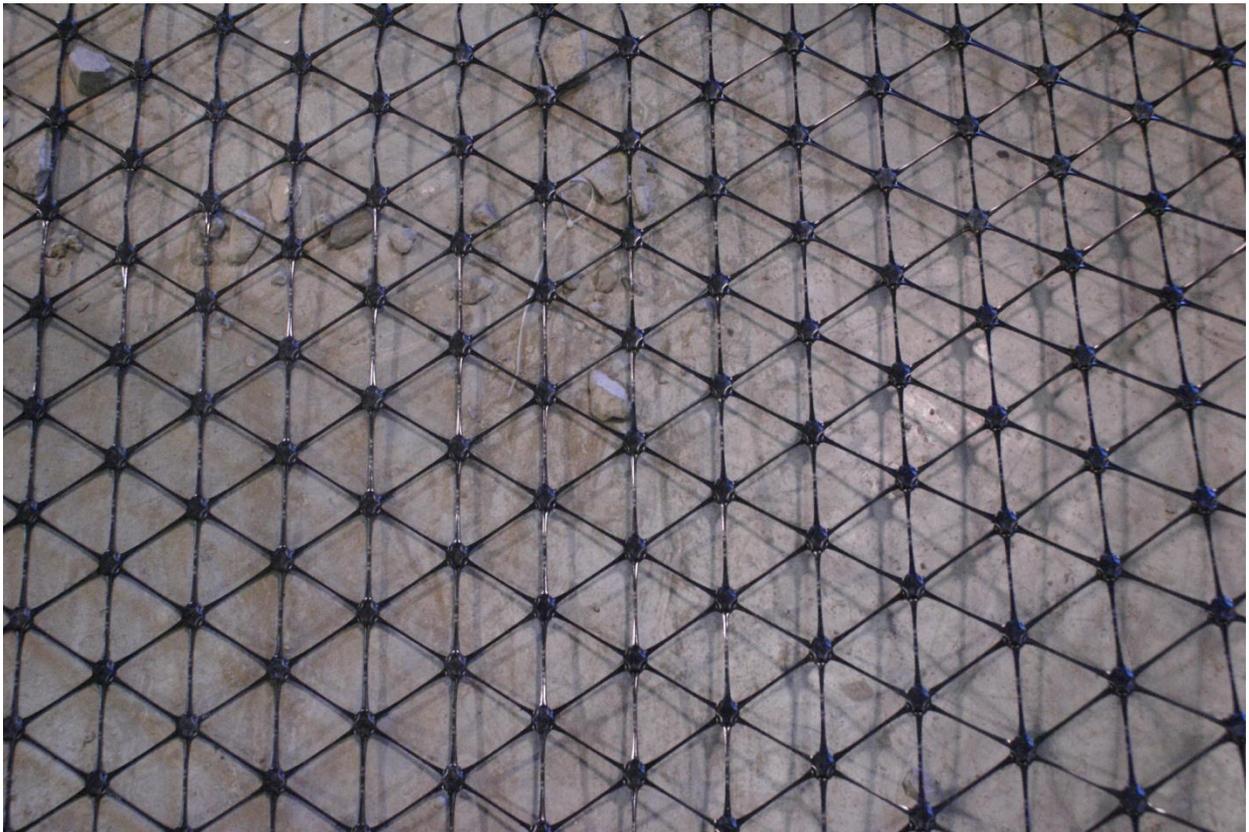
Figure 3.23 Triaxial geogrid used in reinforced test

Triaxial geogrid (TX190L) provided by Tensar Int. Corporation was used to reinforce the ballast section in the reinforced test.

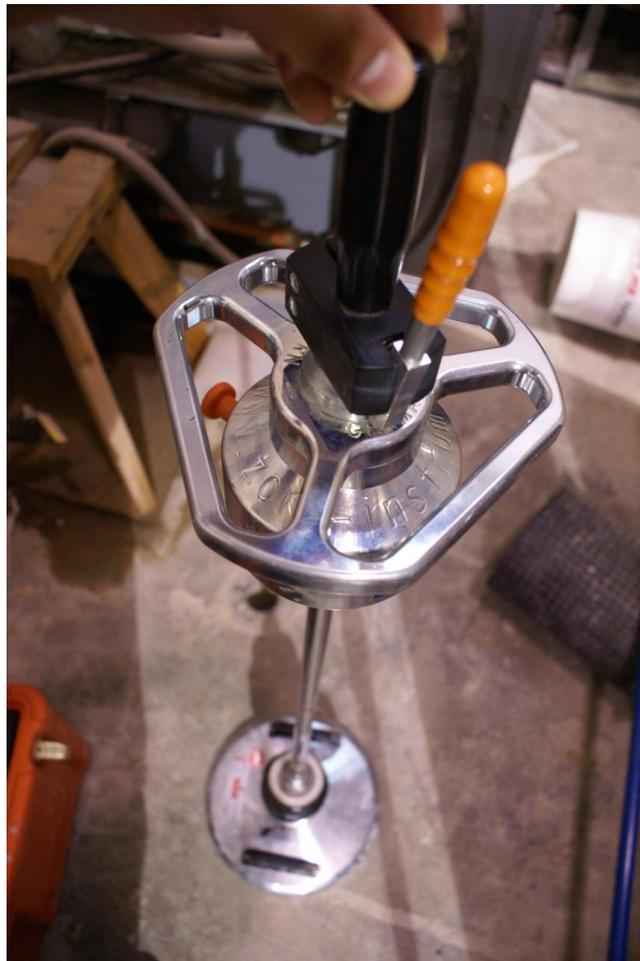
Figure 3.24 Light weight deflectometer

LWD is a test method for measuring deflection and compaction quality control during construction. There is an acceleration sensor on the loading plate. LWD also measures the degree of compressibility and average settlement of the section. The LWD tests were carried out on the subgrade with the 30 cm plate, since this plate is suitable for fine soil. This device has a 10 kg drop hammer with a drop height of 1 meter. In LWD, the device hammer is released, which hits the plate. Acceleration is measured with time, and a modulus is calculated based on the force required to generate a given deflection for that soil type. Figure 3.25 shows the LWD.

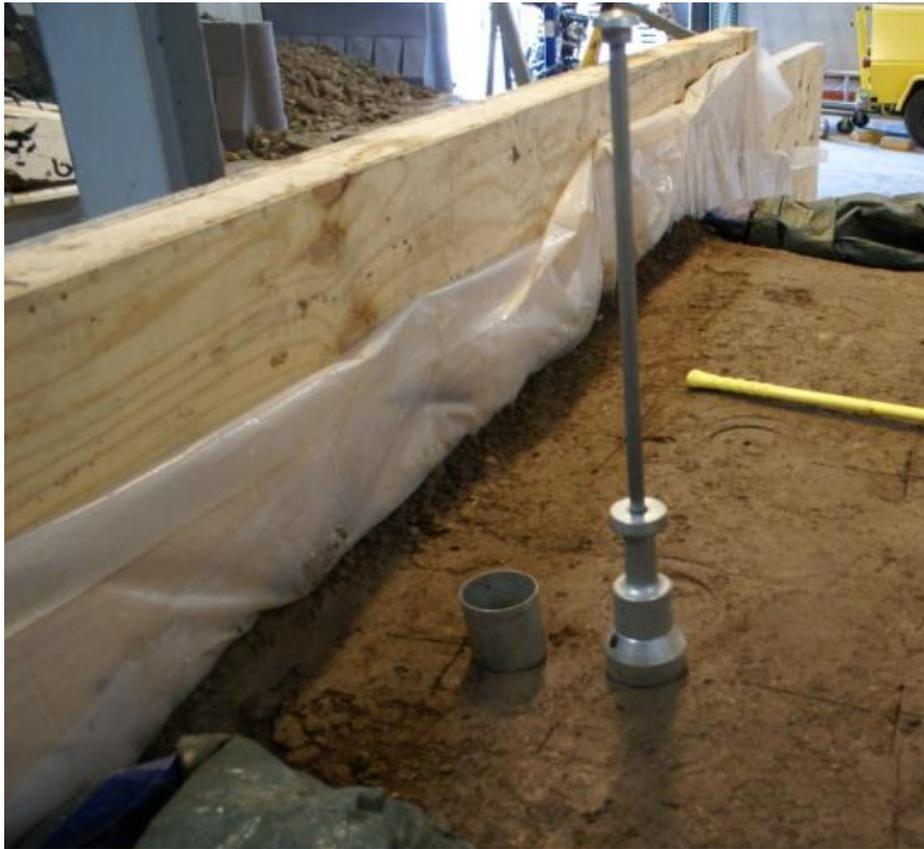
Figure 3.25 Drive tube and sampler driver

Drive tubes were used to determine the level of compaction of the subgrade, as shown in figure 3.18. The average dry unit weight for the subgrade based on an average of four samples was 91.5 lb/ft³ for the unreinforced test (92% of Proctor) and 93lb/ft³ for reinforced case (93% of Proctor).

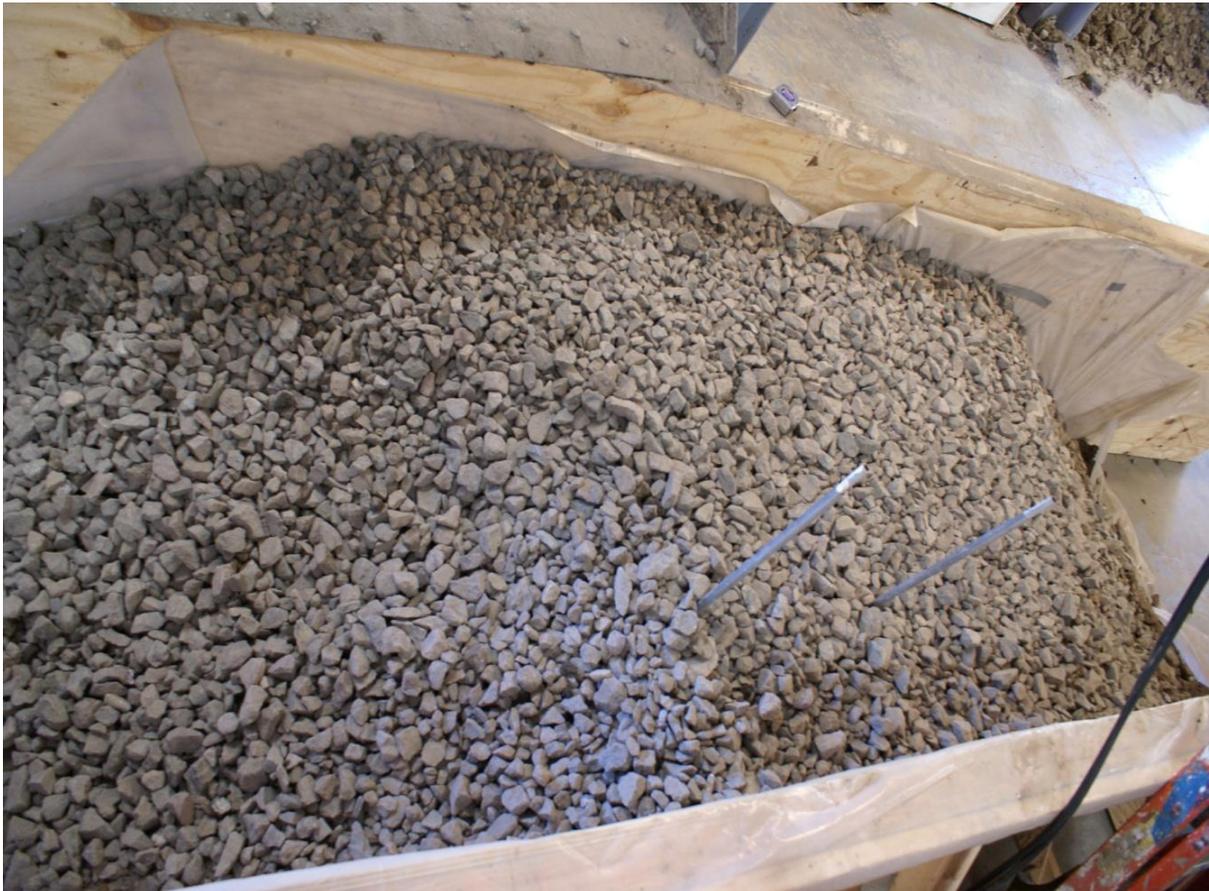
Figure 4.1 Unreinforced test section

Two dynamic loading tests were conducted on full scale railroad sections to investigate the effects of triaxial geogrid on reducing settlement and ballast degradation. The first test was conducted on an unreinforced control section. The second test was conducted with reinforcement using triaxial geogrid. Figure 4.1 shows the unreinforced section prior to placement of the track panel, and figure 4.2 shows the reinforced section with geogrid in place. Figure 4.3 shows the test setup with loading frame.

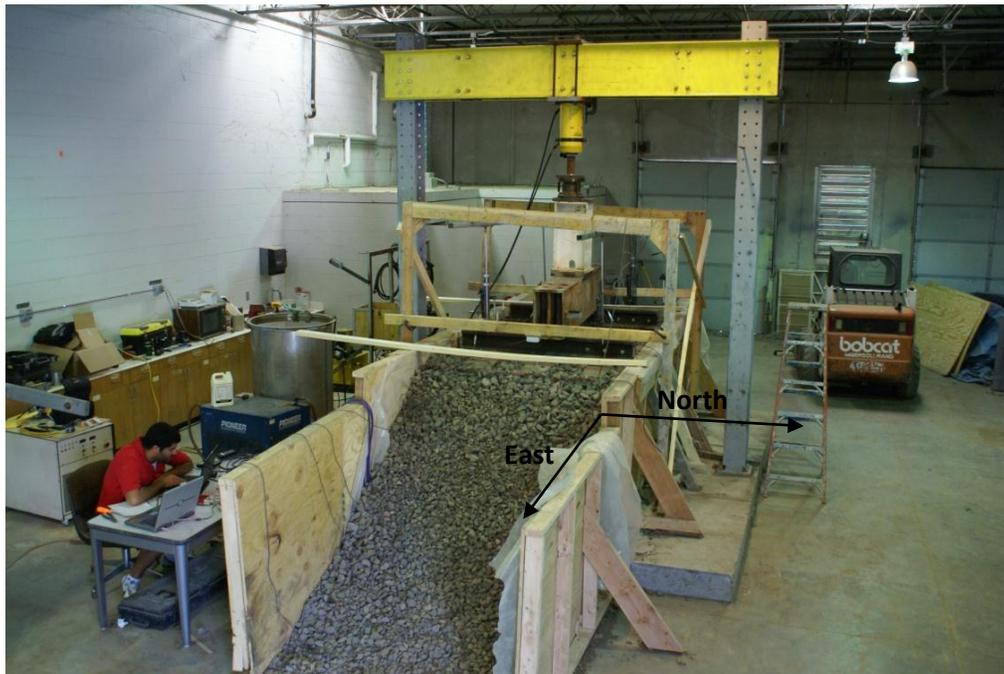
Figure 4.3 Test during dynamic loading

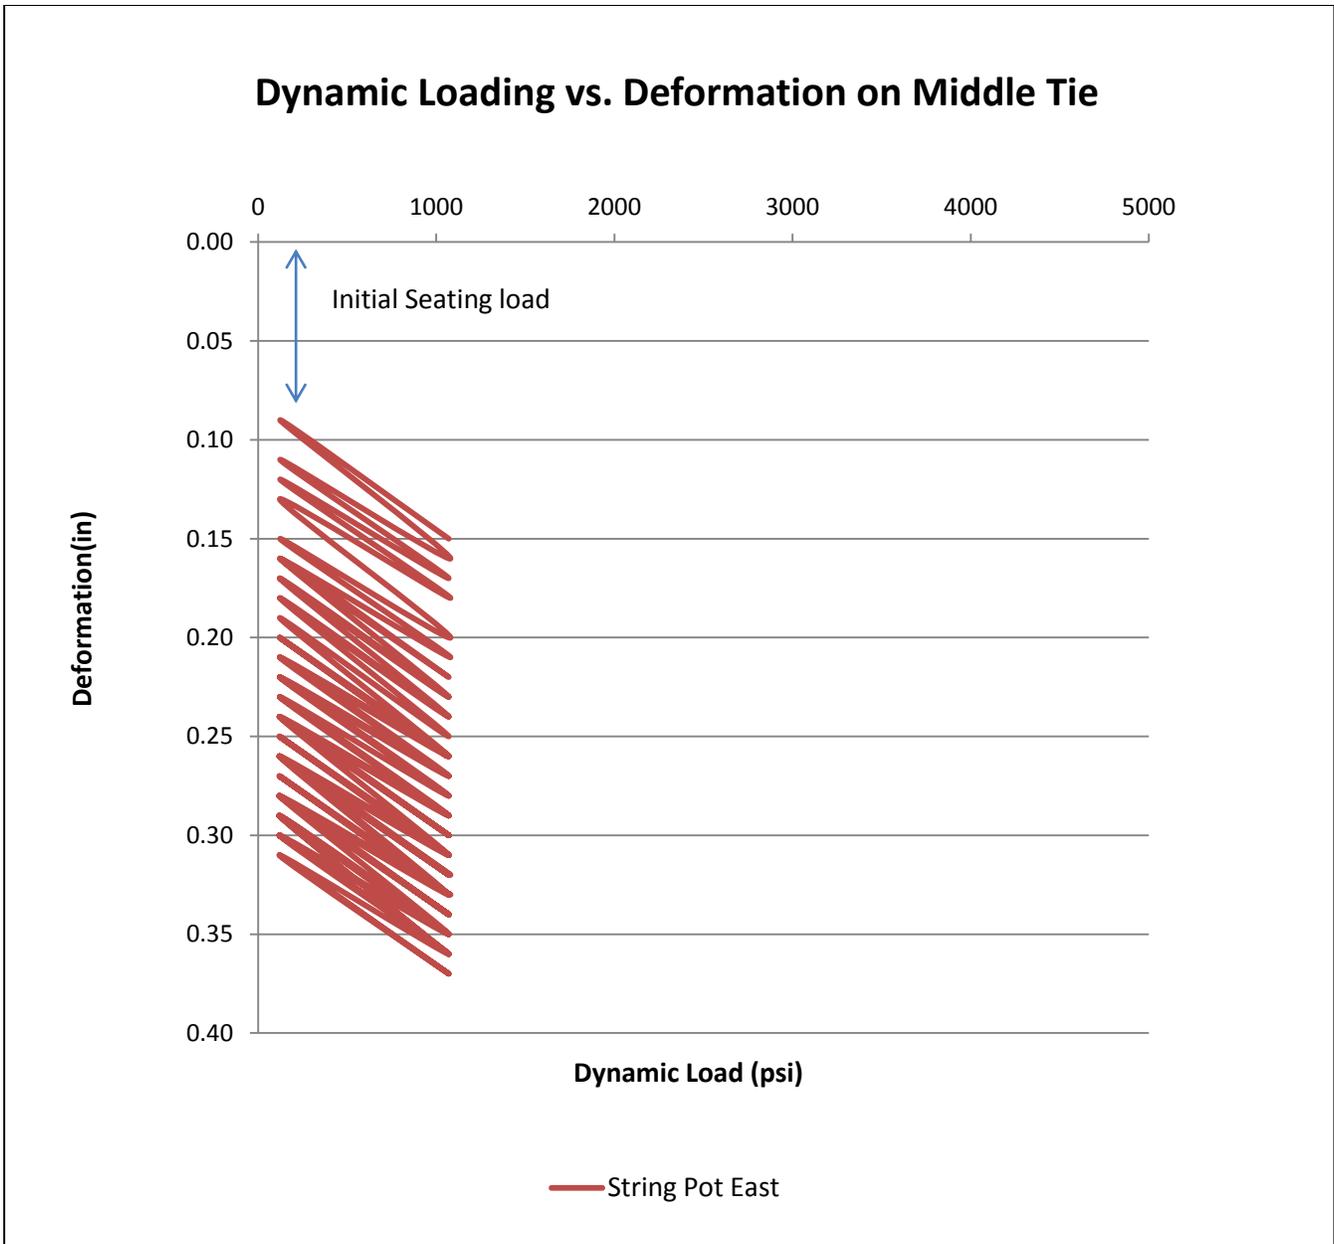
Figure 4.5 East string pot deformations versus dynamic loading at 1100 psi

Seventy-nine cycles were applied on the railroad section at 1100 psi, resulting in a total accumulated deformation after 79 cycles of 0.37 in. Figure 4.5 shows deformations (settlement) recorded by the east string pot for a dynamic loading of 1100 psi.

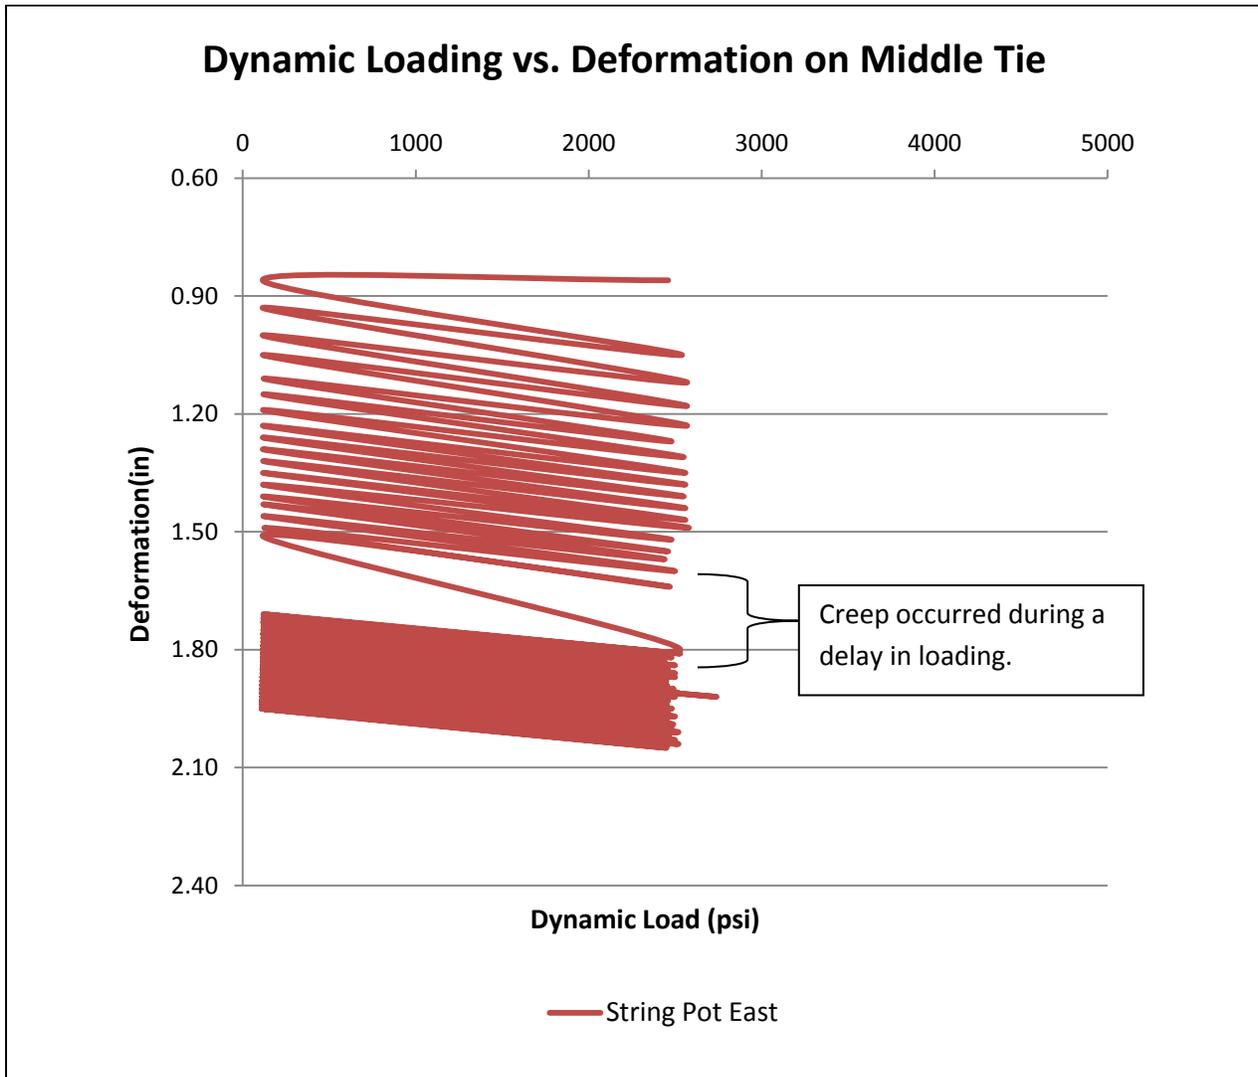
Figure 4.6 East string pot versus dynamic loading at 2500 psi

One hundred sixteen cycles were applied to the railroad section at 2500 psi. The total accumulated deformation after 116 cycles was 2 in. More permanent deformation was observed during the early cycles of each step. As the number of cycles increased, a higher percentage of the

deformation was elastic. Figure 4.6 shows the east string pot reading versus dynamic loading at 2500 psi.
