Report # MATC-KU: 363

Final Report

Performance of Geogrid Reinforced Ballast under Dynamic Loading

July 2012

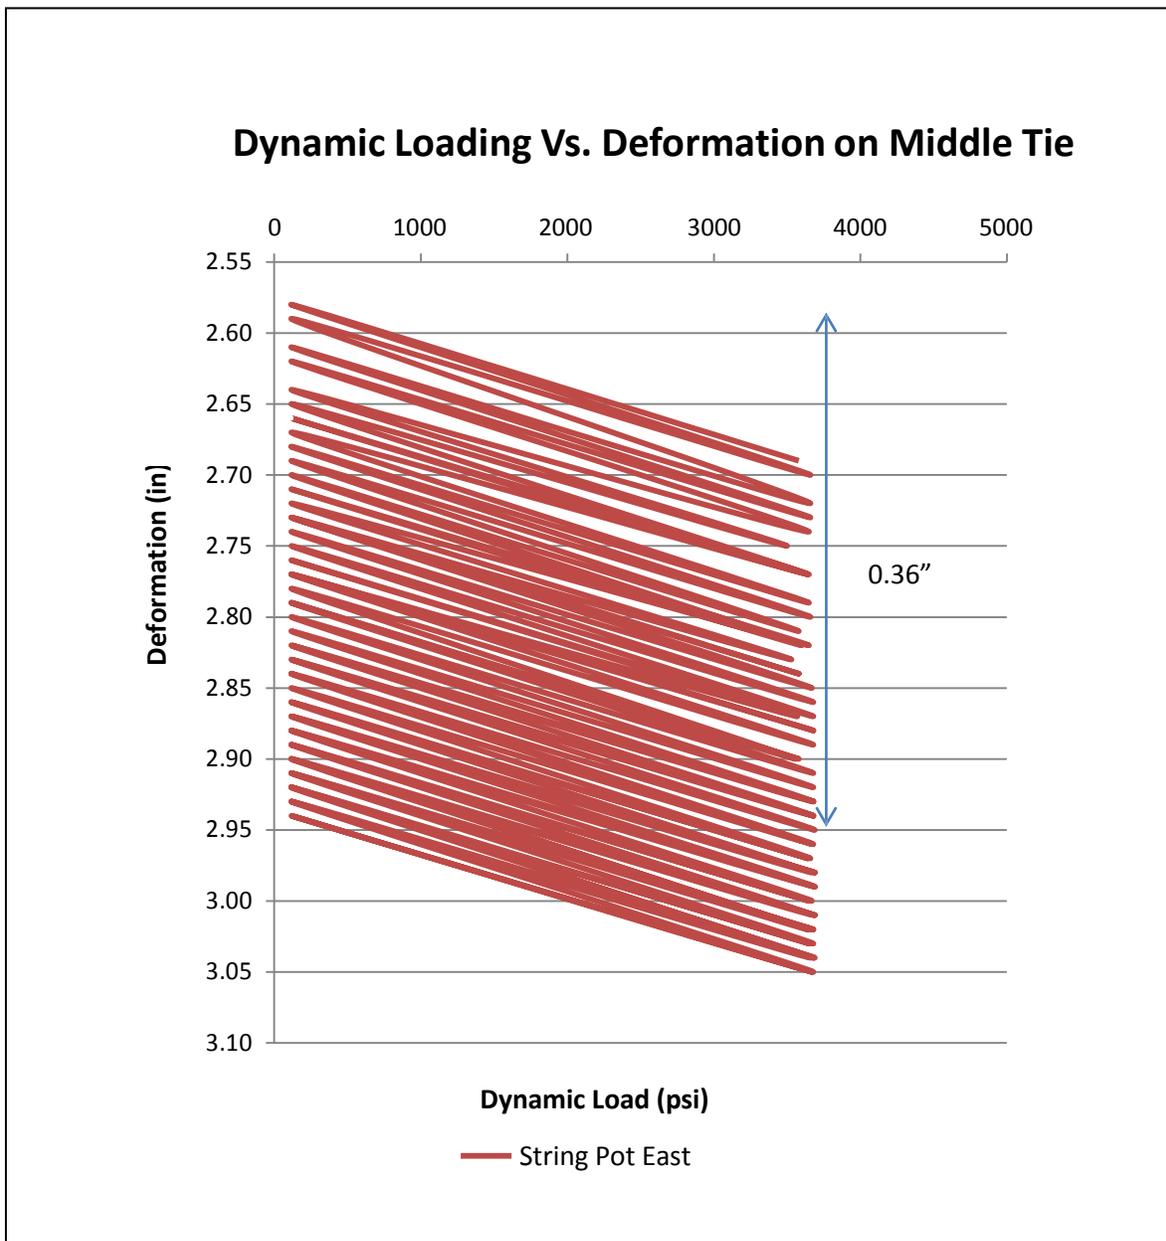
Figure 4.7 East string pot versus dynamic loading at 3500 psi

Fifty-two cycles were applied to the railroad section at 3500 psi for a total accumulated deformation after 52 cycles of 3.05 in. Figure 4.7 shows the east string pot reading versus dynamic loading at 3500 psi.

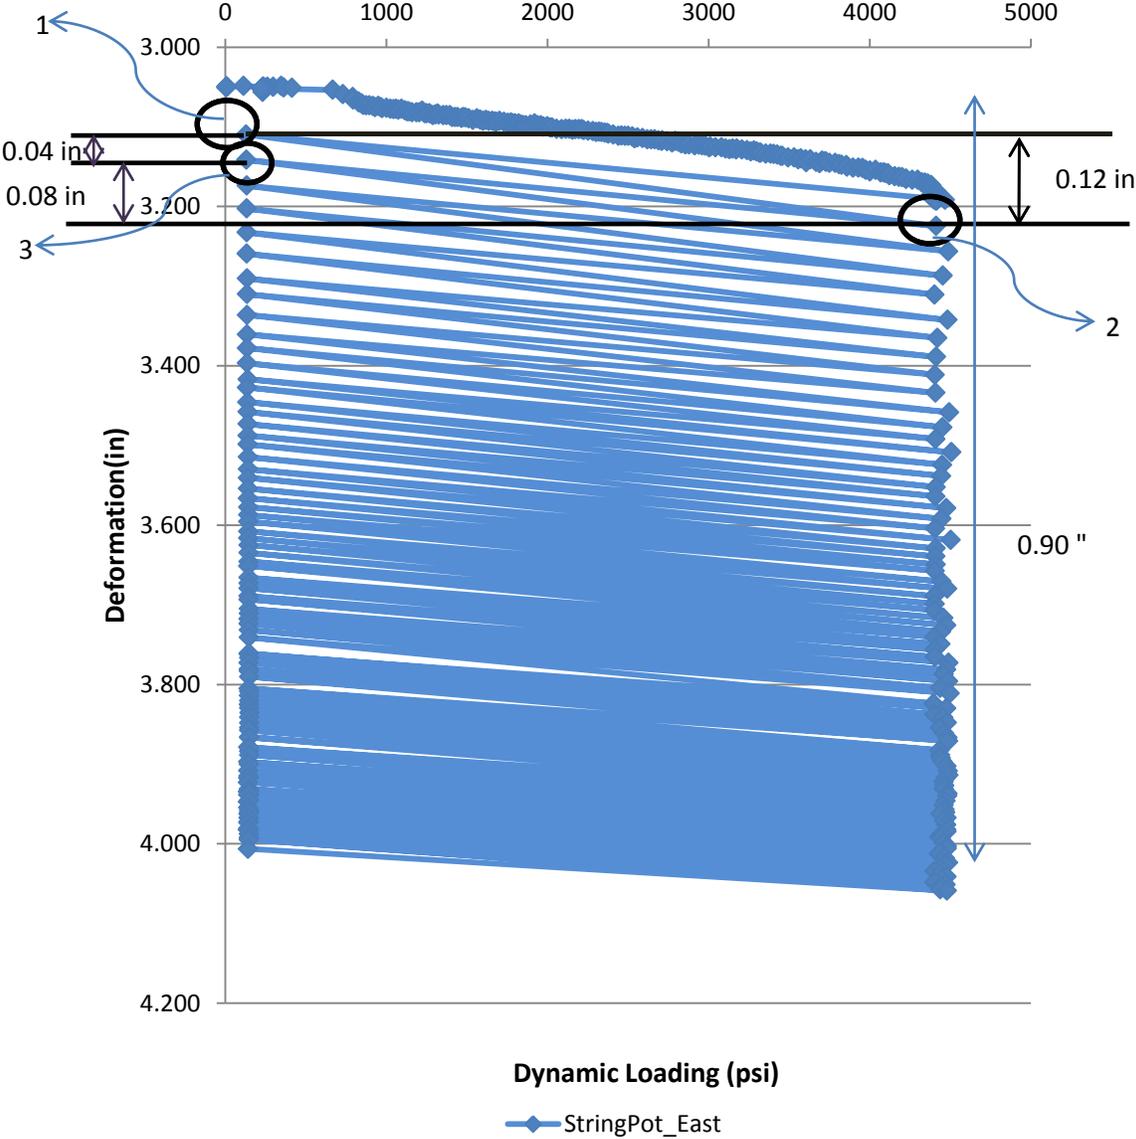
Figure 4.8 East string pot versus dynamic loading at 4500 psi (not soaked)

One hundred cycles were applied to the railroad section at 4500 psi. The total accumulated deformation after 100 cycles was 4.05 in. Figure 4.8 shows the east string pot reading versus dynamic loading at 4500 psi. More permanent deformation was observed for the early cycles. As the number of cycles increased, more elastic deformation was observed.

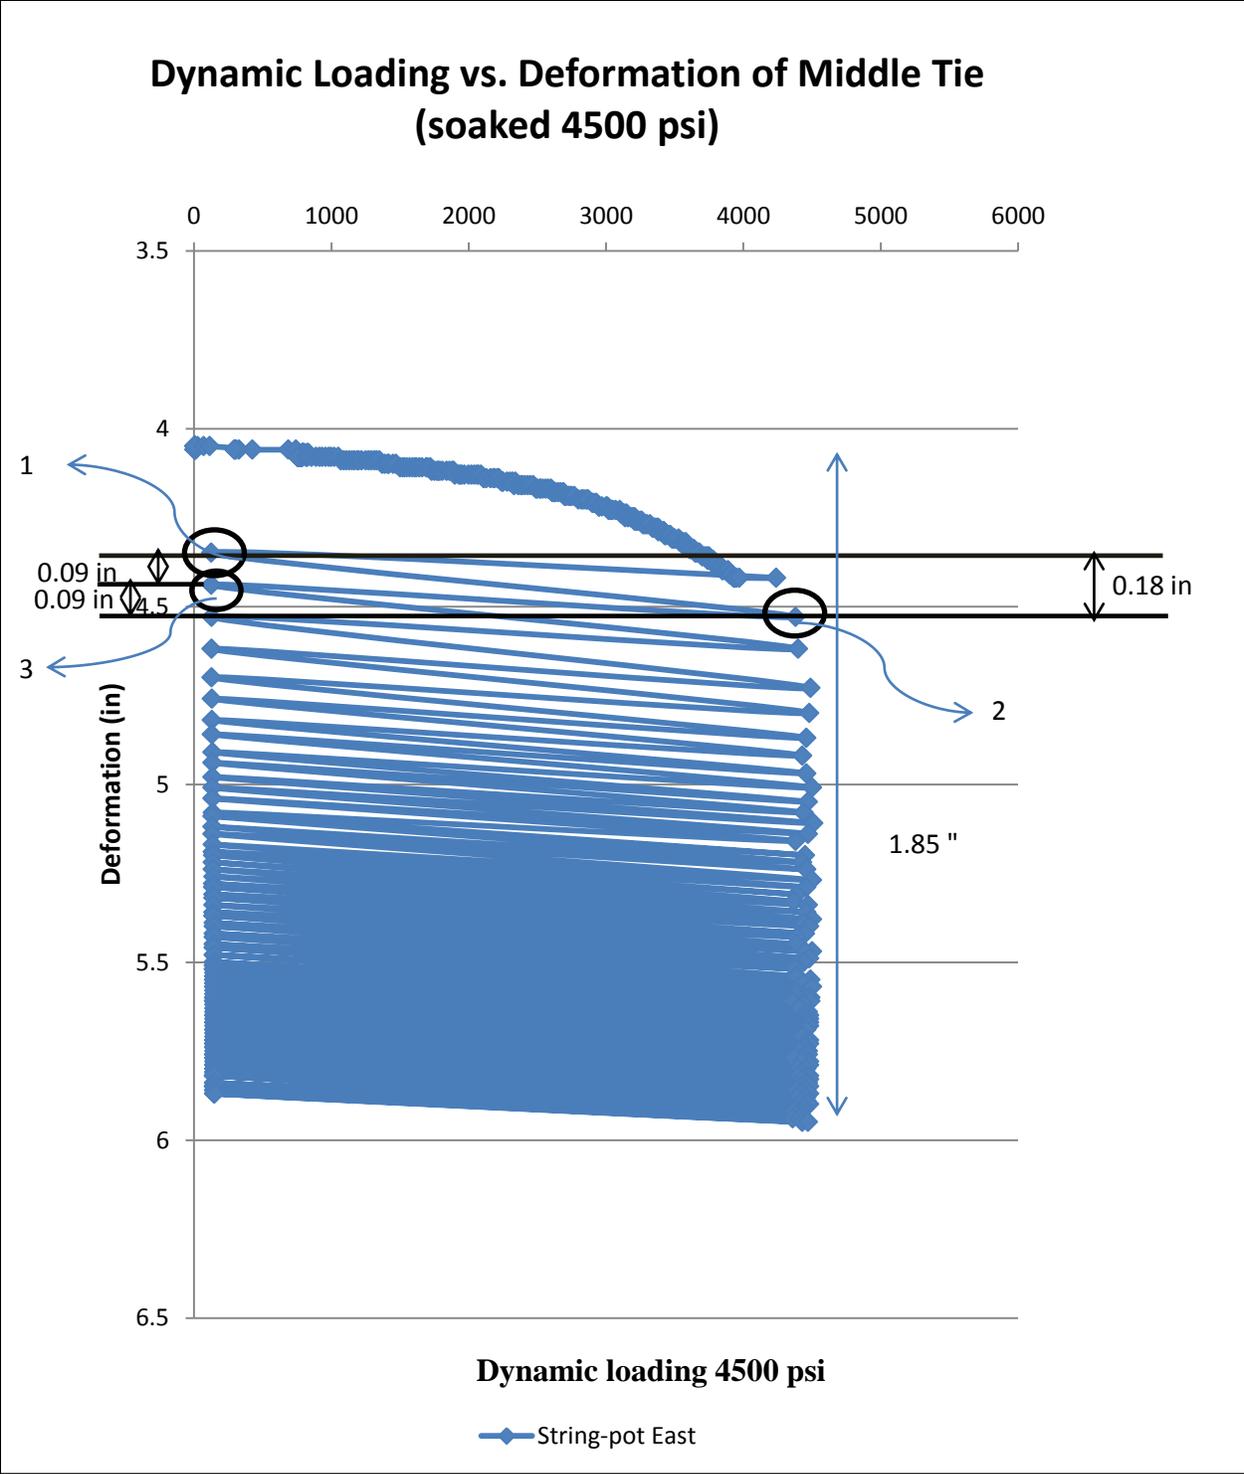
Figure 4.9 East string pot reading versus dynamic loading at 4500 psi soaked

Fifty gallons of water were added to the section via garden hose over period of 15 minutes. The section was left overnight for water to penetrate into the soil. One-hundred cycles were applied to the railroad section at 4500 psi the following day. The total accumulated deformation after 100 cycles was 5.95 in. As with the earlier steps, the beginning cycles resulted in more permanent deformation per cycle. As the number of cycles increased more elastic deformation was observed. Figure 4.9 shows the east string pot reading versus dynamic loading at 4500 psi, soaked.

As shown in figure 4.9, at the beginning of the loading step the difference between numbers 1 and 2 was the total deformation, or, 0.18 in., which was 50% more than was observed during the initial cycles when loading the section to 4500 psi without soaking, and 40% more than was observed at the end of the end of unsoaked loading. Most of the additional deformation per cycle was permanent. On the same graph, the difference between numbers 1 and 3 was the permanent deformation for the same cycle, which was 0.09 in. The elastic deformation is shown on the same graph, and was also 0.09 in. As with the previous loading step, the permanent and total deformations per cycle decreased as the number of cycles increased, and a higher percentage of the deformation was elastic.

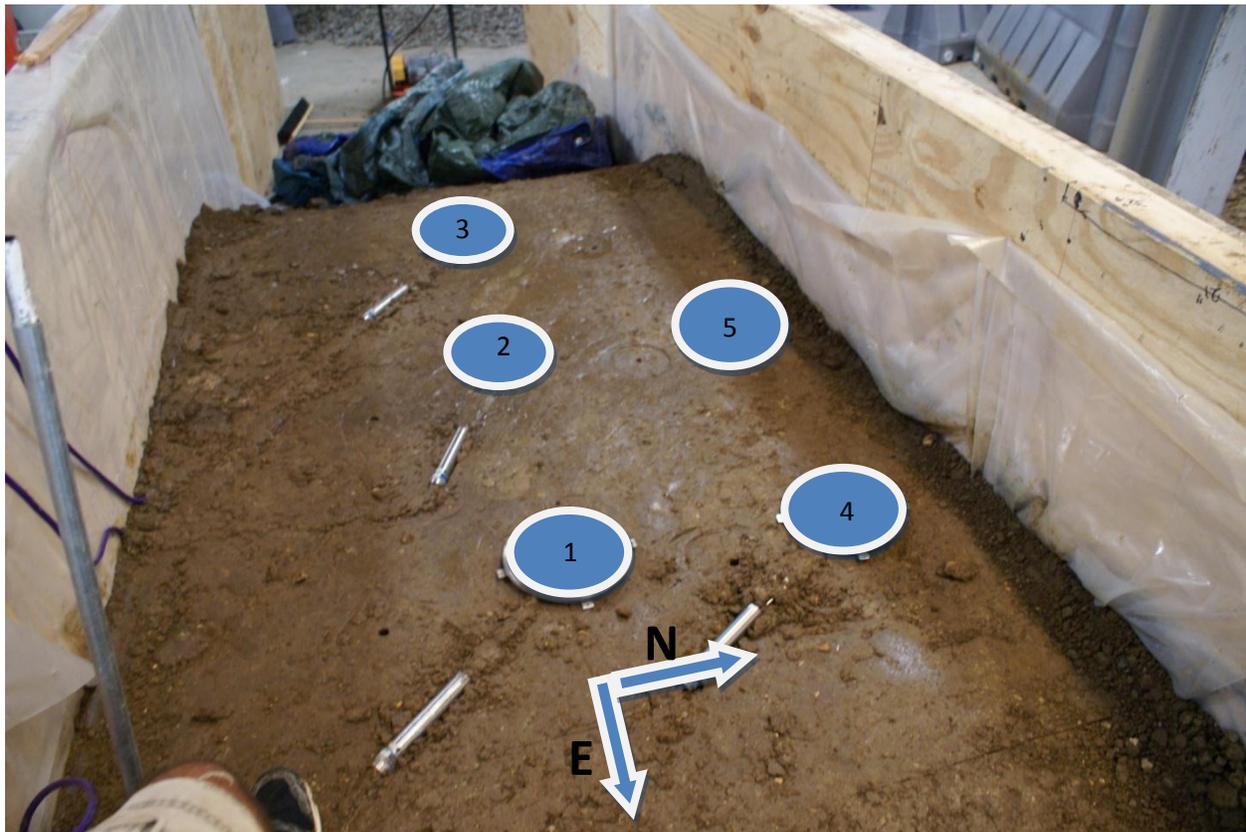
Figure 4.29 Pressure cells

Five pressure cells were installed, as shown in figure 4.29. Pressure cells 1, 2 and 3 were installed at the interface of subgrade and ballast under the middle tie (1 and 3 were right below the rails). Pressure cells 4 and 5 were installed under the right tie with Cell 4 beneath the rail and Cell 5 beneath the center of the tie.

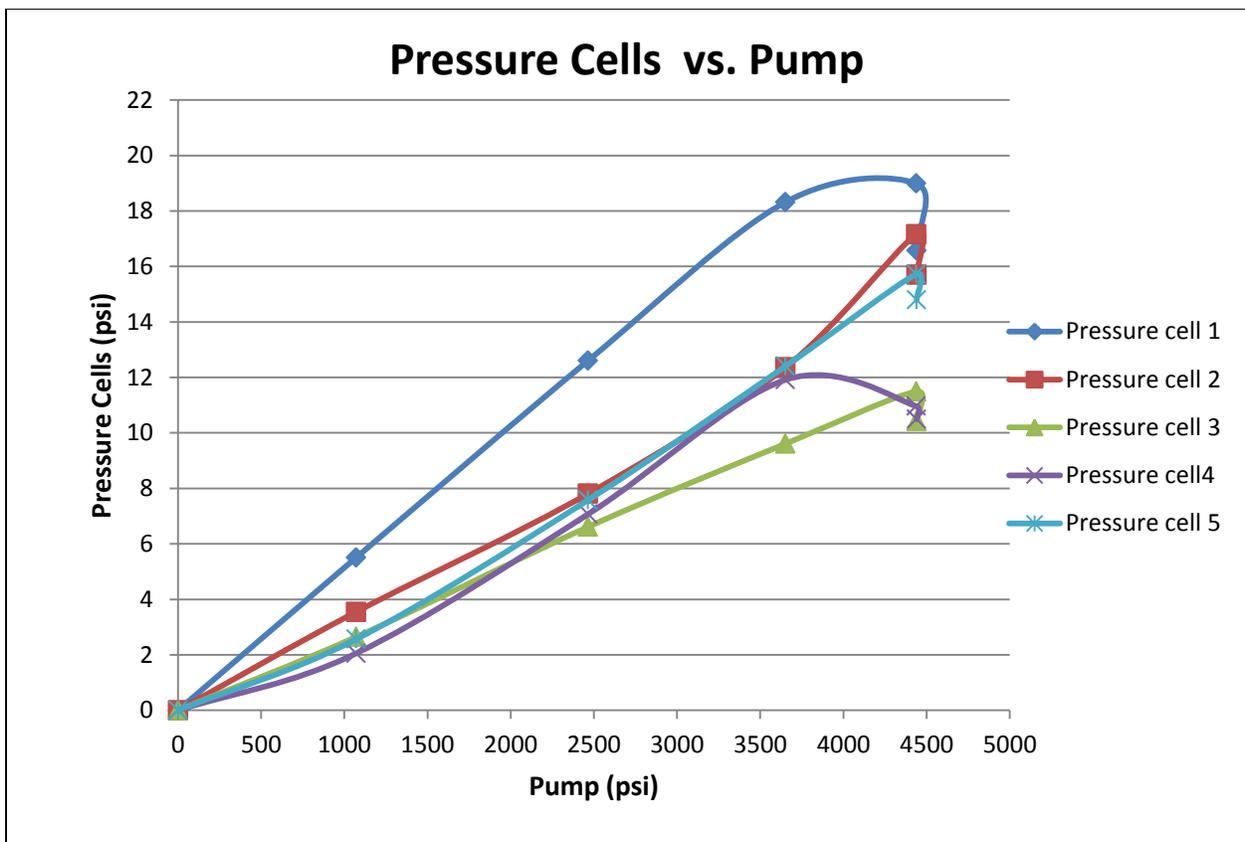
Figure 4.30 Pressure cells vs. pump pressure at subgrade level (target pressure)

Table 4.2 and figure 4.30 show pressure cell response versus hydraulic pressure in the jack. Pressure cell 1 measured the highest vertical stress observed, of 19 psi. When subgrade pressure at the location of pressure cell 1 reached 18 psi, the subgrade began to yield (fail). Pressure cell 4 experienced subgrade failure at a pressure of 12 psi. The soil beneath these pressure cells began to yield as the hydraulic pressure was increased to 4500 psi. The subgrade did not experience failure at the locations of pressure cells 2, 3, or 5 until it was soaked with 50 gallons of water and reloaded. Pressure cell 3 experienced lower pressure due to the movement of the tie or the pressure cell itself. Table 4.3 and figure 4.31 show the same plot with tie bearing pressure on the x-axis (actual pressure).

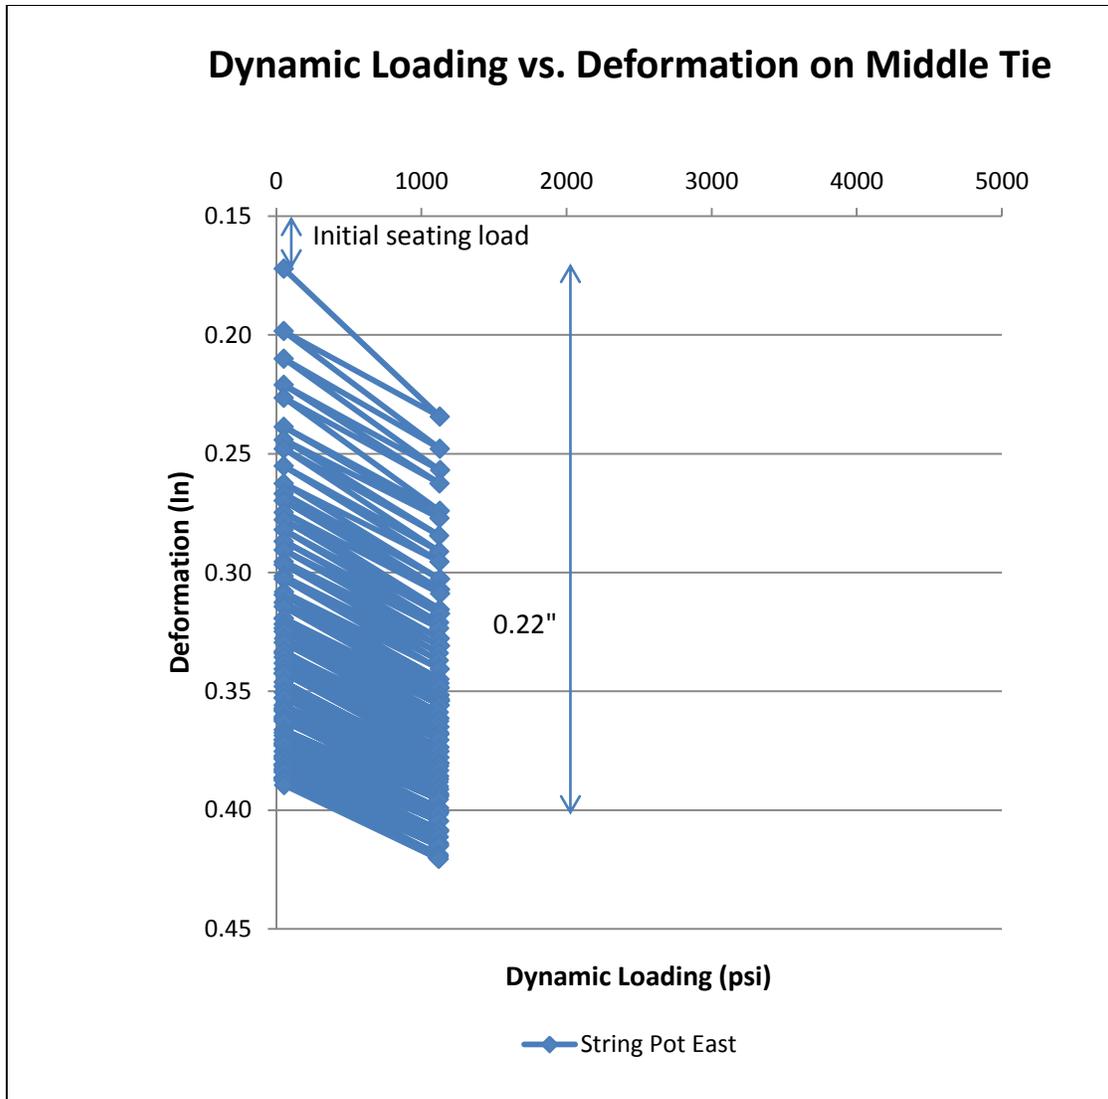
Figure 4.33 East string pot deformations versus dynamic loading at 1100 psi

Seventy-nine cycles were applied on the railroad section at 1100 psi, resulting in a total accumulated deformation after 79 cycles of 0.42 in. Figure 4.33 shows deformations (settlement) recorded by the east string pot for a dynamic loading of 1100 psi.

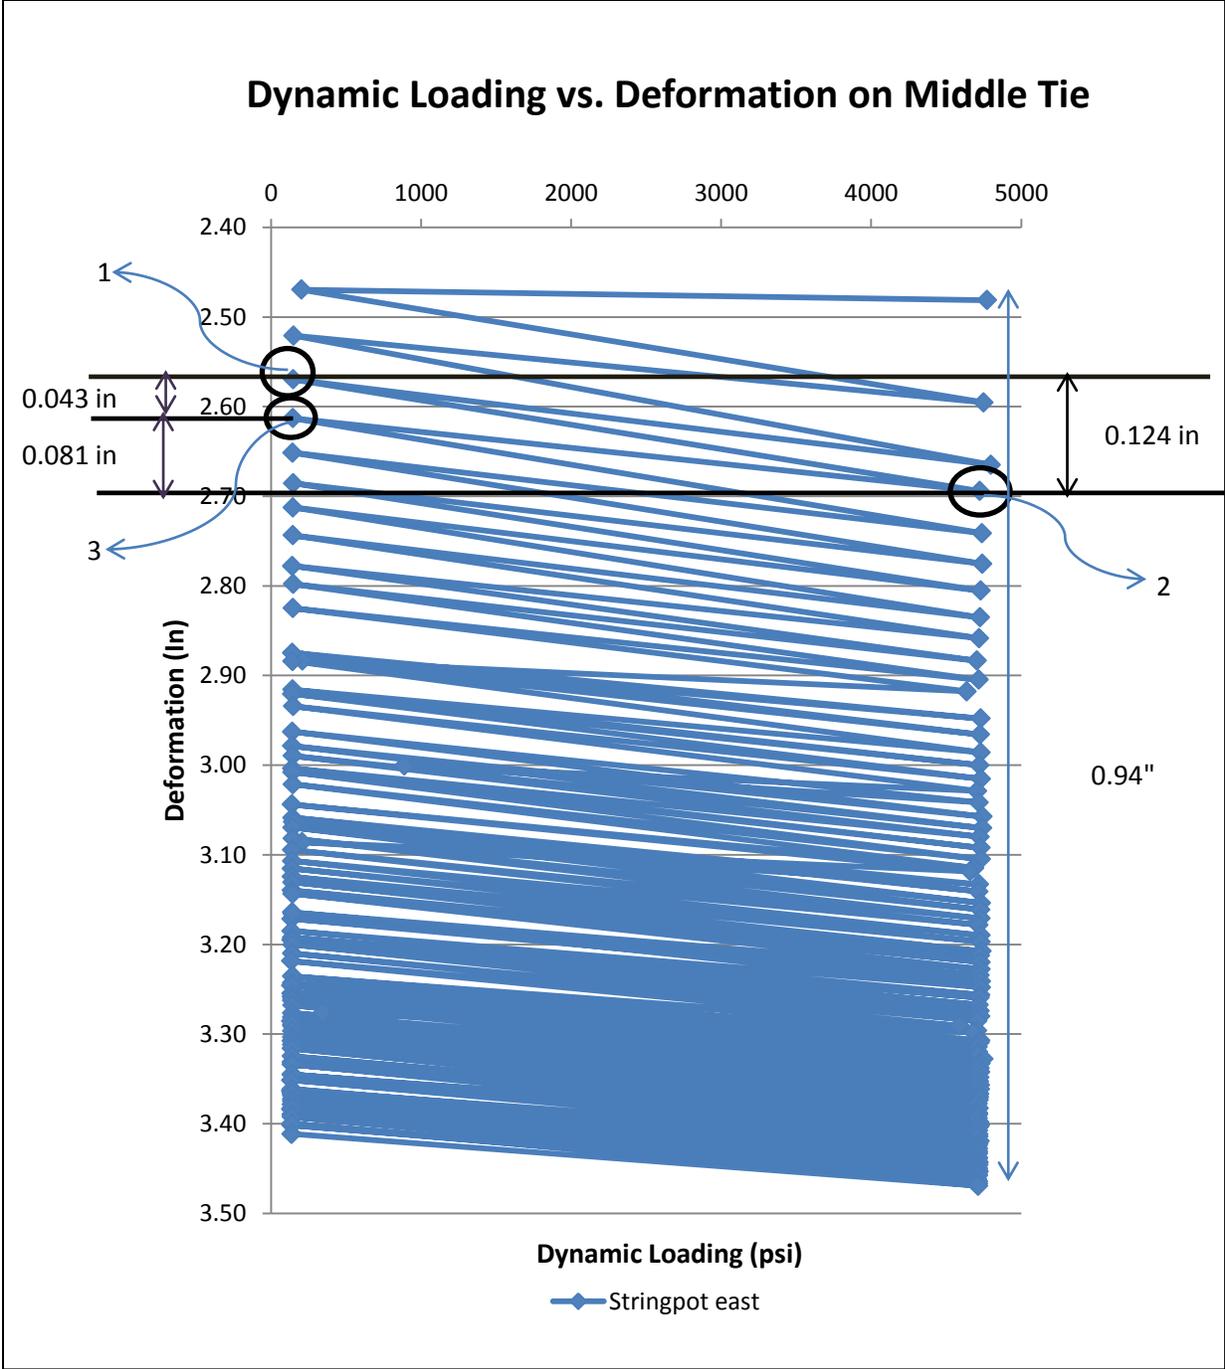
Figure 4.36 East string pot versus dynamic loading at 4500 psi (not soaked)

One-hundred cycles were applied to the railroad section at 4500 psi. The total accumulated deformation after 100 cycles was 3.46 in. Figure 4.36 shows the east string pot reading versus dynamic loading at 4500 psi. More permanent deformation was observed for the early cycles. As the number of cycles increased, more elastic deformation was observed.

As figure 4.36 (below) shows, at the beginning of the loading step the total deformation is the difference between numbers 1 and 2 on figure 4.36, which is about 0.124 in. On the same graph, the difference between numbers 1 and 3 is the permanent deformation for the same cycle, which is 0.043 in., while the difference between points 2 and 3 is the elastic deformation. This elastic deformation is 0.081 in. As the number of cycles, increases the permanent and total deformations per cycle decrease and a higher percentage of the deformation is elastic.

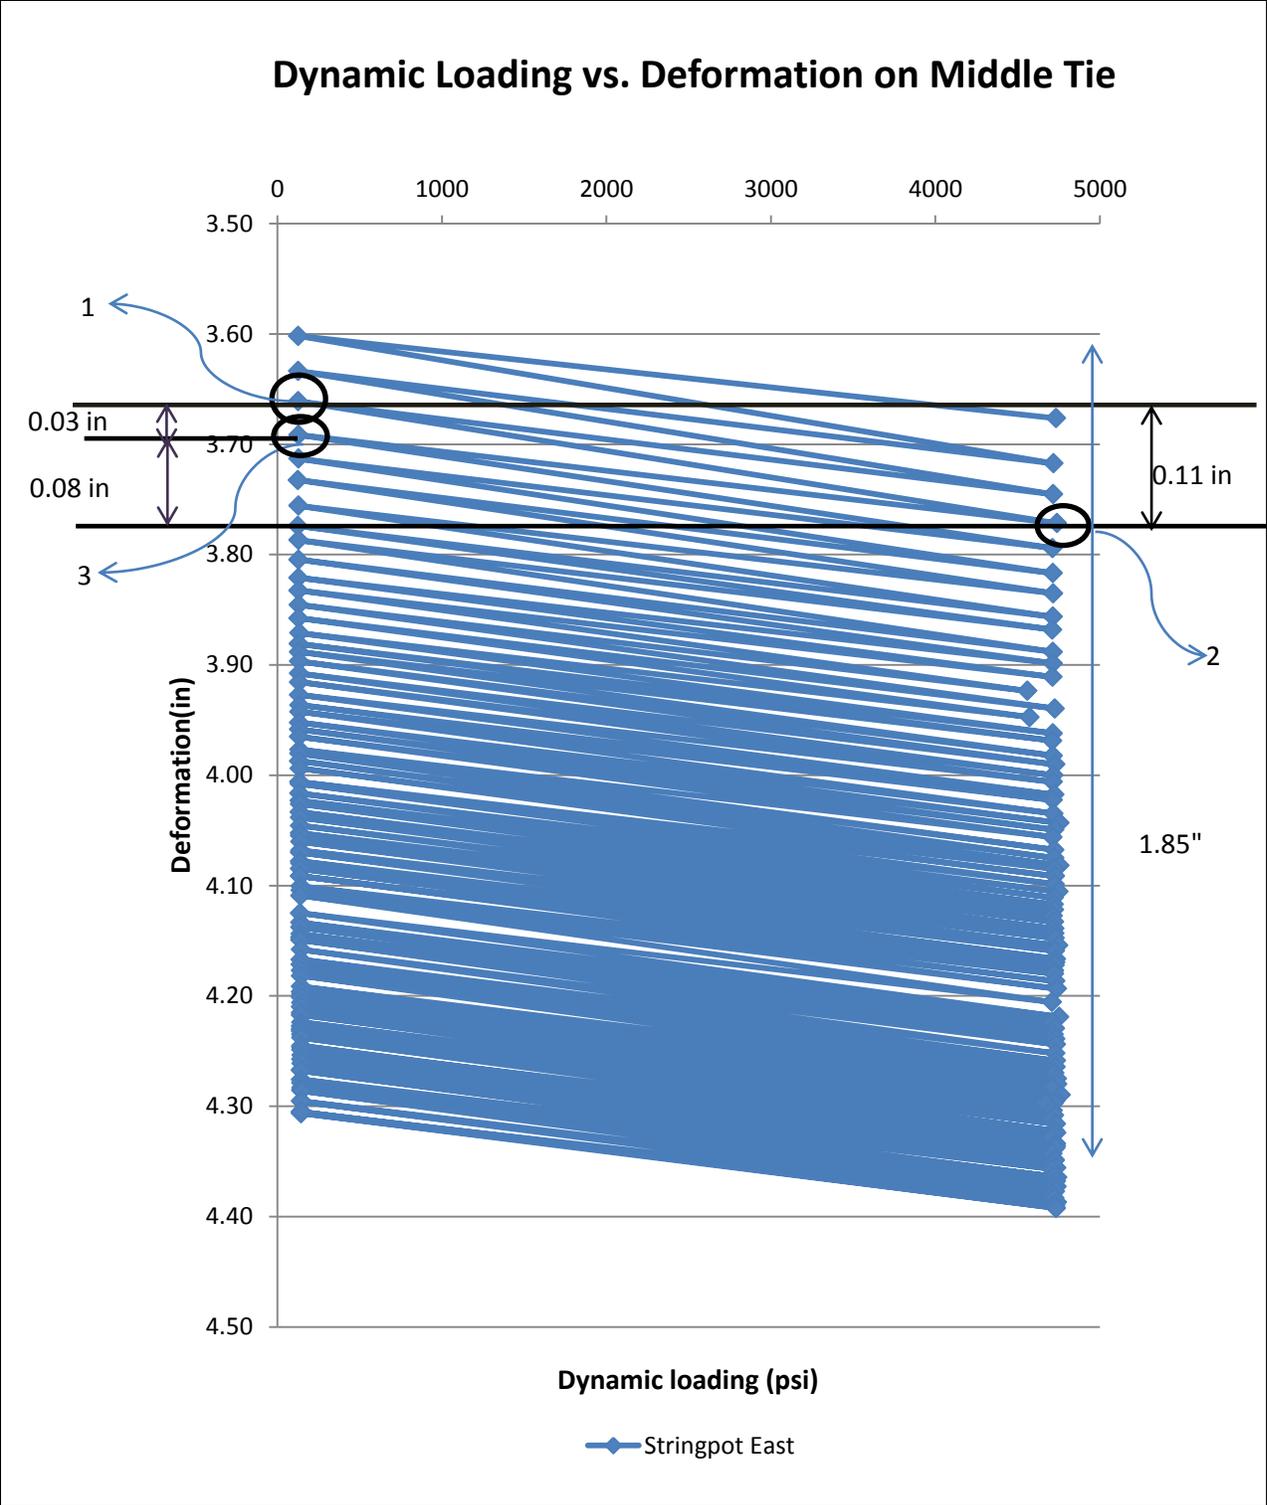
Figure 4.37 East string pot versus dynamic loading at 4500 psi (soaked)

As figure 4.5.6 shows, at the beginning of the loading step the difference between numbers 1 and 2 in figure 4.37 was the total deformation, observed as 0.11, which was 50% more than was observed during the initial cycles when loading the section to 4500 psi without soaking, and 40% more than was observed at the end of the end of unsoaked loading. Most of the additional deformation per cycle was permanent. On the same graph the difference between numbers 1 and 3 was the permanent deformation for the same cycle, or 0.08 in. The elastic deformation is shown on the same graph, and was 0.03 in. As with the previous loading step, the permanent and total deformations per cycle decreased and a higher percentage of the deformation was elastic.

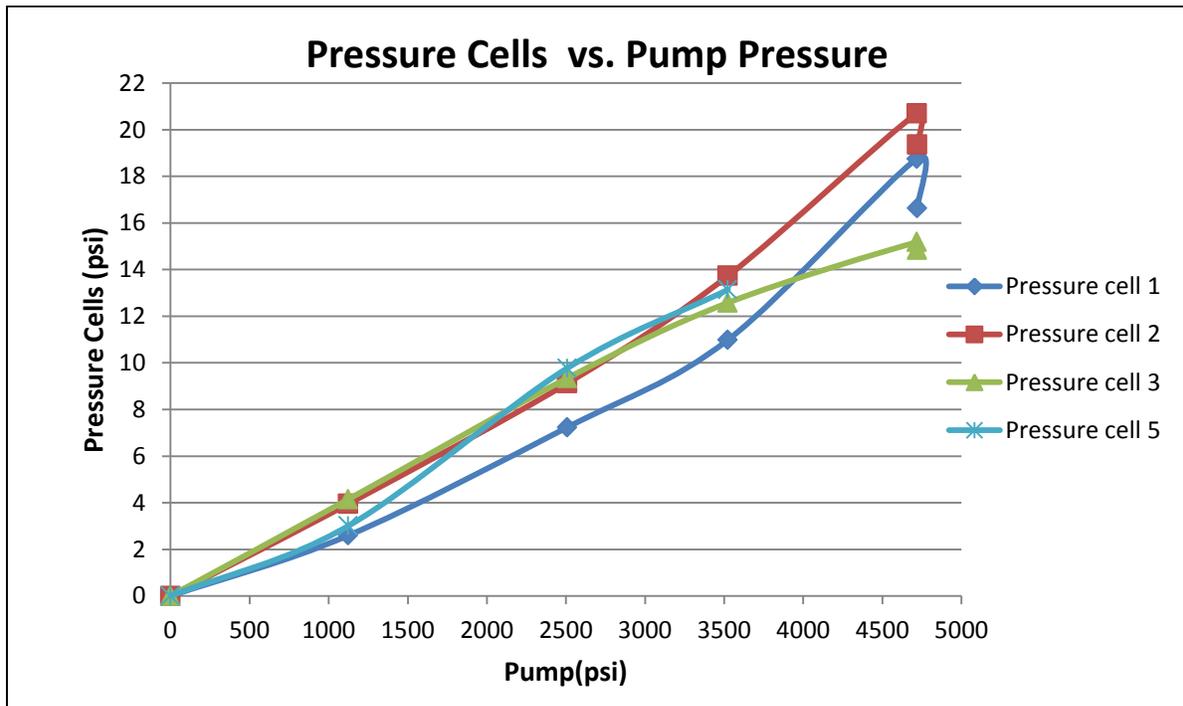
Figure 4.49 Pressure cells vs. pump pressure at subgrade level

Figure 4.49 and table 4.5 and show the pressure cell data versus pressure transducer data for the reinforced case. Pressure cell 4 data was not recorded due to the failure of pressure cell 4. For this test, unlike the unreinforced case, the subgrade did not fail at any location until it was soaked with 50 gallons of water. Pressure cell 2 experienced the highest pressure at approximately 21 psi. Figure 4.50 and table 4.6 present the similar information vs. tie bearing pressure.

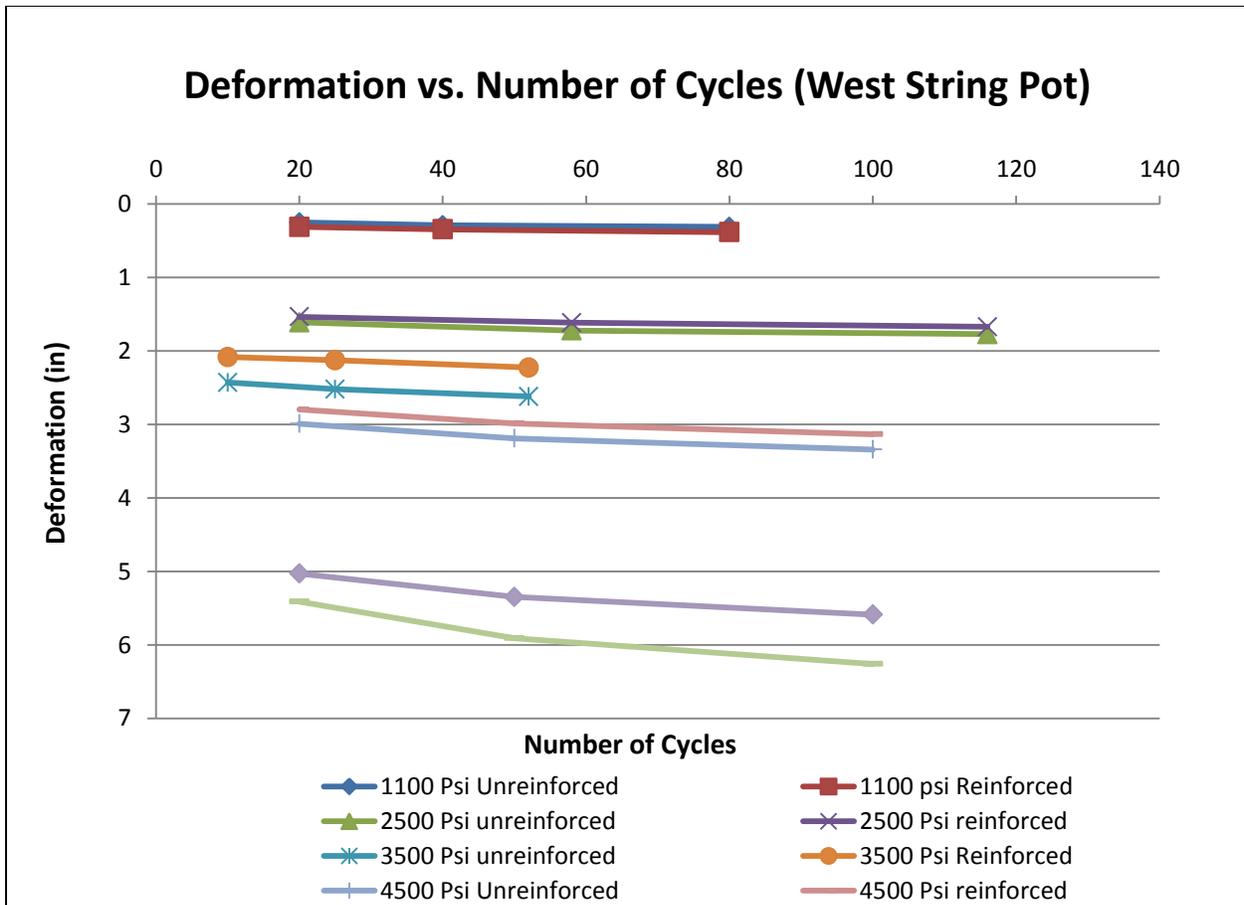
Figure 4.51 West string pot result comparison

At the end of the 1100 psi loading step there was no substantial difference in settlement between the two sections. After the 2500 psi loading step an improvement of 0.09 in was observed for the reinforced case. The amount of improvement improved to 0.4 in after the 3500 psi loading step, 0.2 in after the 4500 psi loading step (not soaked) and 0.6 in after loading of the soaked section.

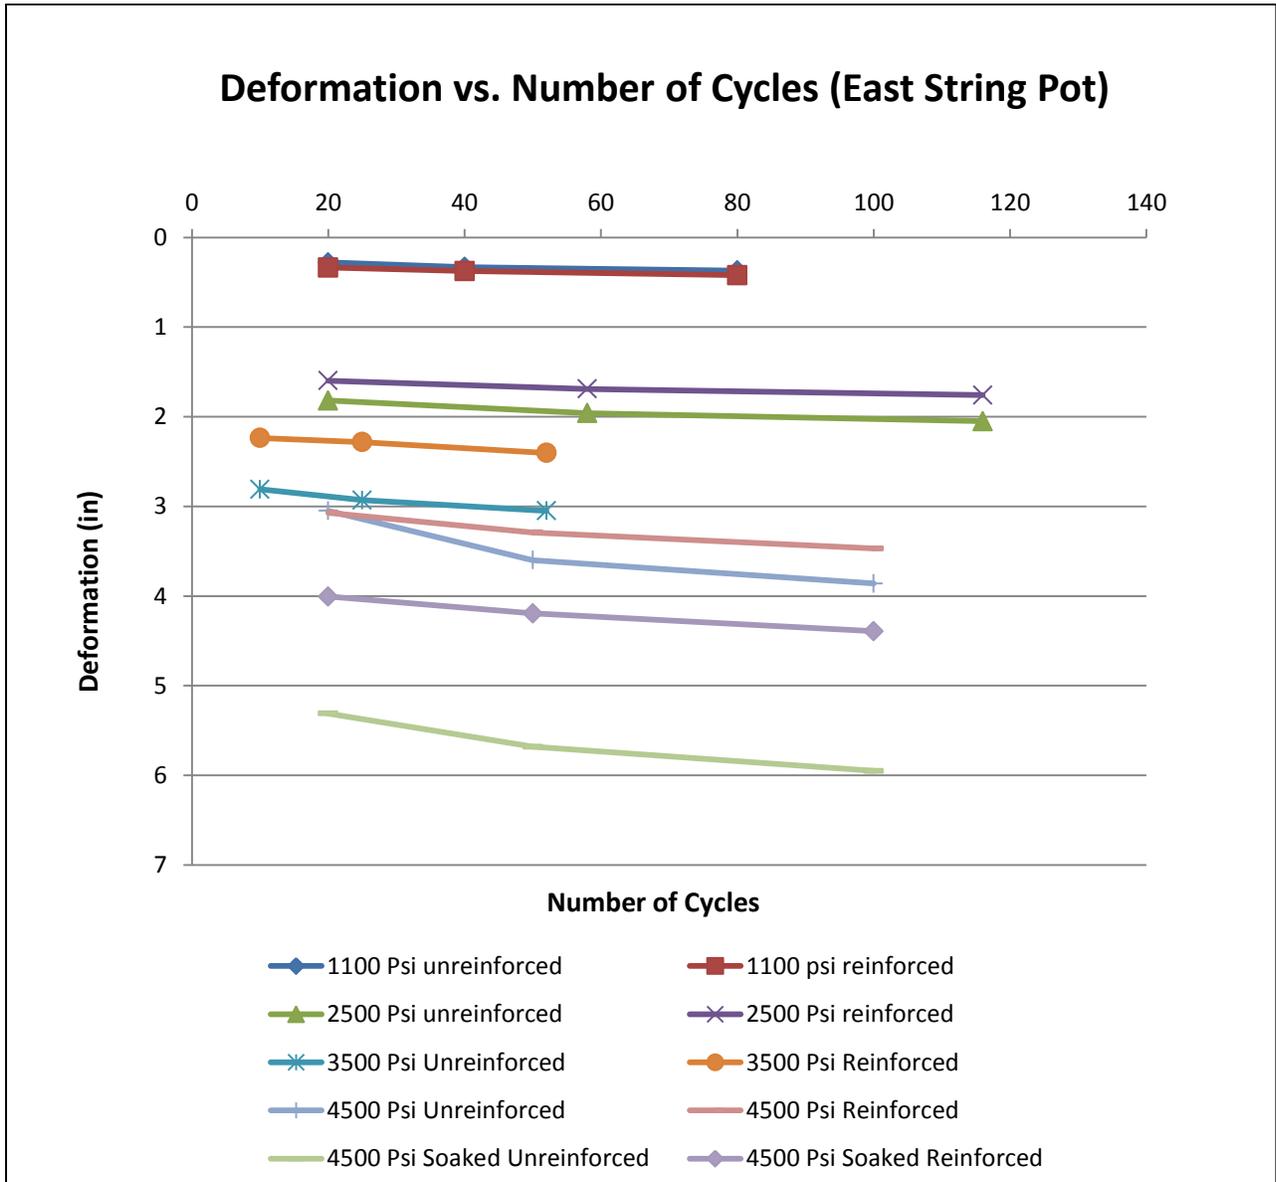
Figure 4.53 East string pot result comparison

Figure 4.53 shows the deformation vs. number of cycles for the east string pot.

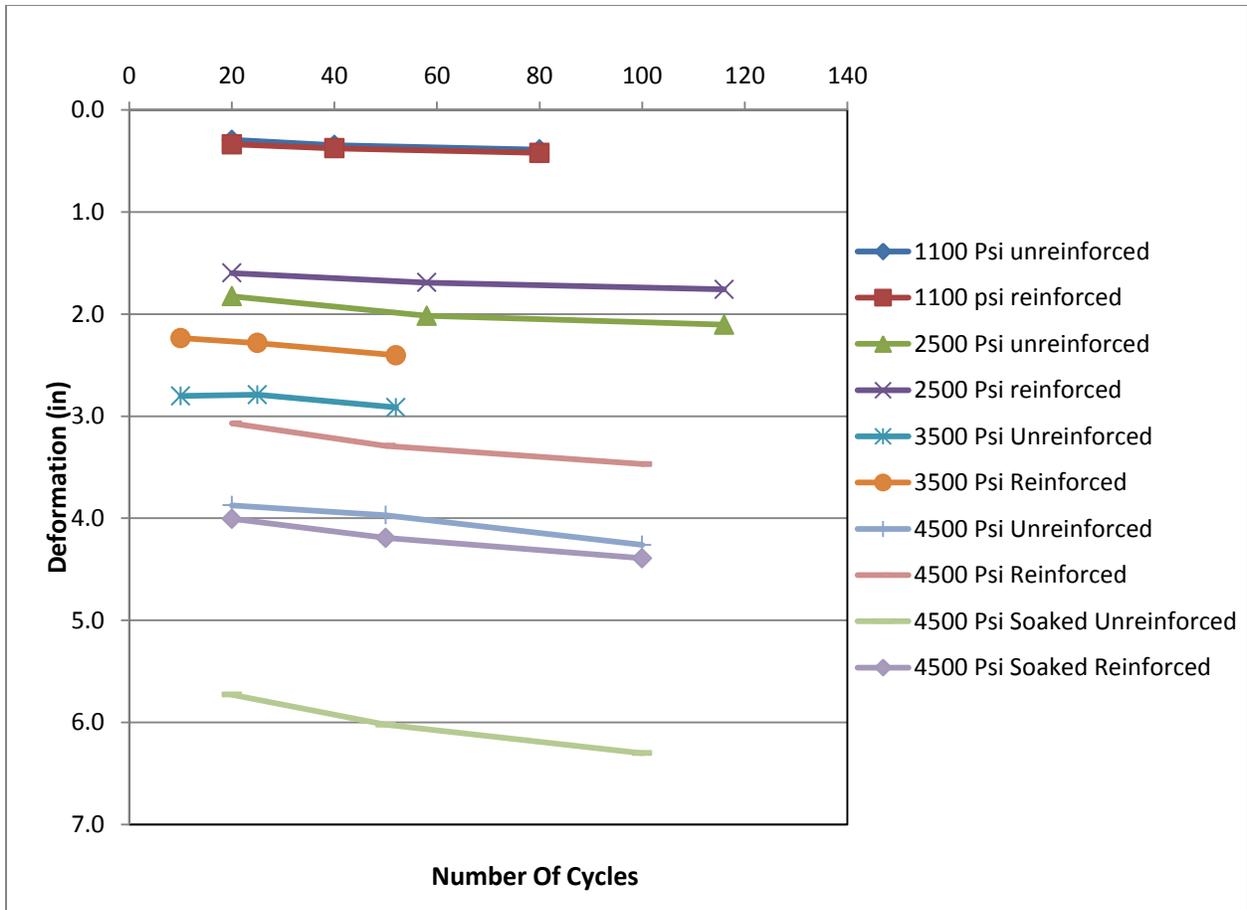
Figure 4.54 East string pot result comparison (after adjusting for load differences)

As table 4.10 shows, at the end of the 1100 psi loading no improvement was observed. After the 2500 psi loading, a 0.3 in improvement in settlement was observed. After the 3500 psi loading, 0.64 in of settlement improvement was obtained; after 4500 psi loading (not soaked), about 0.58 in of settlement improvement was obtained, and the end of soaked section loading about 1.55 in of settlement improvement was obtained. Notice on figure 4.53 for the 1100 psi loading step how the reinforced and unreinforced curves are laid on top of each other. As the loads applied get bigger, the gap between the reinforced and unreinforced cases gets higher until the 3500 psi loading step. However, in the case of the 4500 psi, the loading step gap becomes smaller. This is because the pressure applied in the unreinforced and reinforced cases are not identical. Table 4.10 shows the percent difference in load applied in-between both unreinforced and reinforced cases. The test data were adjusted to account for the loading difference in loading using the same procedure, as was used in figure 4.52.

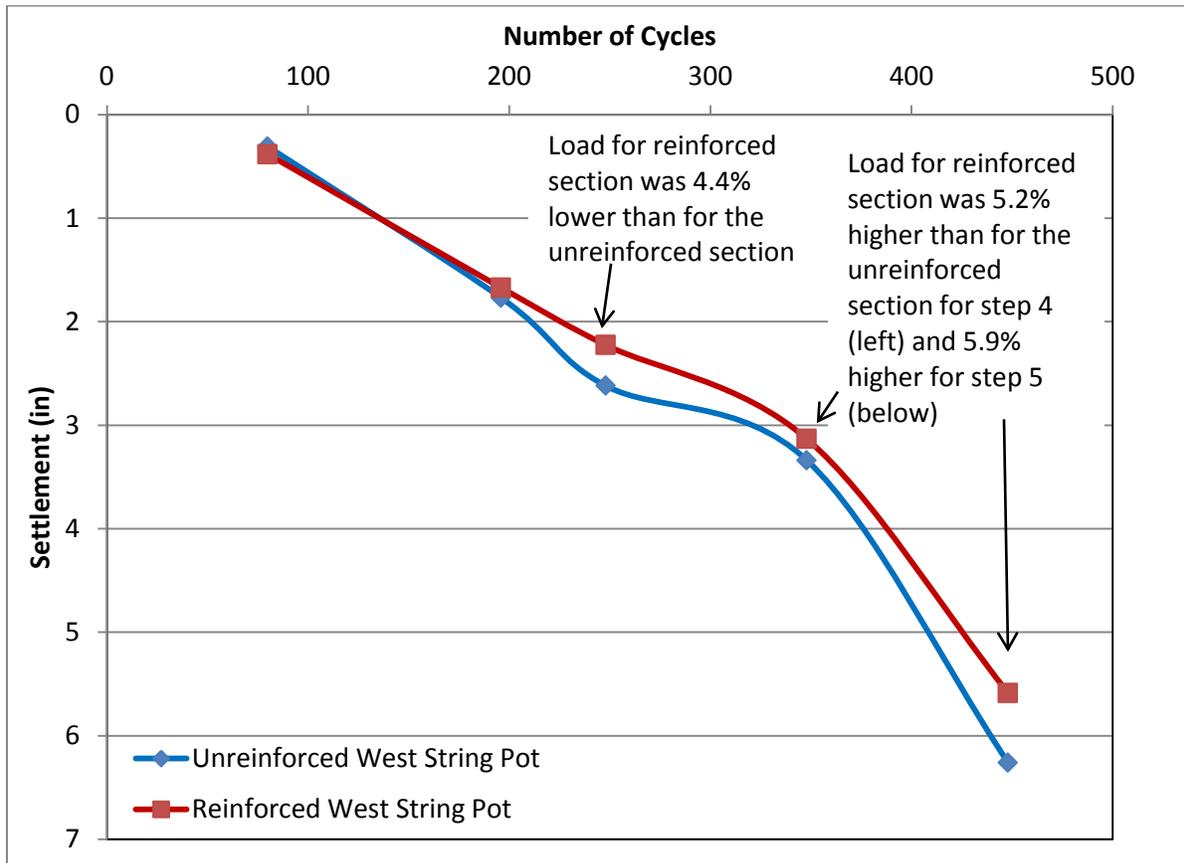
Figure 4.55 Number of cycles vs. settlement (west string pot)

Figures 4.55 and 4.56 show the settlement with cycles for both tests observed by west and east string pots. These figures also show less settlement for the reinforced section.
