Report # MATC-KU: 363

Final Report

Performance of Geogrid Reinforced Ballast under Dynamic Loading

July 2012

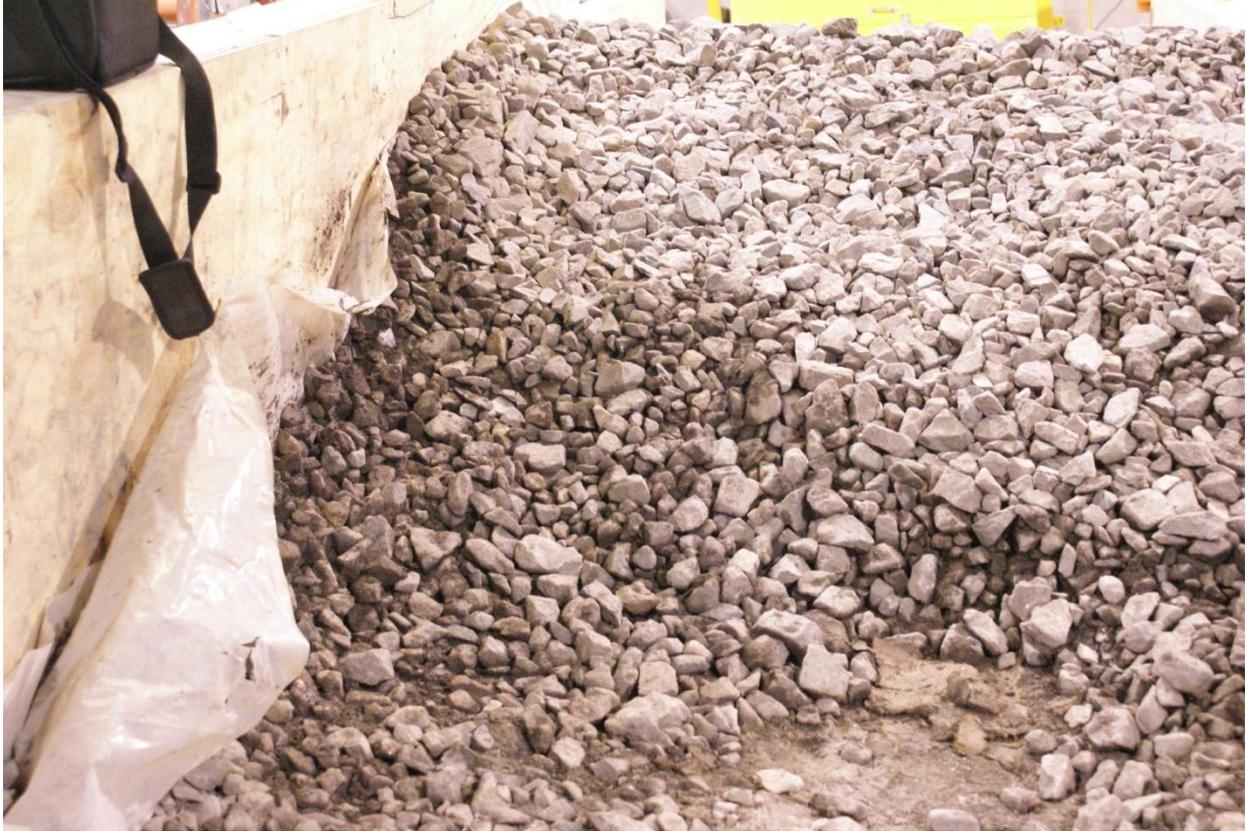
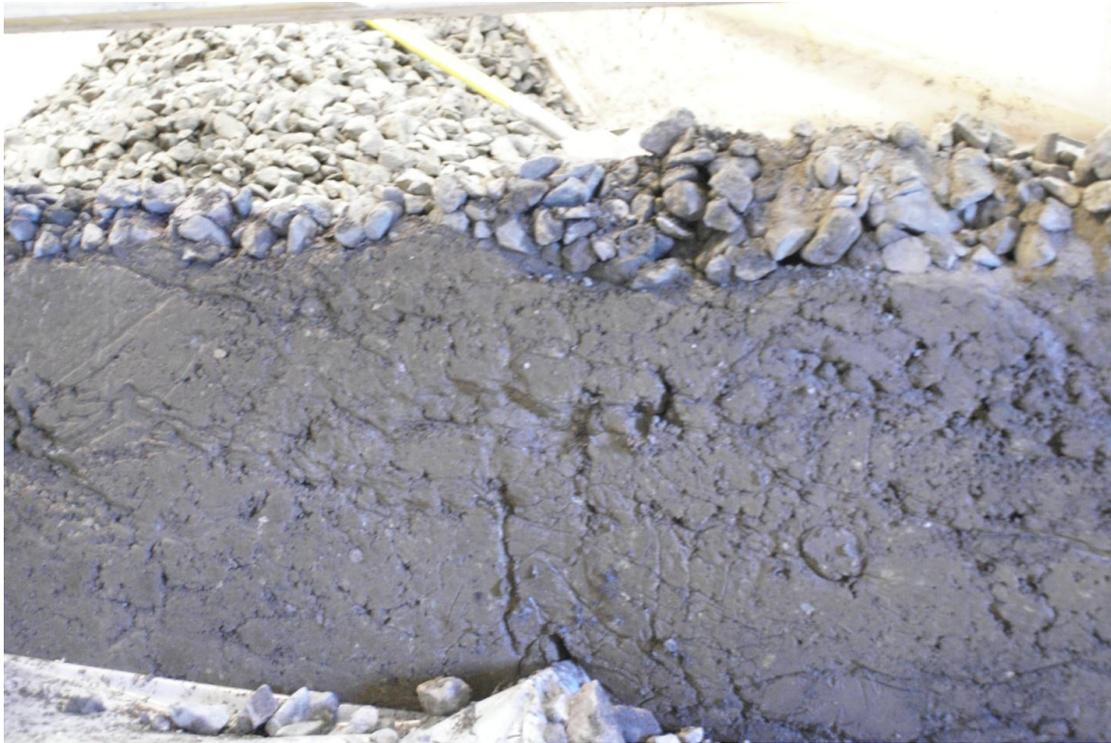
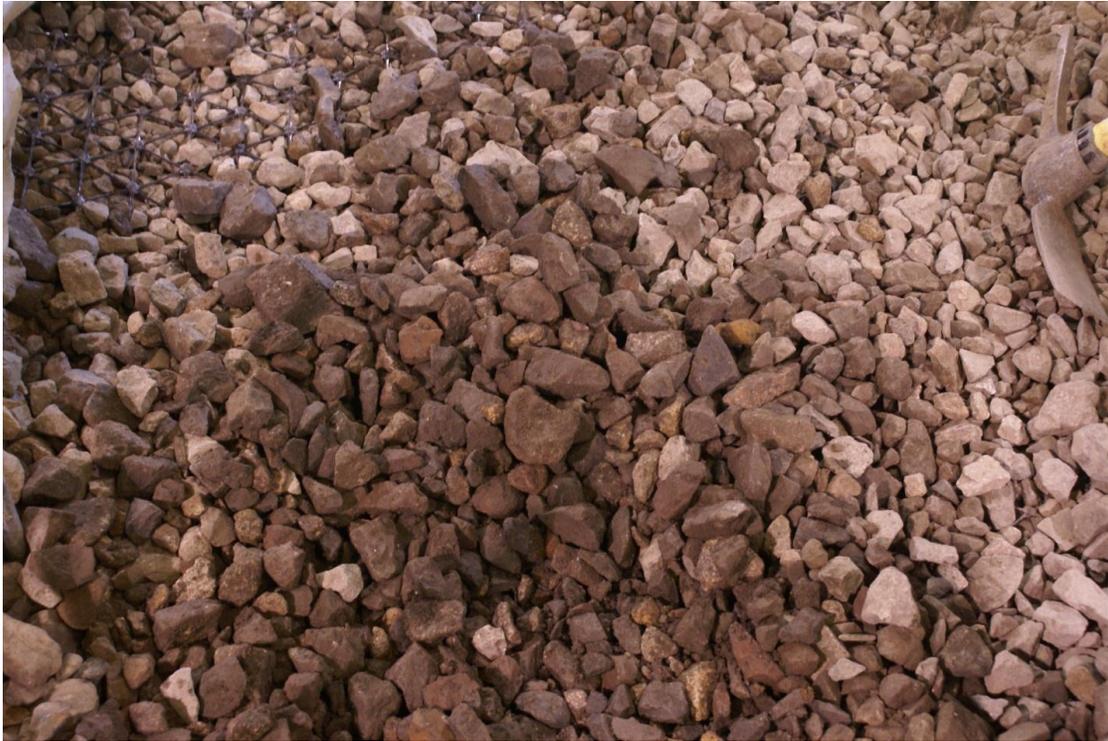
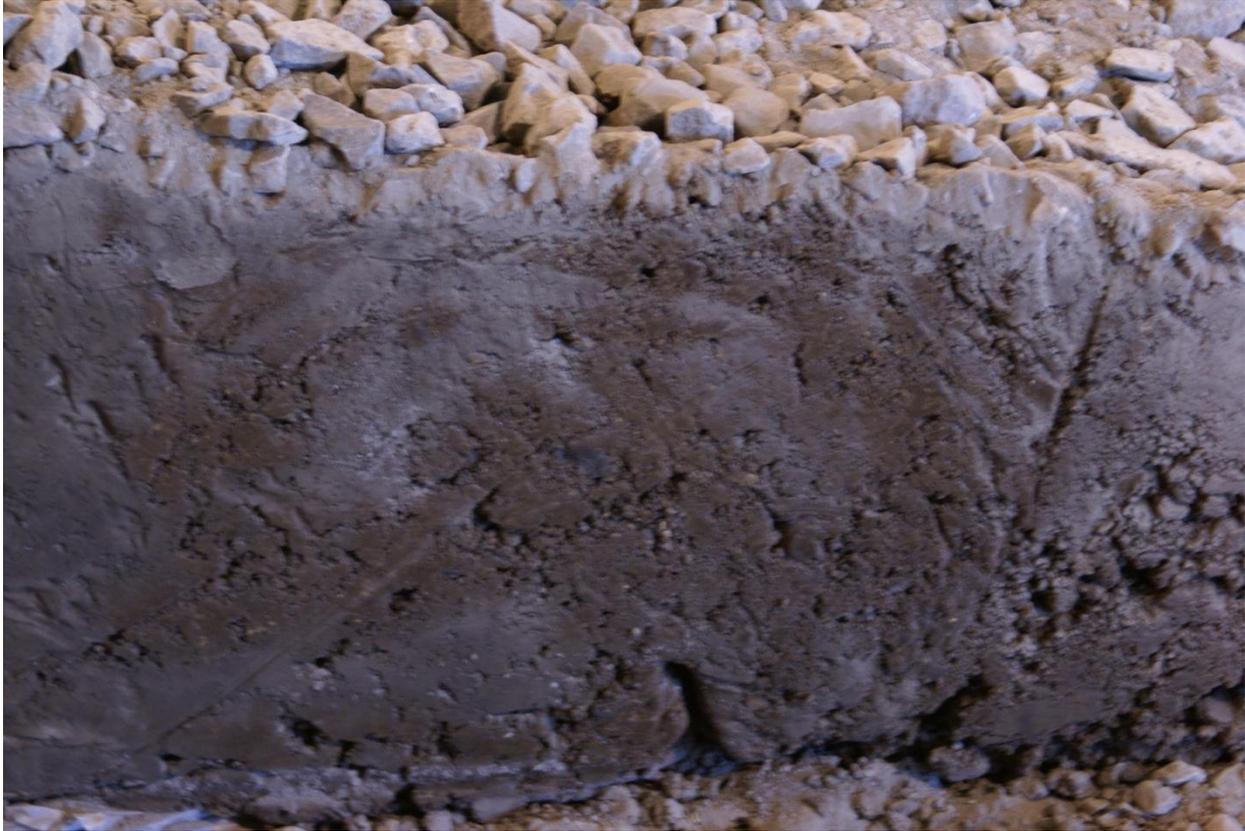
Figure 4.67 Condition of ballast after unreinforced test

Figure 4.68 Condition of ballast at top of subgrade after unreinforced test

Figure 4.69 Condition of ballast at top of geogrid after reinforced test

Figure 4.70 Condition of ballast at top of subgrade after reinforced test

Figures 4.67-4.70 show the condition of the ballast after the completion of the reinforced test and unreinforced test. Based on visual observation there was a concentration of rock dust at the bottom of the ballast after both tests. Given the open graded condition of the material it is likely that a significant portion of the dust was generated at a higher levels and filtered down to lower levels during the loading process or were washed down during the wetting process. It was also observed that more fines were present locally beneath the ties after the unreinforced test than after the reinforced test.

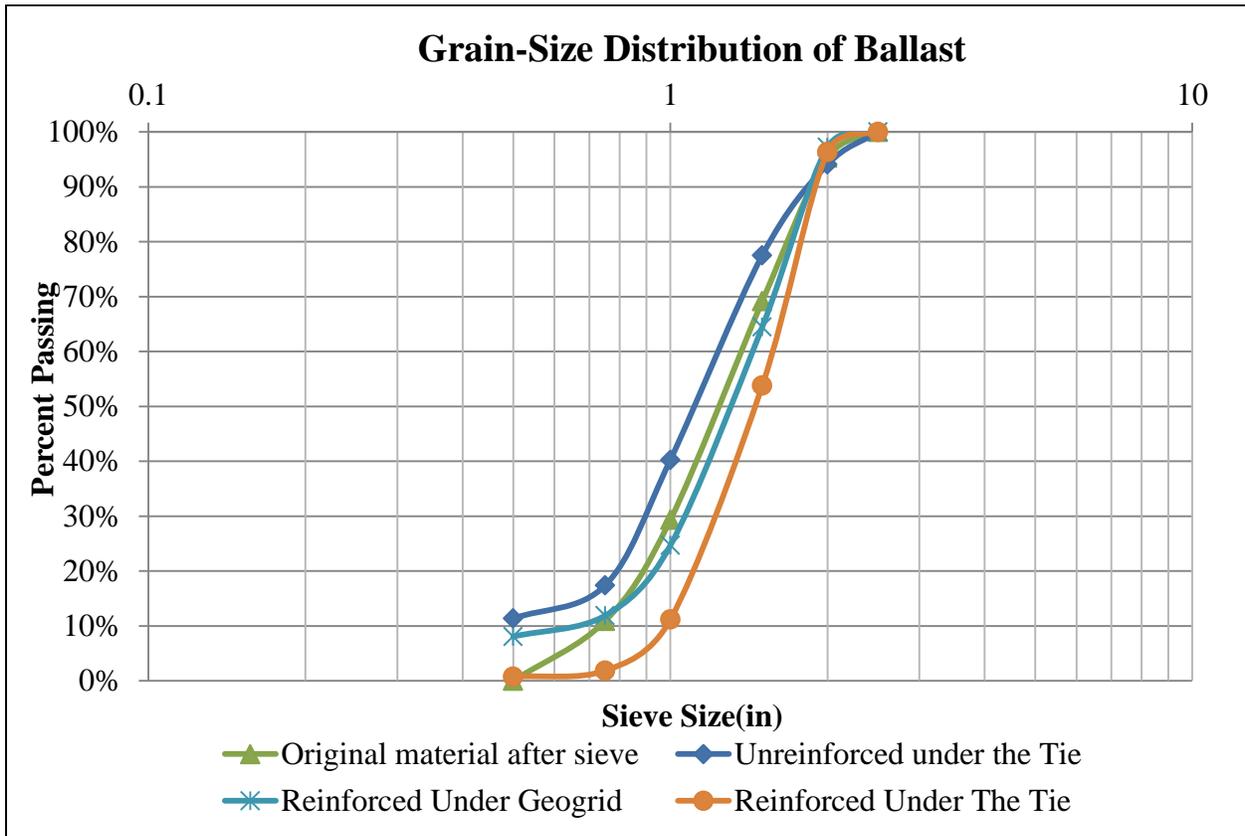
Figure 4.71 Grain size distribution of ballast

A series of ballast samples was taken after each test from different locations in an attempt to determine if the presence of the geogrid reduced the breakdown of ballast. Effective sampling of the ballast material was challenging, as disturbance from the act of sampling caused some loss of fines to lower levels within the ballast. It is also possible that some segregation of material occurred during handling and placement of the ballast, particularly with respect to the ballast for the reinforced test, as there was additional handling of this material. These factors can be shown to have impacted the results, and therefore grain size distribution results (shown in fig. 4.71) should be viewed with caution. For example, the samples near the subgrade showed almost no small diameter material, which was not consistent with the visual observations. These distributions are not included.
