BDV25-977-07

Project ManagerIvan Lasa
FDOT Materials Office**Principal Investigator**Alberto Sagüés
University of South Florida**Florida Department of Transportation Research****MSE Wall Void Repair Effect on Corrosion of Reinforcement - Phase 2: Specialty Fill Materials**

June 2015

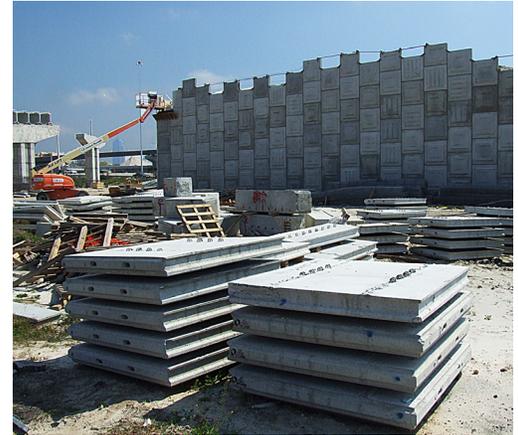
Concrete panels stacked in the foreground will be added to the MSE wall structure of this overpass.
