# An Assessment of Automatic Fare Collection Equipment at Three European Transit Properties

J. Morrissey  
D. Mesnick

Input Output Computer Services, Inc.  
400 Totten Pond Road  
Waltham MA 02154

December 1982  
Final Report

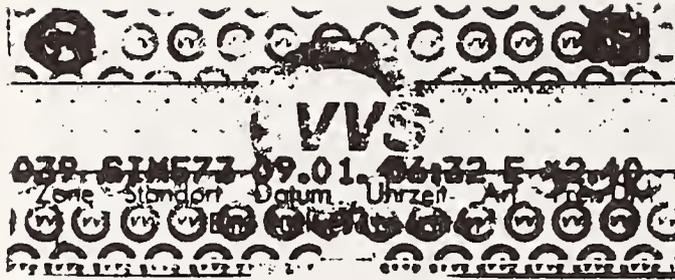
SINGLE-RIDE TICKET

MULTIPLE- (5-RIDE) TICKET

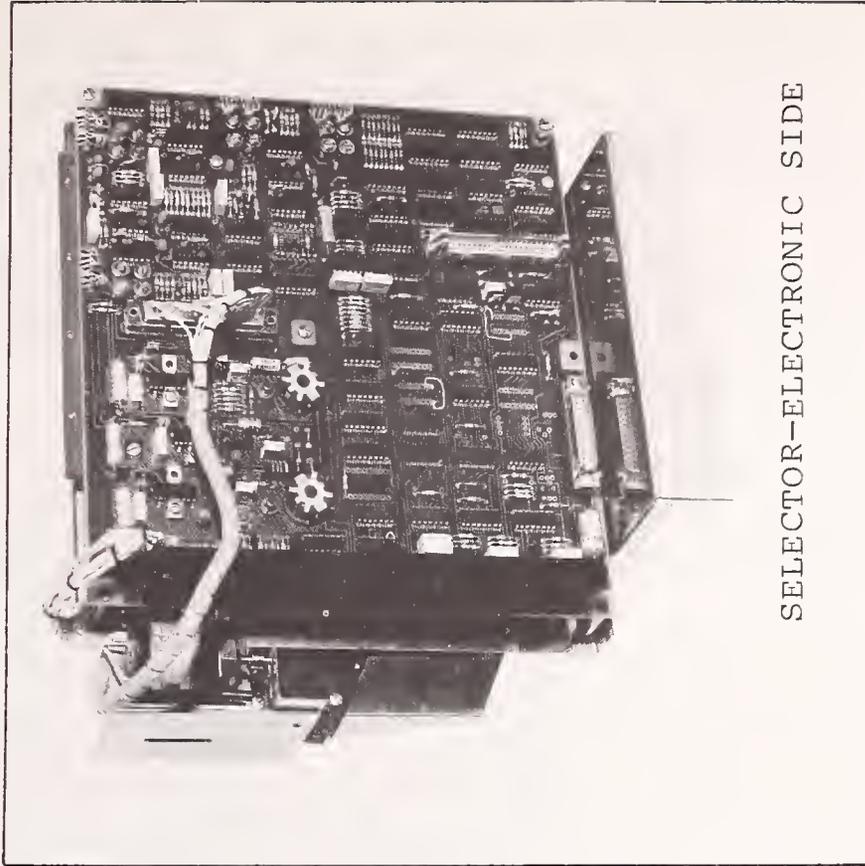
FIGURE A-3. COIN SELECTOR - TYNE AND WEAR VENDOR

2. Bent coins are returned to the customer. If a bent coin becomes lodged in the sensor, an electronically controlled cancelling facility is triggered.
3. Switch points controlled by electromagnets drop good coins into their respective coin drum, or recycler cassette.
