**Urban Mass
Transportation
Administration**

Evaluation of Electronic Registering Fareboxes

Prepared by
Booz-Allen & Hamilton, Inc.

Final Report
January 1984

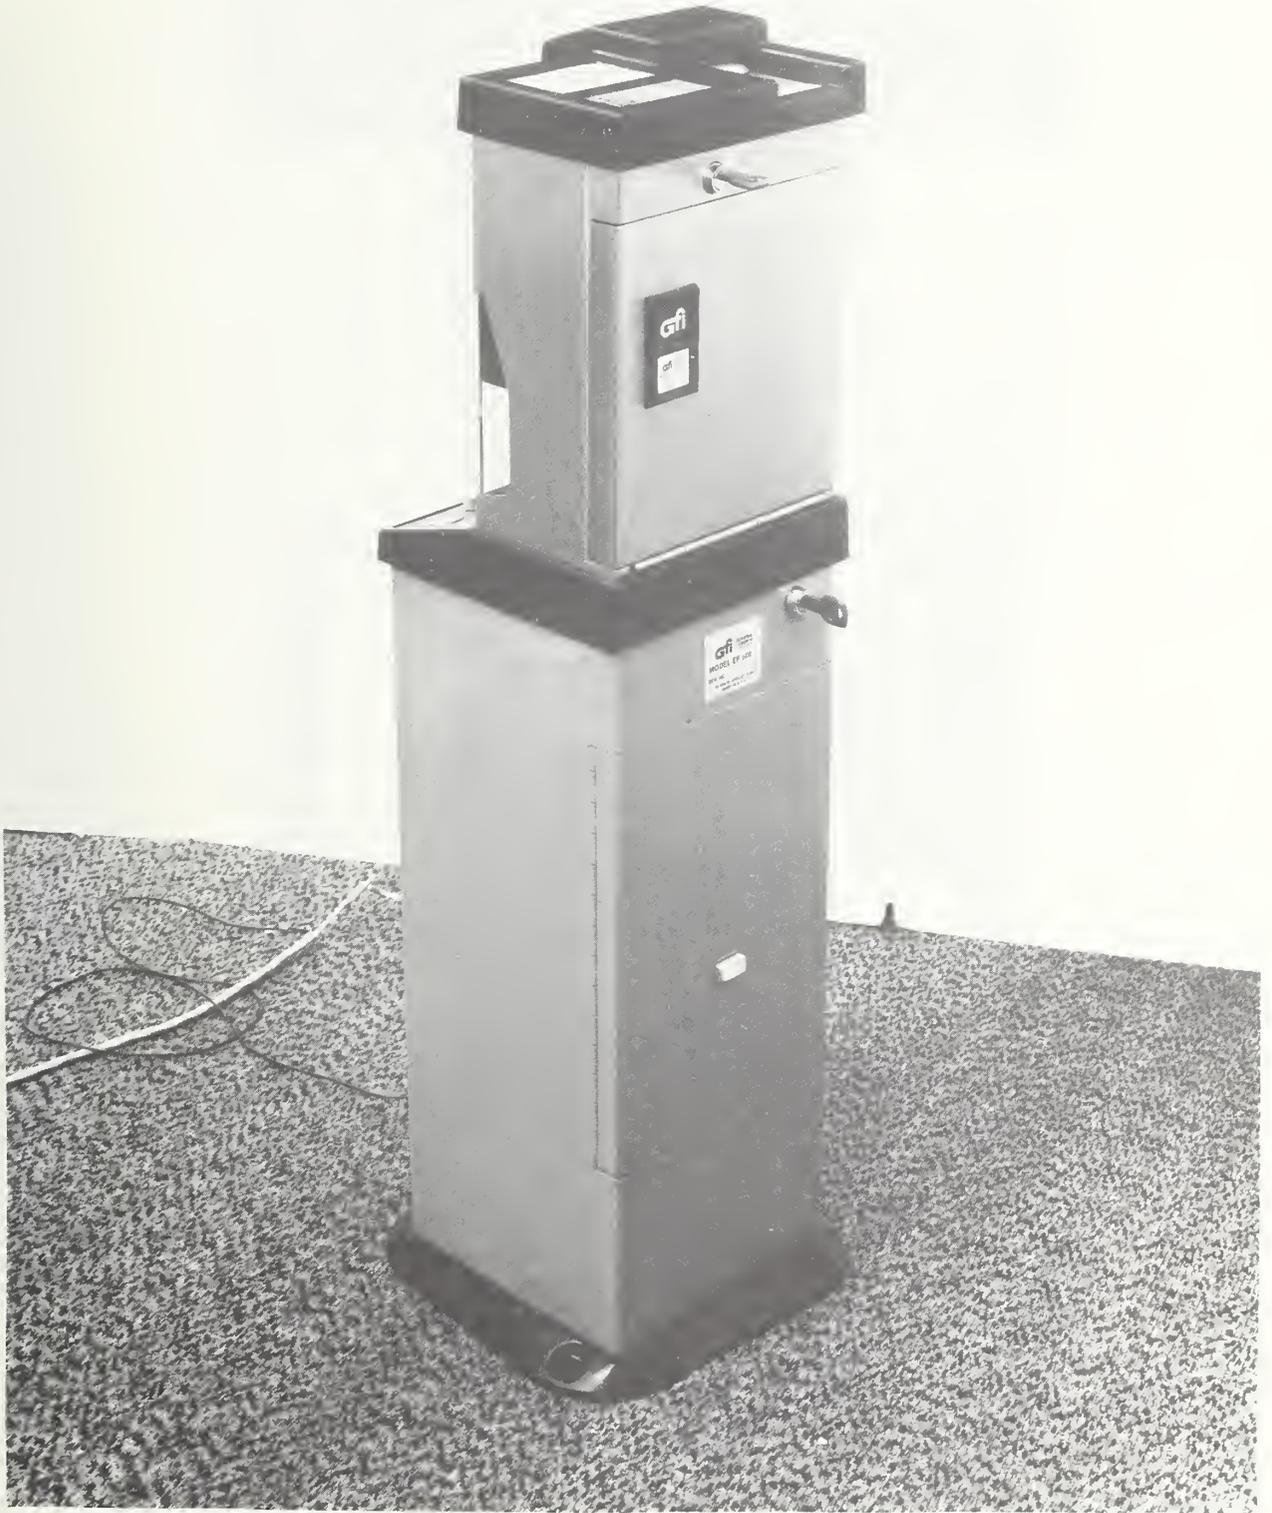
FIGURE 2-1. VIEW OF GFI FAREBOX FACING THE PASSENGER

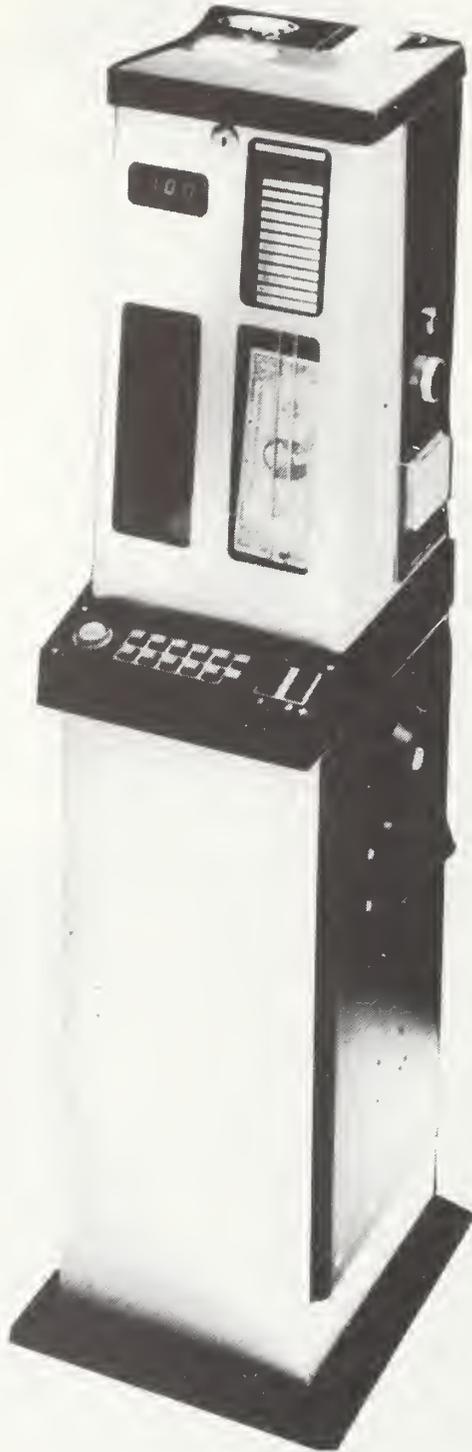
FIGURE 2-2. VIEW OF DUNCAN FAREBOX FACING THE BUS DRIVER

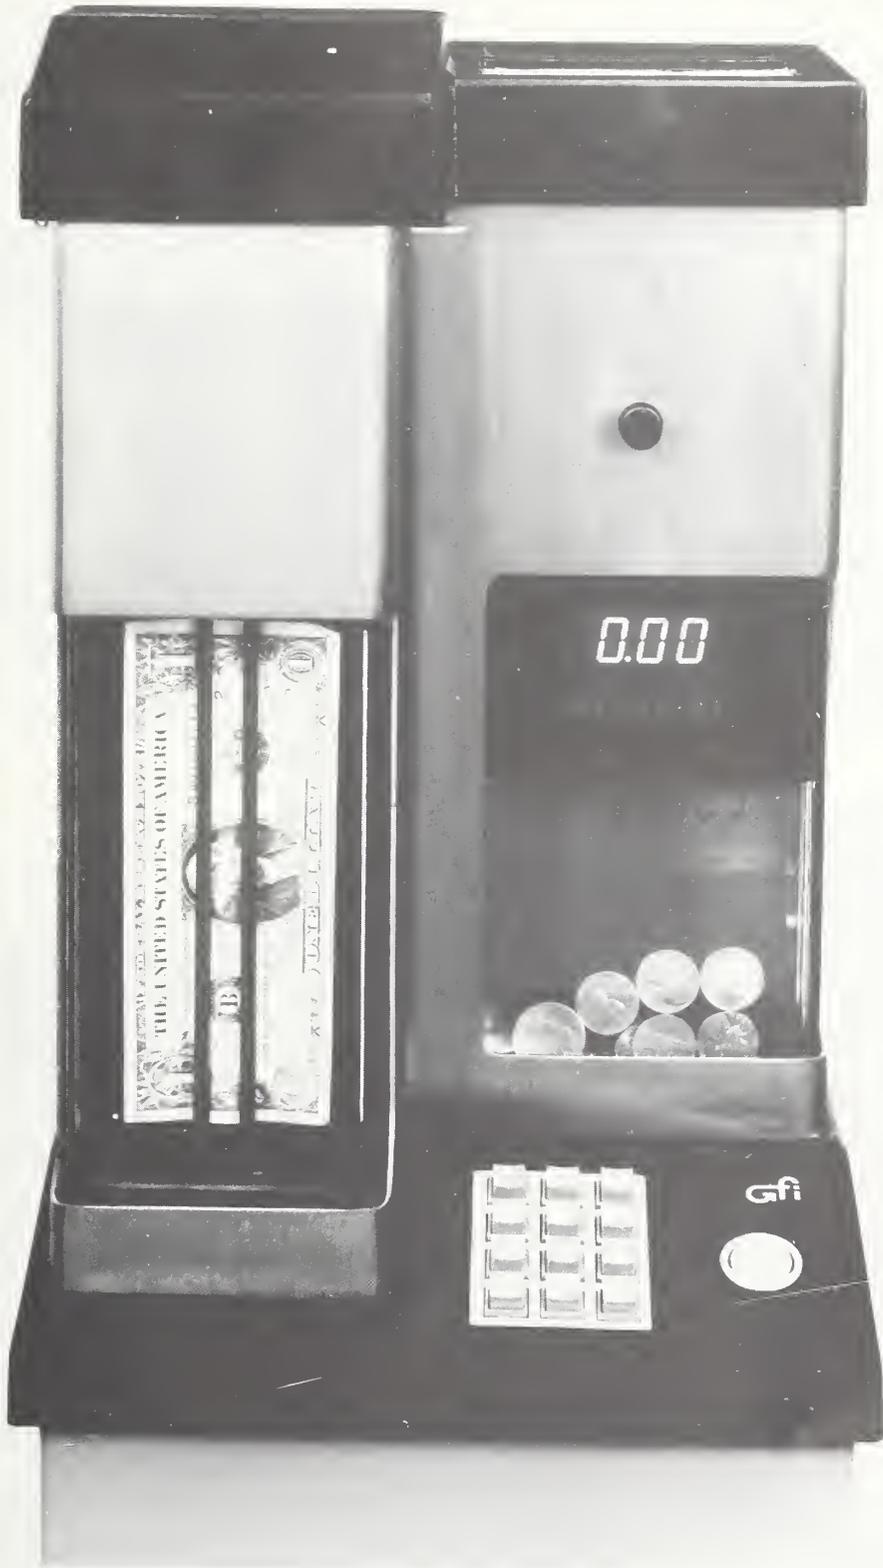
FIGURE 2-3. FARE DISPLAYED TO BUS DRIVER ON GFI FAREBOX

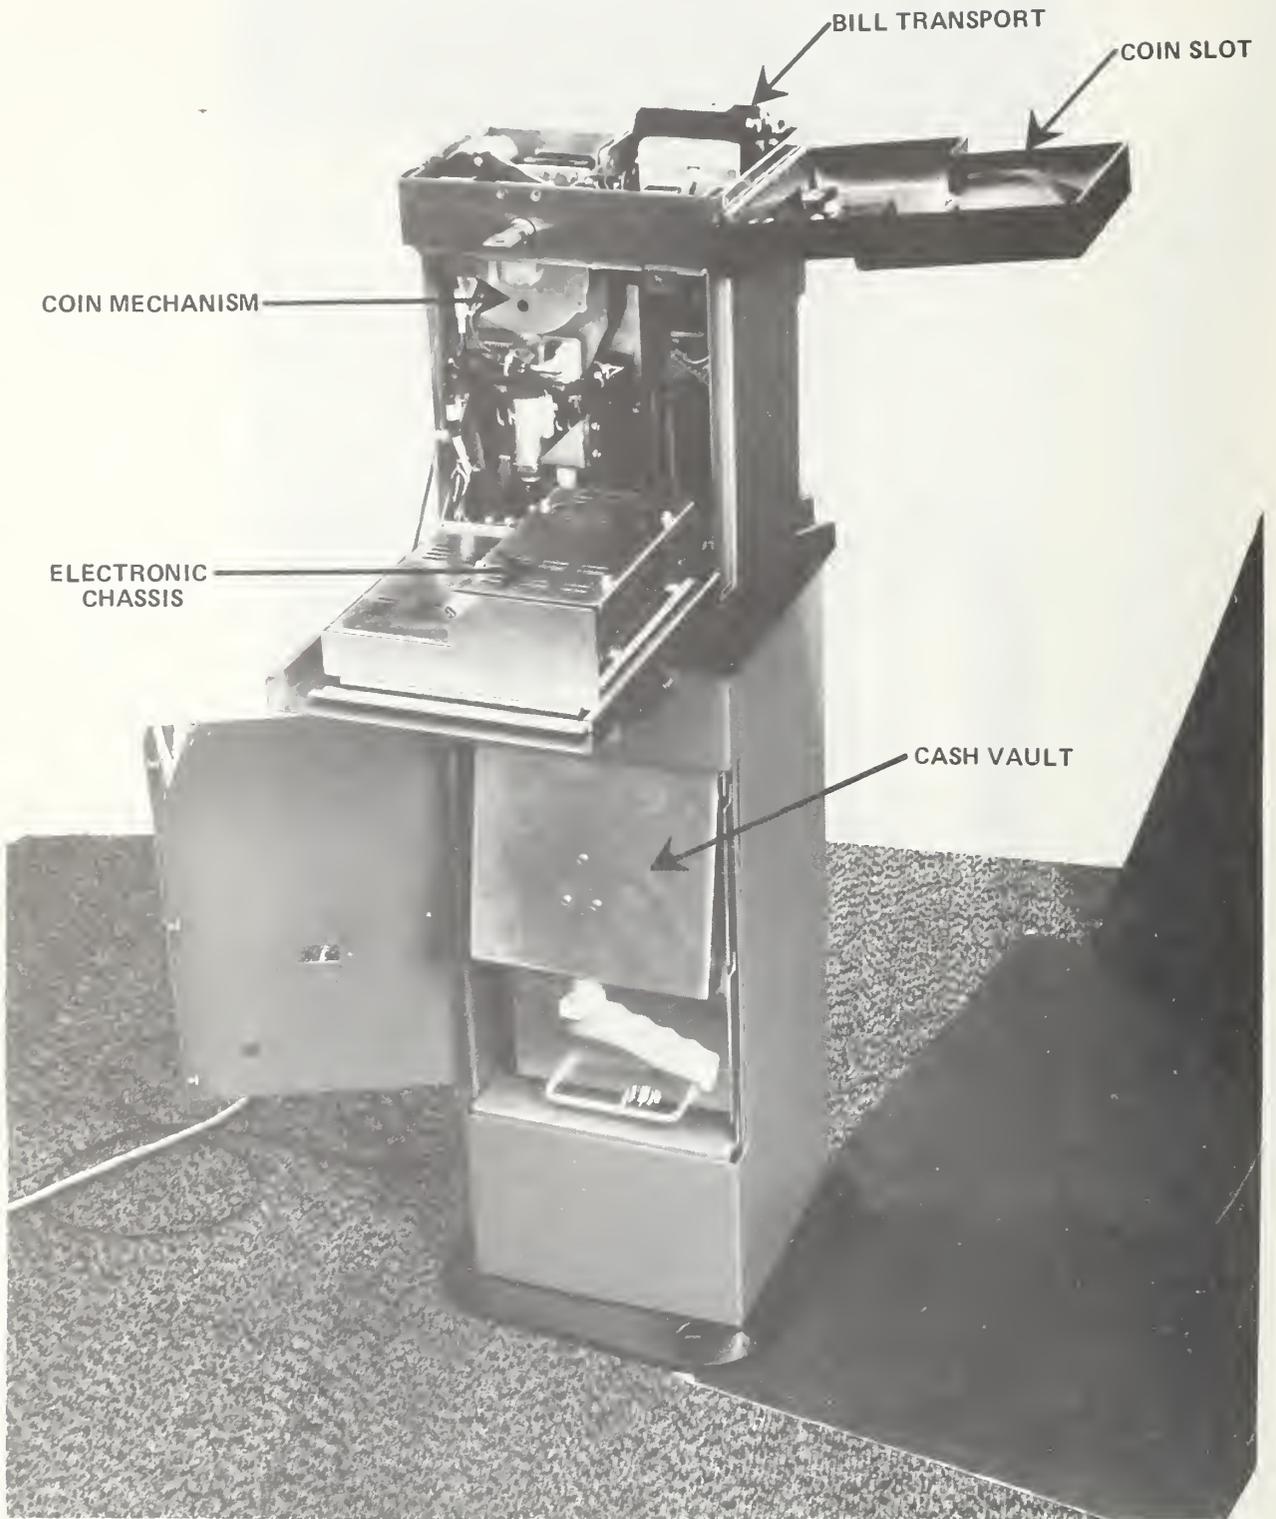
FIGURE 2-4. INTERIOR VIEW OF GFI FAREBOX

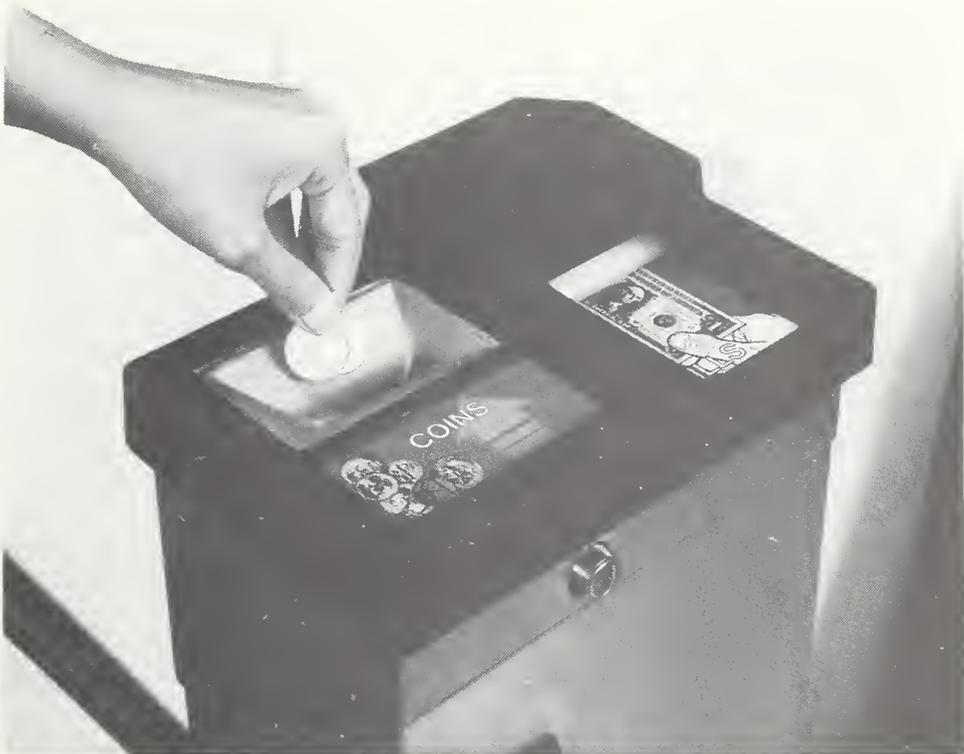
FIGURE 2-5. COIN SLOT ON GFI FAREBOX

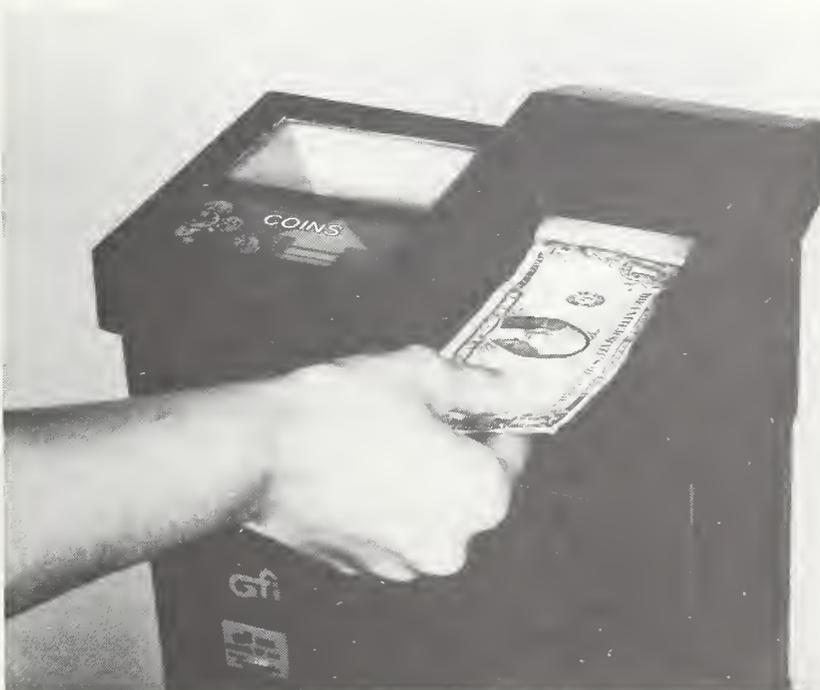
FIGURE 2-6. BILL ACCEPTOR ON GFI FAREBOX

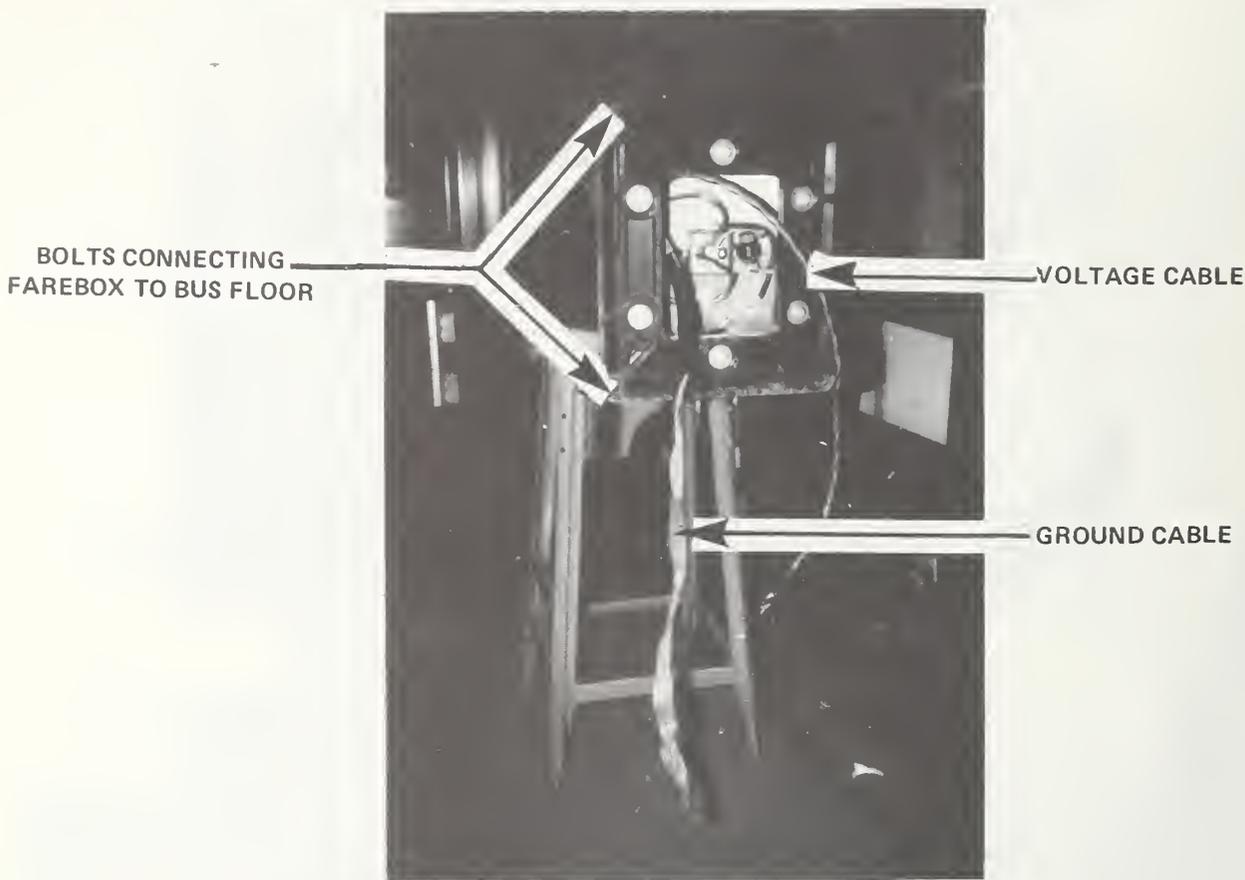
FIGURE 2-7. UNDERSIDE OF DUNCAN FAREBOX SHOWING CABLE CONNECTIONS

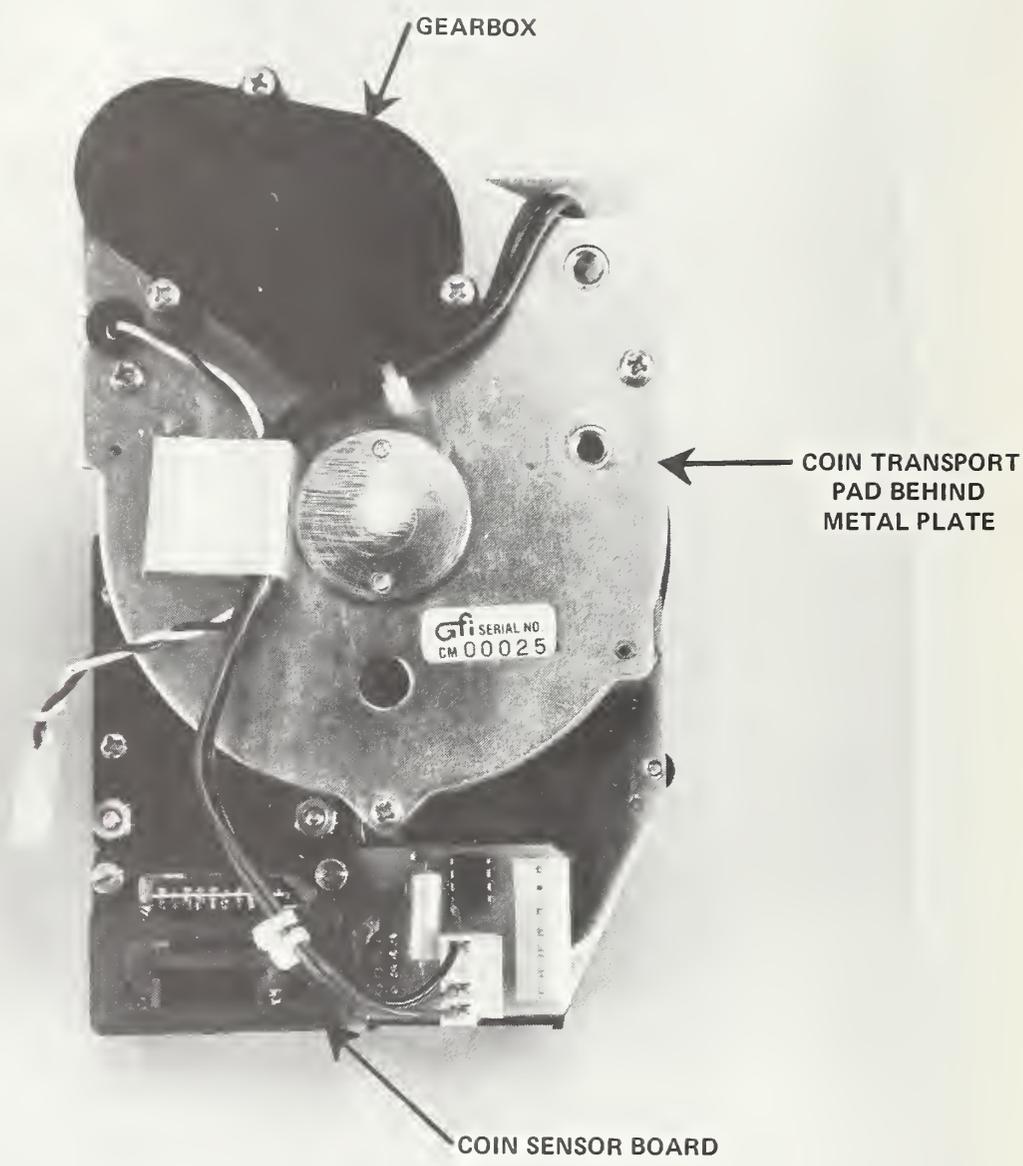
FIGURE 2-8. GFI COIN MECHANISM

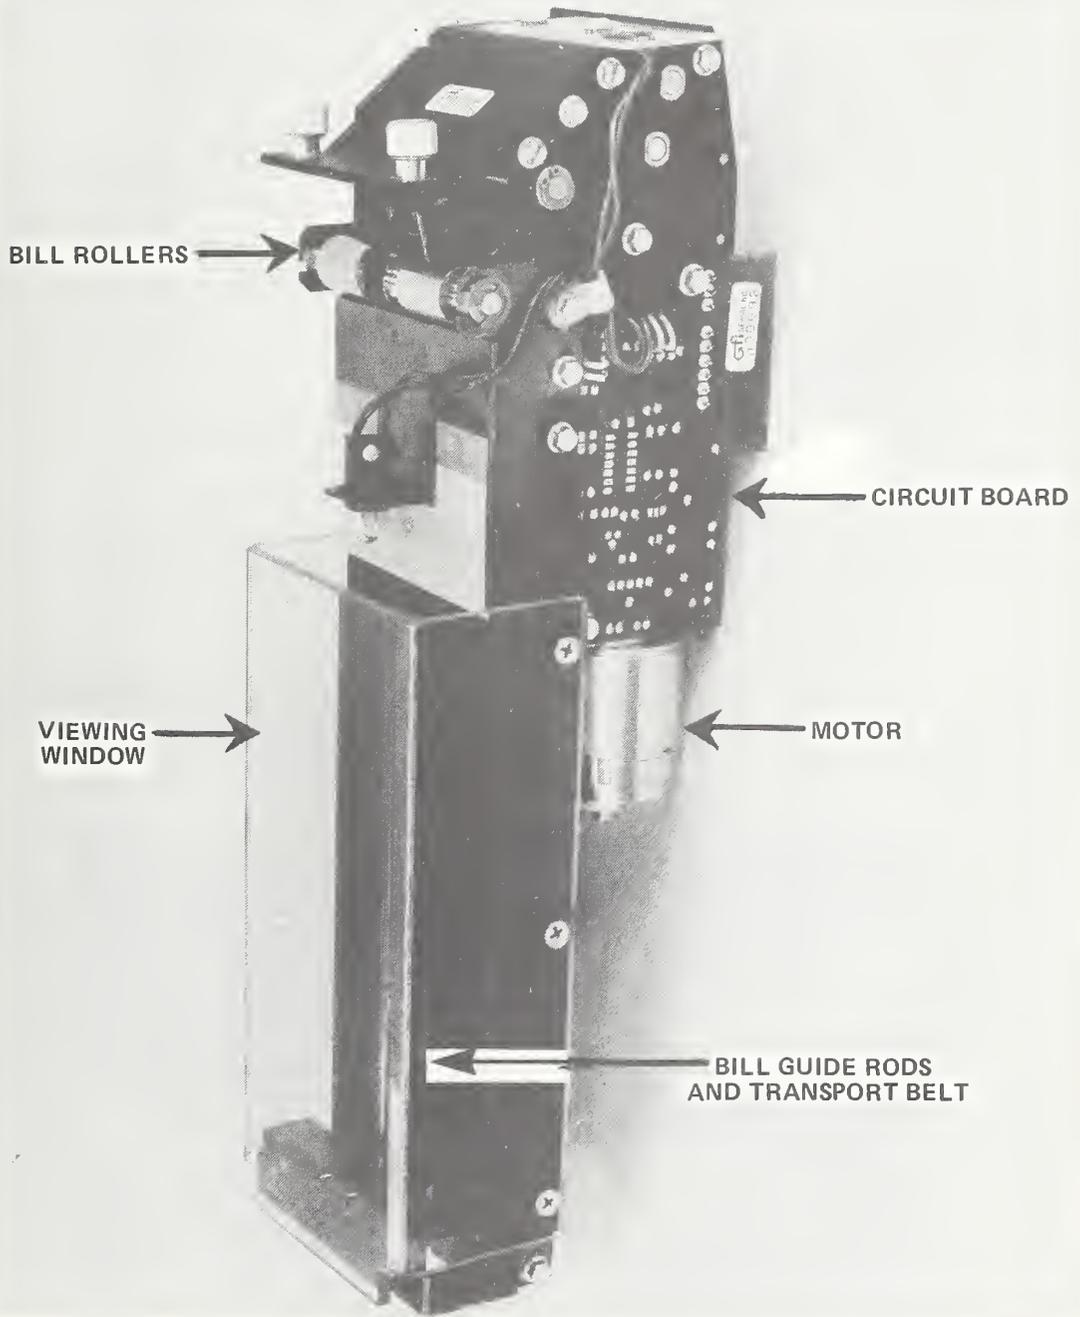
FIGURE 2-9. GFI BILL TRANSPORT

Once inserted into the bill slot, the presence of the bill is detected by micro-switches in the Duncan farebox and a photocell array in the GFI farebox. The micro-switches or photocells measure the length and width of paper inserted to identify it either as a bill or a ticket. If the paper is approximately 6 inches long, the farebox will identify it as a dollar bill. The mechanism cannot distinguish between a \$1, \$2 or \$5 bill; all will register as a \$1 bill. The inserted paper is displayed on an illuminated plate for driver verification that the currency is a true dollar bill or true ticket.

A DC motor, similar to the motor used in the coin mechanism, is mounted at the bottom of the transport. The motor drives a gear belt which in turn transports the bill. The bill is transported to an illuminated plate inspection area where a time delay of the motor drive allows the bus driver to view the bill to detect the insertion of invalid currency. Then the motor starts automatically to drive the bill into the locked vault. The bill transport can be delayed if the driver wants to study the bill longer. Also, the driver can dump all fares into the locked vault before the automatic dump. Figure 2-9 shows a GFI bill transport.

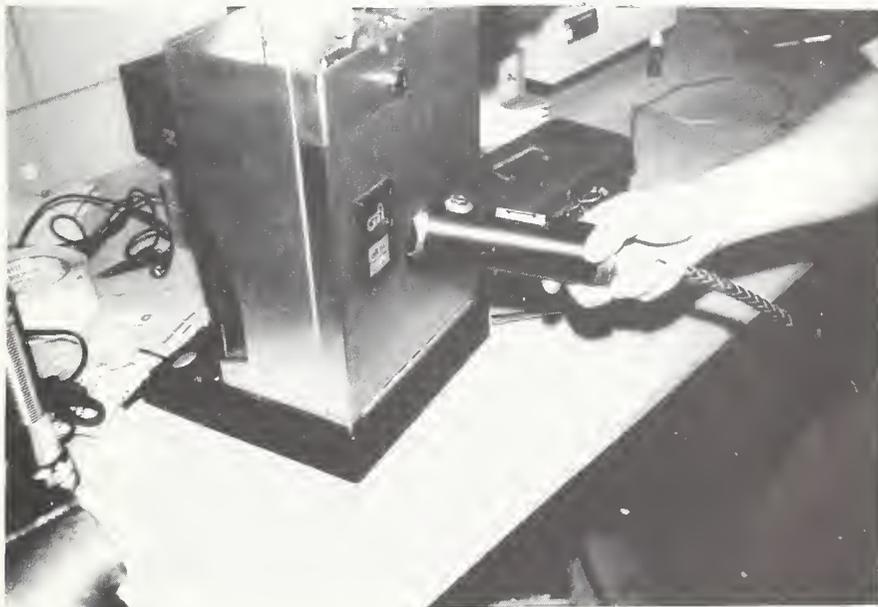
FIGURE 2-10. GFI ELECTRONIC DATA PROBE

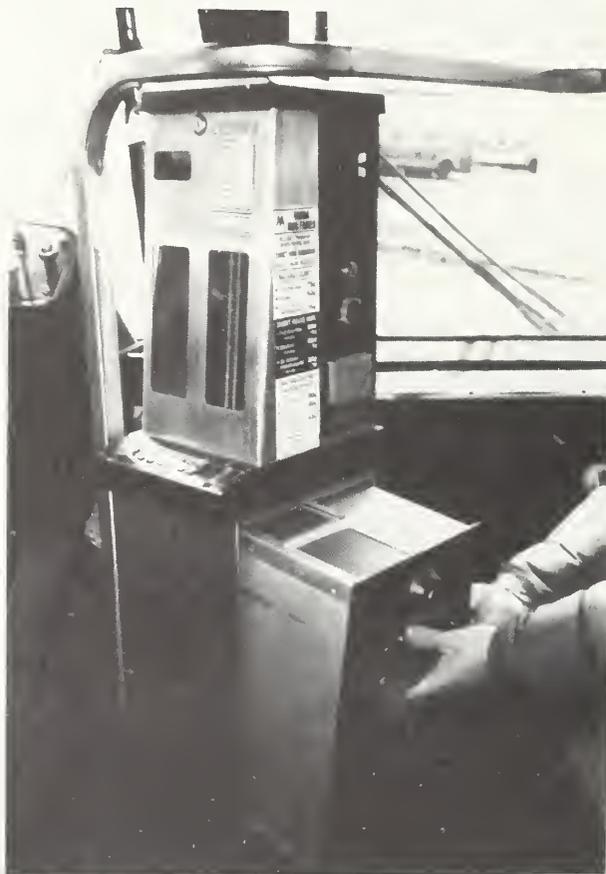
FIGURE 2-11. DUNCAN QUANTAFARE CASHBOX

The Duncan Quantafare and GFI Dualport cashboxes have two separate compartments--one to hold coins and one to hold dollar bills. A dual chamber cashbox is shown in Figure 2-11. The Duncan Quantafare cashbox

is designed to hold a maximum of 600 bills, assuming the bills are inserted correctly into the bill acceptor and they stack properly in the cashbox. The GFI Dualport cashbox is designed to hold a maximum of 400 bills. The stacked configuration of the bills is not preserved when the cashbox is emptied into a vault (cashbox) receiver. According to GFI, the bills typically fall into a heap when the cashbox is emptied. This heap of bills is then manually removed from the vault receiver, counted and re-stacked.

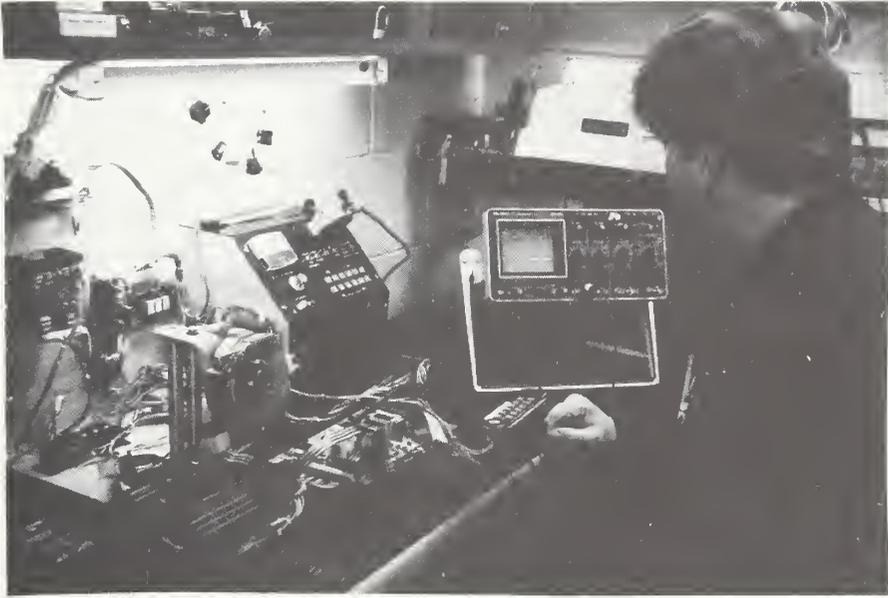
FIGURE 3-5. ELECTRONIC TEST BENCH
AT MSBA

Farebox maintenance requires the use of conventional hand tools such as screwdrivers and pliers; electrical tools such as variable power supplies, ammeters, voltmeters and multimeters; and electronic equipment such as soldering tools, oscilloscopes and electronic test benches. The types of electronic equipment used varies according to the extent of responsibility assumed by the transit system for electronic troubleshooting and repair.

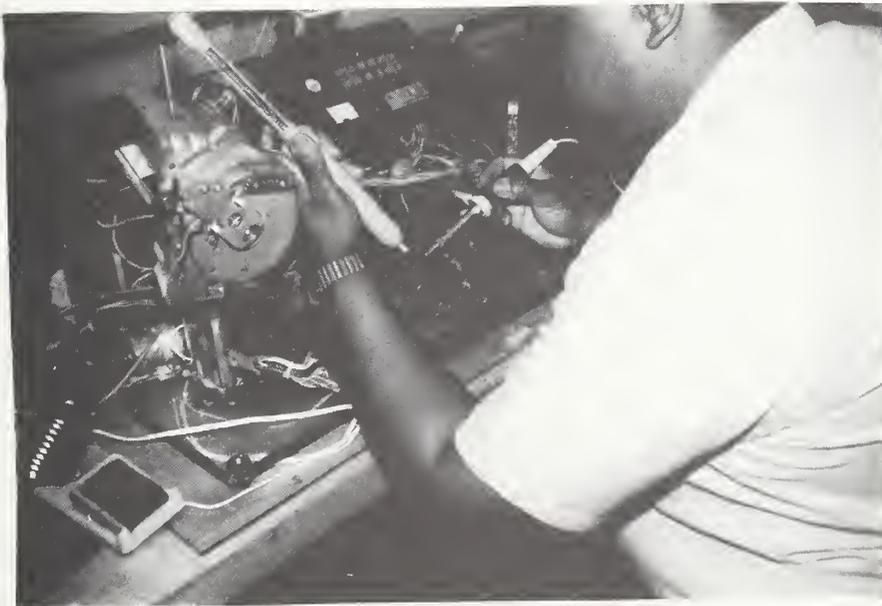
FIGURE 3-6. SEPTA FAREBOX TECHNICIAN
SOLDERS CHASSIS CIRCUIT BOARD

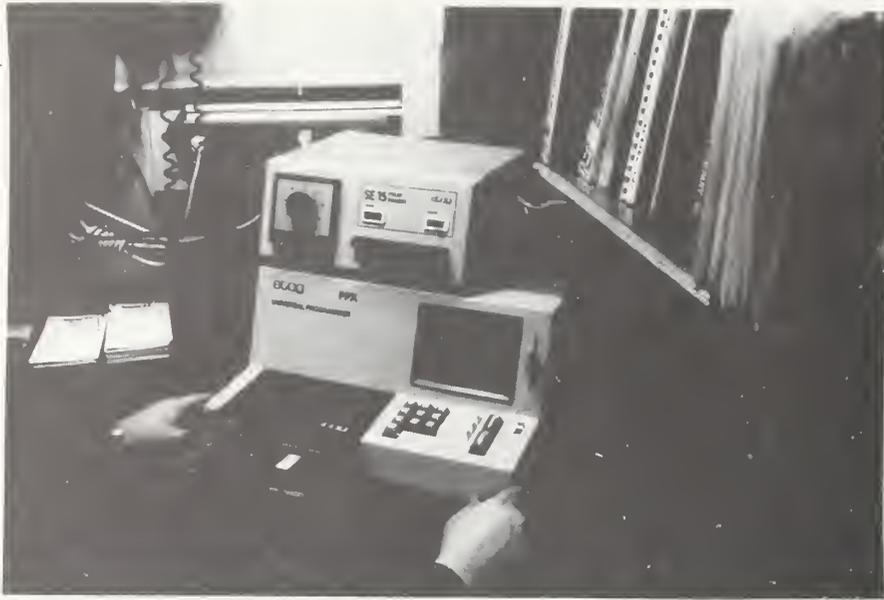
FIGURE 3-7. UNIVERSAL PROM PROGRAMMER
AT MSBA

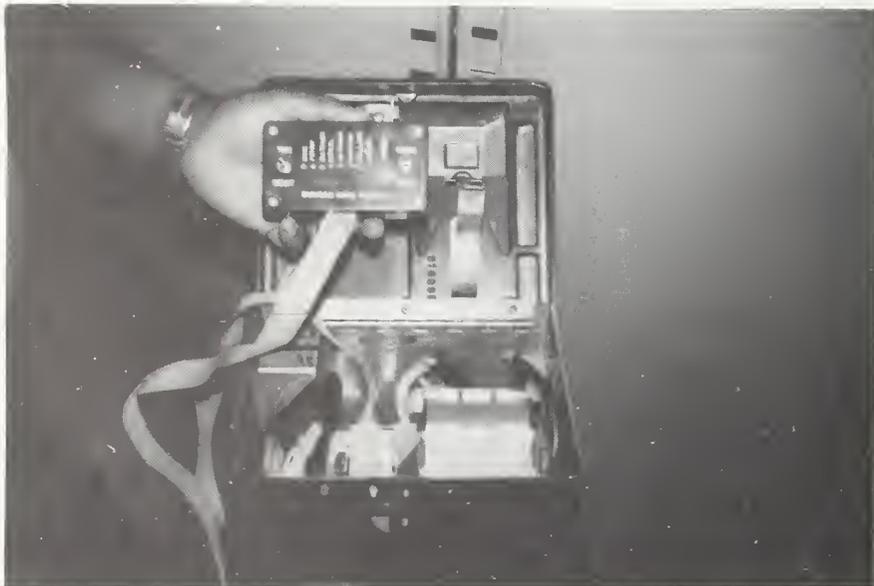
FIGURE 3-8. COIN MECHANISM TESTER
AT SEPTA

The simulator shown in Figure 3-8 was built by a technician at SEPTA. It simulates coins being dropped through the coin mechanism and identifies the point when a failure in the coin mechanism occurs. Thus, an intermittent problem can be diagnosed without the technician having to physically insert coins into the coin mechanism. Another simulator, in use at SEPTA, single-steps the chassis microprocessor through each fare handling function, judges the condition of all the electronic chips, and determines whether an EPROM is bad or a component has failed. This simulator works as a signaturing analyzer--it finds the address in the software where the problem exists.

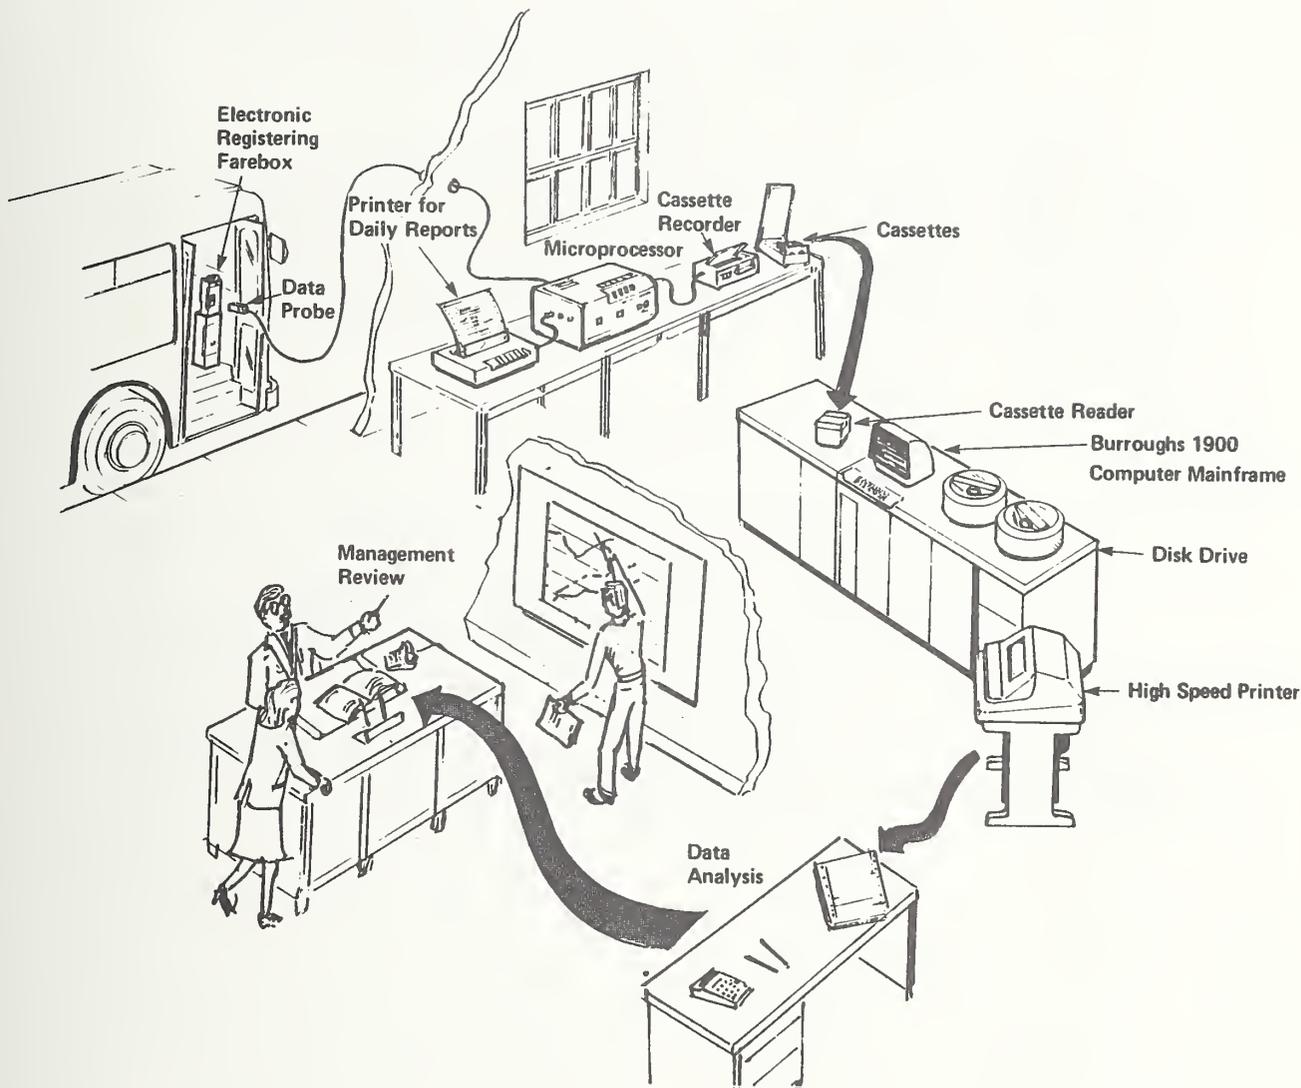
FIGURE 3-9. ILLUSTRATION OF HARDWARE FOR PROCESSING REVENUE DATA AT DALLAS TRANSIT SYSTEM

The transit systems either have in place or are planning the installation of automated data processing systems to track farebox performance and revenue collections. The hardware elements of the information processing system at Dallas are illustrated in Figure 3-9. These elements include:

- . The electronic data probe to collect the end of run or end of day farebox data

- . A microprocessor and printer for generating immediate hard copies of the data
- . A cassette recorder for transcribing the data onto a cassette tape
- . Equipment for transcribing the data from cassette to disk so that it can be processed by the transit system's main computer.

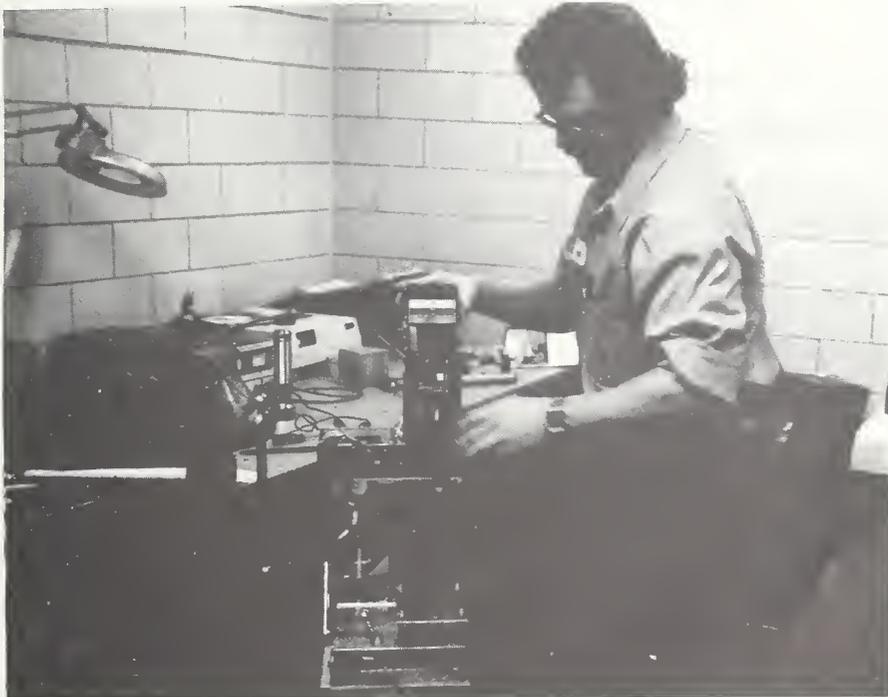
FIGURE 6-1. BILL TRANSPORT BEING REMOVED FOR PREVENTIVE MAINTENANCE AT DALLAS TRANSIT SYSTEM

Maintenance technicians at all four transit systems consider all of the farebox modules to be easily accessible. When asked what module is most inaccessible, most technicians mentioned the bill transport, since both the coin mechanism and the electronic chassis have to be removed before the bill transport can be accessed. Figure 6-1 shows a technician removing a bill transport for preventive maintenance.
