T NO. UMTA-MA-06-0025-78-7

IN-SERVICE PERFORMANCE AND COSTS OF METHODS  
TO CONTROL URBAN RAIL SYSTEM NOISE  
INITIAL TEST SERIES REPORT

De Leuw, Cather & Company  
1201 Connecticut Avenue, NW  
Washington DC 20036

AUGUST 1978  
INTERIM REPORT

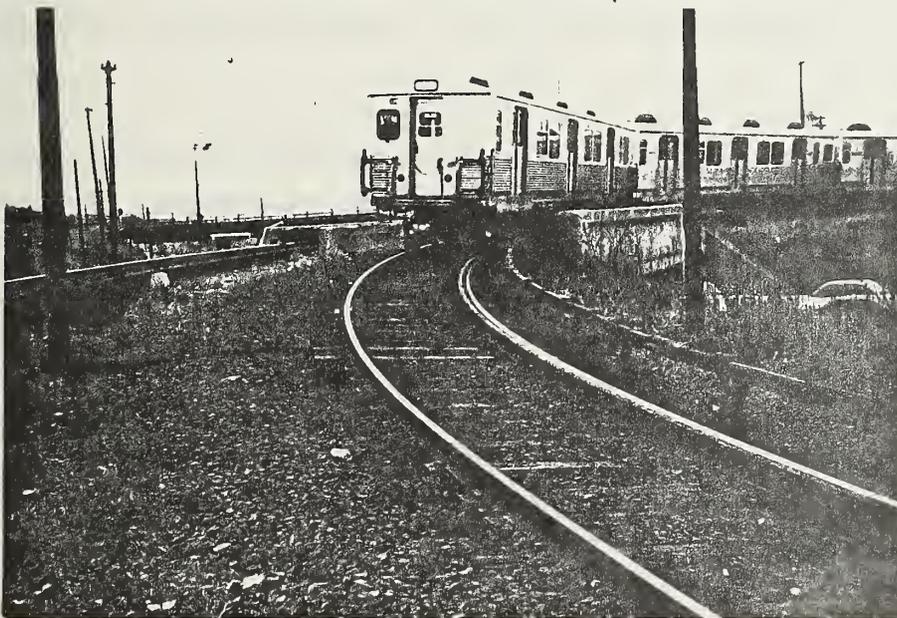
Figure 1-6. PHOTOGRAPHS OF 69TH STREET TURNAROUND

TRANSITION BETWEEN TEST SECTION  
AND CONTROL SECTION OCCURS AT BRIDGE.  
THE CONTROL SECTION IS IN THE FOREGROUND.

THE TEST SECTION IS IN THE FOREGROUND

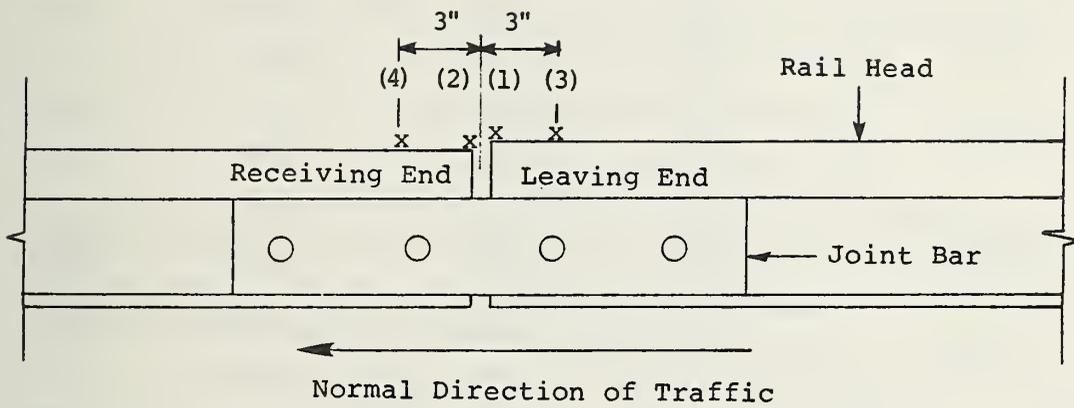
FIGURE 3.1 JOINT BAR MEASUREMENT LOCATIONS  
TJ TEST SECTION, SEGMENT "B"

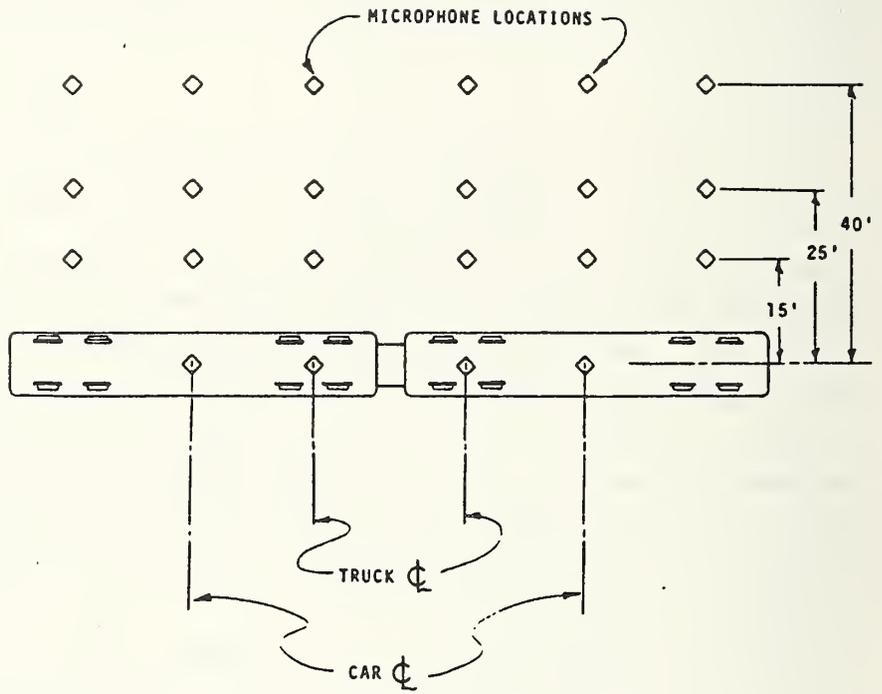
FIGURE 4-1. MEASUREMENT LOCATIONS WITH CARS ON BLOCKS

The car-on-blocks tests were performed at the notch 1 and notch 3 settings which resulted in constant wheel spin of 375 and 750 rpm, respectively, on Car #613. On the married pair set, the wheel speed was much less constant. At notch 1 the speed varied from 300 to 540 rpm. At the high speed setting the speed would go through a cycle. A peak speed of 700 to 860 rpm would be reached before an overload relay would open, removing power for 10 to 15 seconds. In this

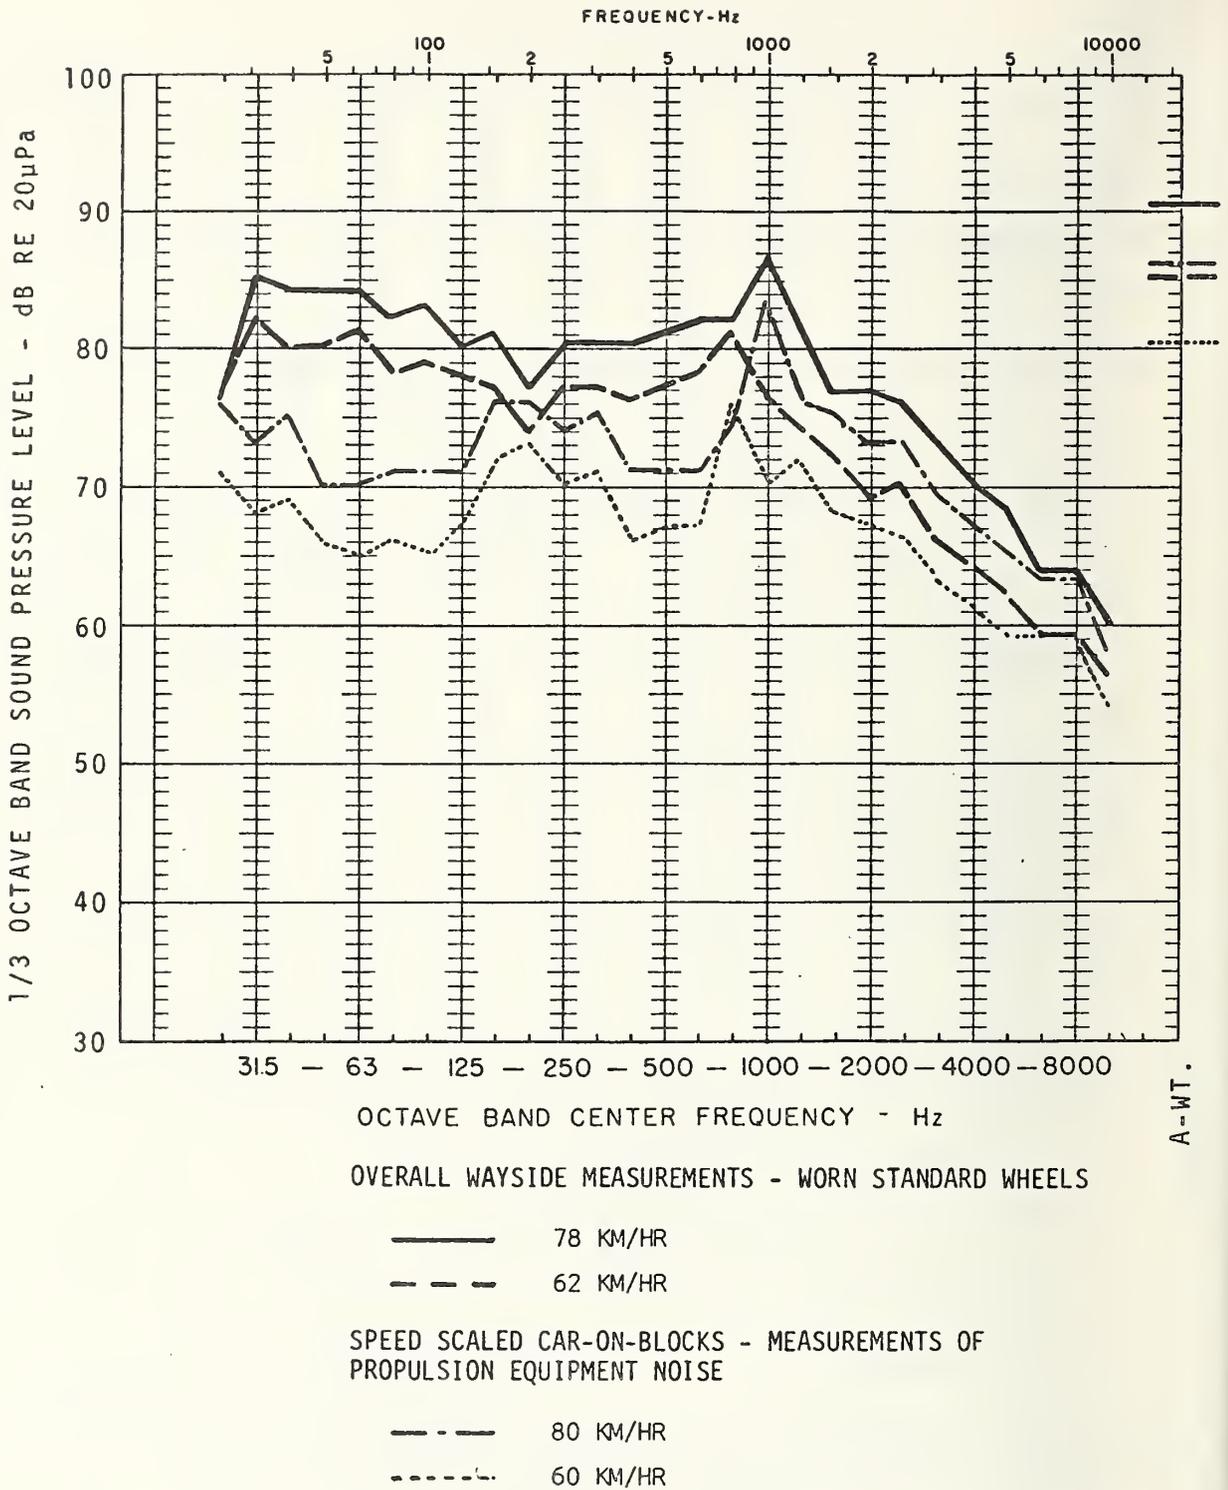
FIGURE 4-4 COMPARISON OF PASSBY NOISE AND CAR PROPULSION EQUIPMENT -  
 25 FT FROM TRACK CENTERLINE  
 PASSBY MEASUREMENTS MADE ON TANGENT WELDED  
 BALLAST AND TIE TEST TRACK

Tests of the propulsion equipment noise as a component of the total noise from the SEPTA transit cars indicate that the propulsion equipment noise is only 4 to 5 dBA below the total noise for trains operating on tangent welded track. Therefore, *the propulsion equipment noise limits the ability to reduce overall noise from the SEPTA trains through reduction of wheel-rail noise.* This leads to the conclusion that there may have been greater reduction of wheel-rail noise than was observed for the reduction of total train noise measured on SEPTA and reported herein. Tests on other transit systems<sup>1,2,3</sup>, that achieved greater reductions of overall wayside and car interior noise levels tend to support this conclusion.

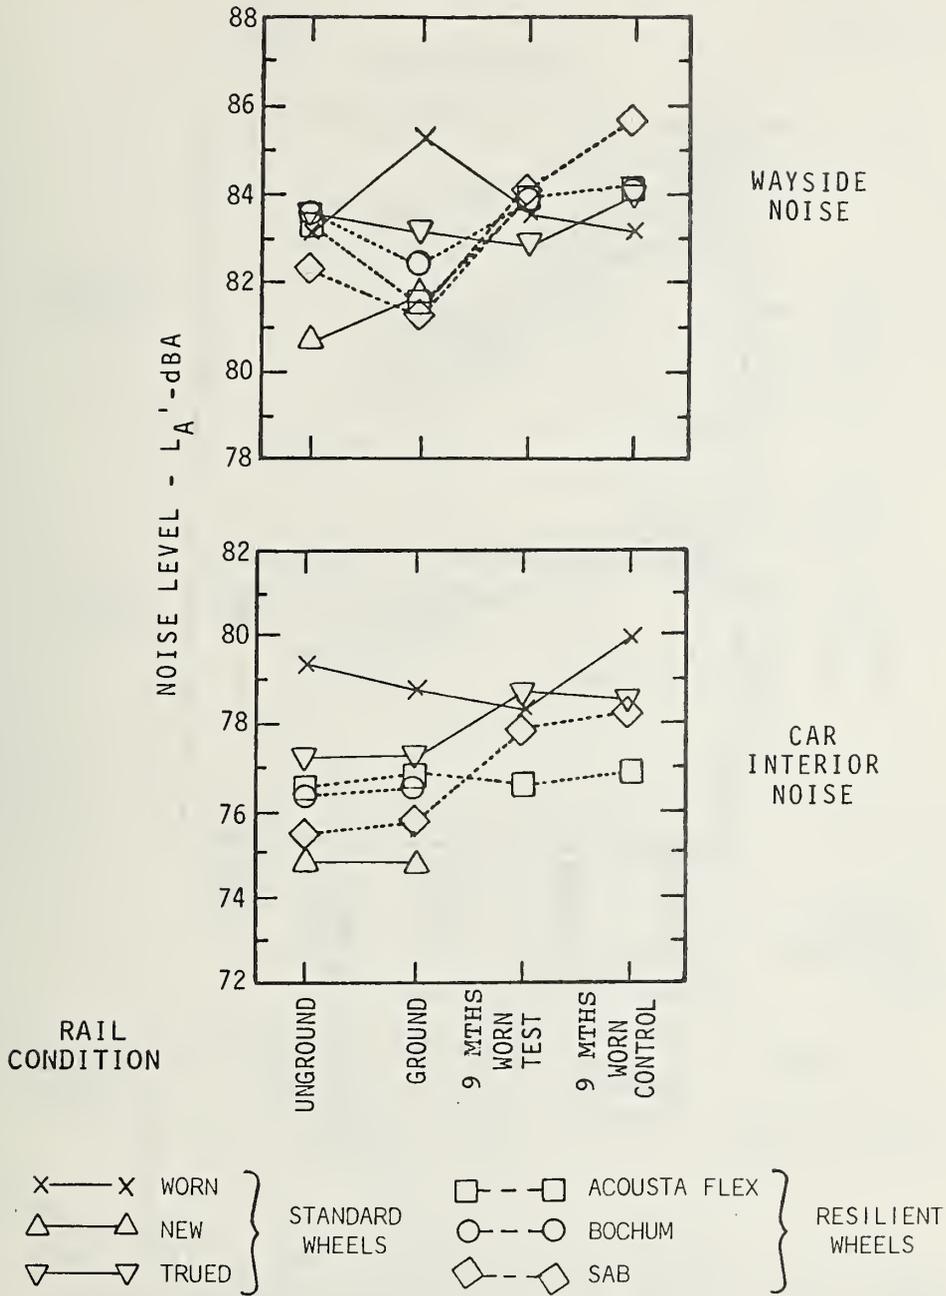
FIGURE 4-6. AVERAGE NOISE LEVELS AT THE TW TEST TRACK FOR VARIOUS WHEELS AND RAIL CONDITIONS

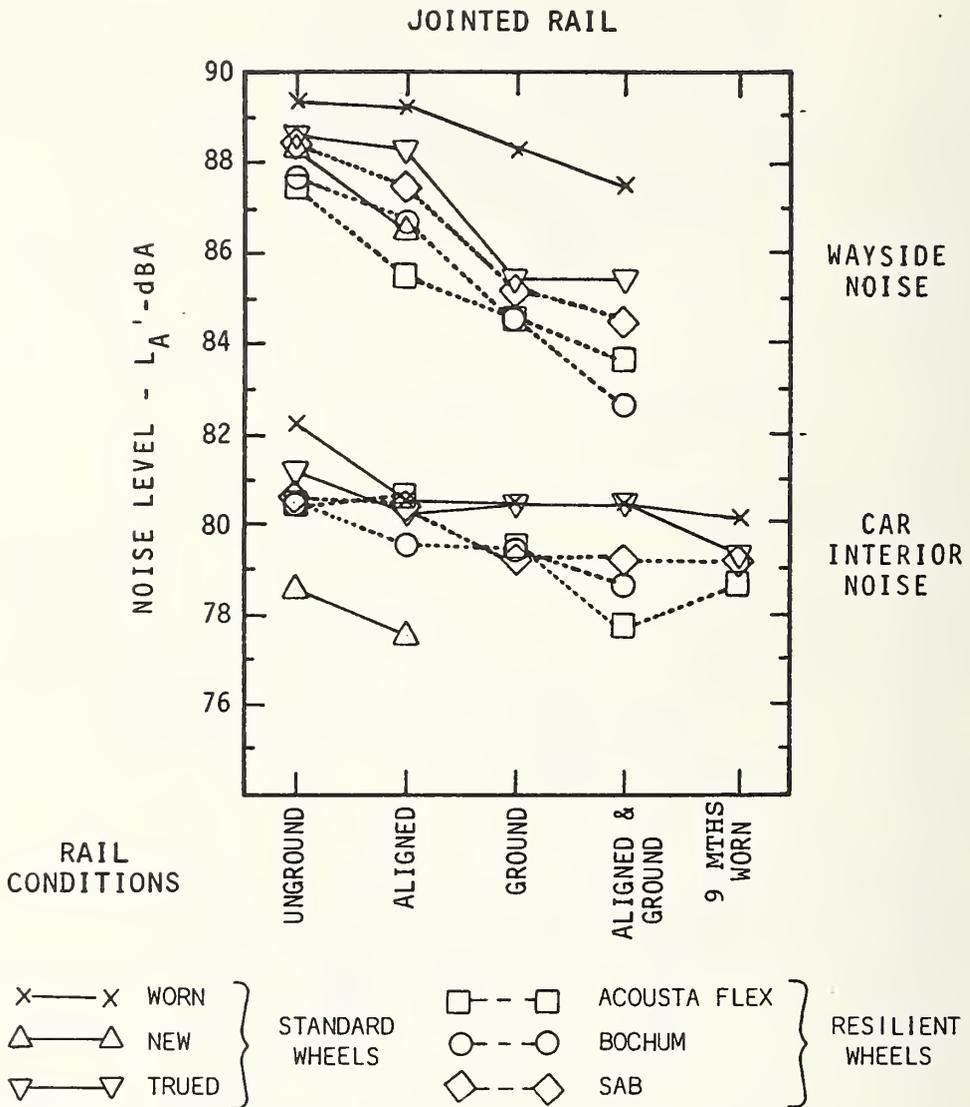
FIGURE 4.7. AVERAGE NOISE LEVELS AT THE TJ TEST TRACK FOR VARIOUS WHEELS AND RAIL CONDITIONS

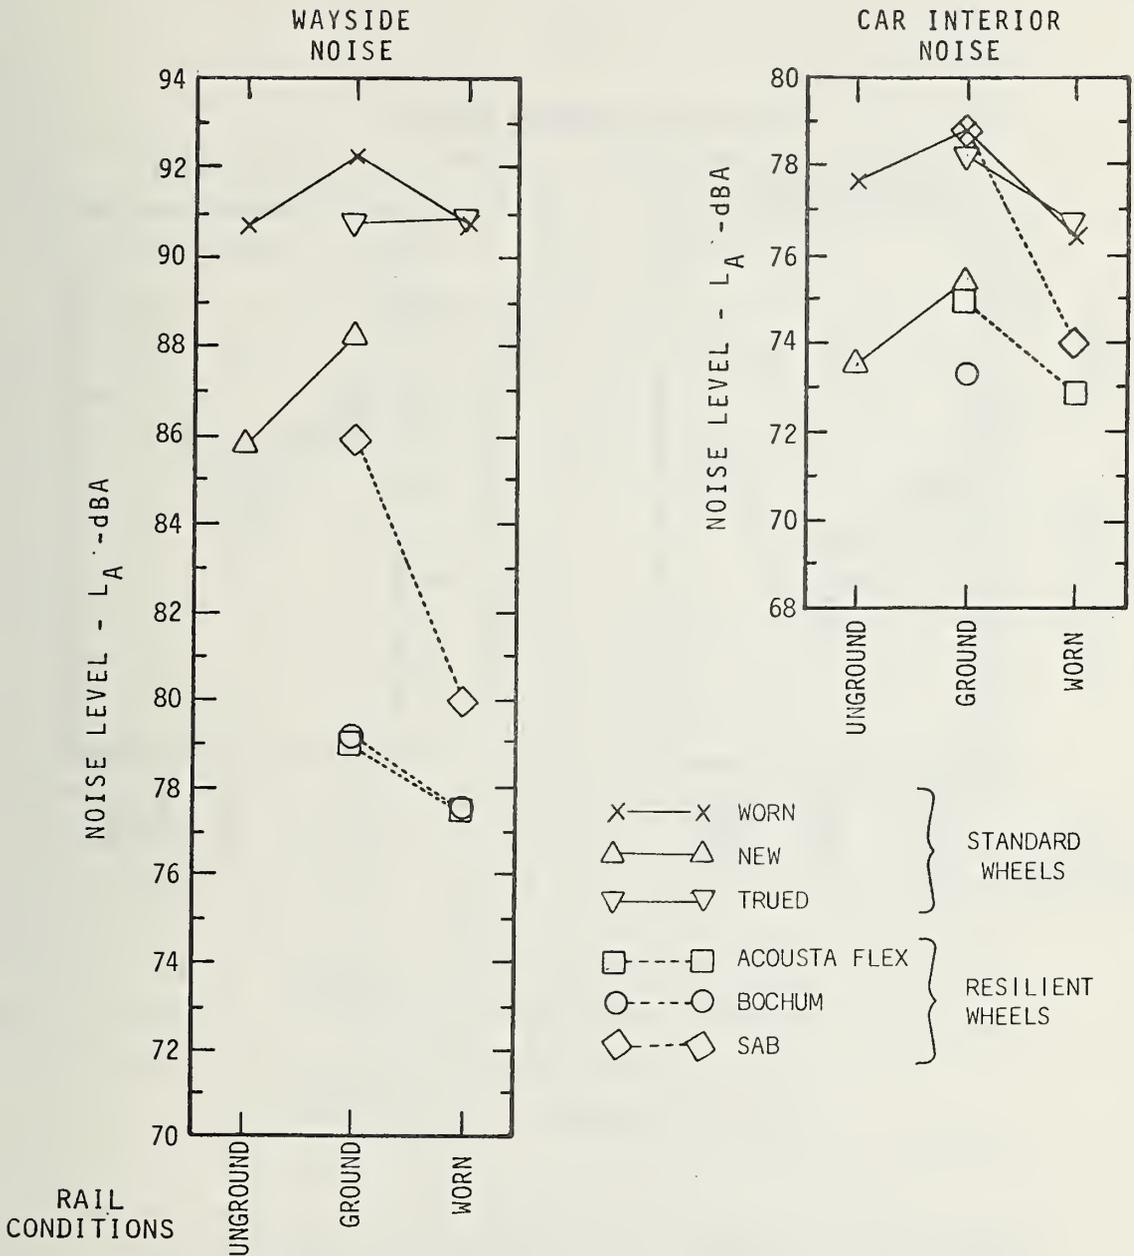
FIGURE 4-8. AVERAGE NOISE LEVELS AT THE TURN TEST TRACK FOR VARIOUS WHEELS AND RAIL CONDITIONS

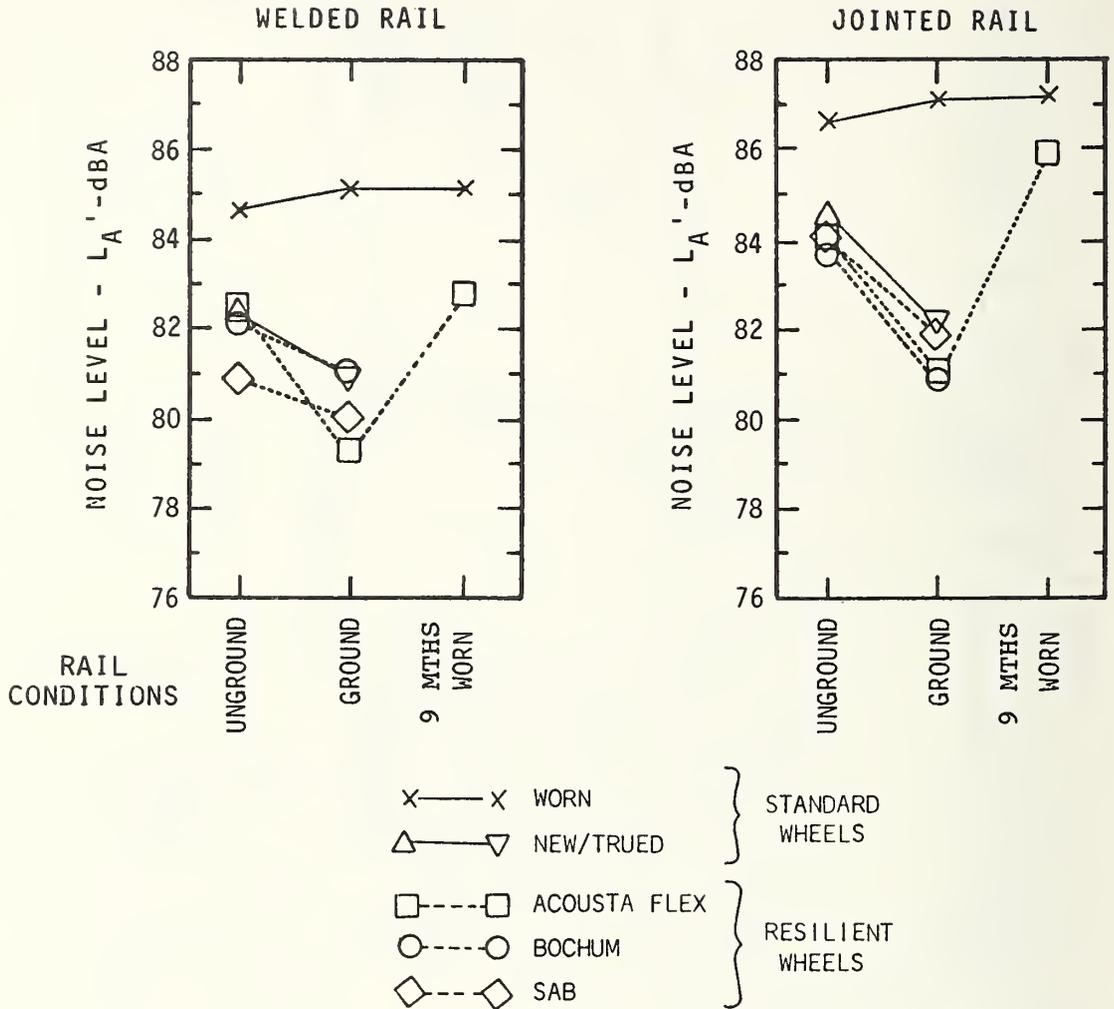
FIGURE 4.9. AVERAGE CAR INTERIOR NOISE LEVELS AT THE SUBWAY TEST TRACKS FOR VARIOUS WHEELS AND RAIL CONDITIONS

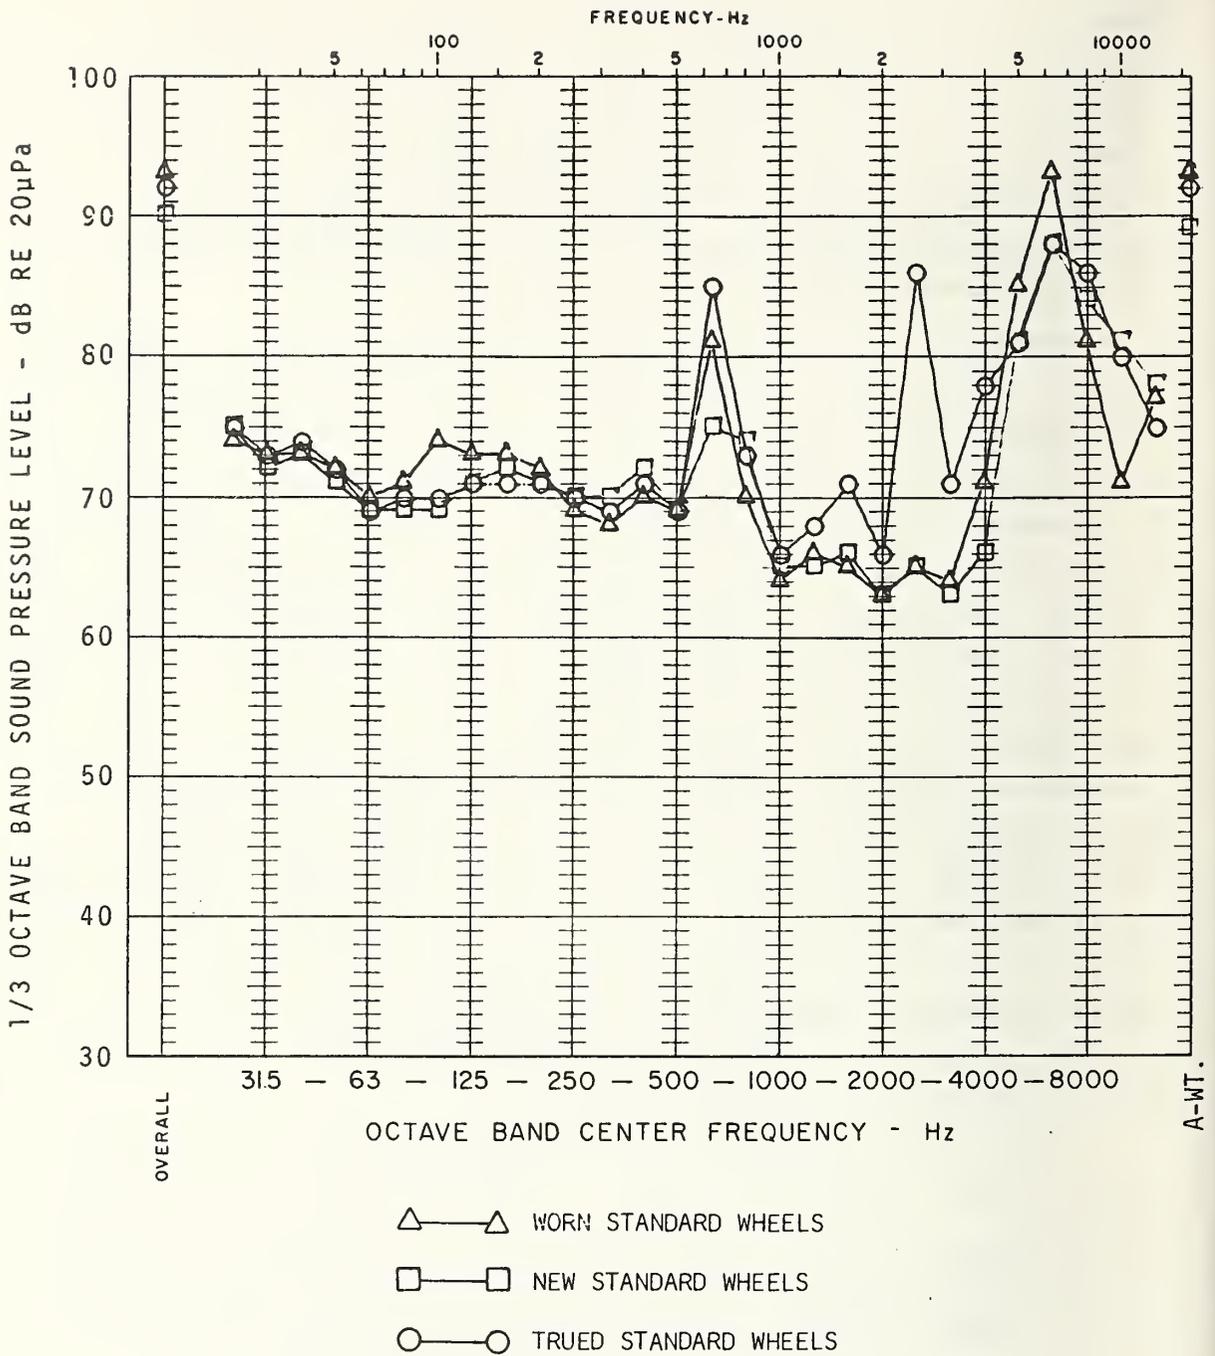
FIGURE 4-10. AVERAGE 1/3 OCTAVE BAND SPECTRA FOR WHEEL SQUEAL TESTS WITH STANDARD WHEELS ON THE TURN TEST TRACK

The overall evaluation of the effect of truing on tangent track is that the use of either a lathe type truing machine or a milling type truing cutter results in 2 to 4 dBA lower noise levels on welded track and similar reductions on jointed track. On short radius curved track, the lathe turned wheels result in about 4 dBA less squeal and the wheels trued with the milling cutter machine result in about the same overall squeal levels with a somewhat different spectrum.

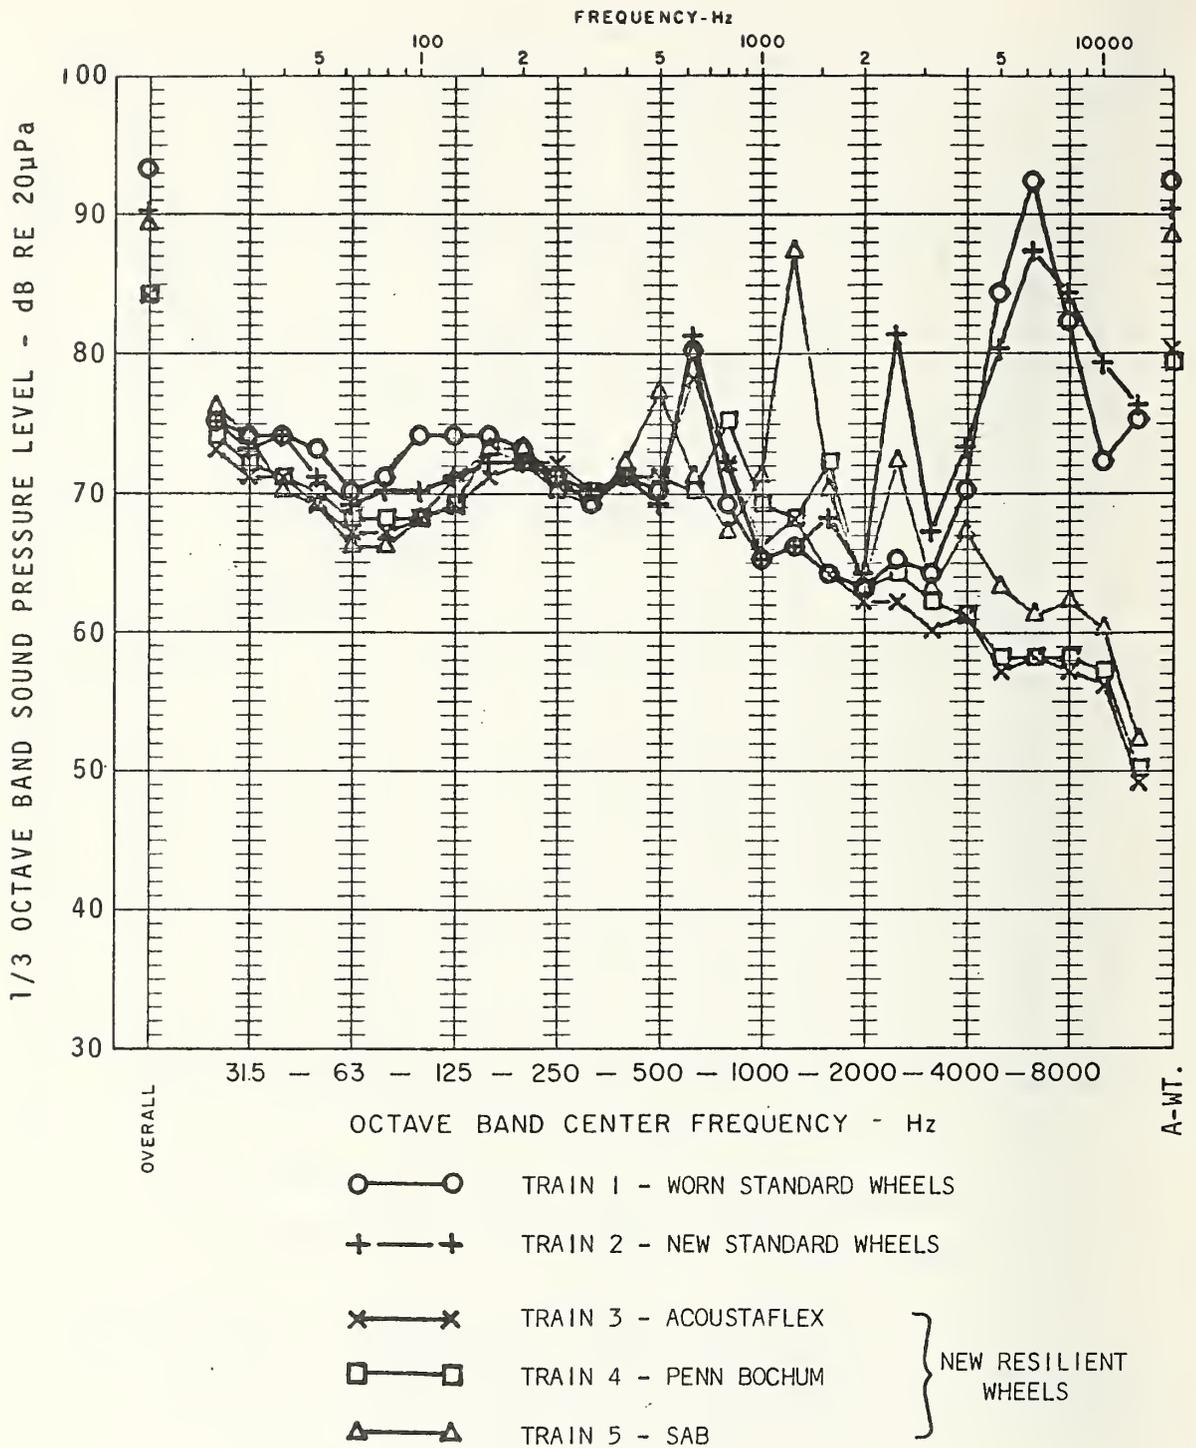
FIGURE 4-13. AVERAGE WHEEL SQUEAL LEVELS FOR PHASES I AND II TURNAROUND MEASUREMENTS, BOTH TRACK SEGMENTS - WAYIDE NOISE

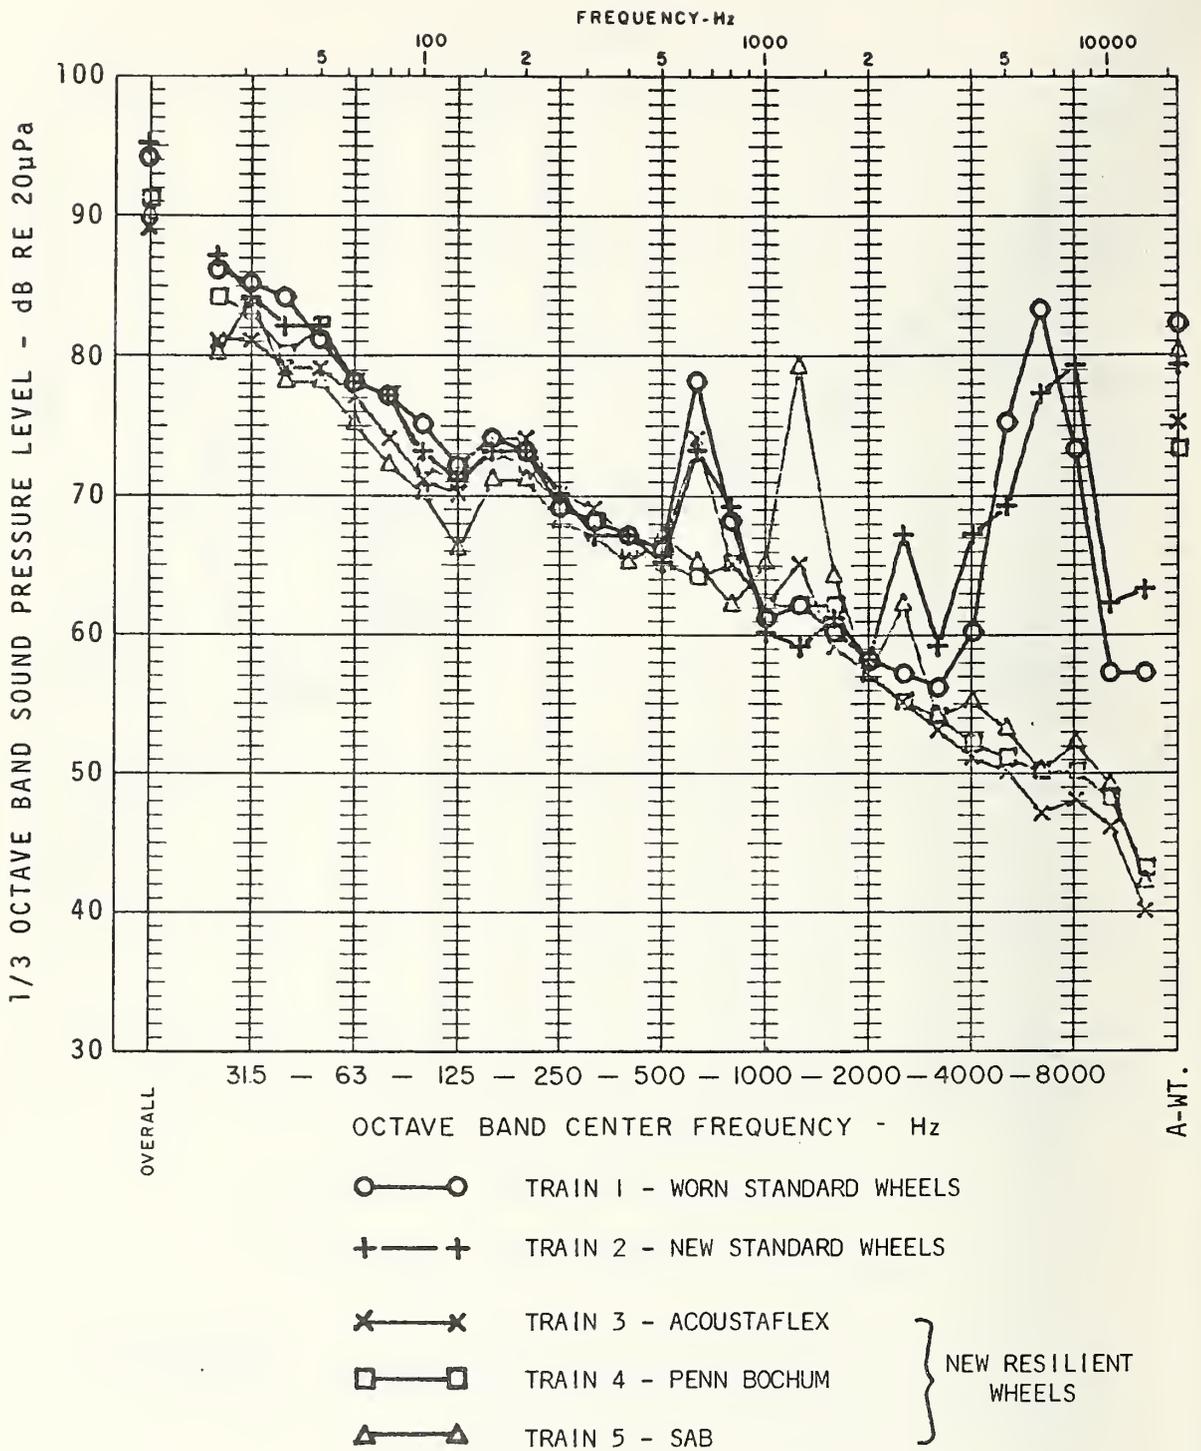
FIGURE 4-15. AVERAGE WHEEL SQUEAL LEVELS FOR TURNAROUND MEASUREMENTS - TEST TRACK SEGMENT - CAR INTERIOR NOISE

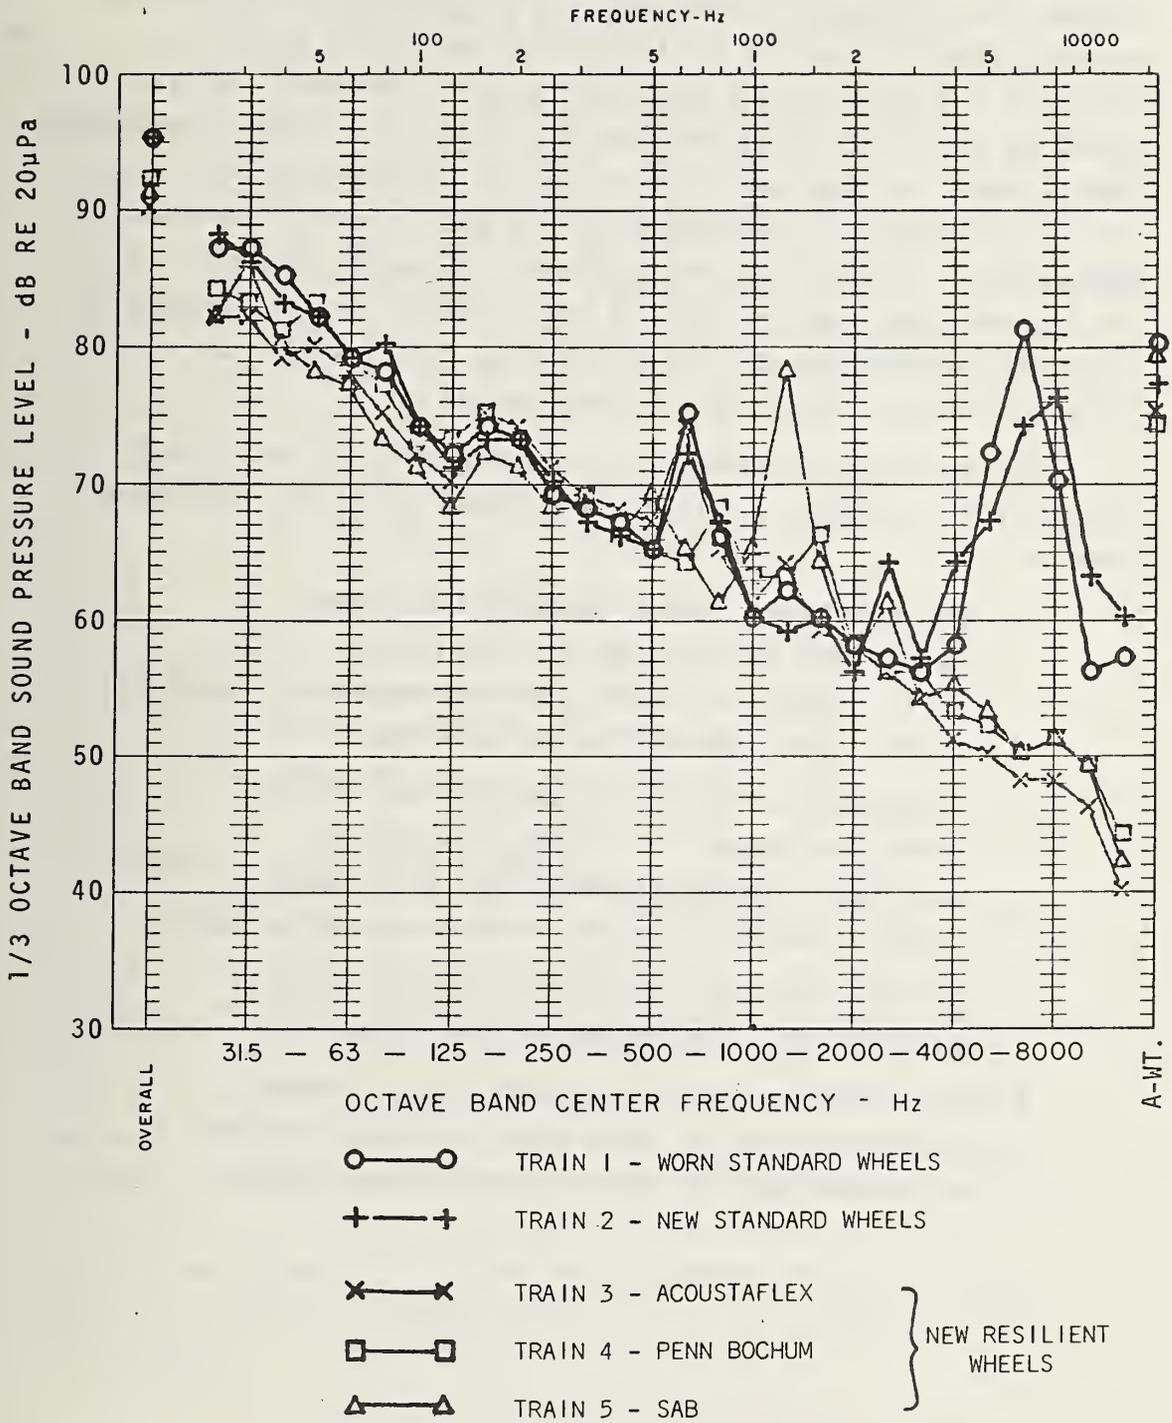
FIGURE 4-16. AVERAGE WHEEL SQUEAL LEVELS FOR PHASES I AND II TURNAROUND MEASUREMENTS, BOTH TRACK SEGMENTS - CAR INTERIOR NOISE

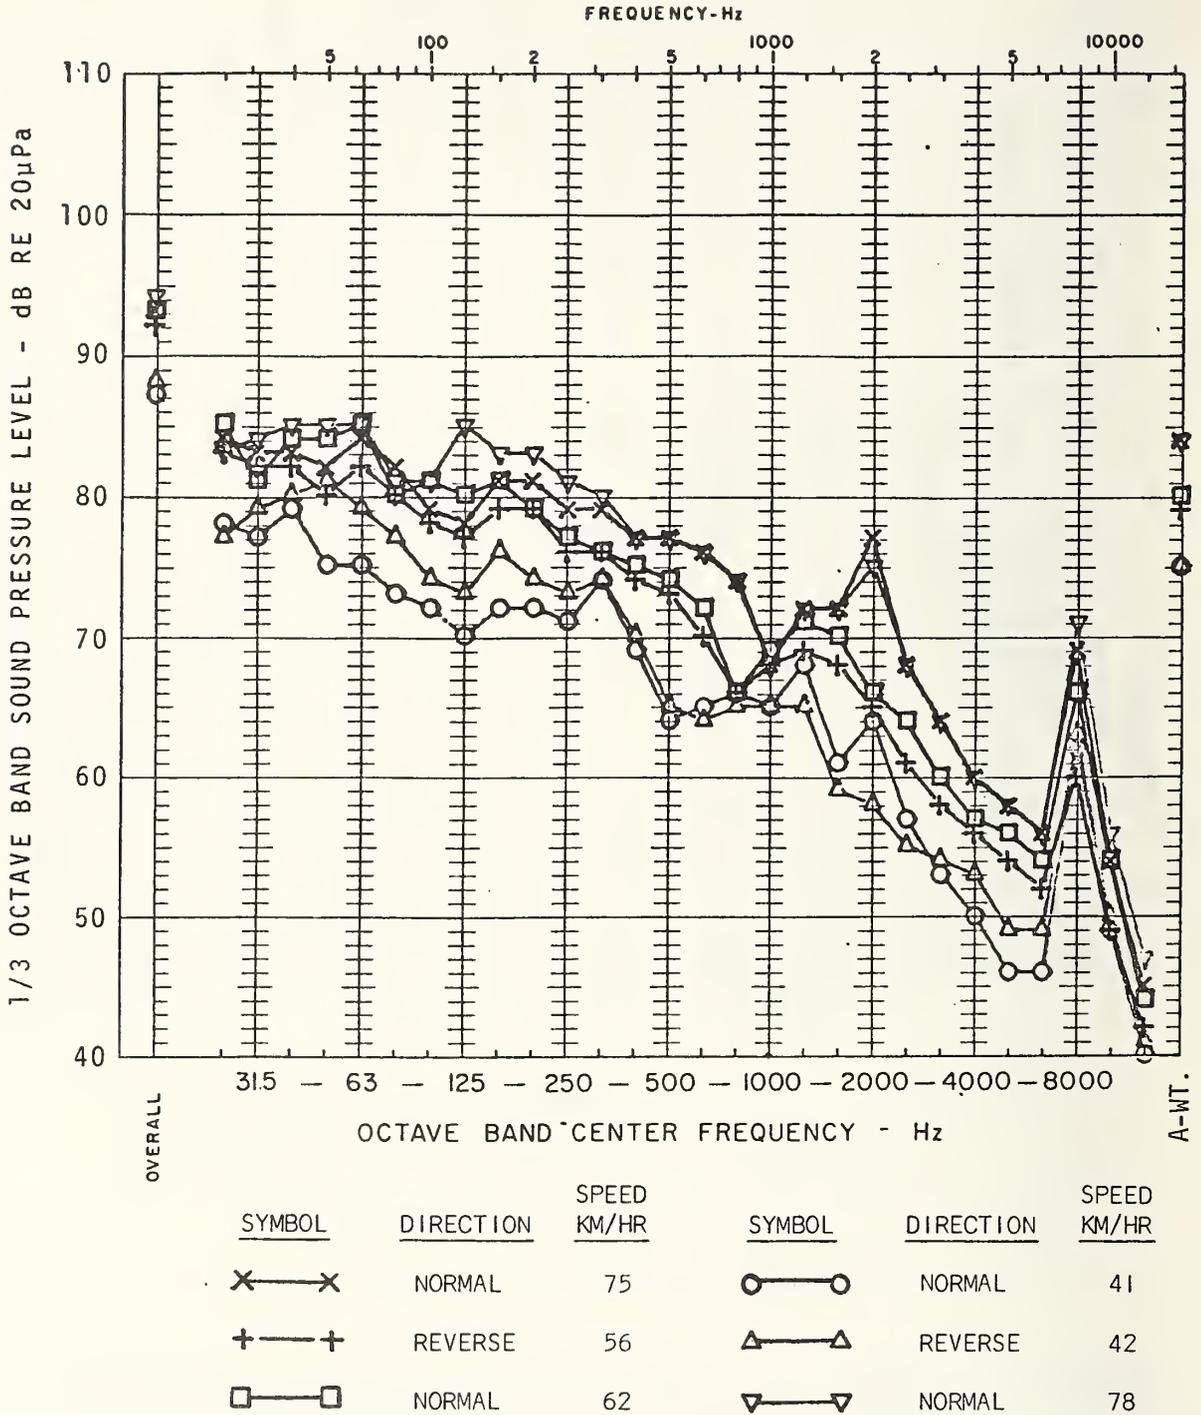
FIGURE 4-19. CAR INTERIOR LEVELS INFLUENCED BY WIND NOISE - TANGENT-WELDED BALLAST-AND-TIE TEST TRACK - PHASE IA: CAR INTERIOR OVER TRUCK - WORN STANDARD WHEELS

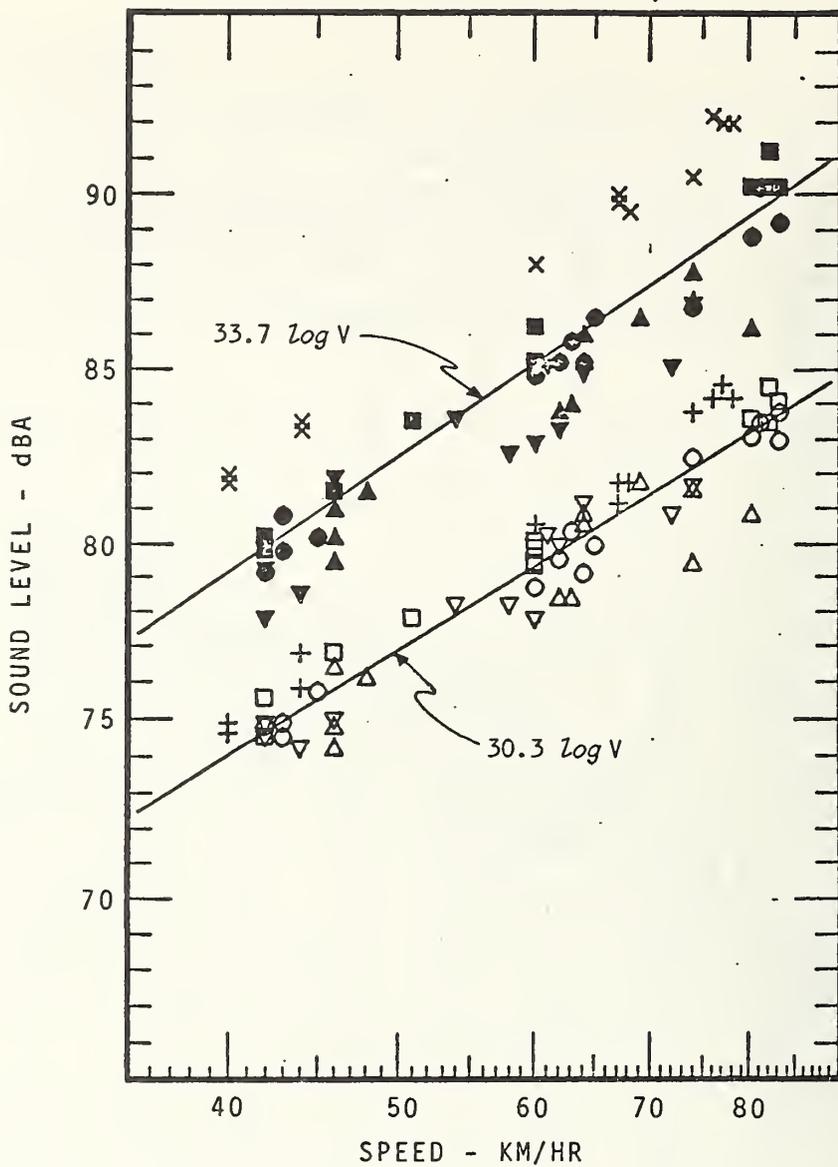
FIGURE 4-20. A-WEIGHTED NOISE LEVELS ON RECENTLY GROUND TJ TEST TRACKS, PHASE IIB. (JOINTED TRACK ON BALLASTED ELEVATED STRUCTURE)

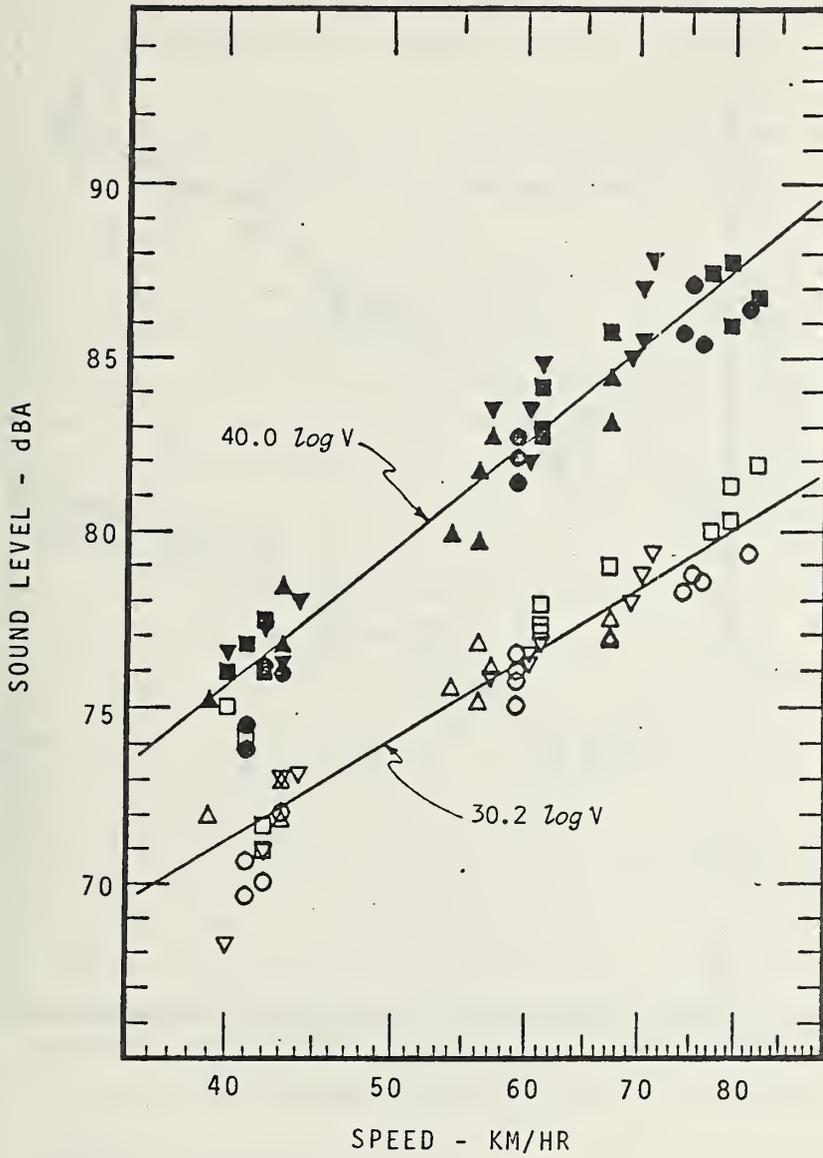
FIGURE 4-21. A-WEIGHTED NOISE LEVELS ON TW TEST TRACK, PHASE IIA.  
(TANGENT WELDED TRACK ON BALLASTED ELEVATED STRUCTURE)

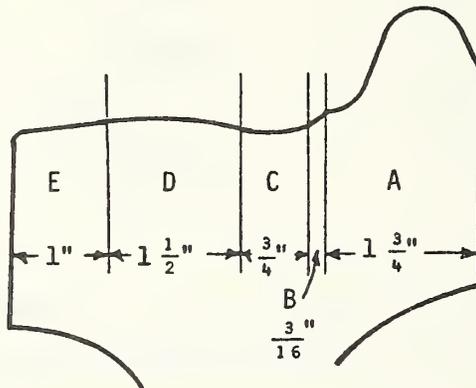
Figure 5-2 is a sketch of a typical wear pattern found on SEPTA wheels that have been in service for several months.

Figure 5-2 Typical Wear Pattern for SEPTA Wheels  
(not to scale)

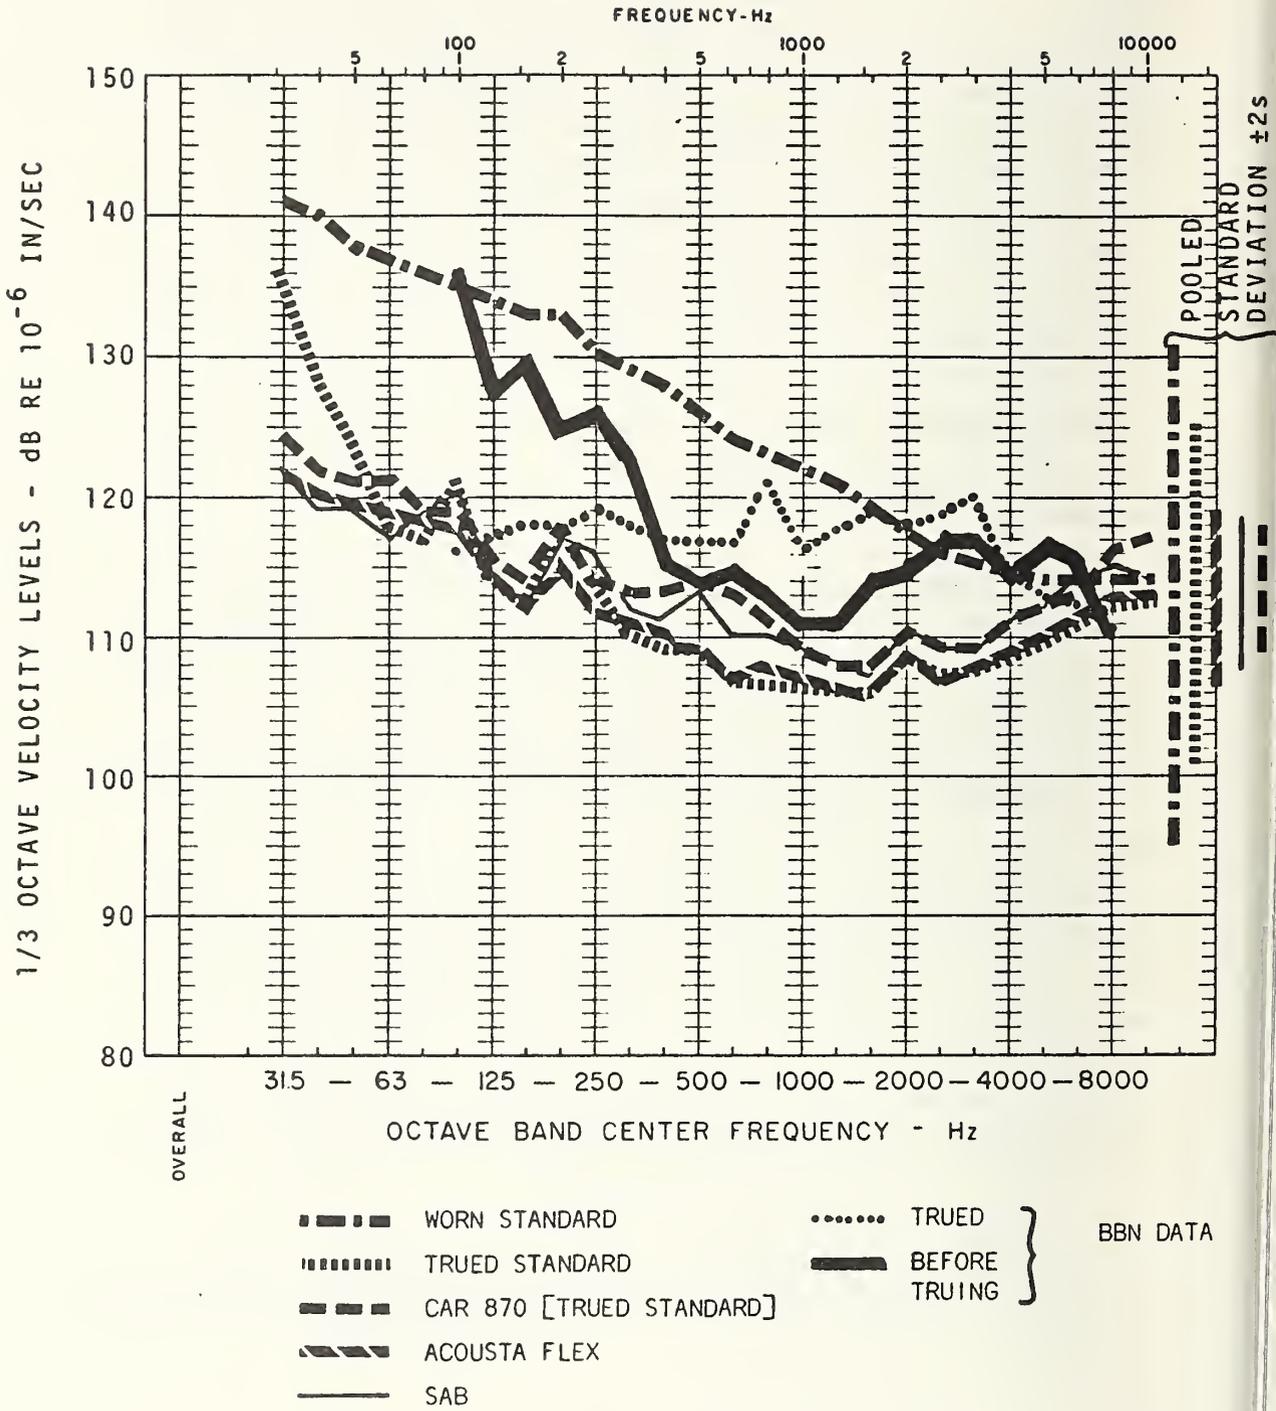
Figure 5-3 illustrates the average 1/3 octave band roughness velocity spectra at 54 km/hr for each of the various

FIGURE 5-3. AVERAGE VELOCITY LEVELS FOR WHEEL ROUGHNESS - DATA NORMALIZED TO 54 KM/HR TRAIN SPEED
