T NO. UMTA-MA-06-0025-78-7

IN-SERVICE PERFORMANCE AND COSTS OF METHODS  
TO CONTROL URBAN RAIL SYSTEM NOISE  
INITIAL TEST SERIES REPORT

De Leuw, Cather & Company  
1201 Connecticut Avenue, NW  
Washington DC 20036

AUGUST 1978  
INTERIM REPORT

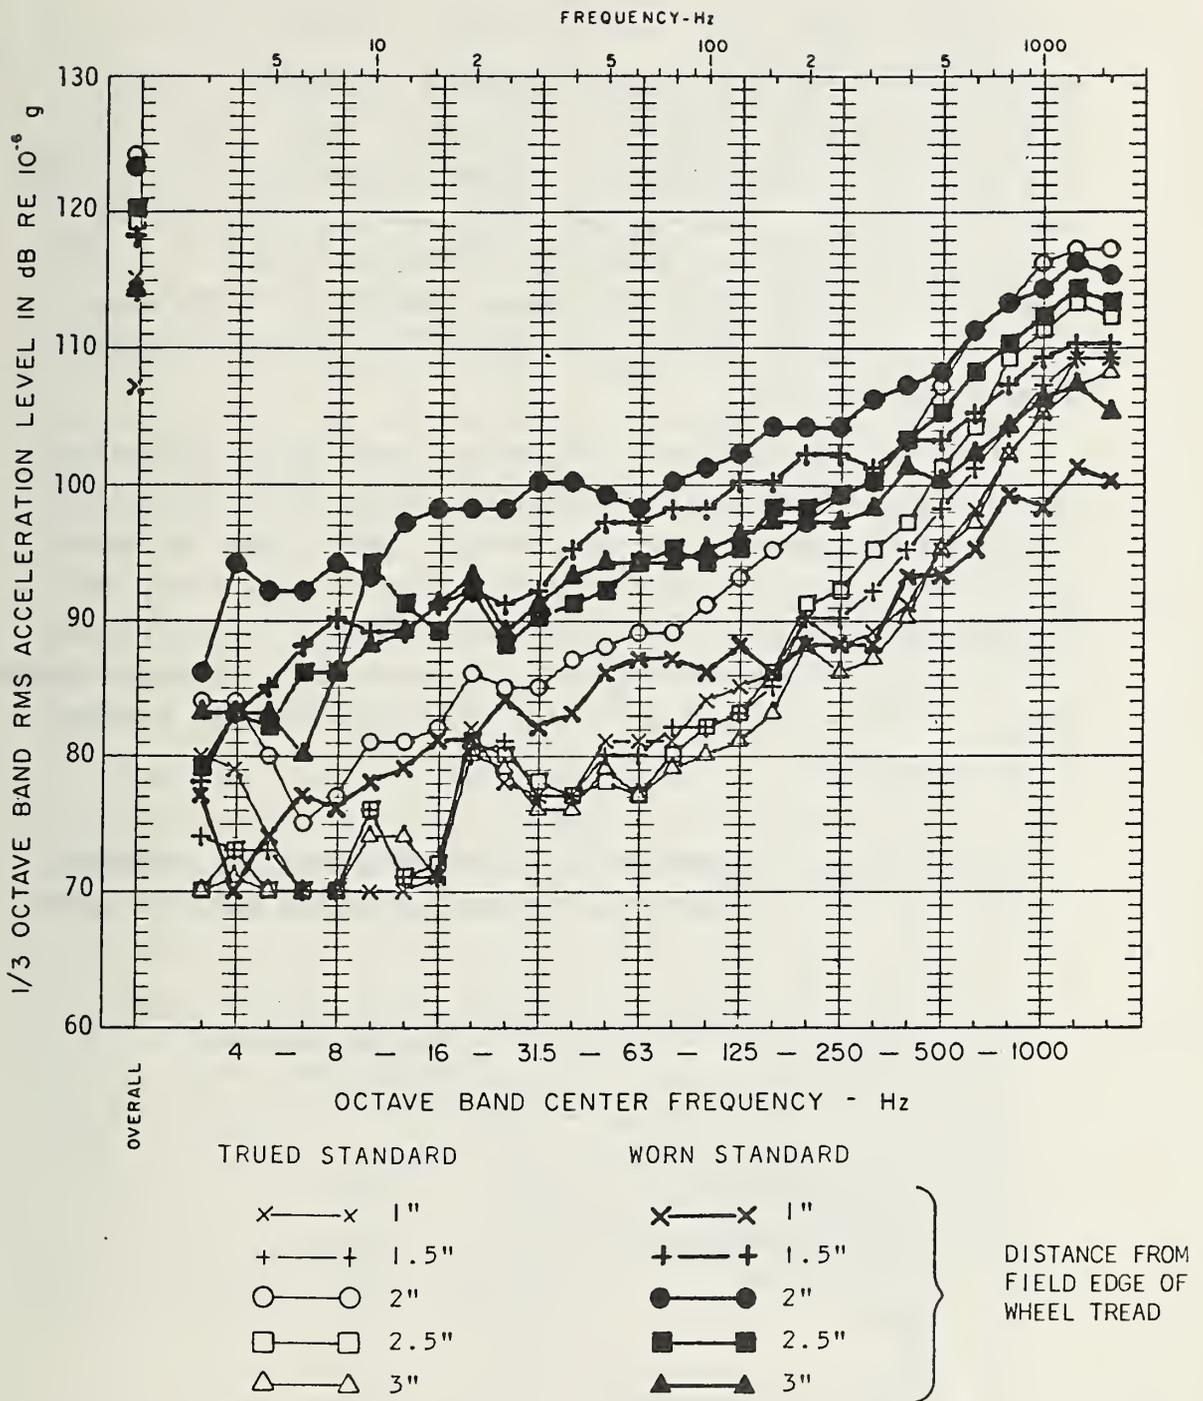
FIGURE 5-4 TYPICAL RANGE OF ROUGHNESS ACCELERATION SPECTRA MEASURED ON WORN STANDARD AND TRUED STANDARD WHEELS

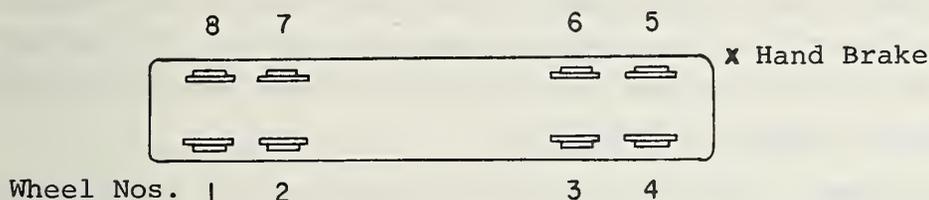
Figure 7-1. SAB Car 609

Wheel No. 6 was most severely damaged, the shunts were broken off, the majority of visible rubber inserts were disintegrated and rubber residue coated the wheel in several locations. The cover plate for the rubber inserts had dropped and was resting against the wheel flange. It appeared, however, that the wheel was still structurally sound as no failures were found in the main bolt system. The temperature tape was severely burned.

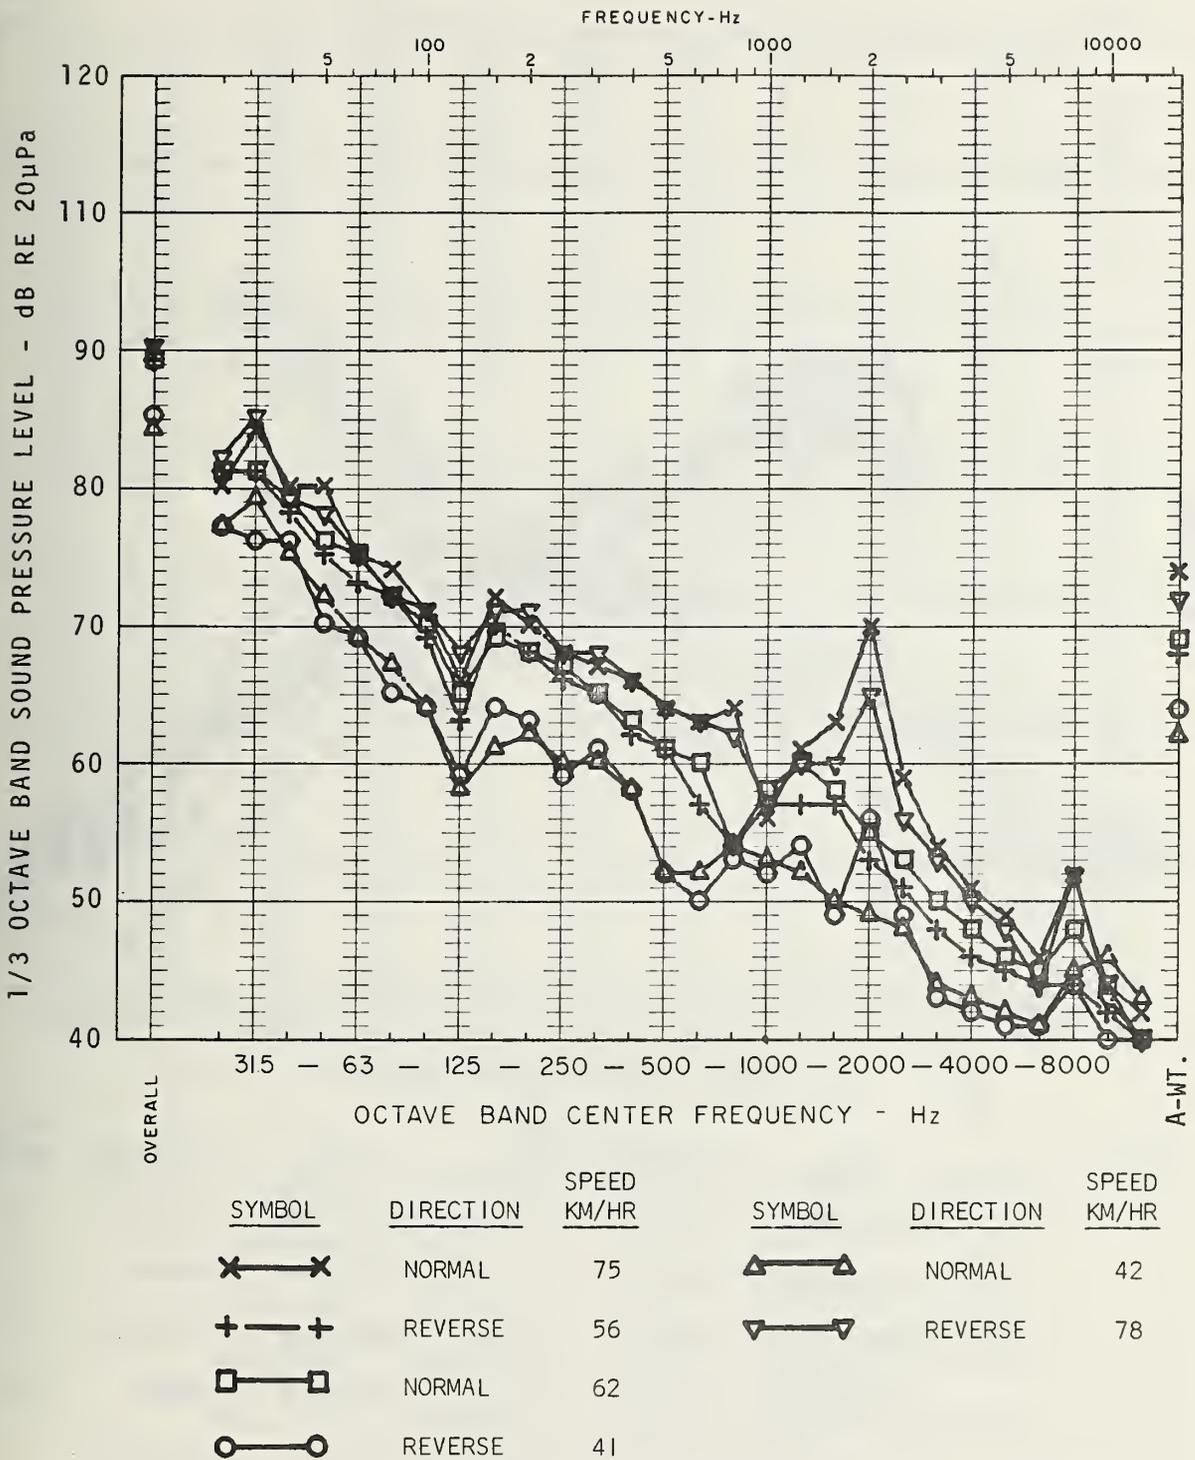
FIGURE A-2. TANGENT-WELDED BALLAST AND TIE TEST TRACK [TW]  
 PHASE IA; JULY 14, 1976  
 CAR INTERIOR, OVER TRUCK - WORN STANDARD WHEELS

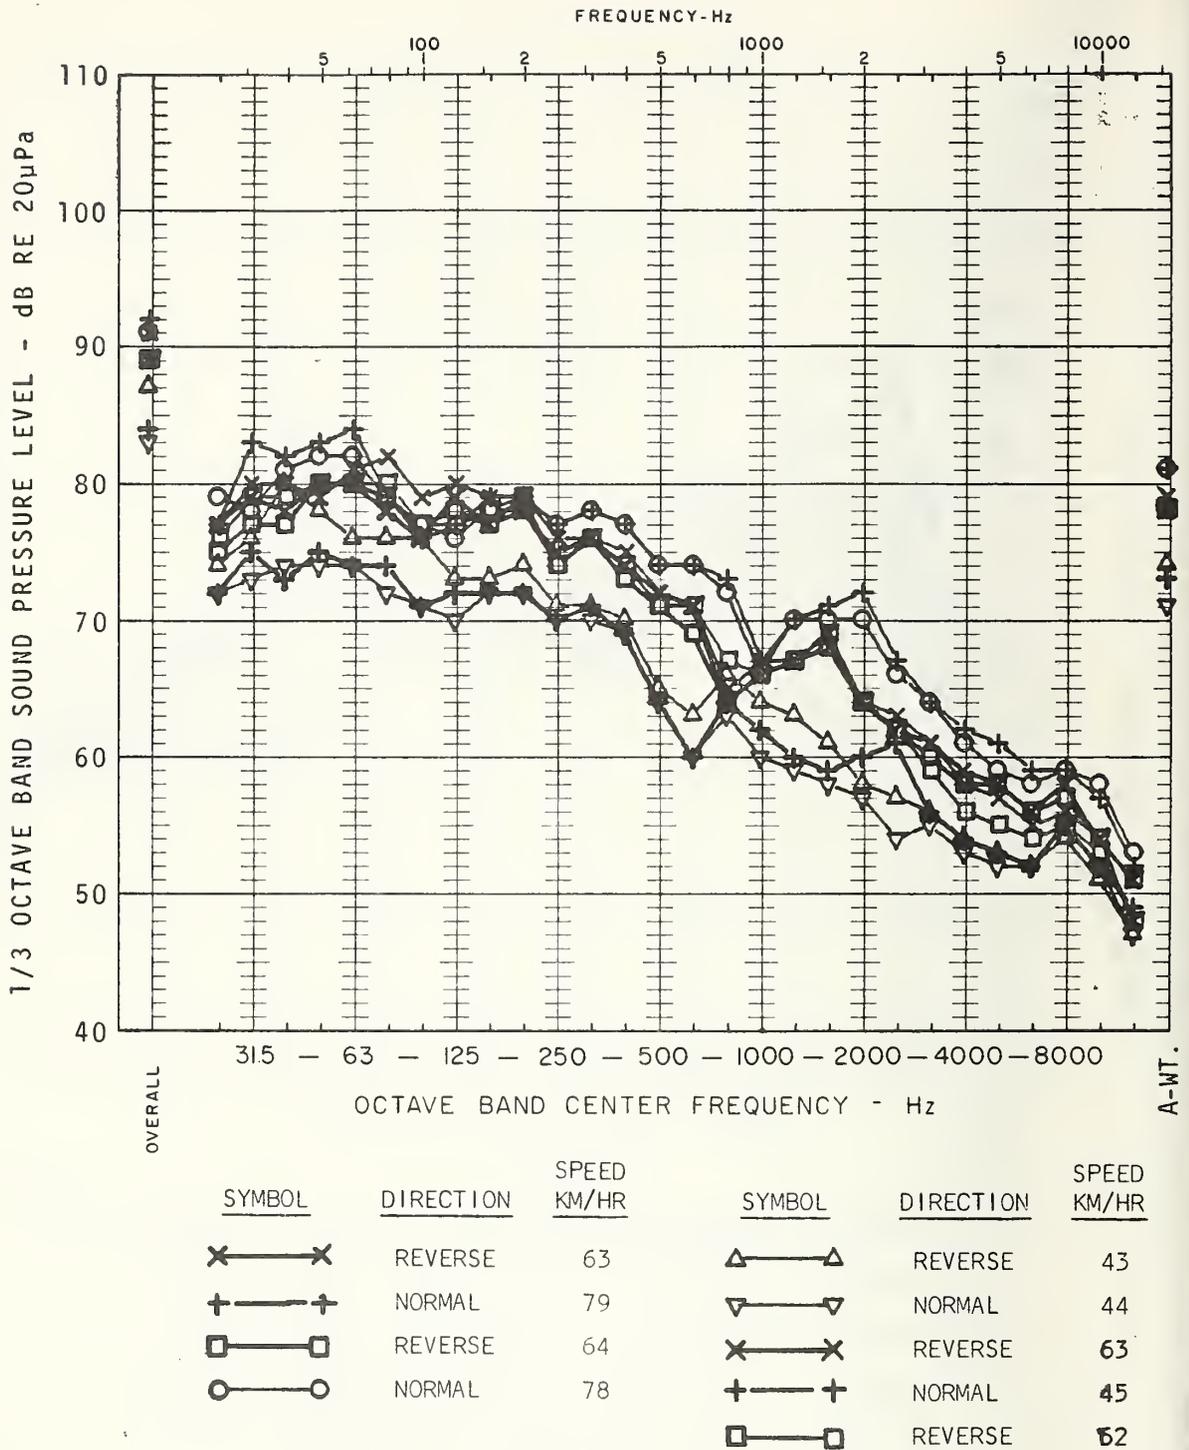
FIGURE A-7. TANGENT-WELDED BALLAST AND TIE TEST TRACK [TW]  
 PHASE IB; AUGUST 17, 1976  
 CAR INTERIOR, OVER TRUCK - WORN STEEL WHEELS

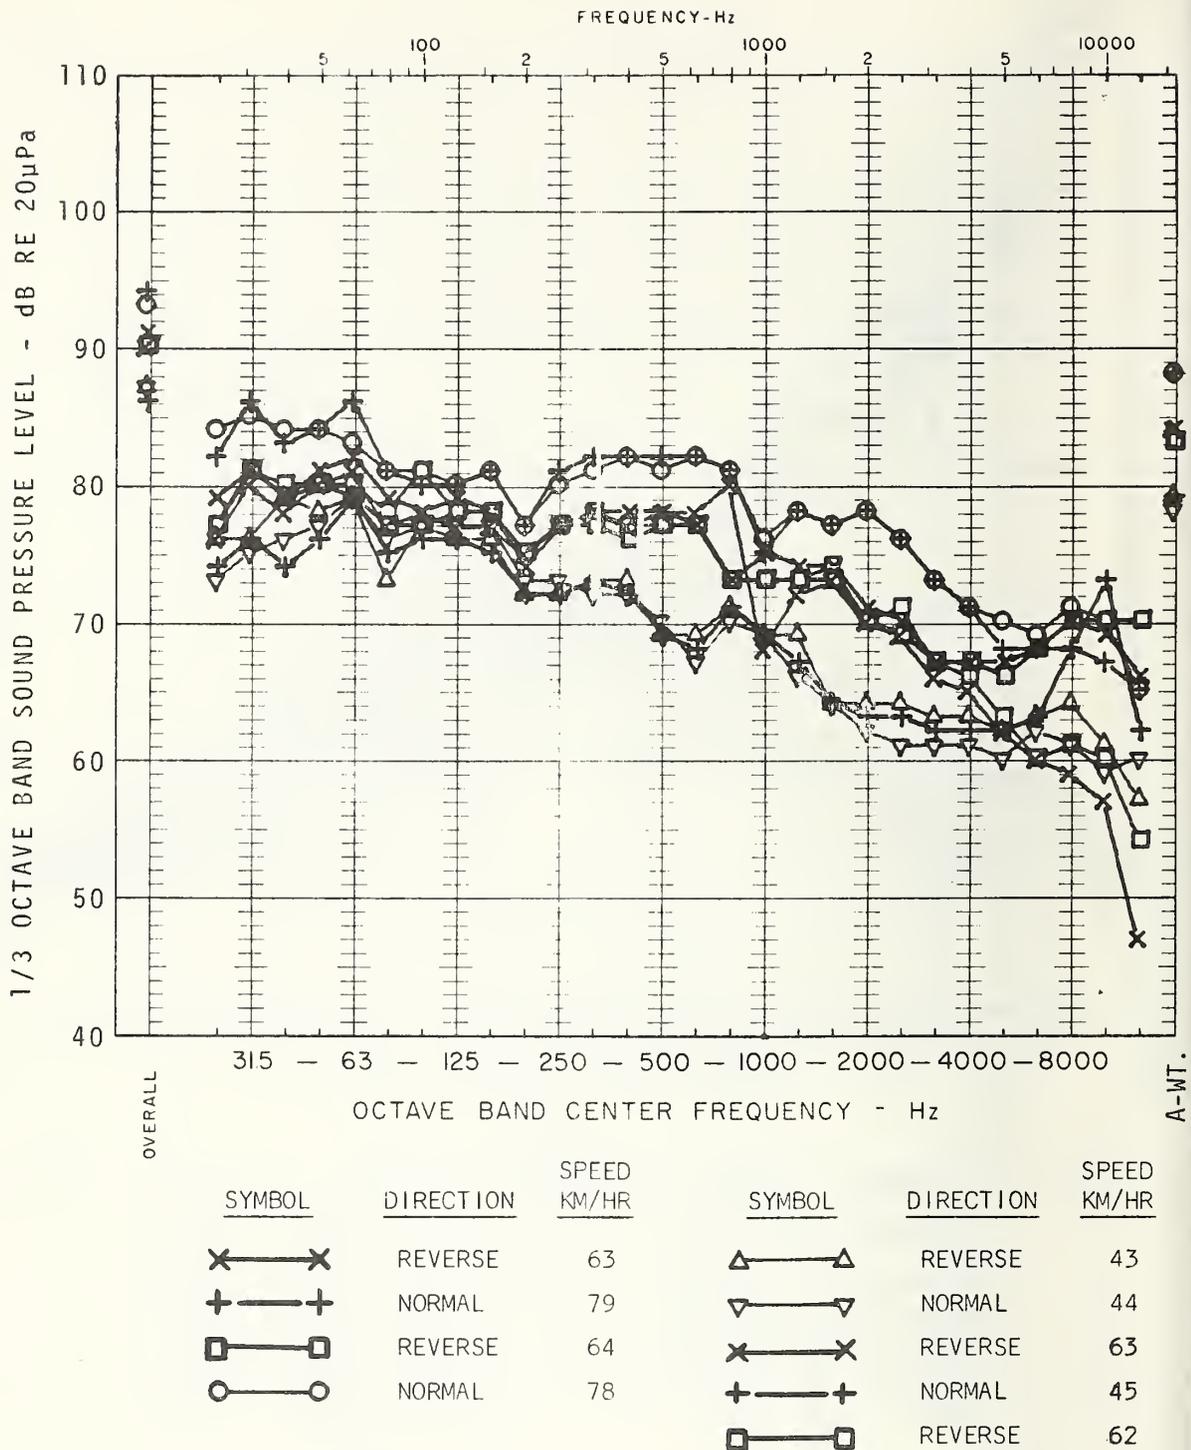
FIGURE A-11. TANGENT-WELDED BALLAST AND TIE TEST TRACK [TW]  
 PHASE 1B; AUGUST 17, 1976  
 WAYSIDE - WORN STANDARD WHEELS

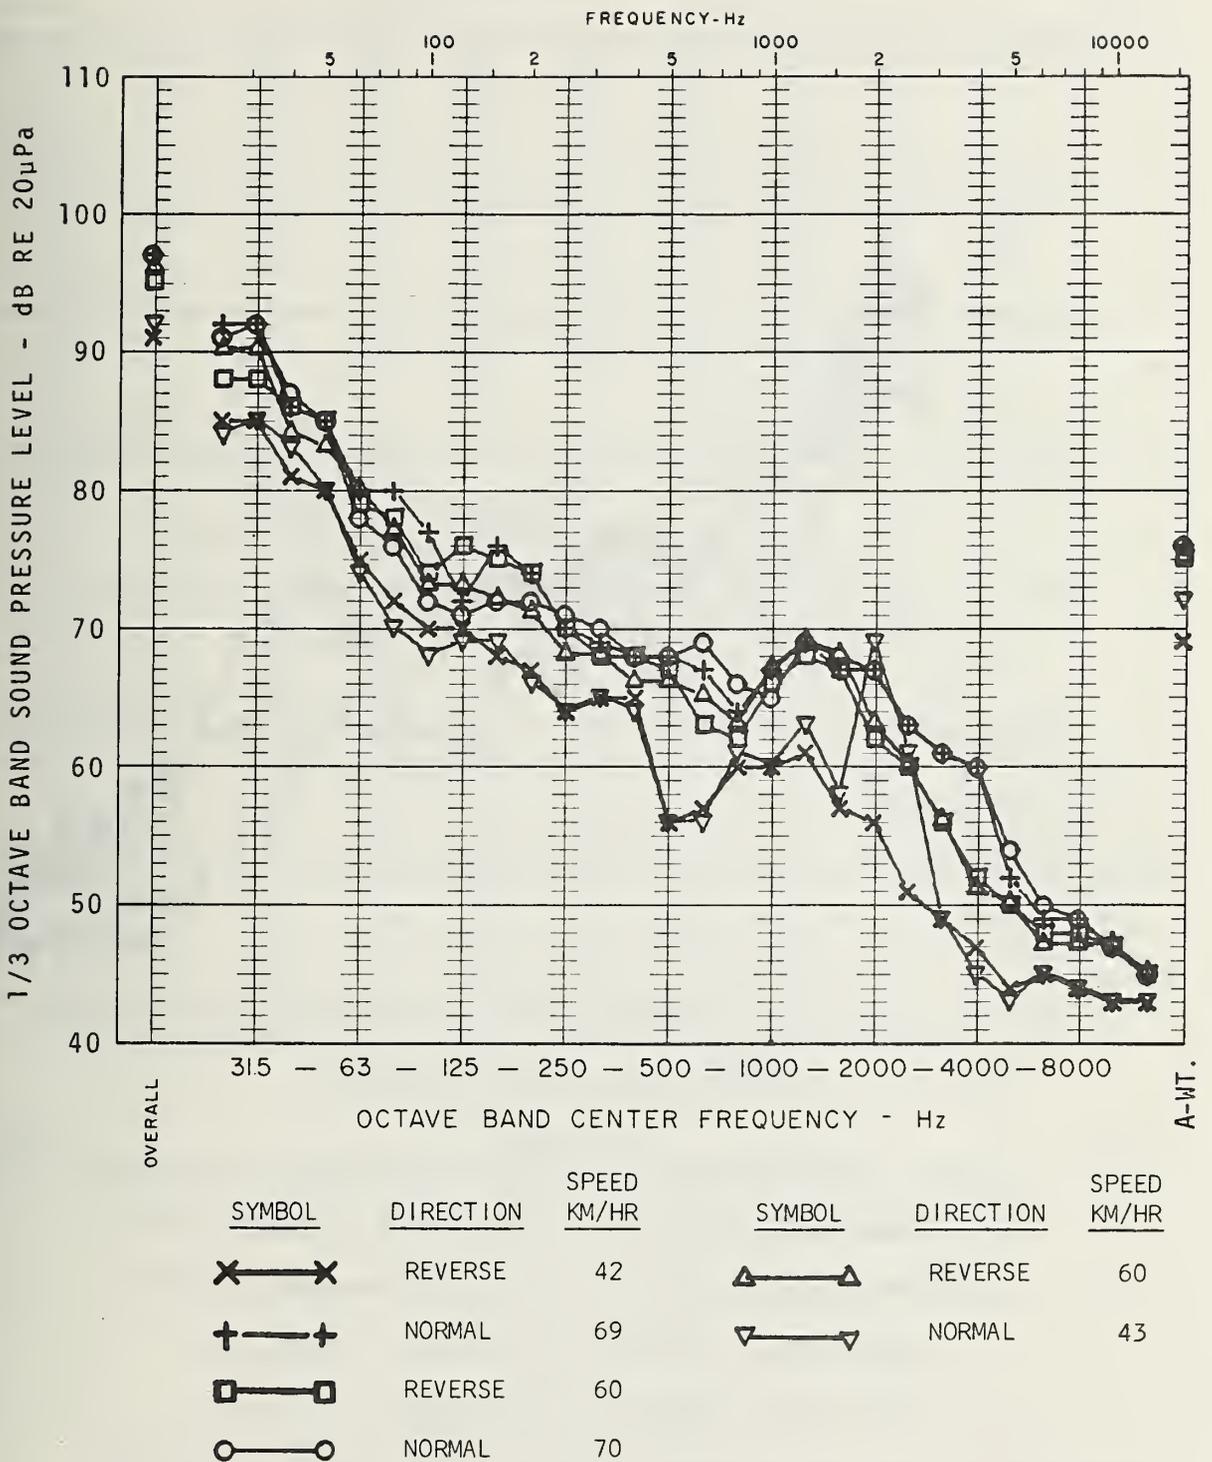
FIGURE A-24. TANGENT-WELDED BALLAST AND TIE TEST TRACK [TW]  
 PHASE IIA; OCTOBER 4, 1976  
 CAR INTERIOR AT CENTER - NEW PENN BOCHUM RESILIENT WHEELS

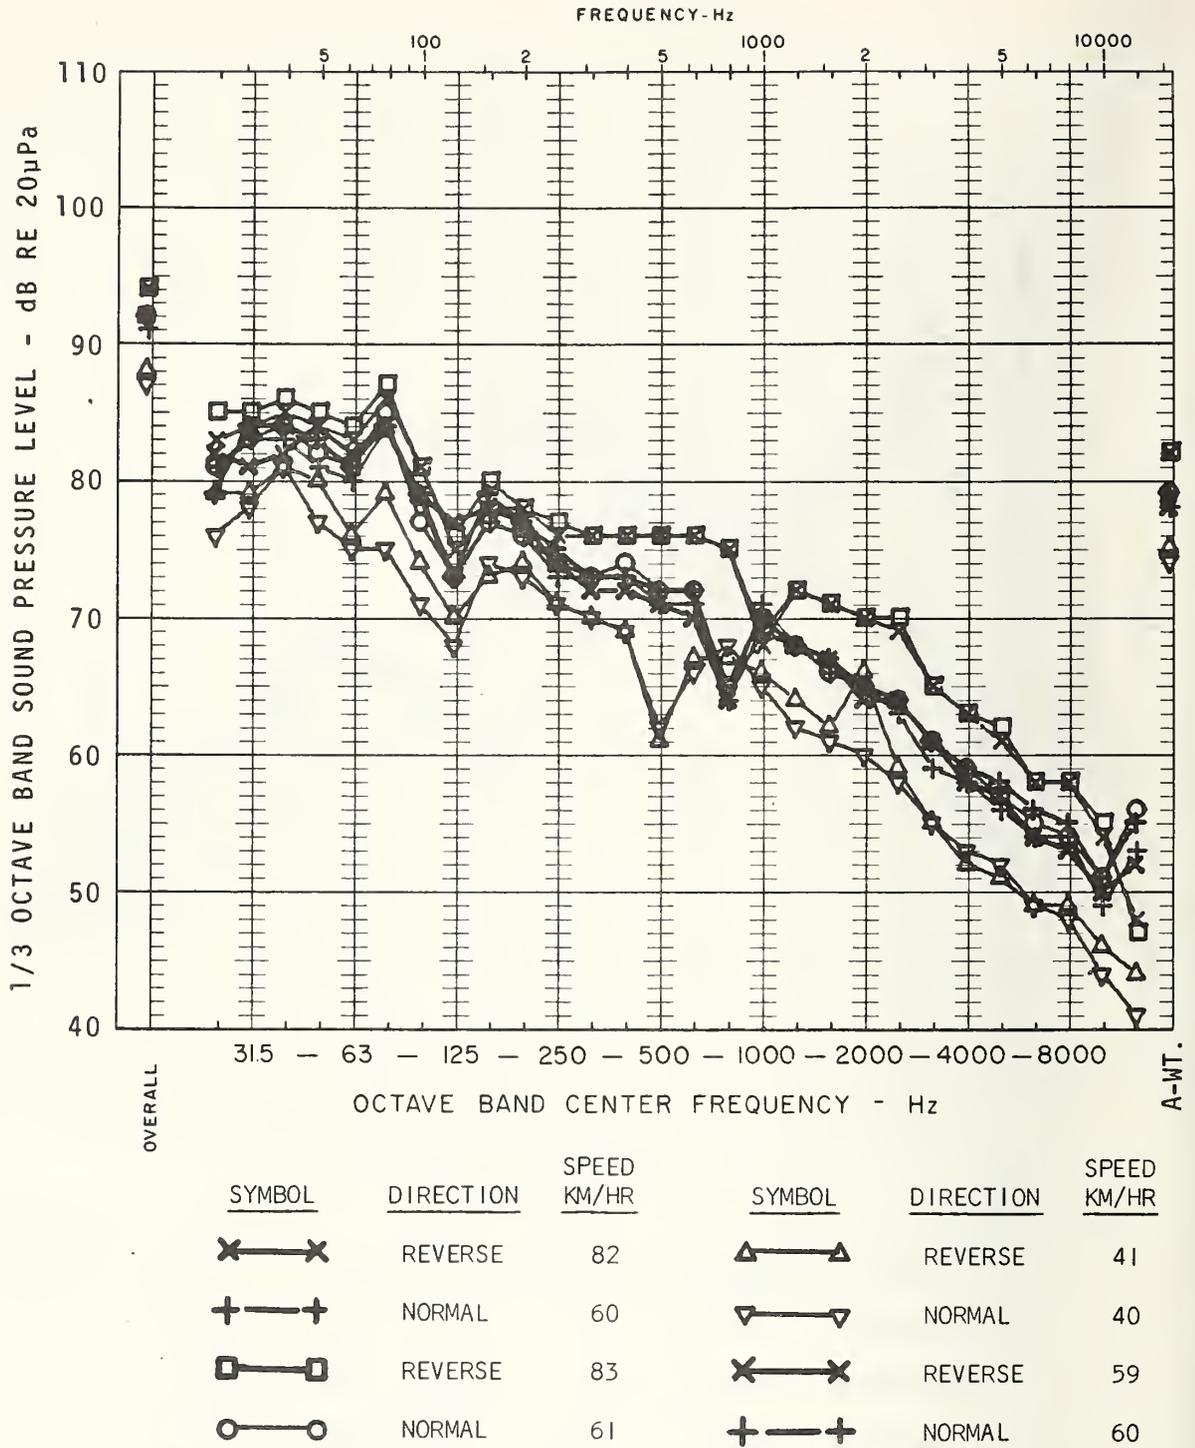
FIGURE B-3.: BALLAST AND TIE TANGENT-JOINTED TEST TRACK A  
 PHASE IA; JULY 14, 1976  
 CAR INTERIOR, OVER TRUCK - NEW STANDARD WHEELS

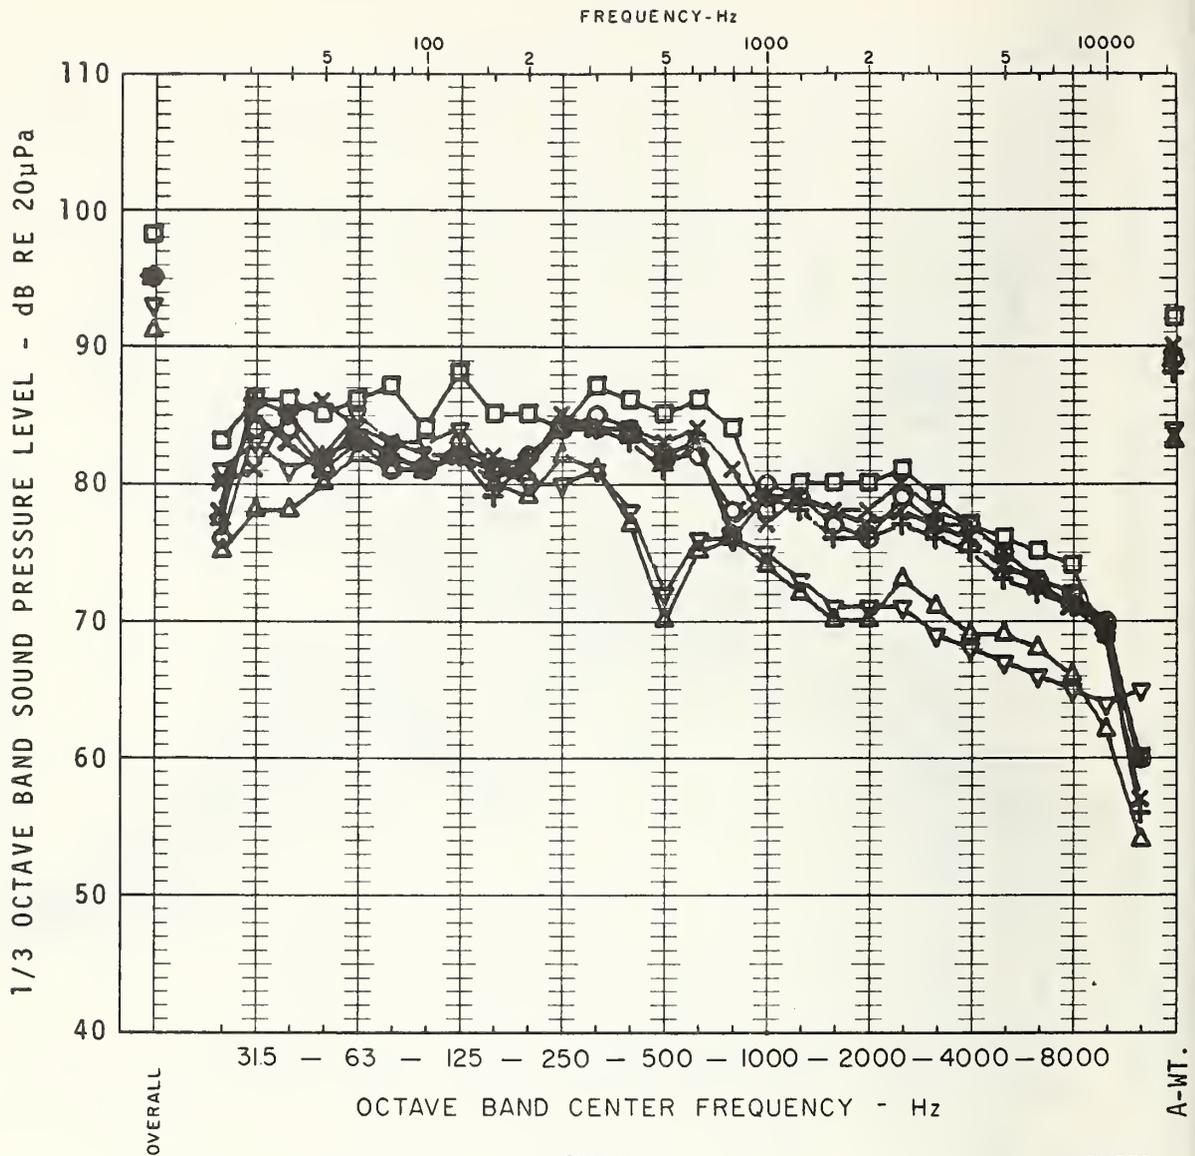
FIGURE B-5. BALLAST AND TIE TANGENT-JOINTED TEST TRACK A  
 PHASE IA; JULY 14, 1976  
 WAYSIDE - WORN STANDARD WHEELS

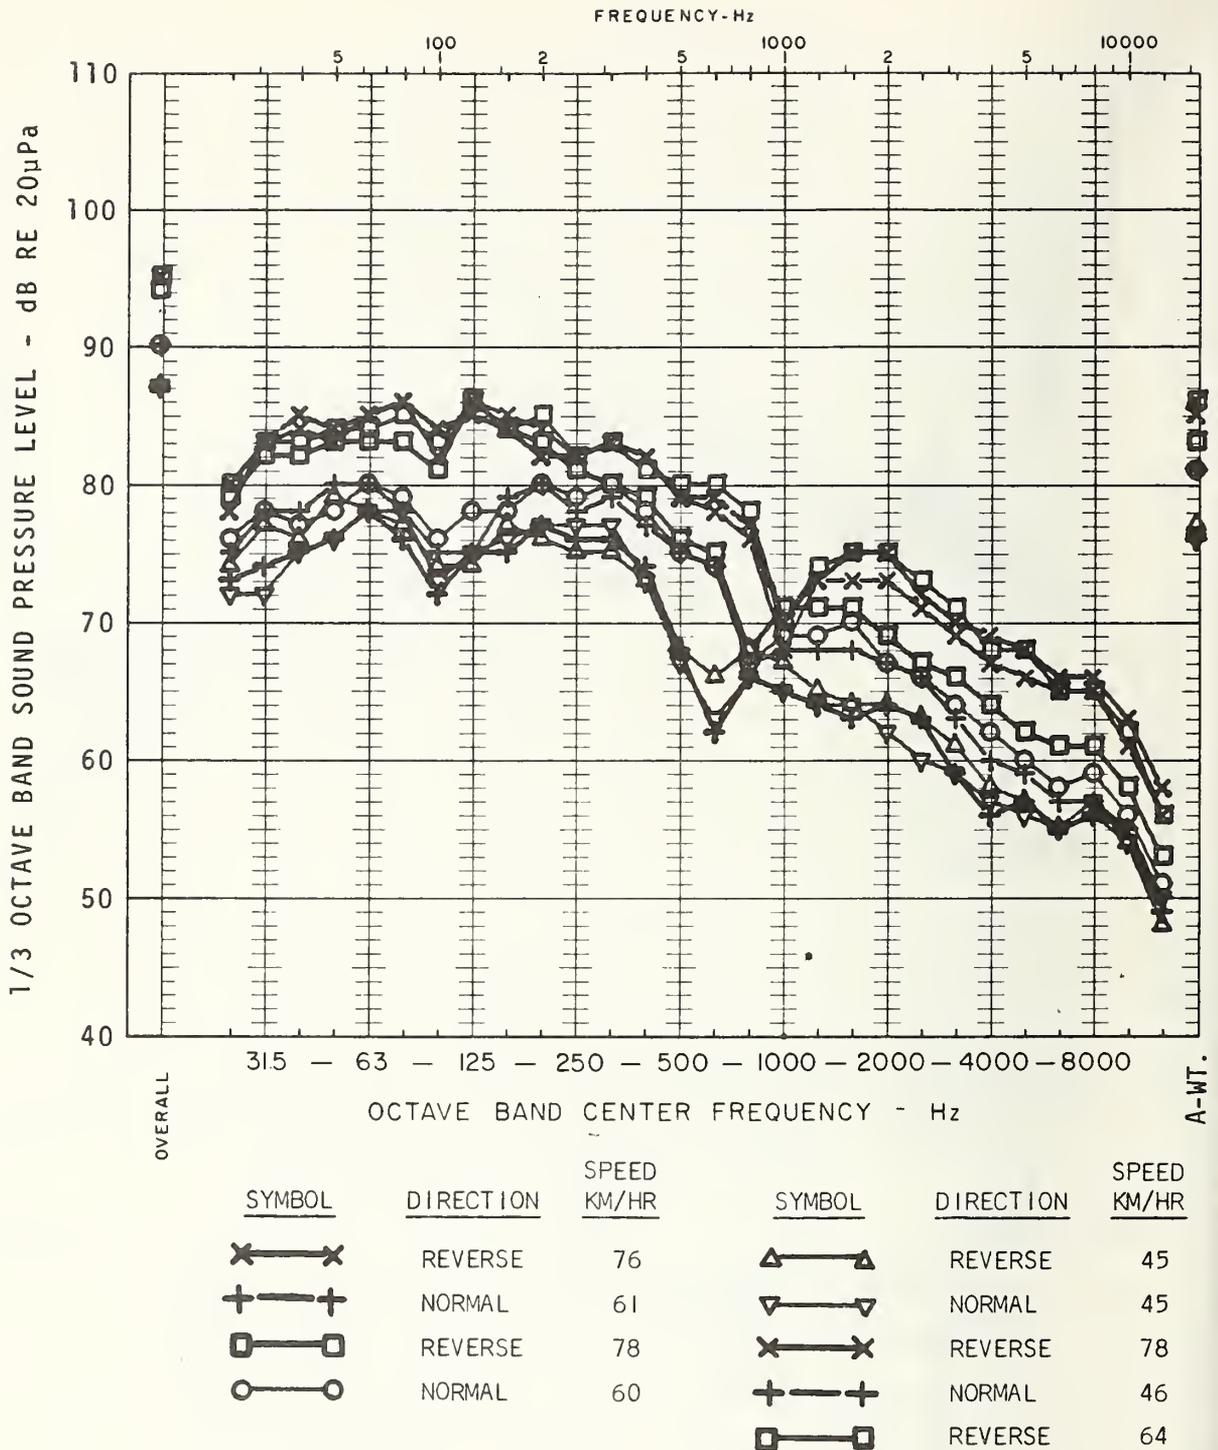
FIGURE B-8. BALLAST AND TIE TANGENT-JOINTED TEST TRACK A  
 PHASE IB; AUGUST 17, 1976  
 CAR INTERIOR, OVER TRUCK - WORN STANDARD WHEELS

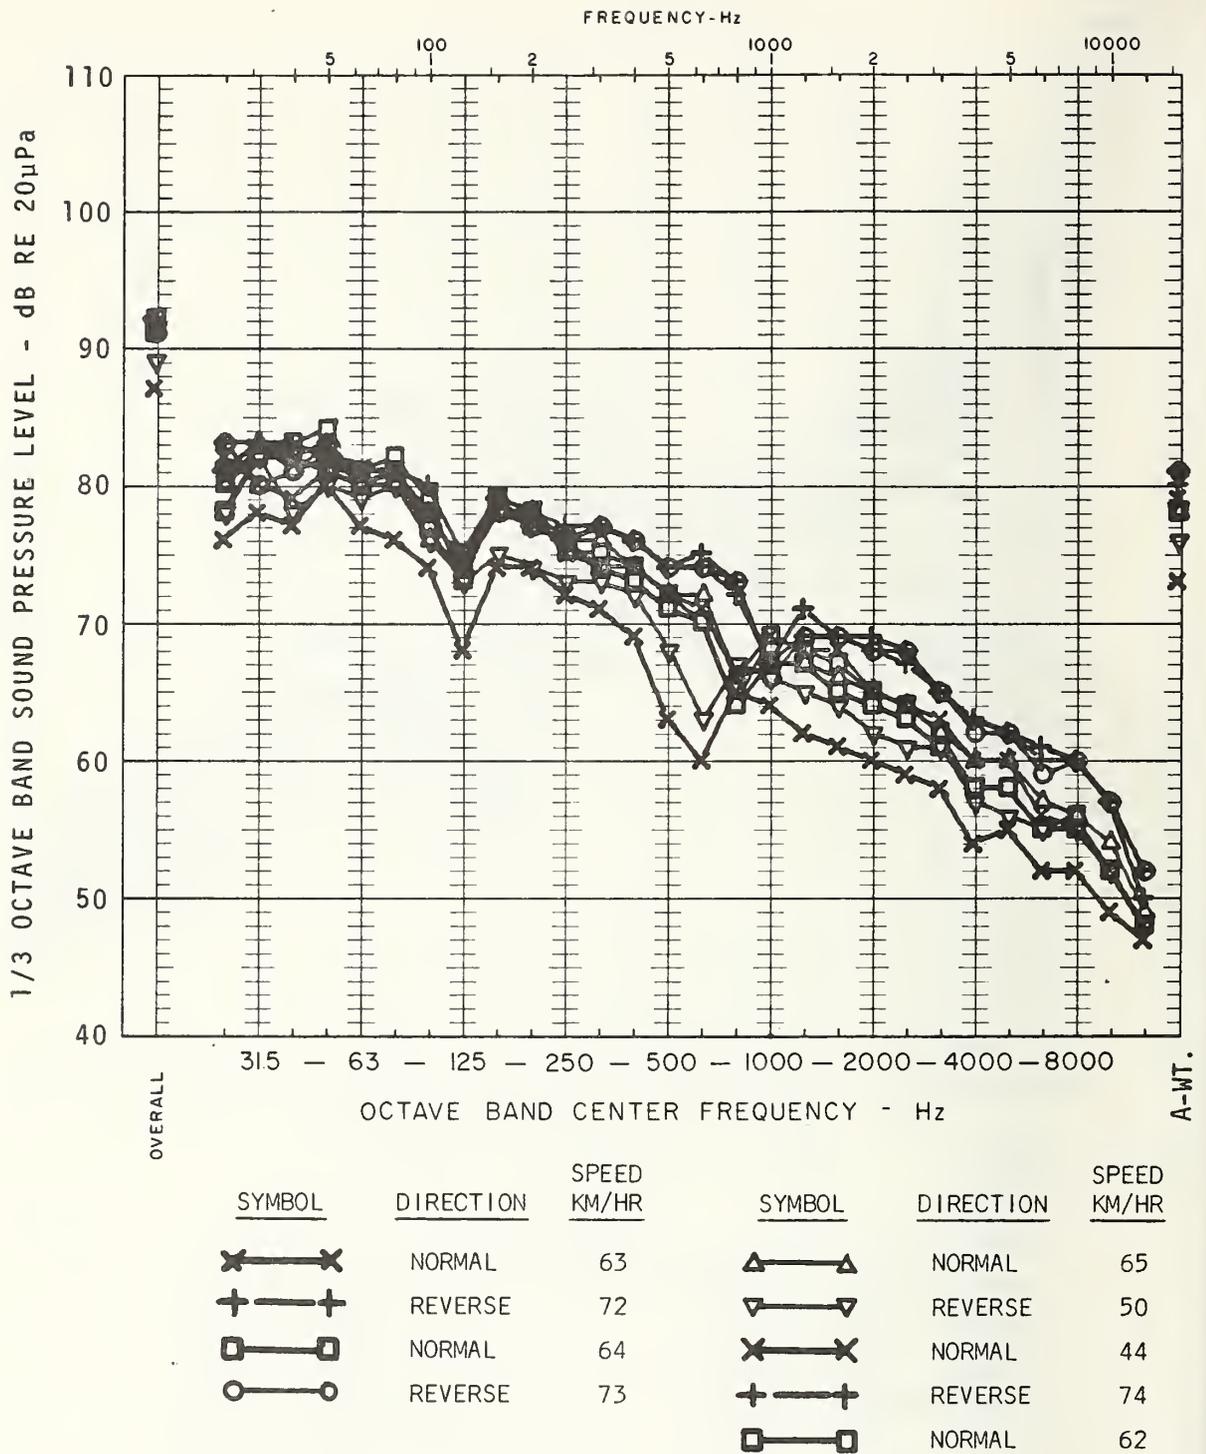
FIGURE B-9. BALLAST AND TIE TANGENT-JOINTED TEST TRACK A  
 PHASE IB; AUGUST 17, 1976  
 CAR INTERIOR, OVER TRUCK - NEW STANDARD WHEELS

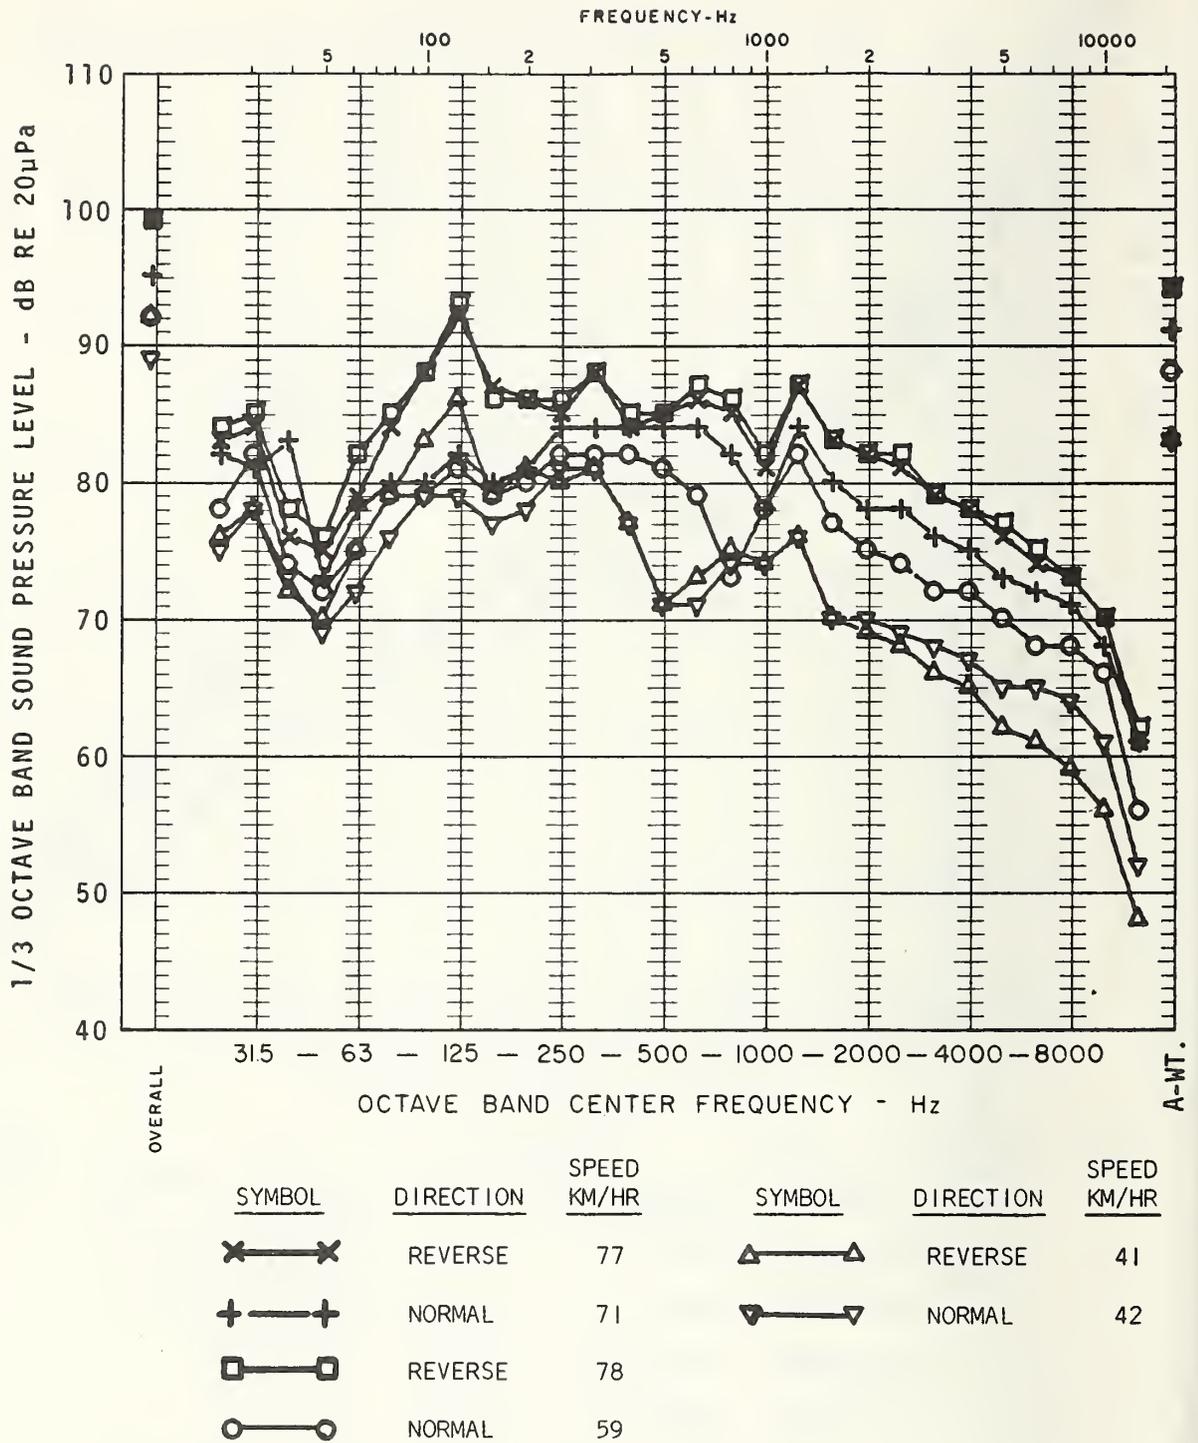
FIGURE B-19. BALLAST AND TIE TANGENT-JOINTED TEST TRACK A  
 PHASE IIA; OCTOBER 4, 1976  
 CAR INTERIOR, OVER TRUCK - NEW SAB RESILIENT WHEELS

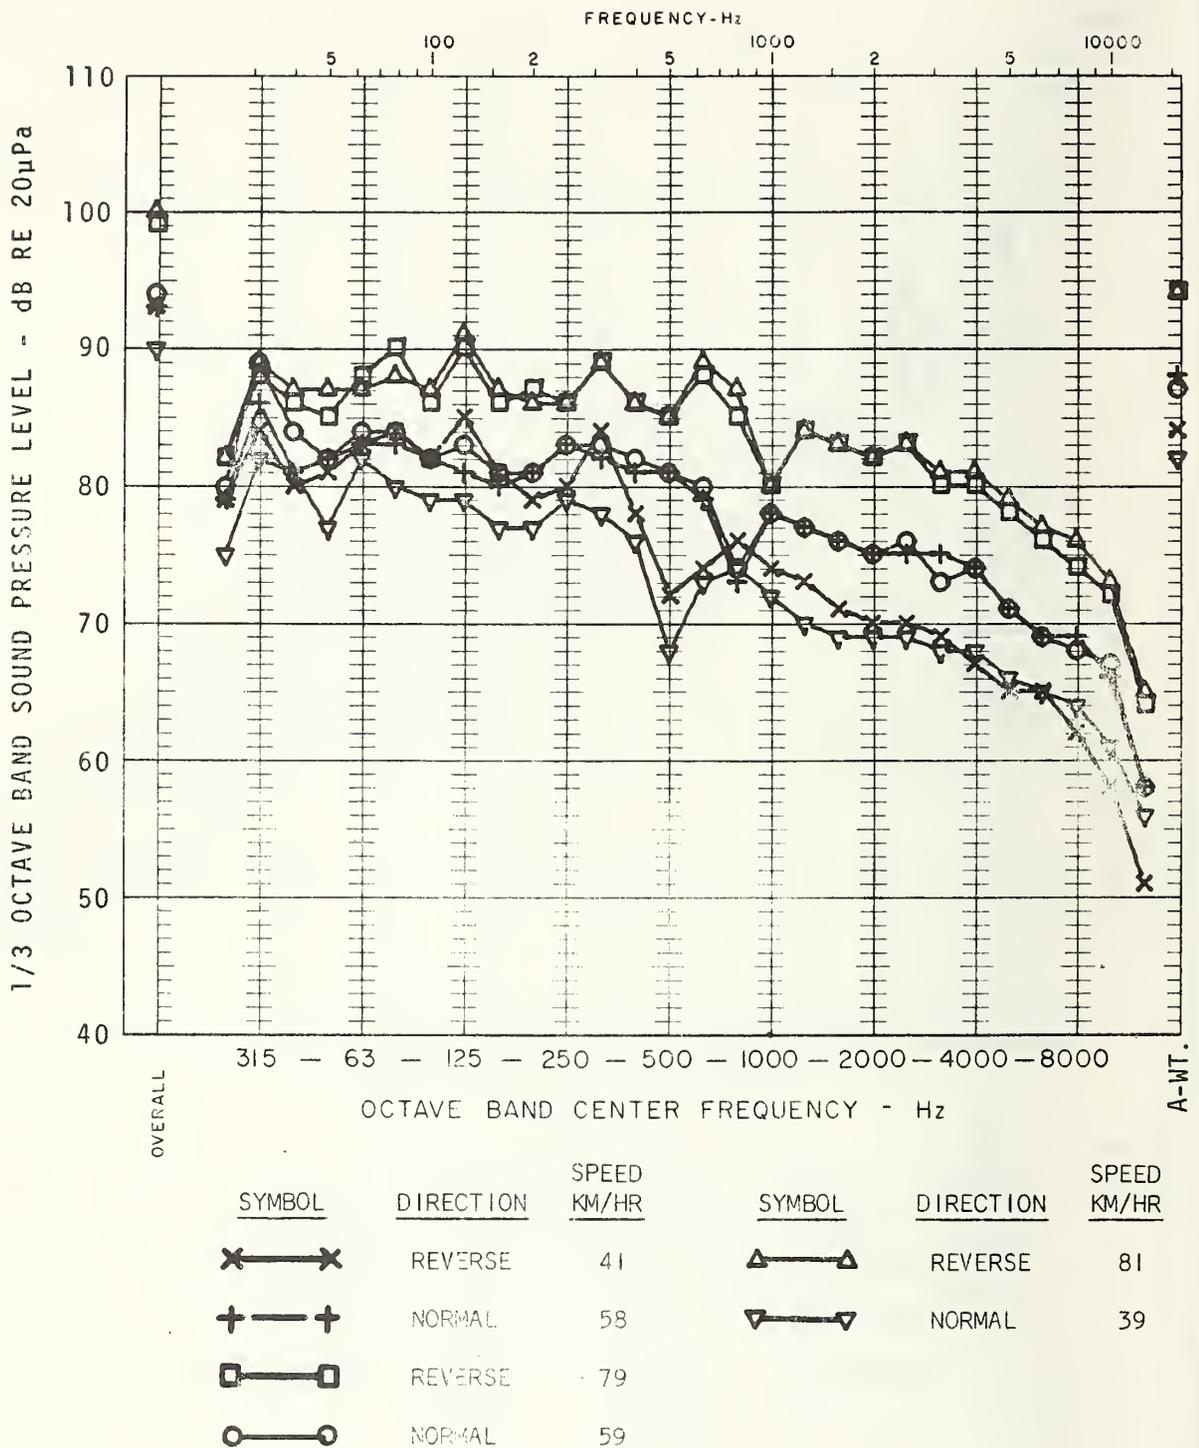
FIGURE B-21. BALLAST AND TIE TANGENT-JOINED TEST TRACK A  
 PHASE IIA; OCTOBER 4, 1976  
 WAYSIDE - TRUED STANDARD WHEELS

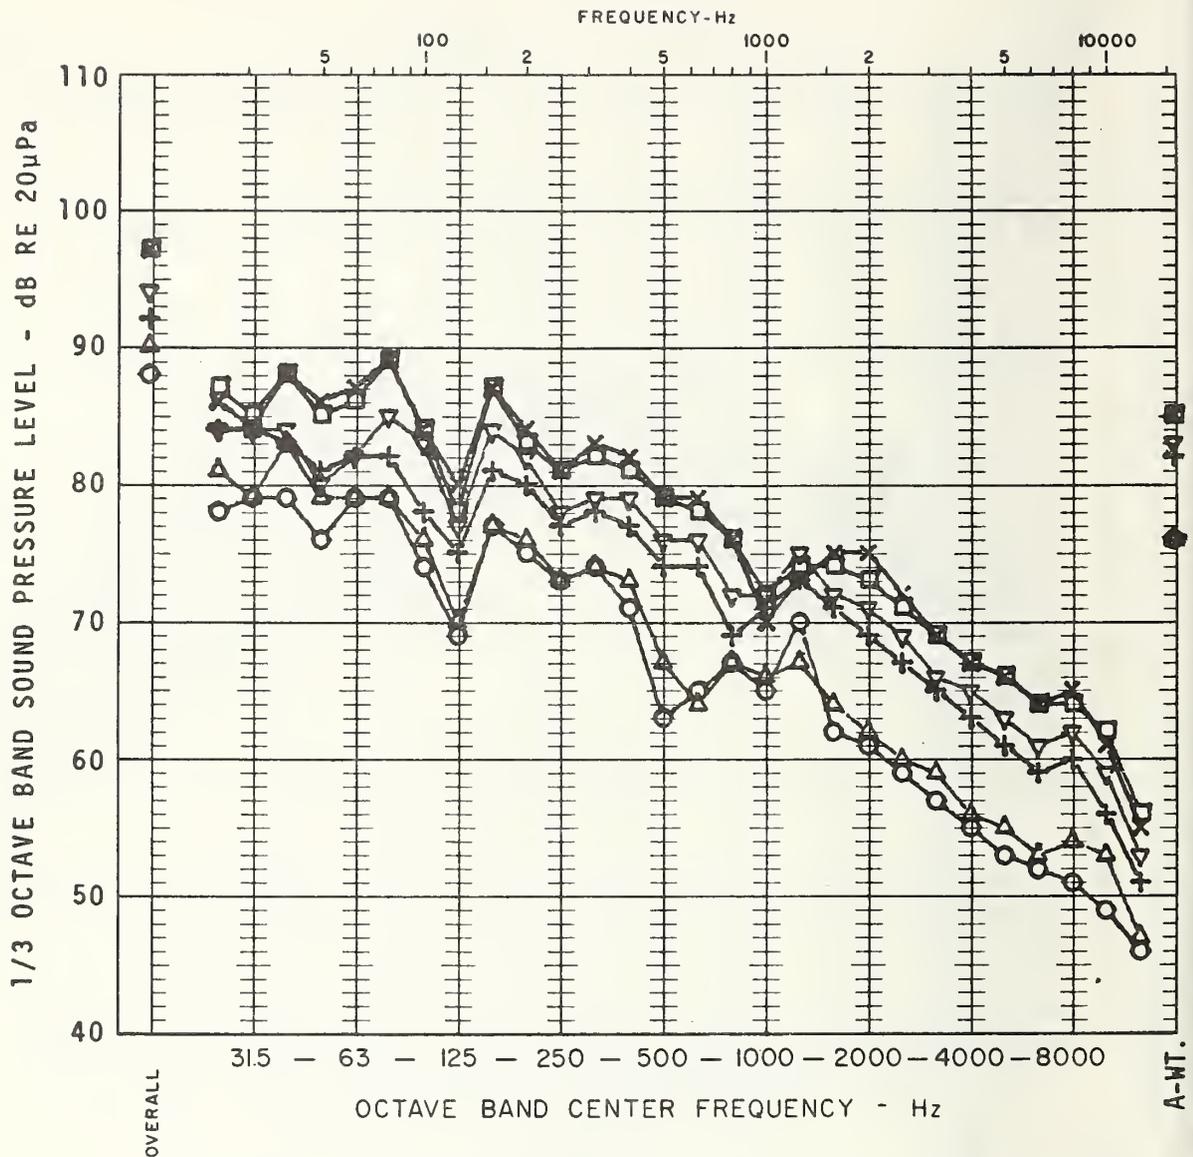
FIGURE B-25. BALLAST AND TIE TANGENT-JOINTED TEST TRACK A  
 PHASE IIB; OCTOBER 14, 1976  
 CAR INTERIOR, OVER TRUCK - WORN STANDARD WHEELS

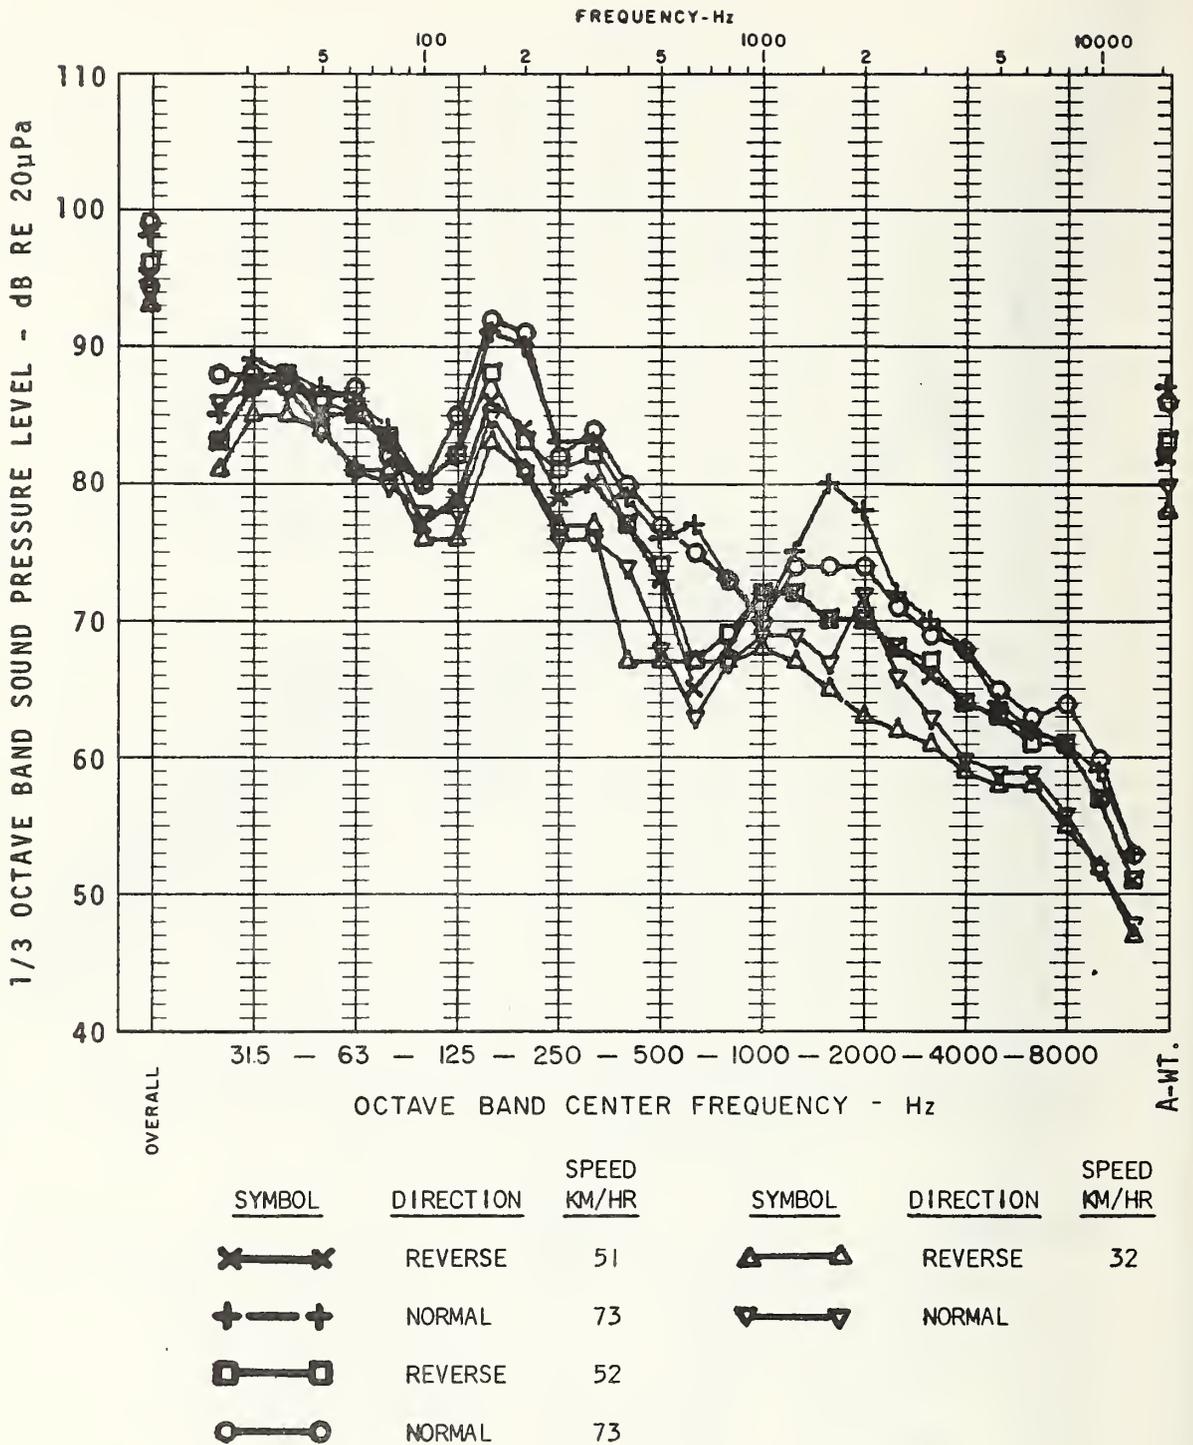
FIGURE C-7. TEST FROG ON BALLAST AND TIE TRACK  
 PHASE IIB; OCTOBER 14, 1976  
 CAR INTERIOR, OVER TRUCK - NEW PENN BOCHUM RESILIENT WHEELS
