T NO. UMTA-MA-06-0025-78-7

IN-SERVICE PERFORMANCE AND COSTS OF METHODS  
TO CONTROL URBAN RAIL SYSTEM NOISE  
INITIAL TEST SERIES REPORT

De Leuw, Cather & Company  
1201 Connecticut Avenue, NW  
Washington DC 20036

AUGUST 1978  
INTERIM REPORT

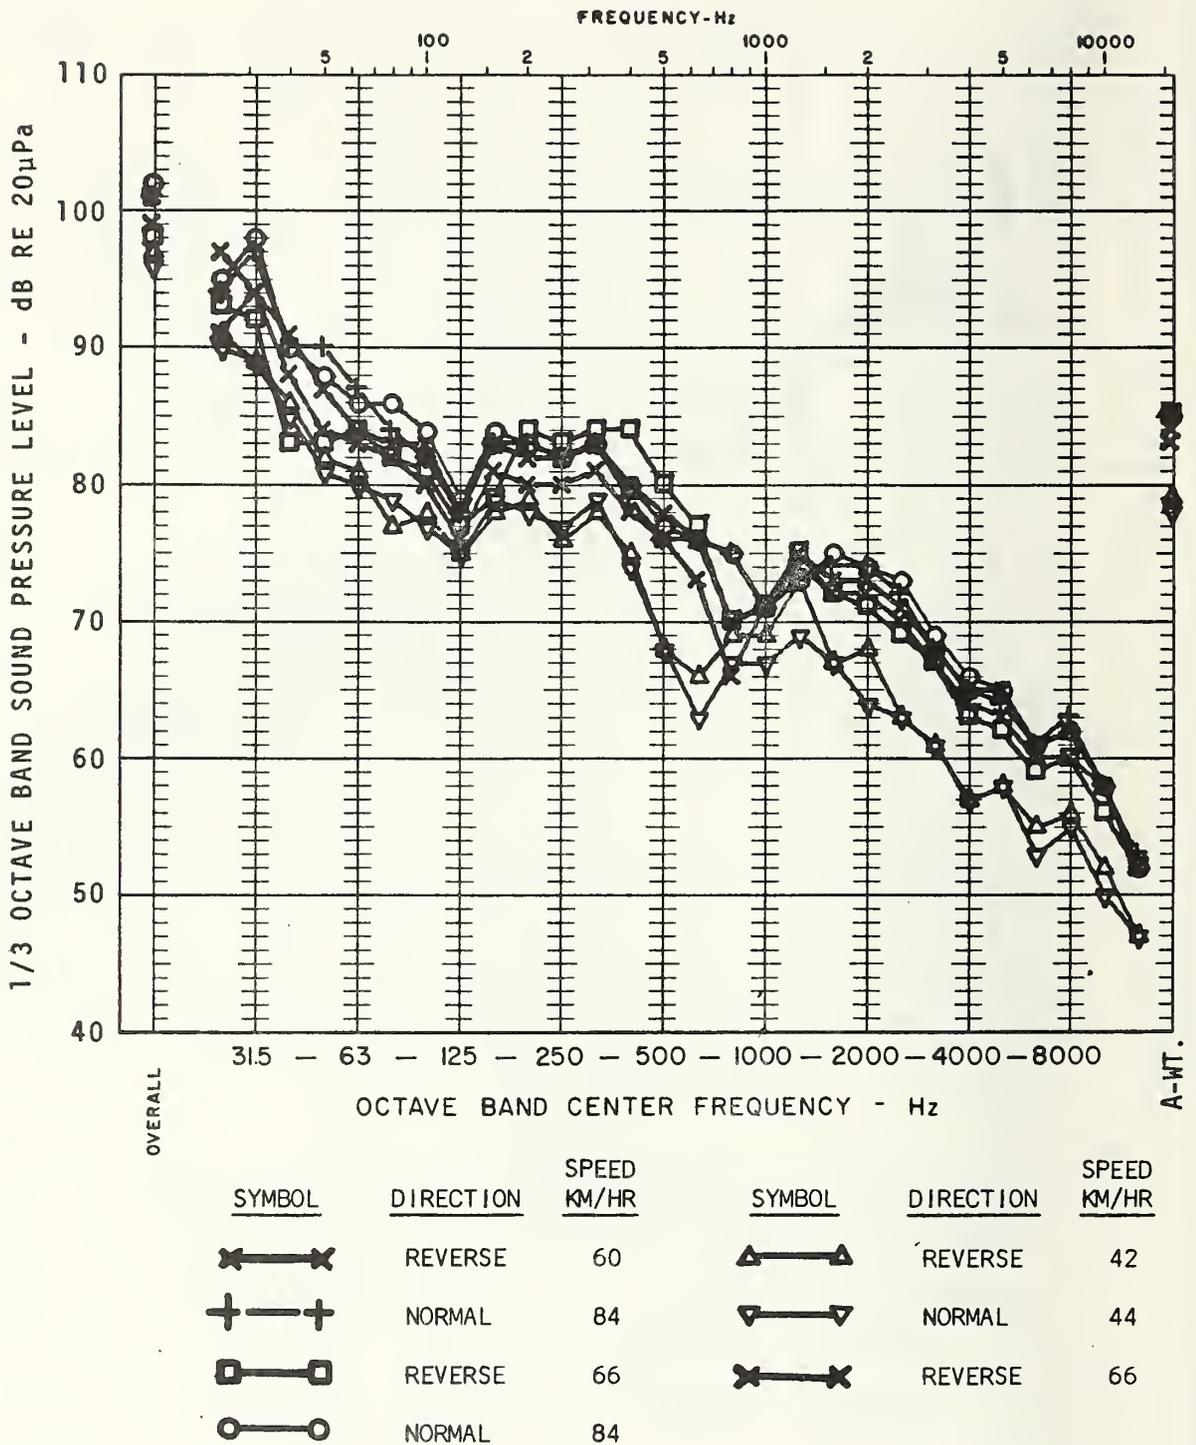
FIGURE C-9. TEST FROG ON BALLAST AND TIE TRACK  
 PHASE IIB; OCTOBER 14, 1976  
 CAR INTERIOR, OVER TRUCK - NEW SAB RESILIENT WHEELS

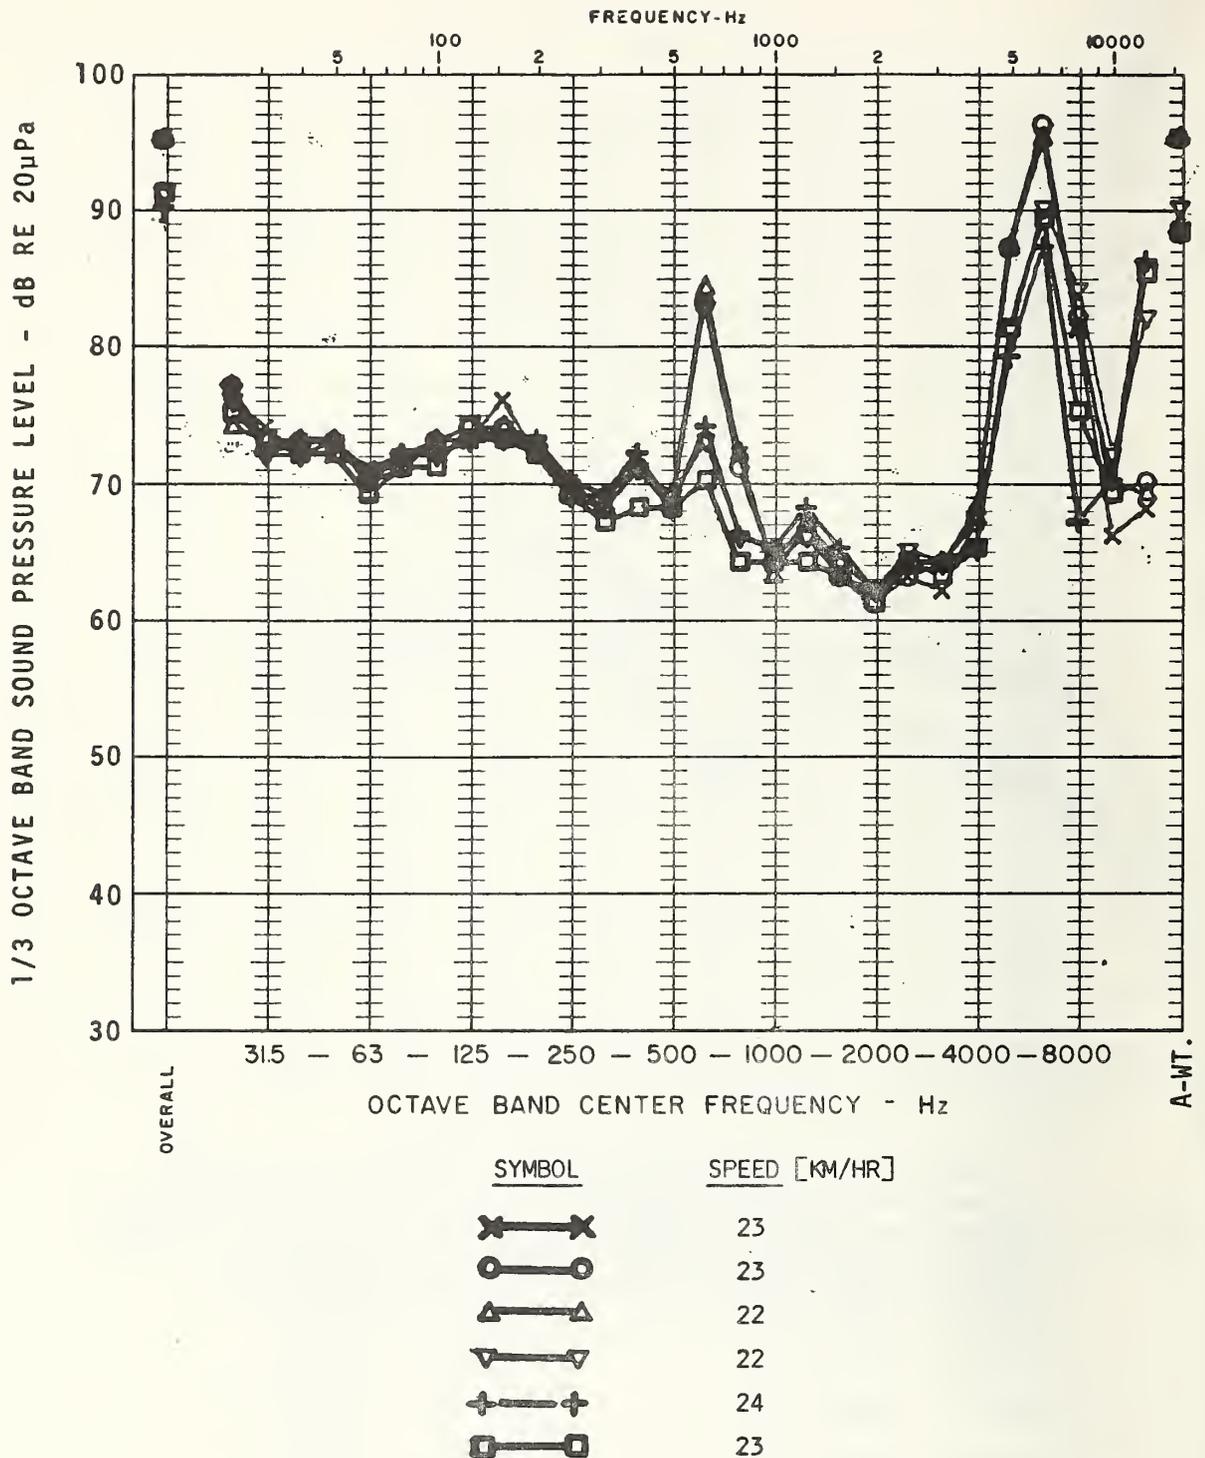
FIGURE D-1. SHORT RADIUS CURVE AT 69TH STREET TURNAROUND  
 PHASE IC; SEPTEMBER 1, 1976  
 CONTROL TRACK, WAYSIDE - WORN STANDARD WHEELS

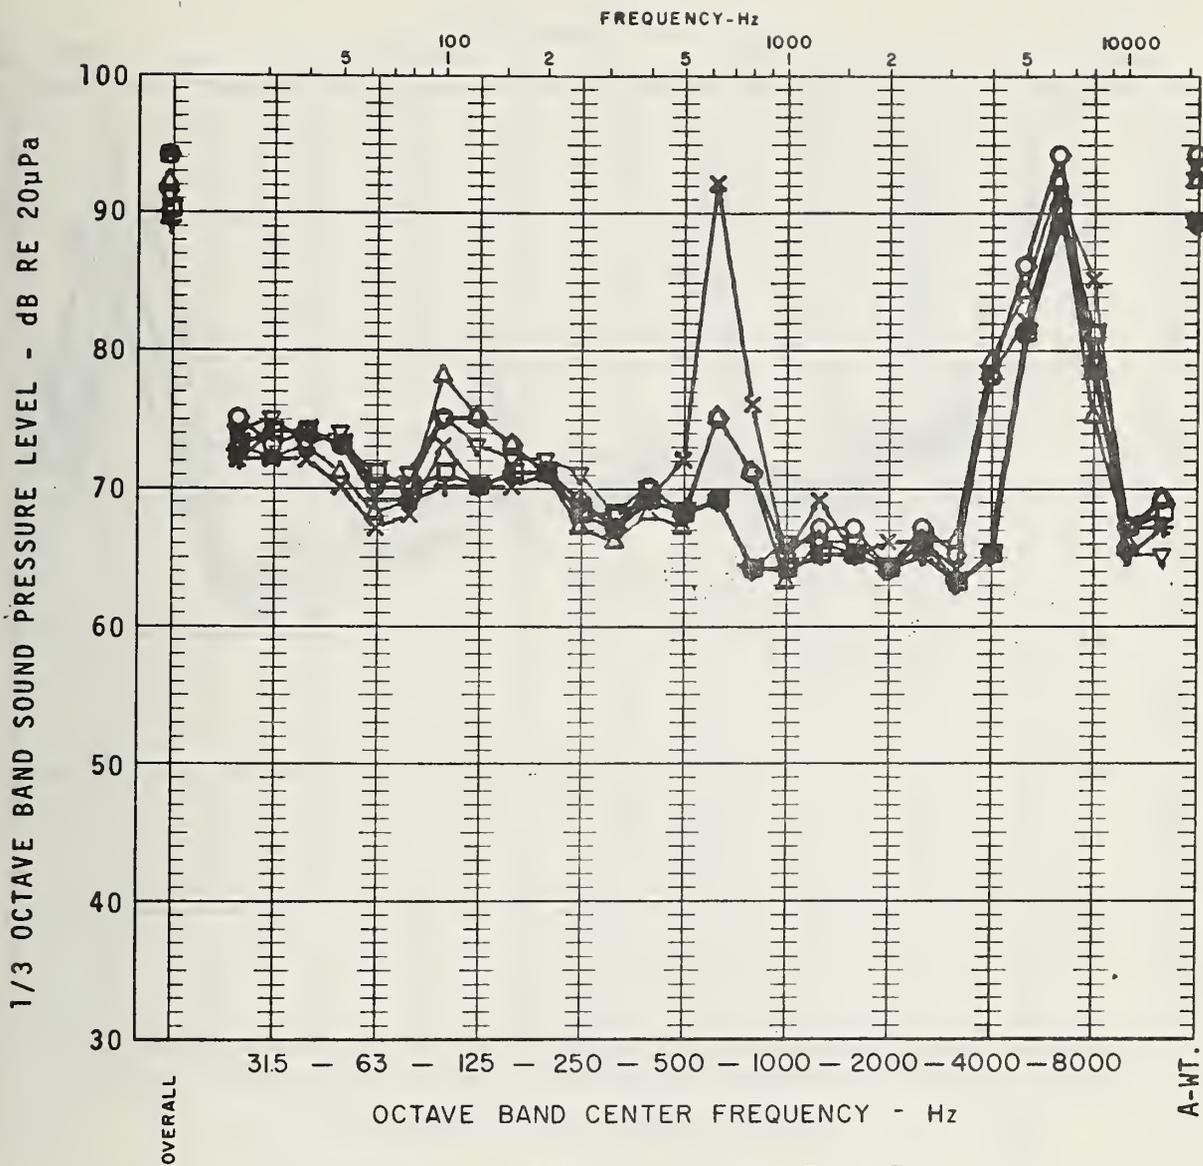
FIGURE D-2. SHORT RADIUS CURVE AT 69TH STREET TURNAROUND  
 PHASE IC; SEPTEMBER 1, 1976  
 TEST TRACK, WAYSIDE - WORN STANDARD WHEELS

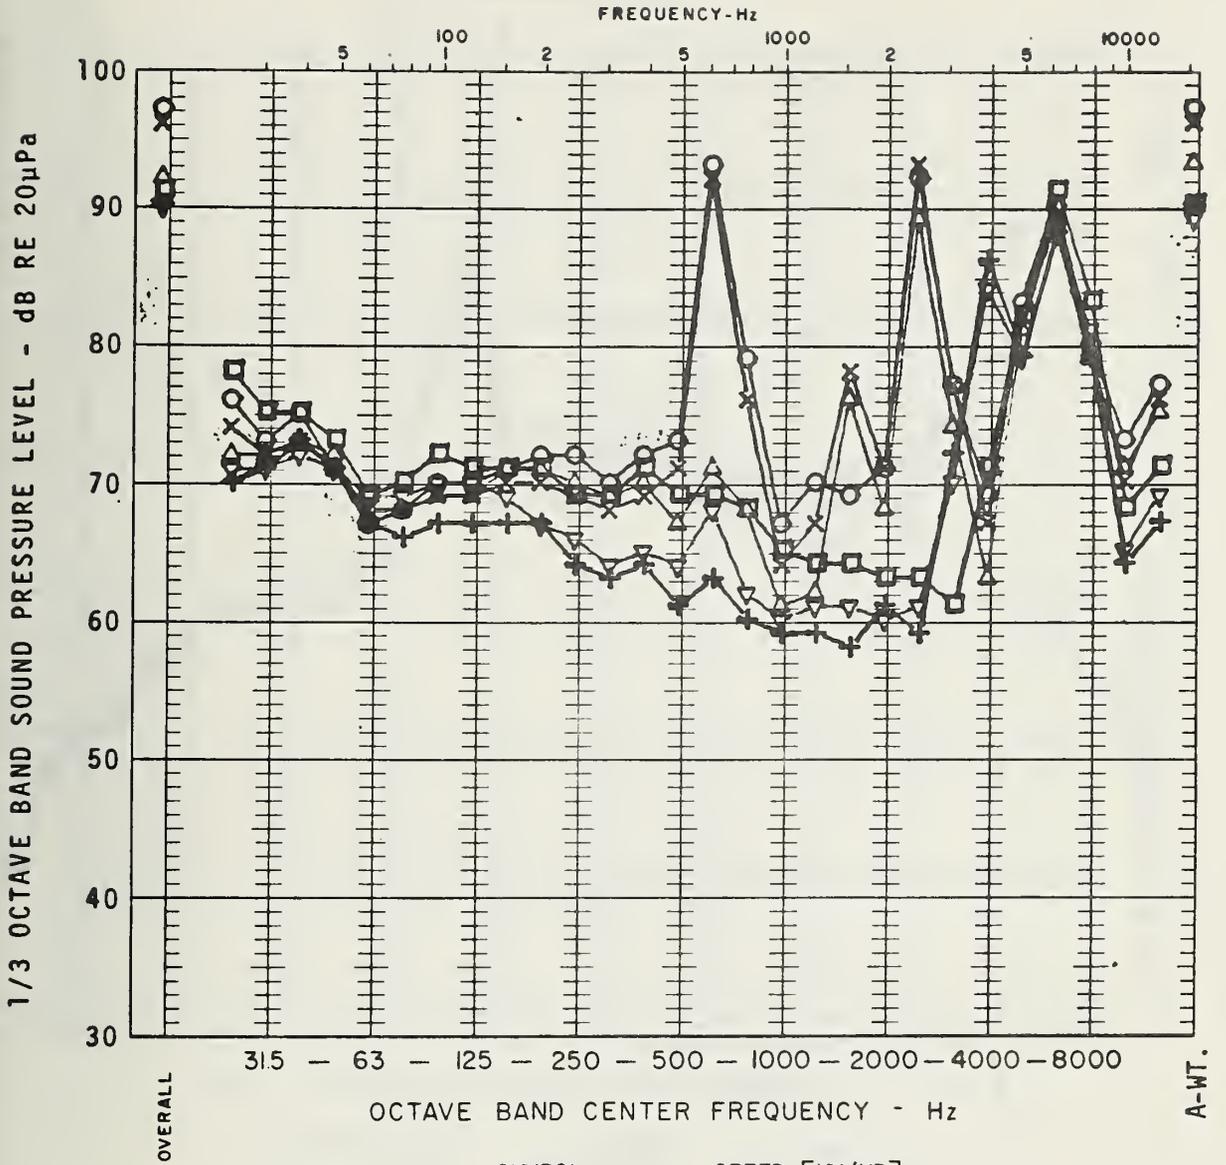
FIGURE D-4. SHORT RADIUS CURVE AT 69TH STREET TURNAROUND  
 PHASE IC; SEPTEMBER 1, 1976  
 TEST TRACK, WAYSIDE - TRUED STANDARD WHEELS

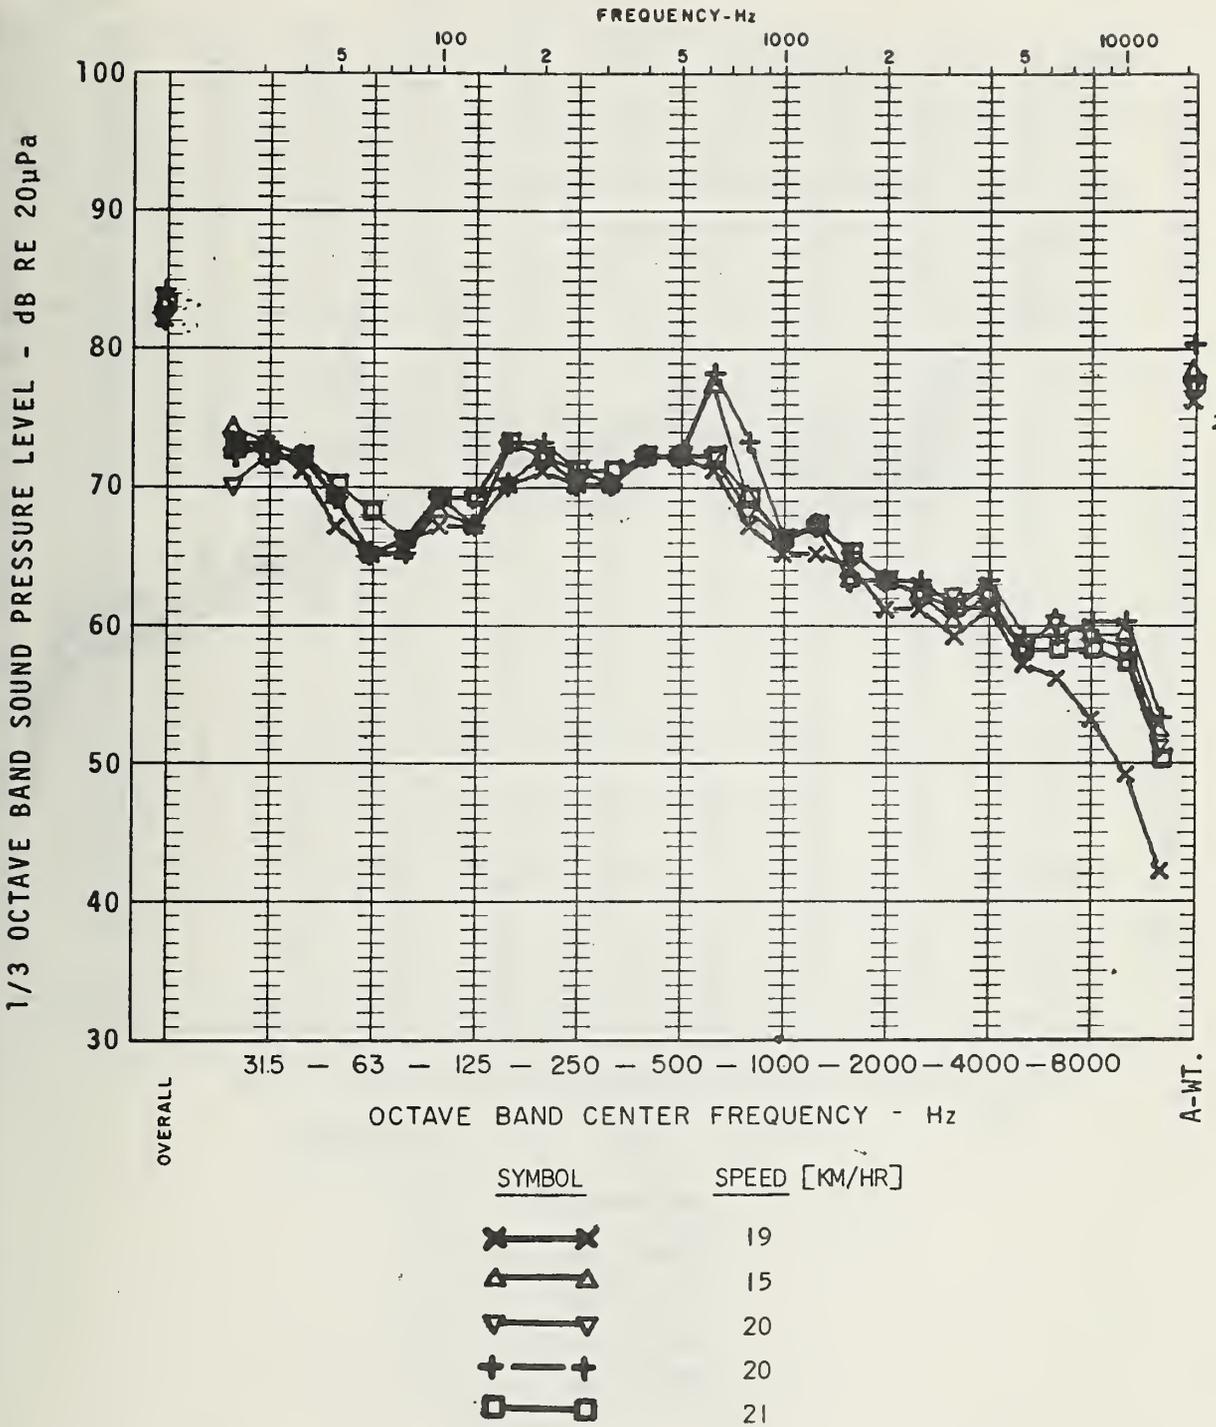
FIGURE D-8. SHORT RADIUS CURVE AT 69TH STREET TURNAROUND  
 PHASE IIA; OCTOBER 3, 1976  
 TEST TRACK, WAYSIDE - NEW RESILIENT ACOUSTAFLEX WHEELS

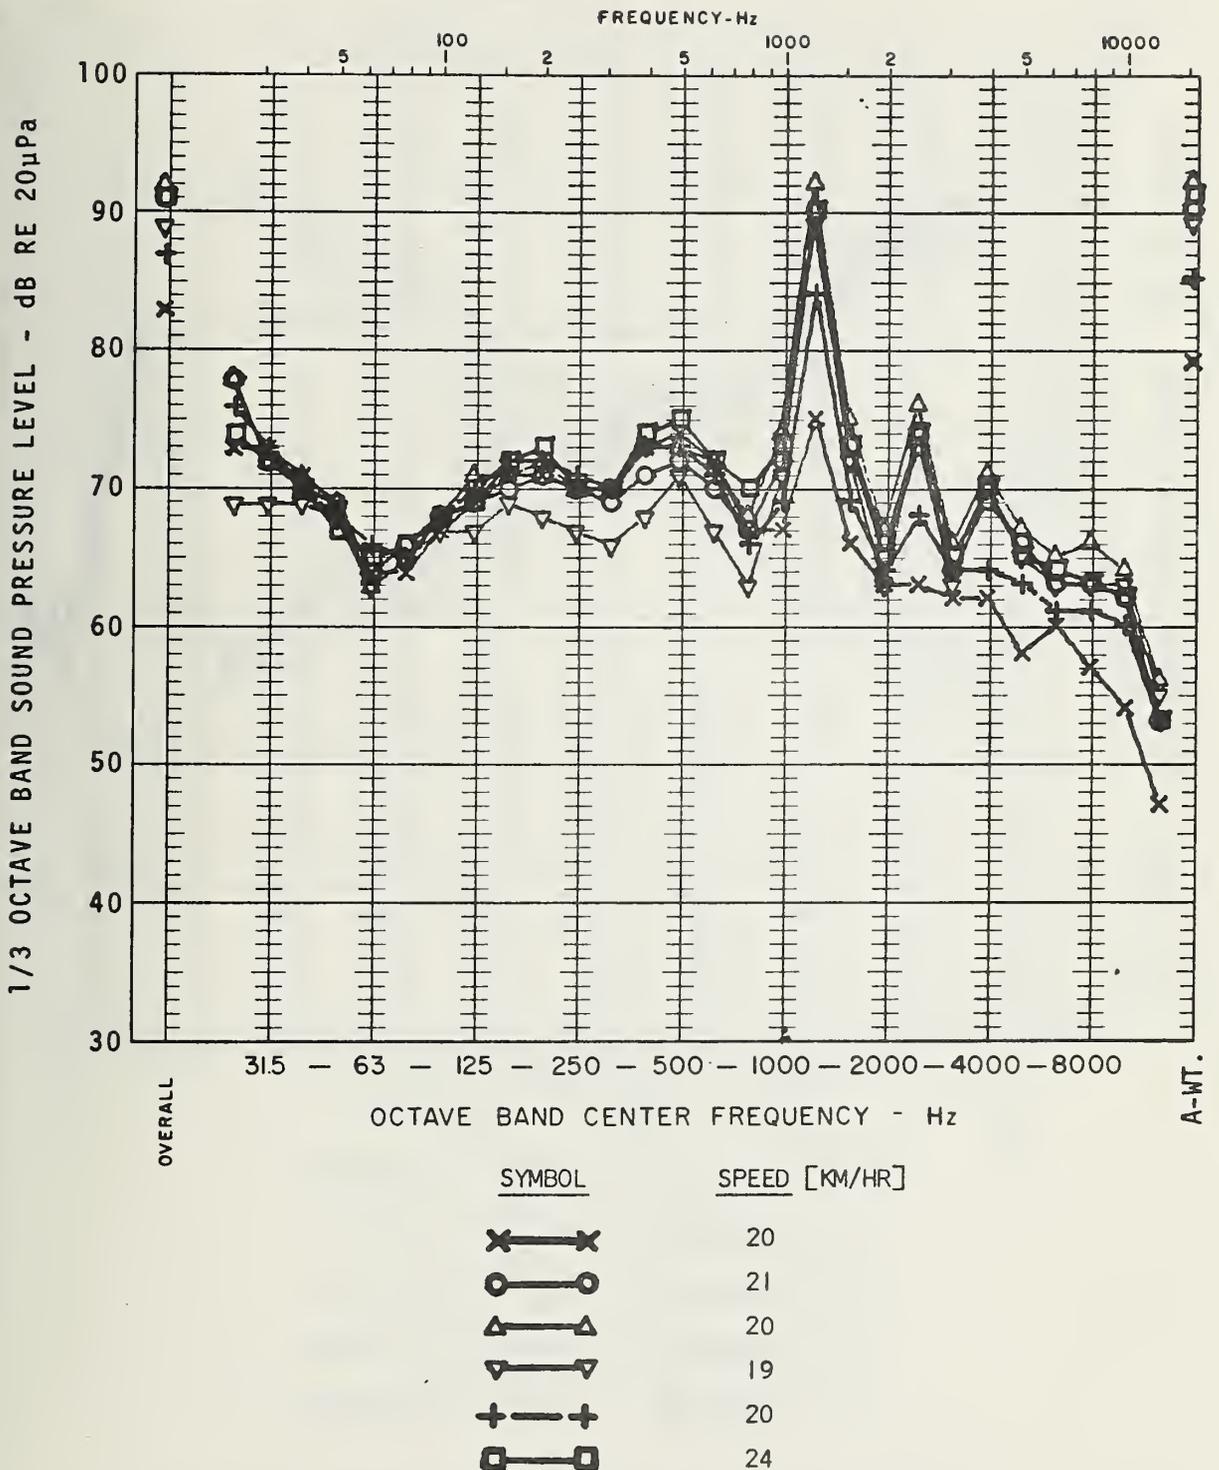
FIGURE D-12. SHORT RADIUS CURVE AT 69TH STREET TURNAROUND  
 PHASE IIA; OCTOBER 3, 1976  
 TEST TRACK, WAYSIDE - NEW SAB RESILIENT WHEELS

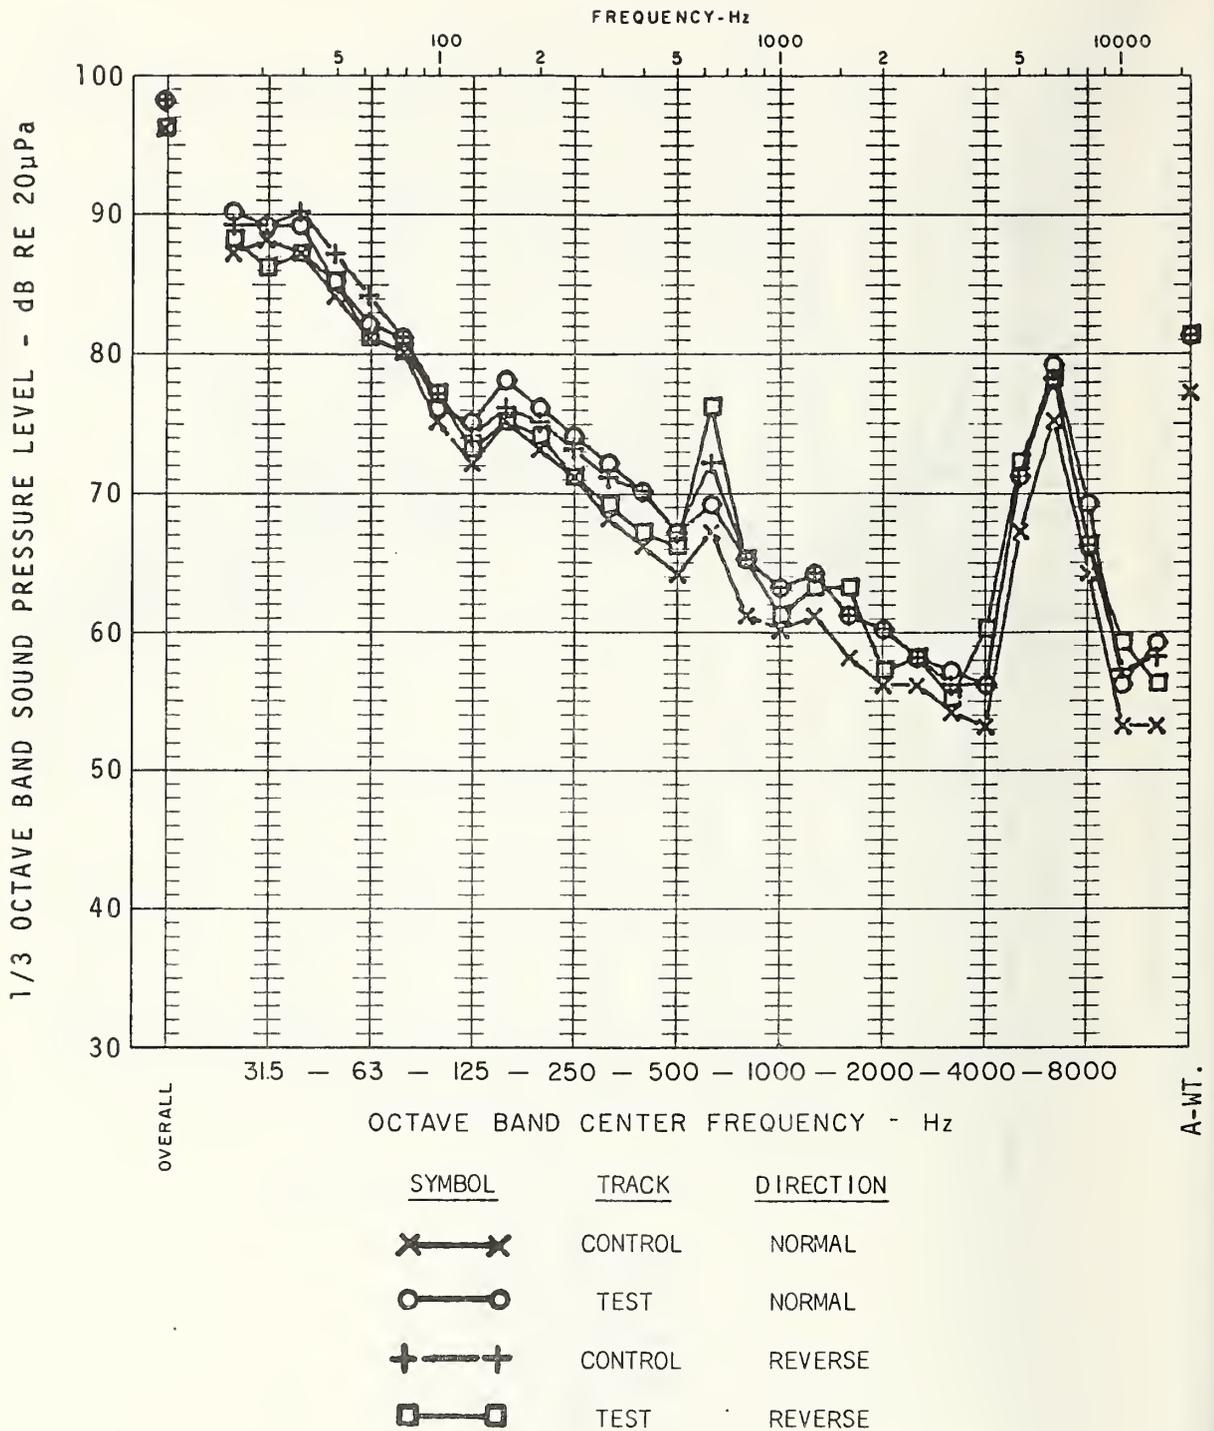
FIGURE D-13. SHORT RADIUS CURVE AT 69TH STREET TURNAROUND PHASE IA; JULY 15, 1976 - ENERGY AVERAGE OF ALL SAMPLES CAR INTERIOR, OVER TRUCK - WORN STANDARD WHEELS

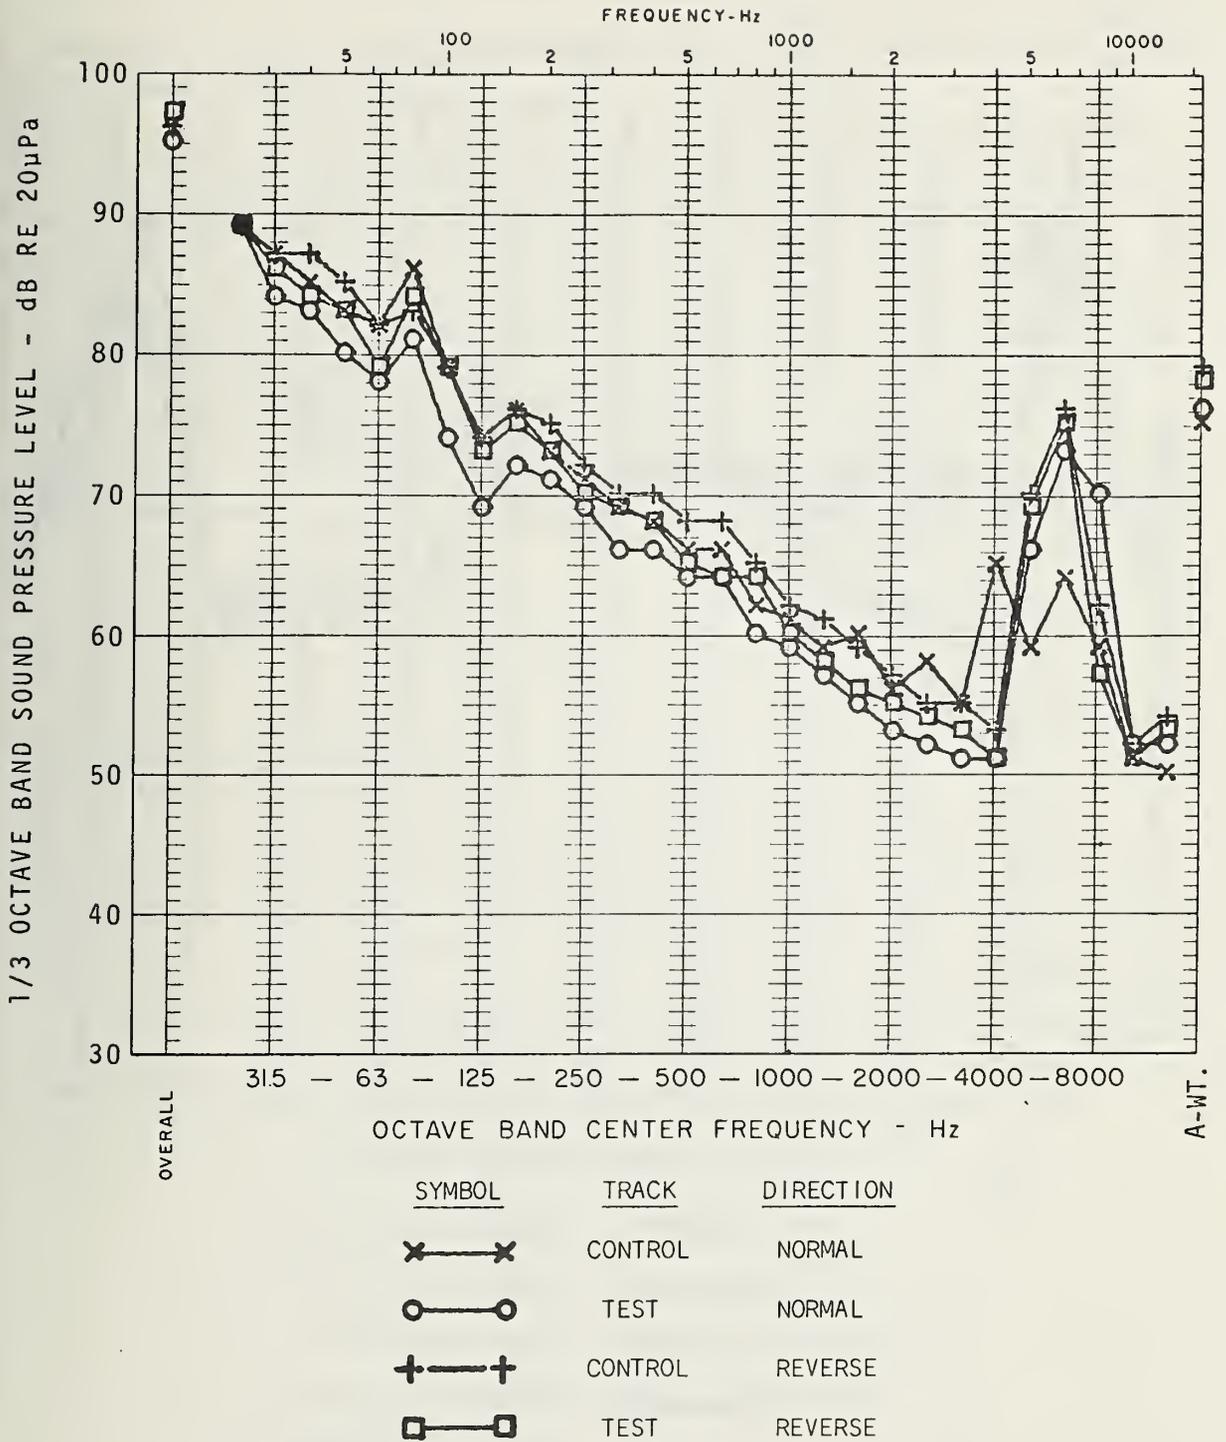
FIGURE D-14. SHORT RADIUS CURVE AT 69TH STREET TURNAROUND  
 PHASE IA; JULY 15, 1976 - ENERGY AVERAGE OF ALL SAMPLES  
 CAR INTERIOR, OVER TRUCK - NEW STANDARD WHEELS

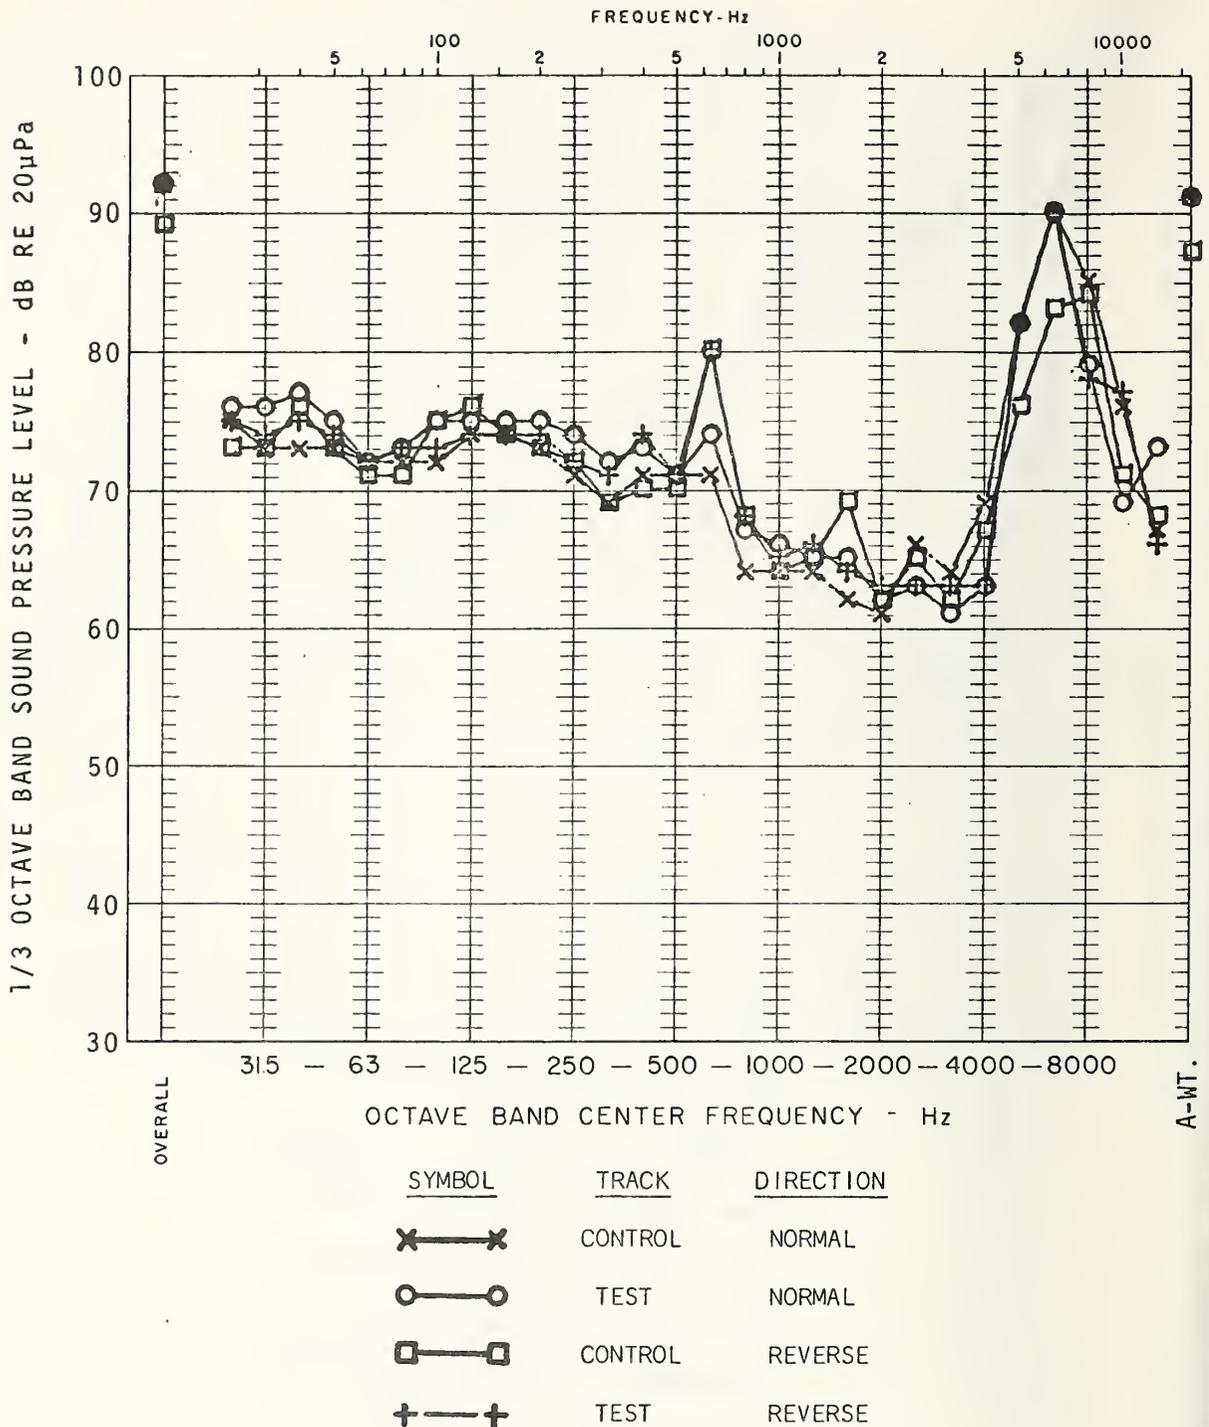
FIGURE D-15. SHORT RADIUS CURVE AT 69TH STREET TURNAROUND  
 PHASE IA; JULY 15, 1976 - ENERGY AVERAGE OF ALL SAMPLES  
 WAYSIDE - WORN STANDARD WHEELS

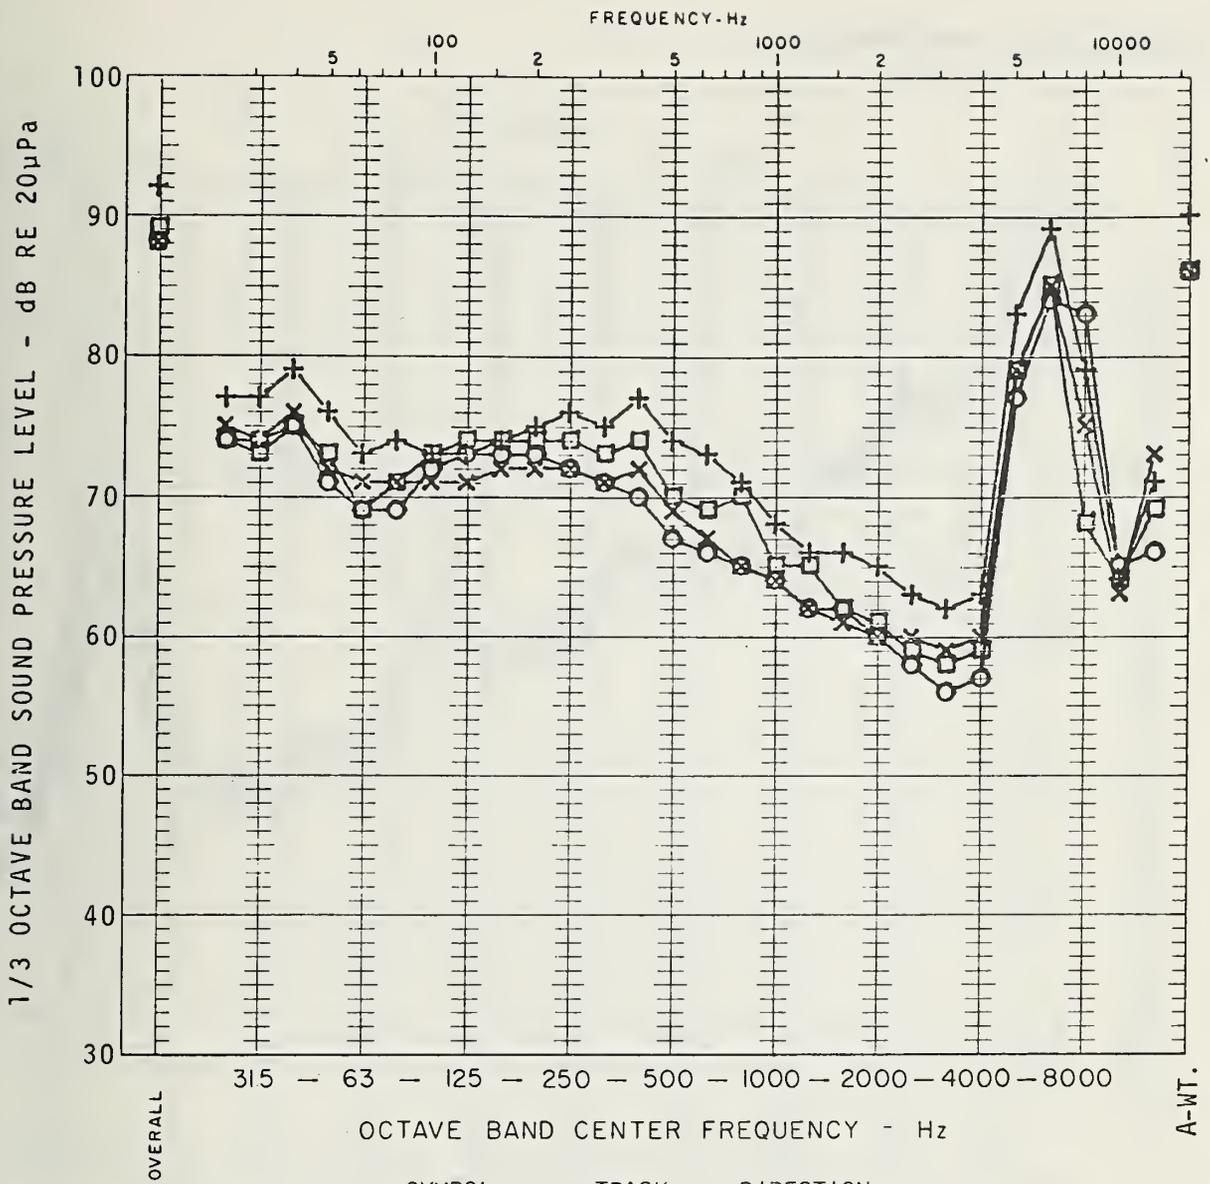
FIGURE D-16. SHORT RADIUS CURVE AT 69TH STREET TURNAROUND  
 PHASE IA; JULY 15, 1976 - ENERGY AVERAGE OF ALL SAMPLES  
 WAYSIDE - NEW STANDARD WHEELS
