RESEARCH PROJECT CAPSULE [15-3ST]

March 2016

Rehabilitation of Deteriorated Timber Piles using Fiber Reinforced Polymer (FRP) Composites

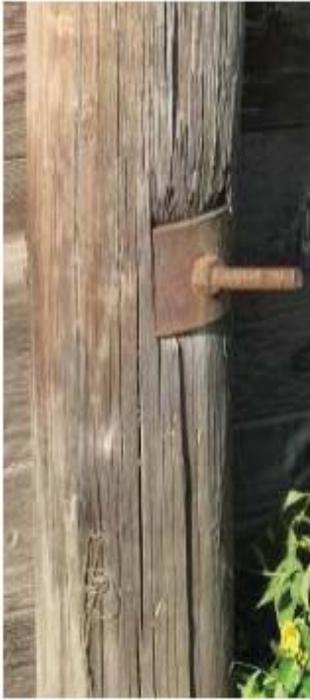
(a) Mechanical damage

Figure 1
Several forms of timber deterioration
(Bigelow et al., 2007)

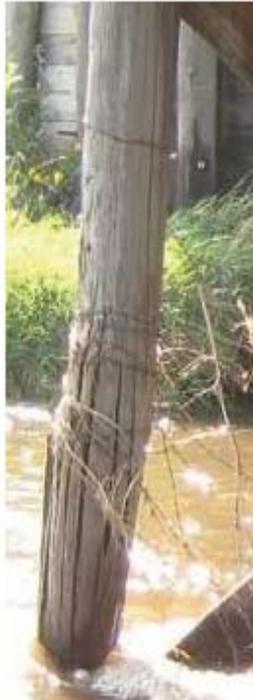
(b) Debris damage

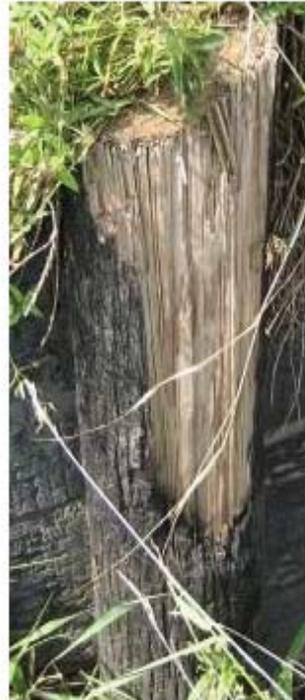
(c) Fire damage

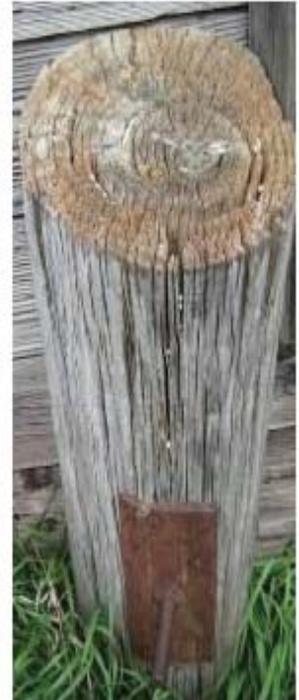
(d) Weathering/UV damage
