RESEARCH PROJECT NO. 86-001

**Geogrid Mesh For Reflective Crack Control In
Bituminous Concrete Overlays**

**FINAL REPORT
JULY 2000**

SITE A
SR 0073, Gilbertsville, Montgomery County
Engineering District 6-0

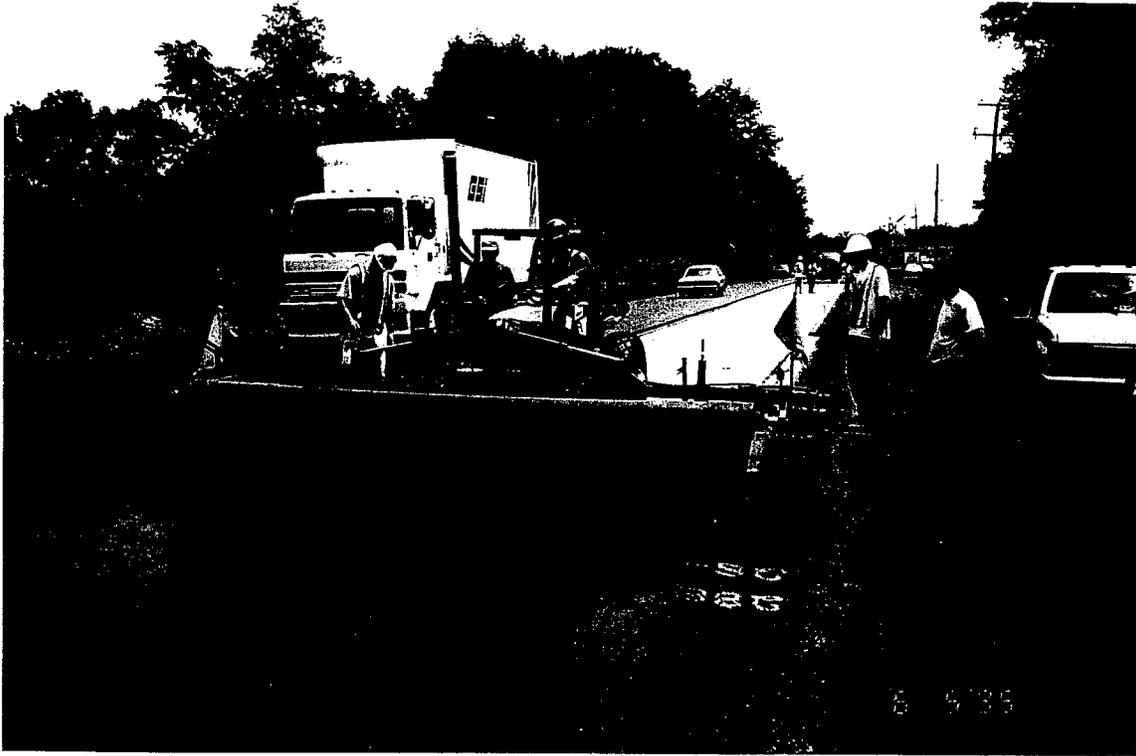
Photograph - 36, Placement of Petromat at 0070/0714 east bound.

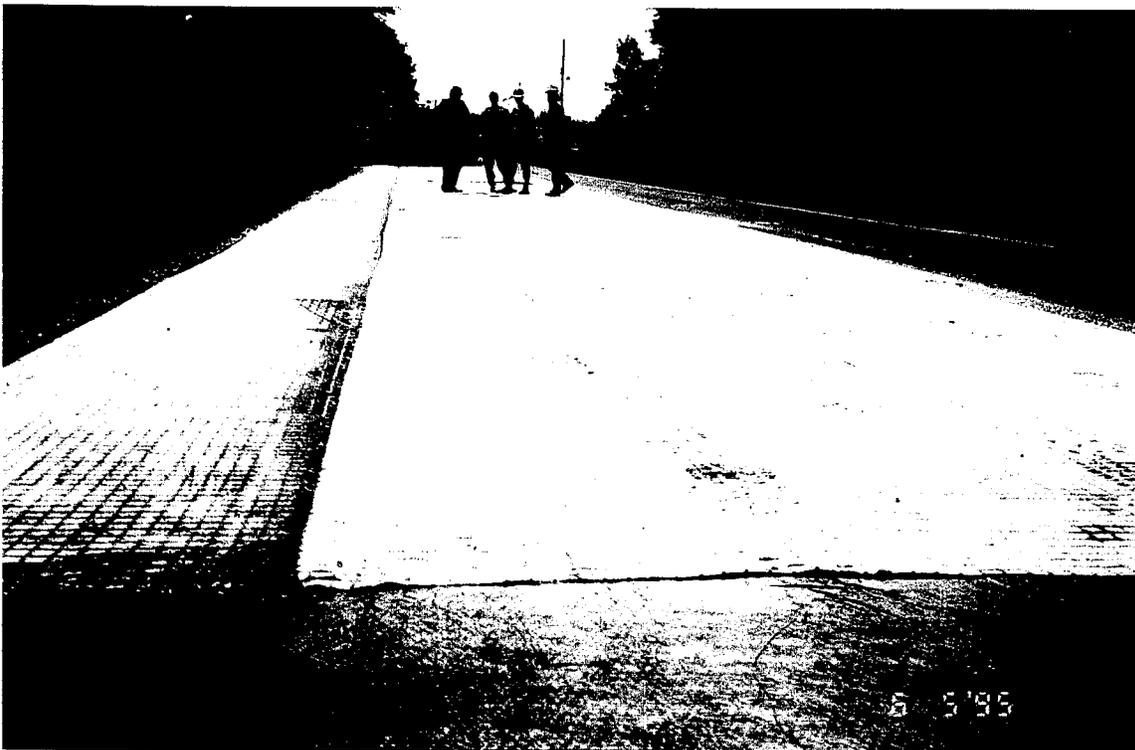
Photograph - 37, Placement of Bit-U-Tex at 0070/0739 west bound.

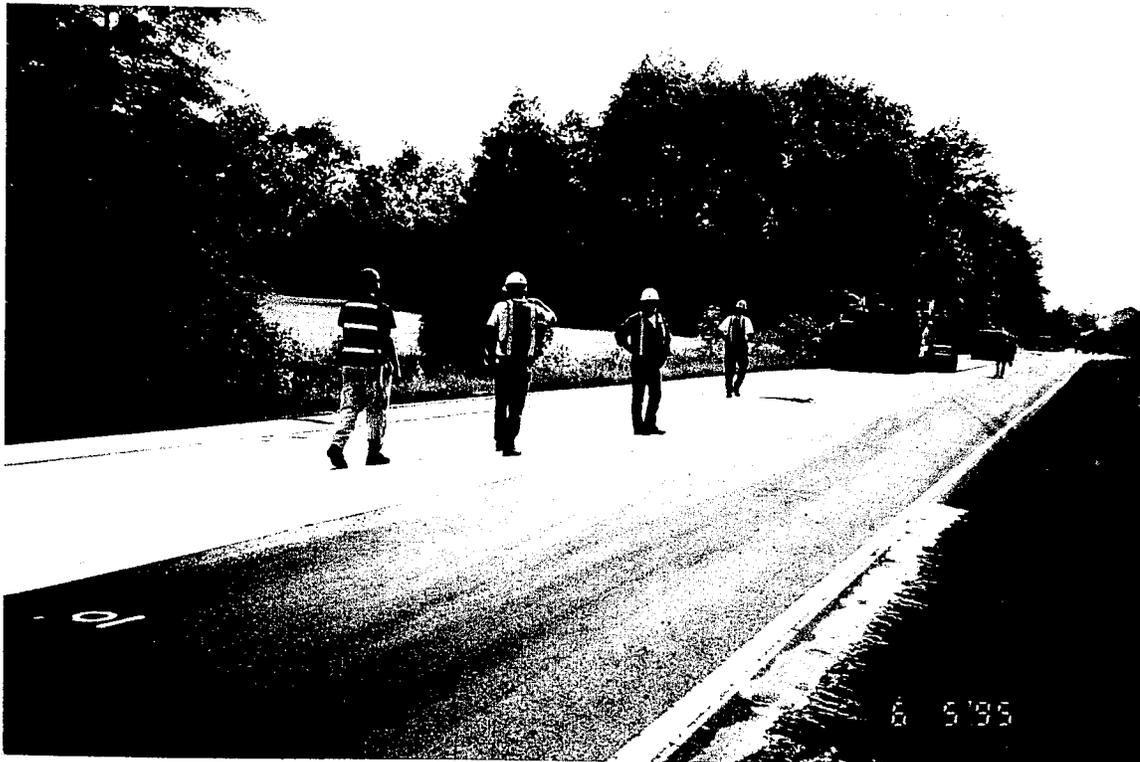
Photograph - 39, 1½" ID-2 bituminous wearing overlay placed over Bit-U-Tex.

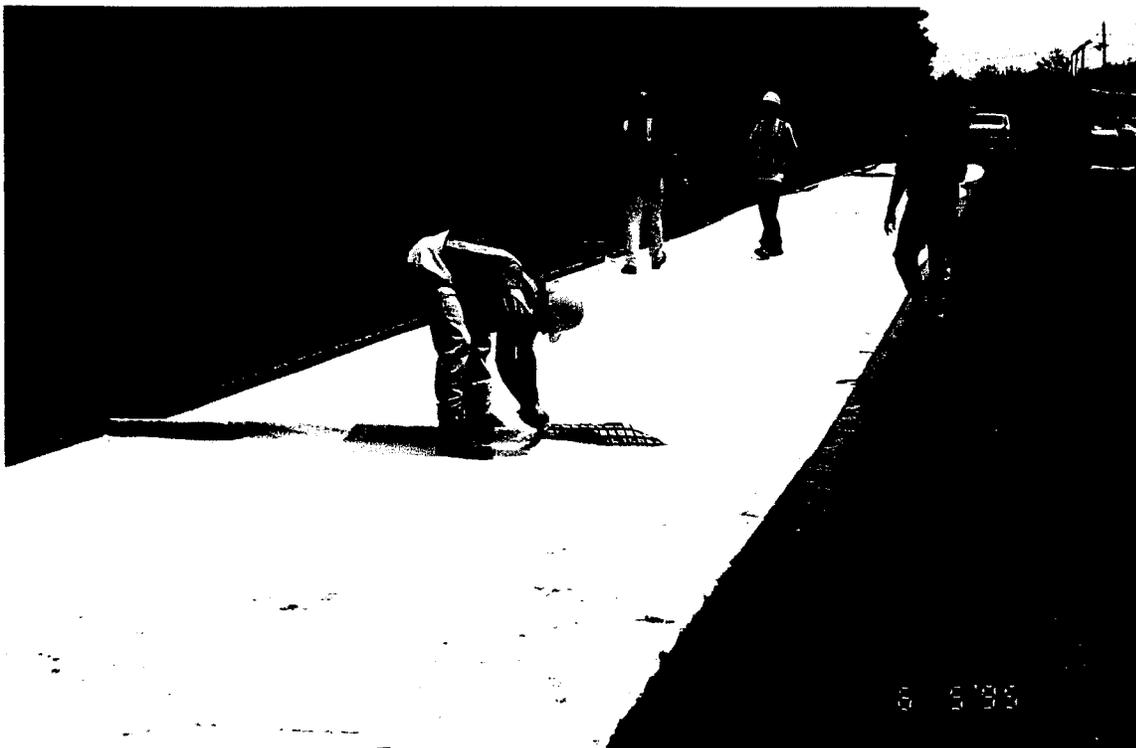
Photograph - 49, Removing a double fold from the Bit-U-Tex ensure adhesion of the material to the pavement.

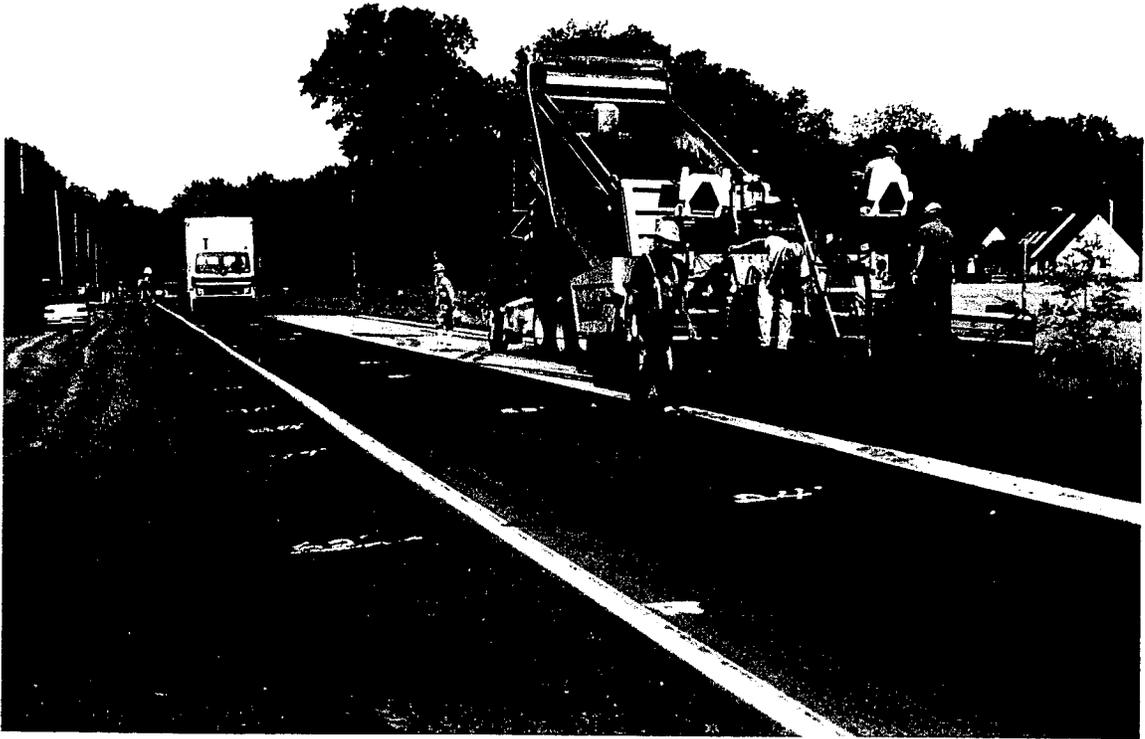
Photograph - 50, Paving over the Bit-U-Tex

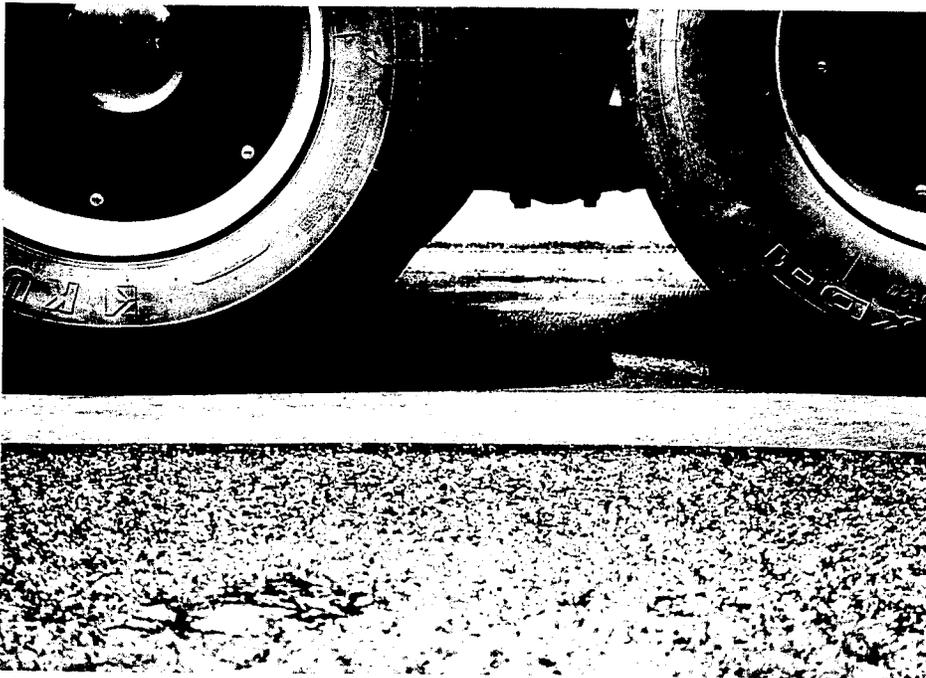
The Petromat test section was installed adjacent to the Bit-U-Tex without incident but was being picked up by the tires on triaxle dump trucks as the trucks were unloading ID-2 into the hopper on the paver (see photograph 41). The paver even picked up the Petromat at each of the overlapped seams during placement of the ID-2 bituminous wearing course. The fabric was being pulled off the AC-20 tack coat by the rubber-tired equipment. The high air temperature did not allow the AC-20 to harden sufficiently prior to placing the bituminous wearing. The first phase of construction on the test sections was done during the cool of the morning. This allowed the AC-20 to cool and become tacky enough to hold down the fabric. The afternoon phase of operations did not have the optimum field temperature to allow the material to be placed without experiencing some problems.

Photograph - 51, Shows the Petromat being picked up by the tire of a triaxle dump truck while unloading bituminous hot mix into the hopper of the paver.

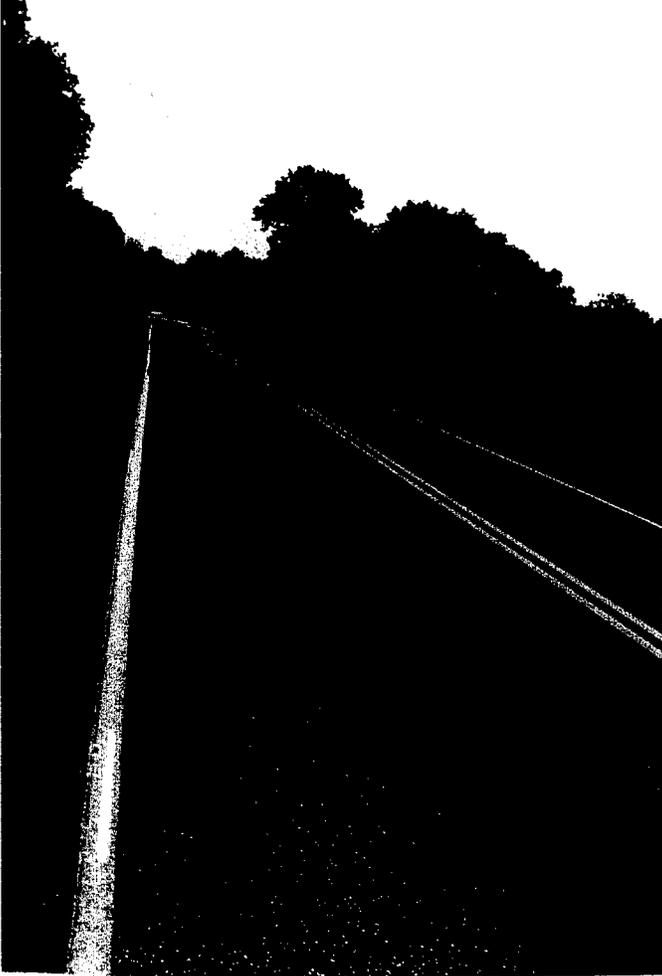
Photograph – 52, Test Section

The Bit-U-Tex and Petromat paving fabrics evaluated on SR 0073 at this site also did not prevent or retard reflective cracking. Both the control and test sections performed the same and began to show reflective cracks in the third year of this study. This is illustrated in Photographs 52 to 80.

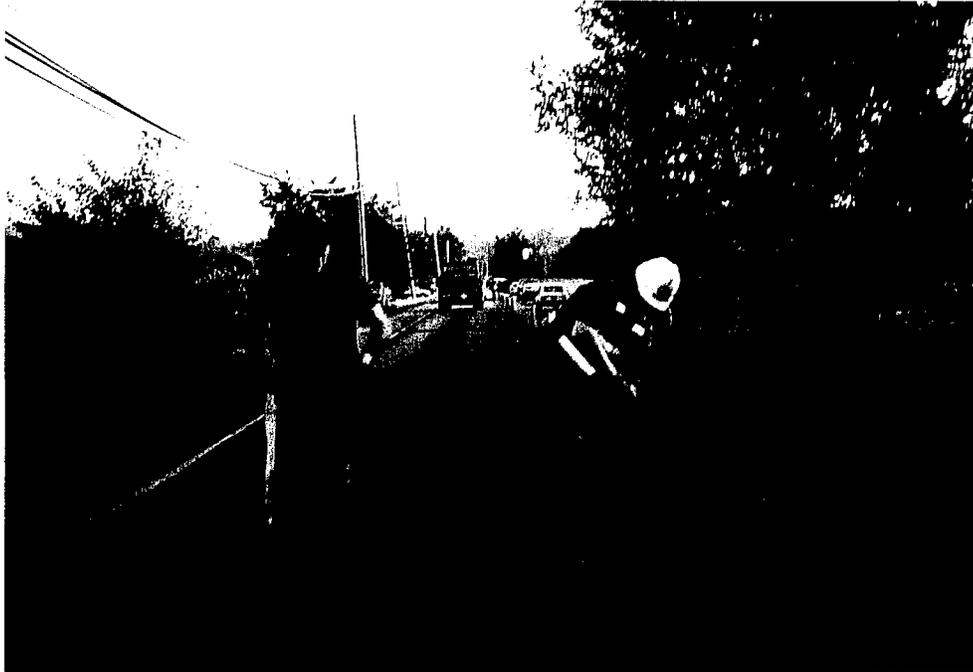
Photograph - 93, Glasgrid is unrolled to the correct length.

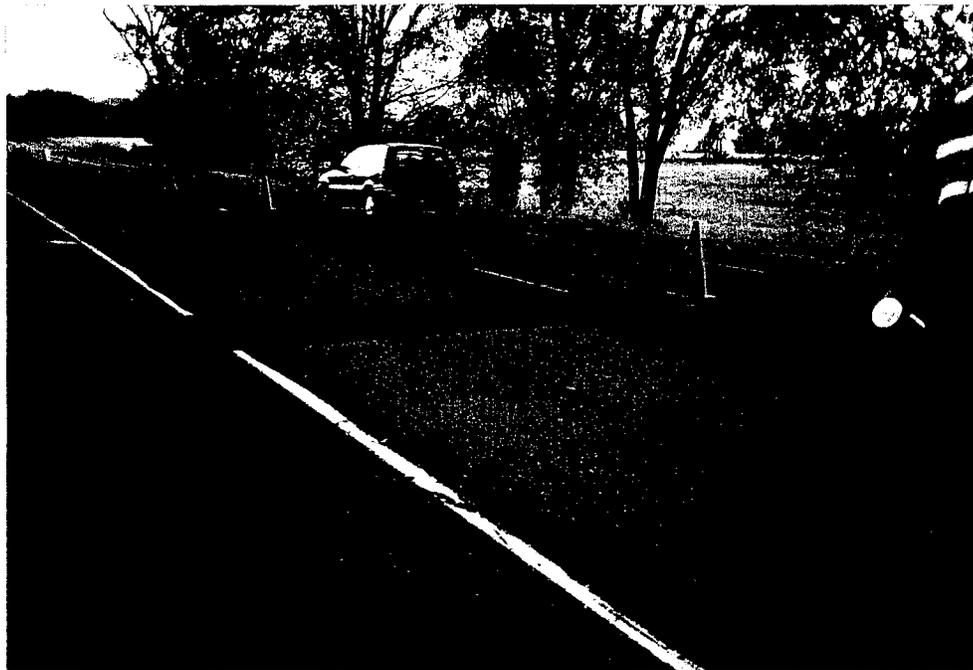
Photograph - 94, the Glasgrid is then placed, and cut to length over a longitudinal pavement joint.

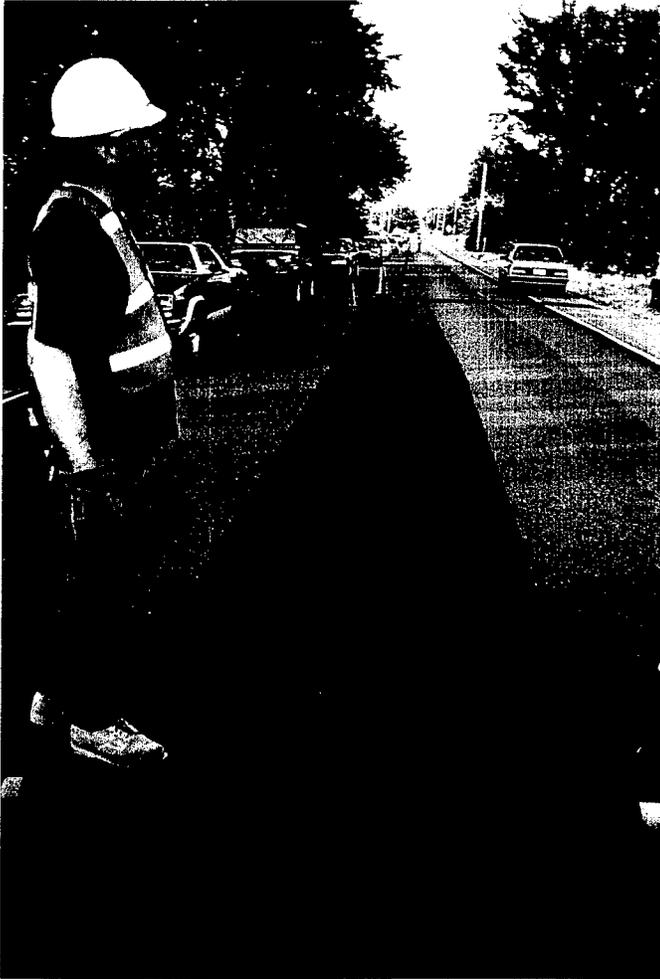
Photograph - 95, After the Glasgrid was placed an automobile was used to track the material in. This ensured adhesion of the material to the existing pavement.

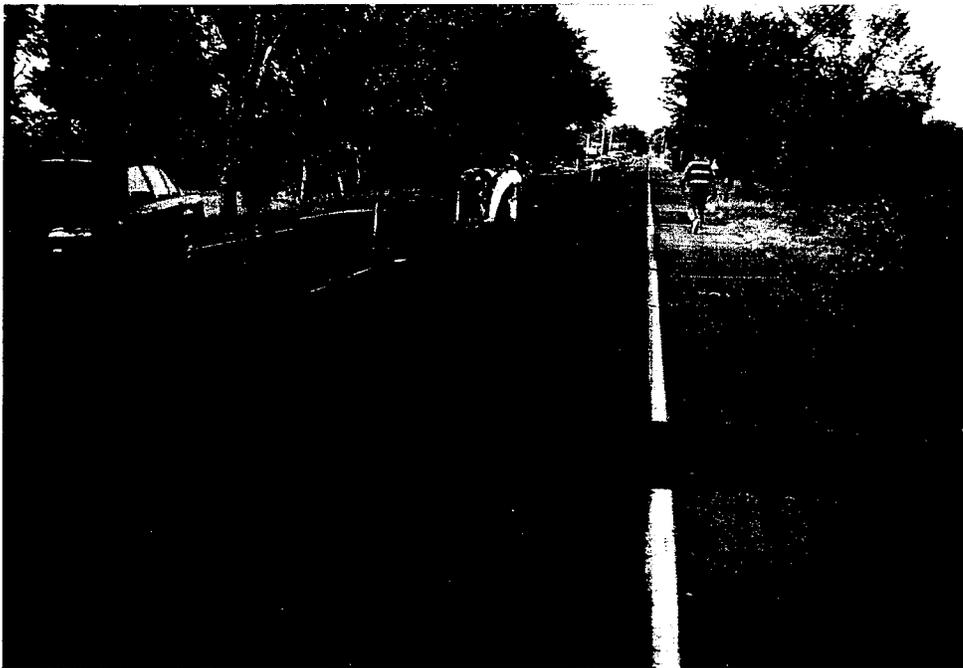
Photograph - 96, The material was placed on 6 transverse and one longitudinal joint.
