Report No. FHWA-RD-73-13

**FHWA- INVESTIGATION OF THE EFFECTIVENESS OF EXISTING
RD- GE DESIGN METHODOLOGY IN PROVIDING ADEQUATE
73-13 STRUCTURAL RESISTANCE TO SEISMIC DISTURBANCES.**

Phase I: Literature Survey

**November 1972
Final Report**

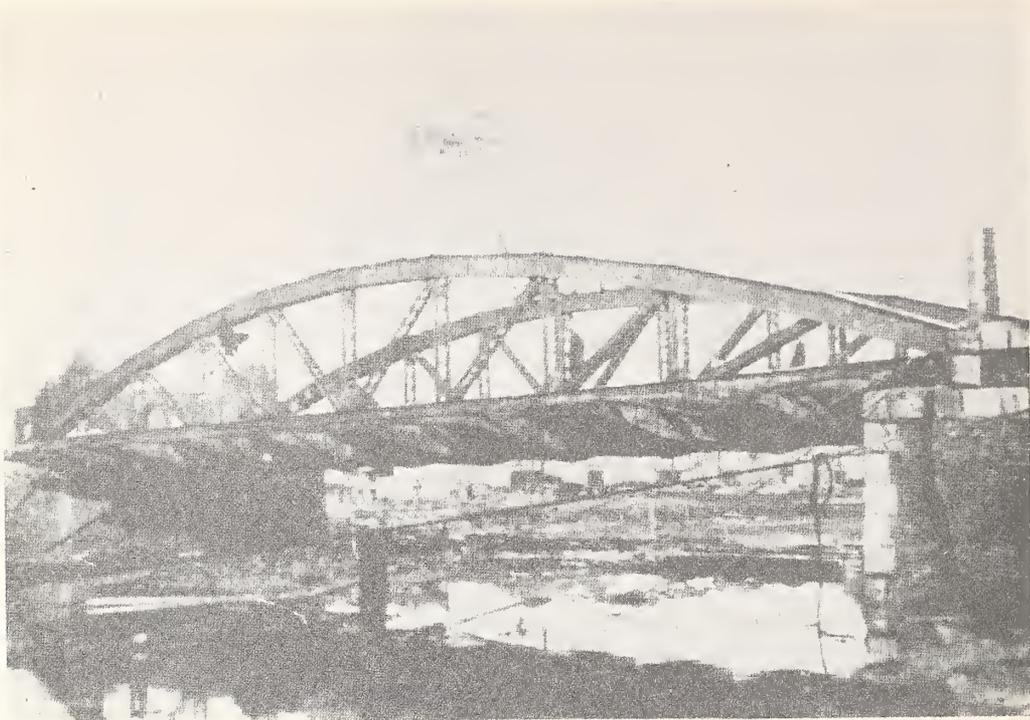
Photo. 2.2 Damage to the west support at the northern abutment of the Shinminato bridge.

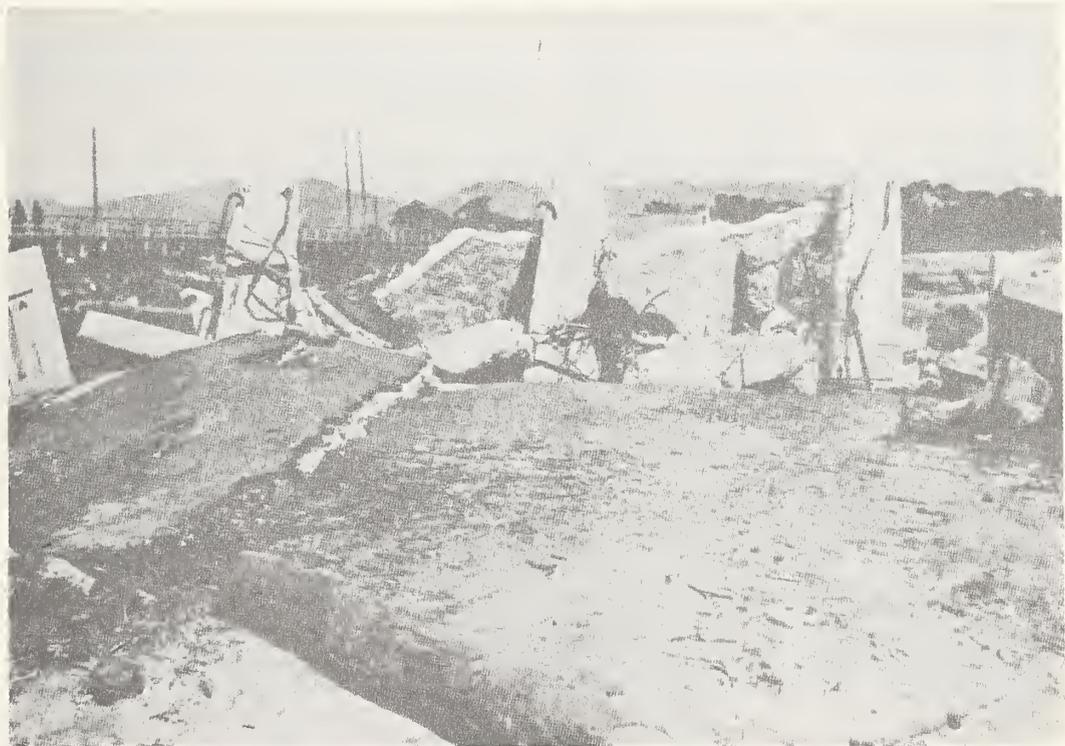
Photo. 2.9 Damage to the Sakawa bridge

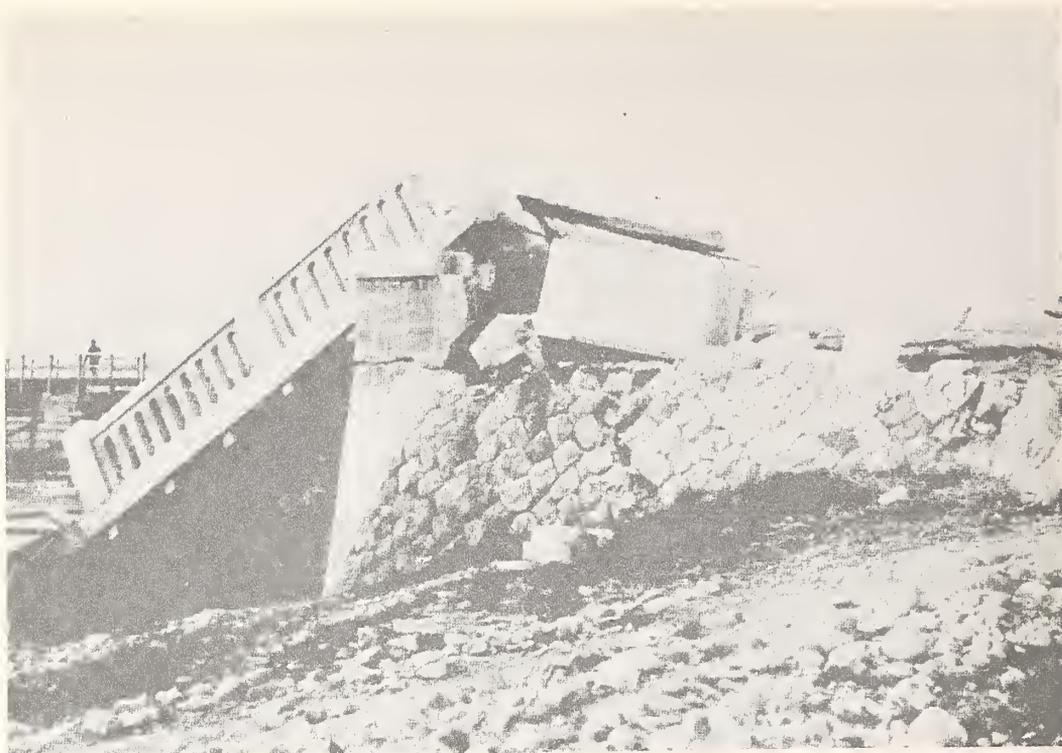
Photo. 2.10 Damaged piers and girders of the Sakawa bridge

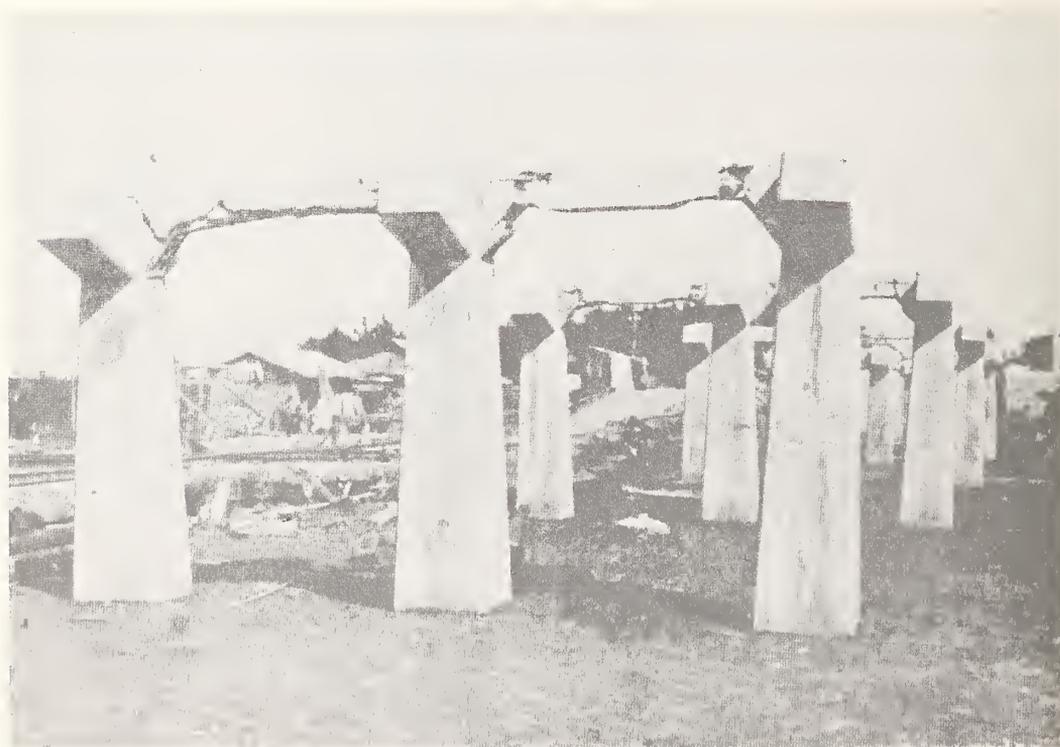
Photo. 2.11 Damage to the left abutment of the Sakawa bridge

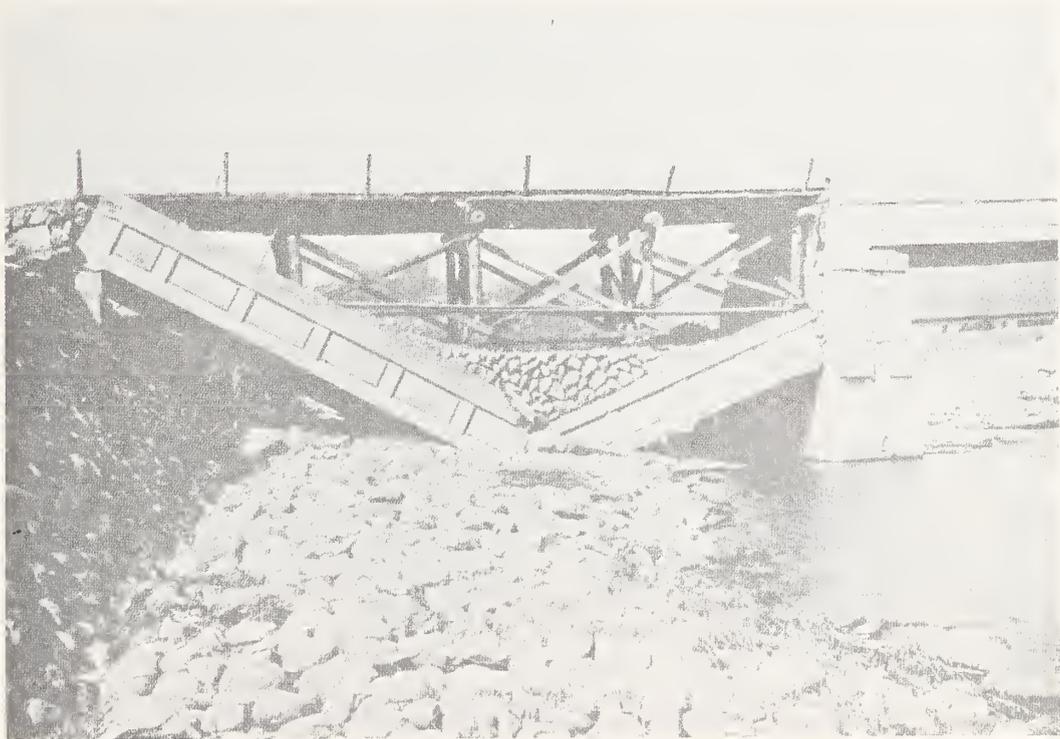
Photo.2.13 Damage to the caisson foundations
of the Banyu bridge while under construction.

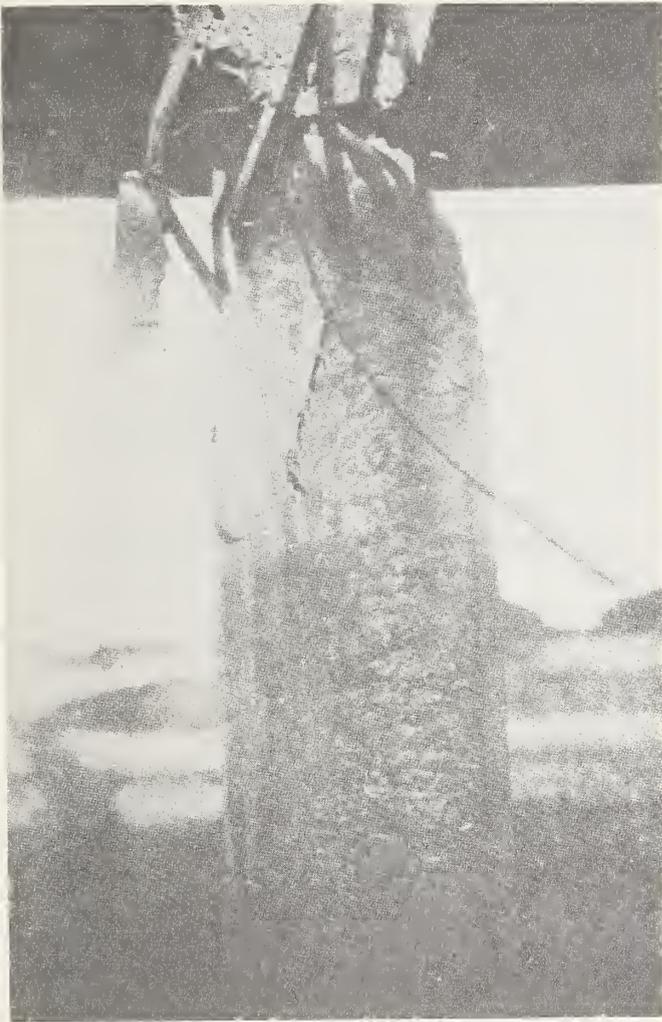
Photo. 2.16 Damage to a pier of the Takahata bridge

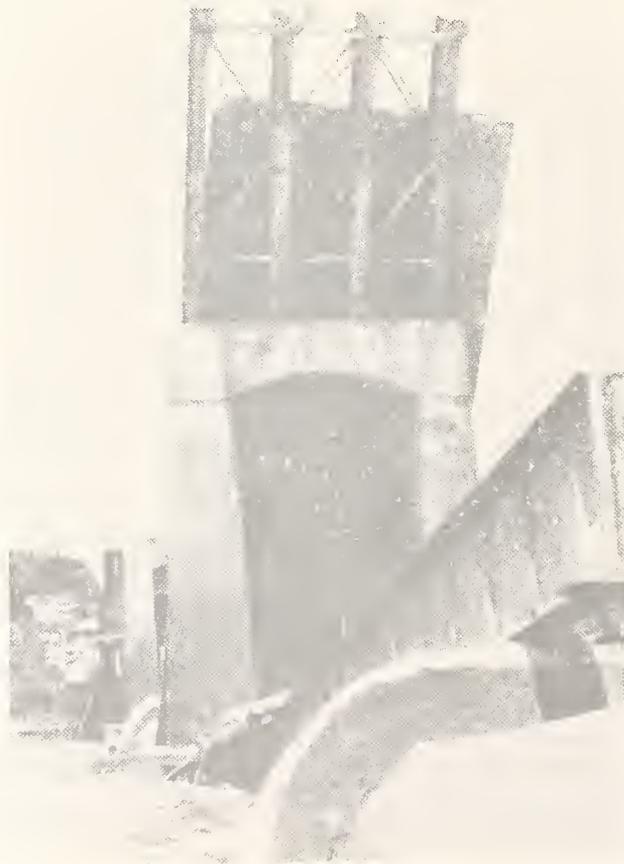
Photo.2.23 Damage to the column and foundation of the Nakazuno bridge.

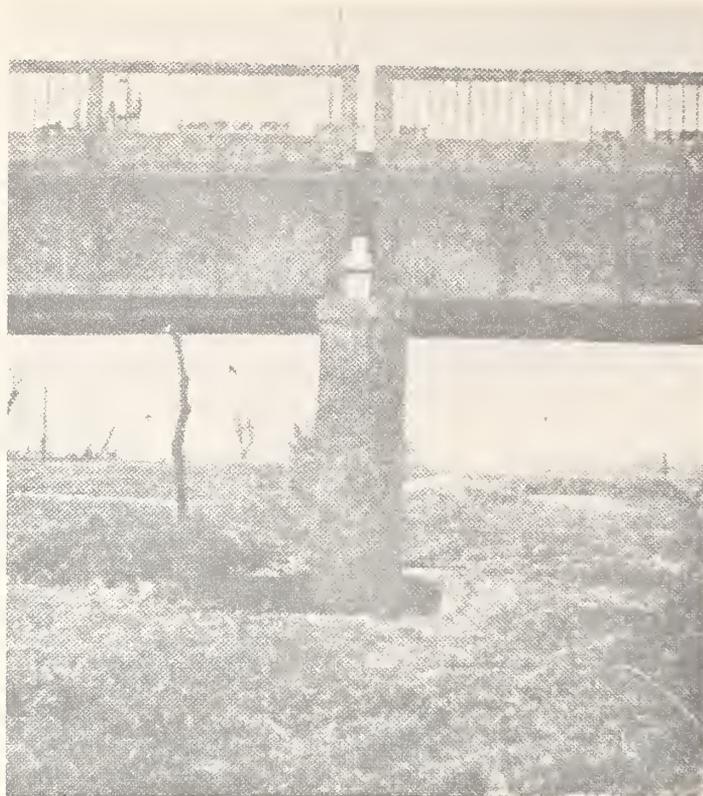
Photo.2.38 Damage to a hinge joint of the Horoman bridge

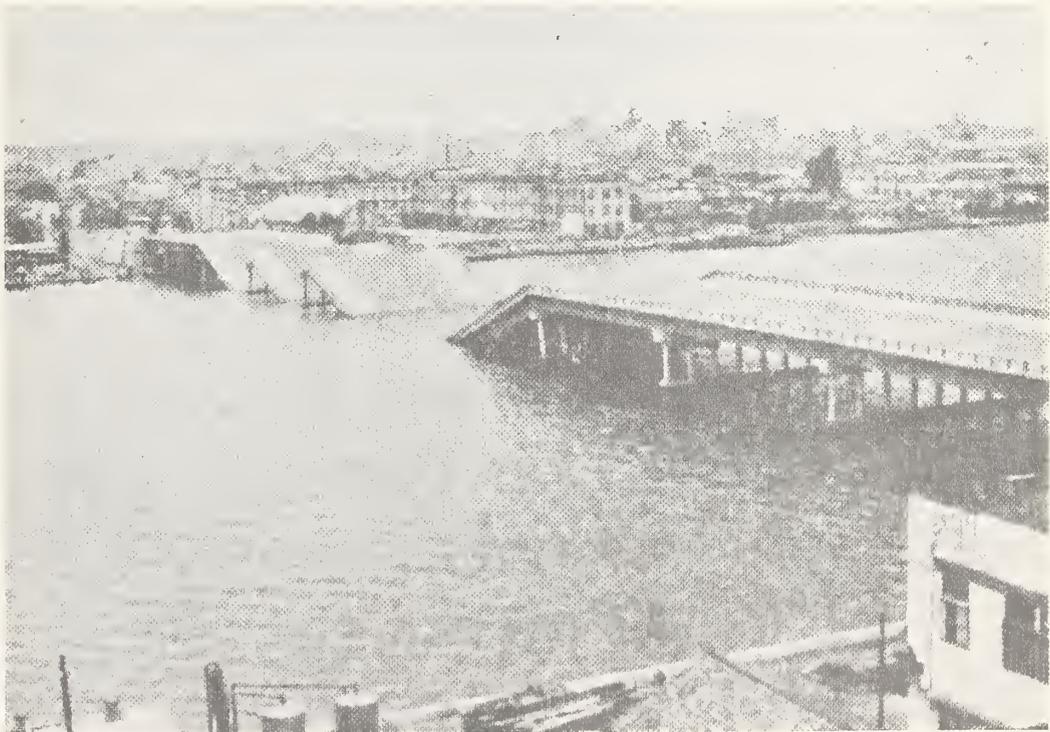
Photo. 2.41 Damage to the Bandai bridge

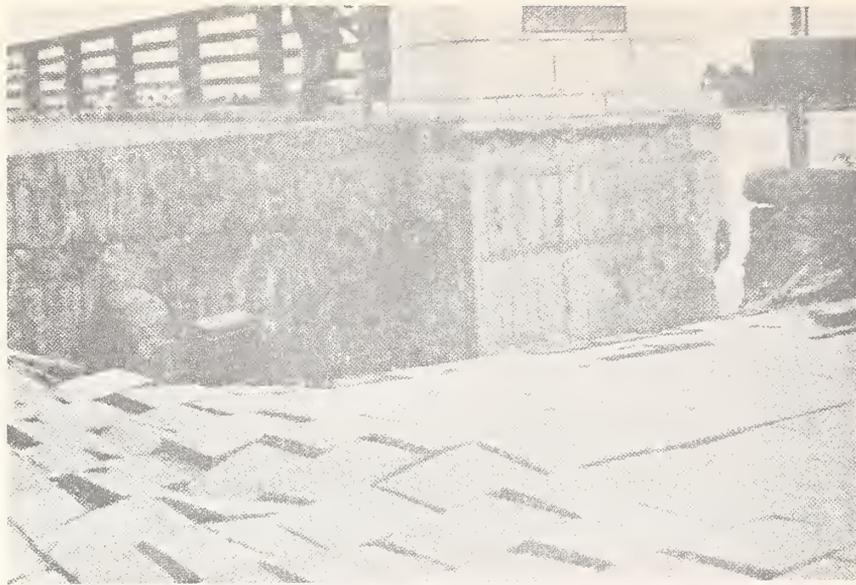
Photo. 2.42 Damage to the Showa bridge

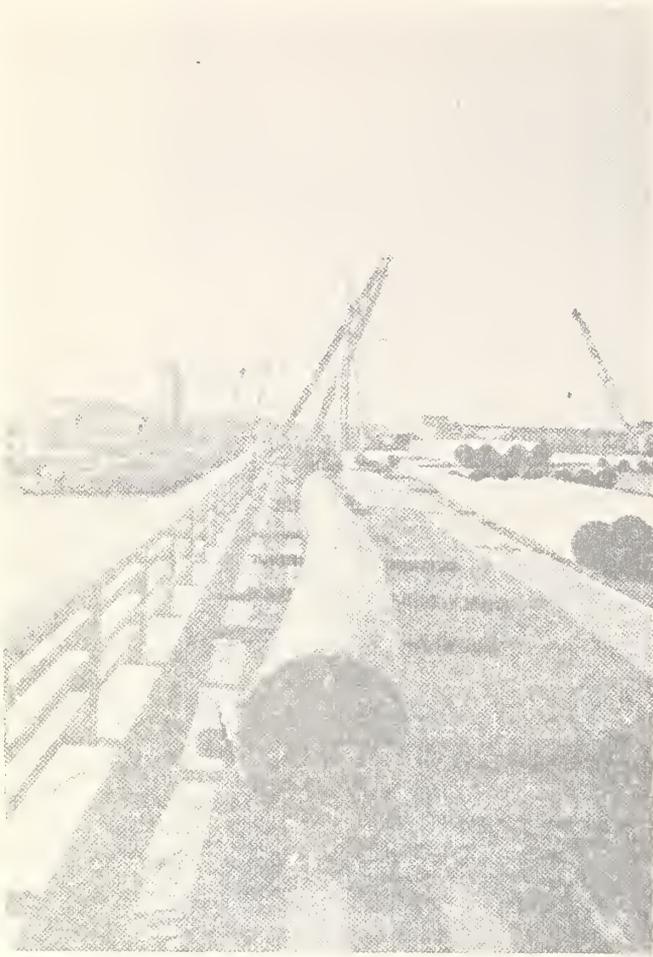
Photo. 2.47 Damage to a pulled-out pile at the fourth pier of the Showa bridge.

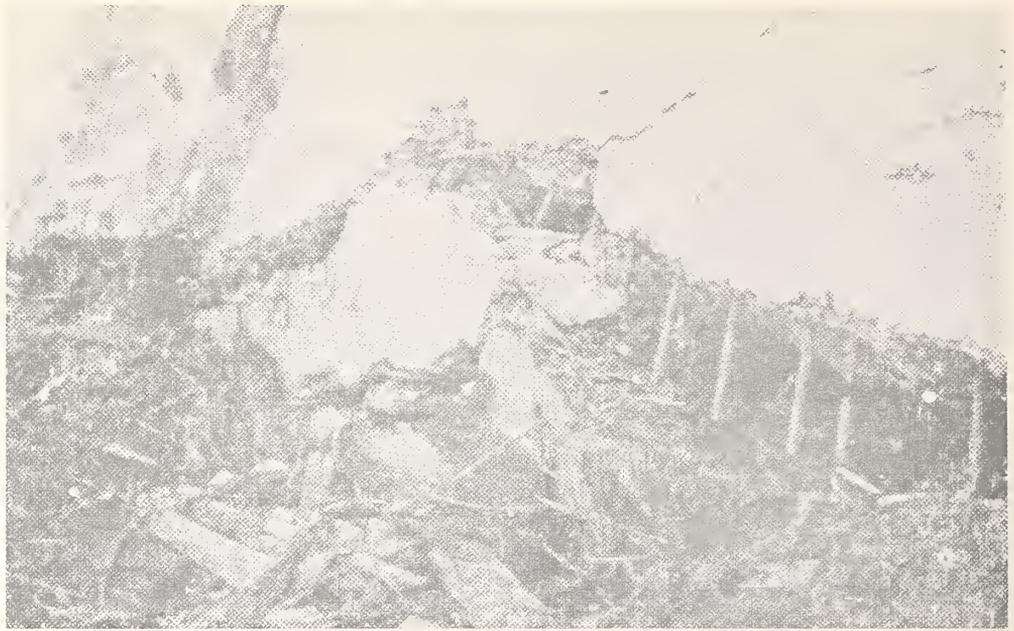
Photo. 2.51 Damage to the second pier of the Yachiyo bridge

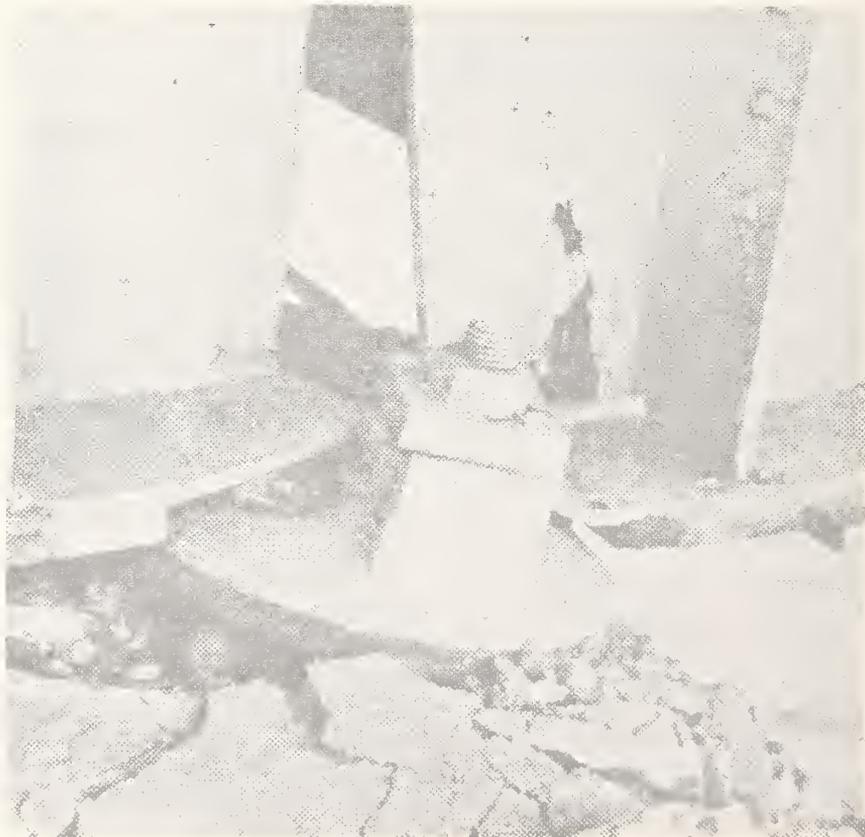
Photo. 2.52 Damage to the end of the tenth girder at the ninth pier of the Yachiyo bridge

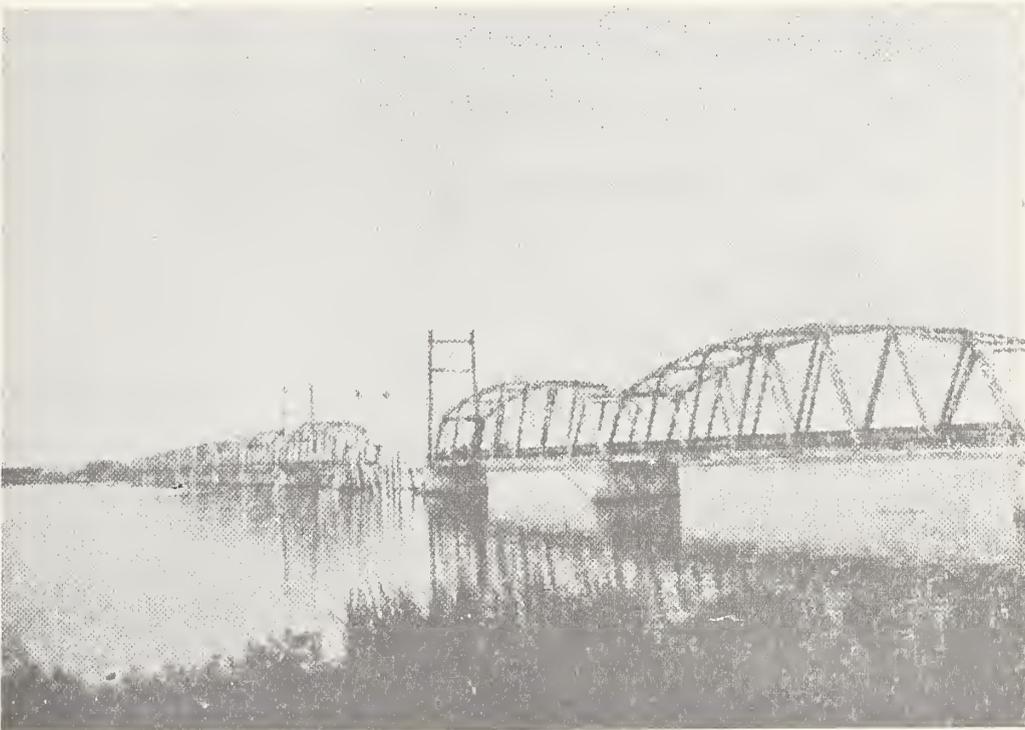
Photo. 2.58 Damage to the Matsuhama bridge.

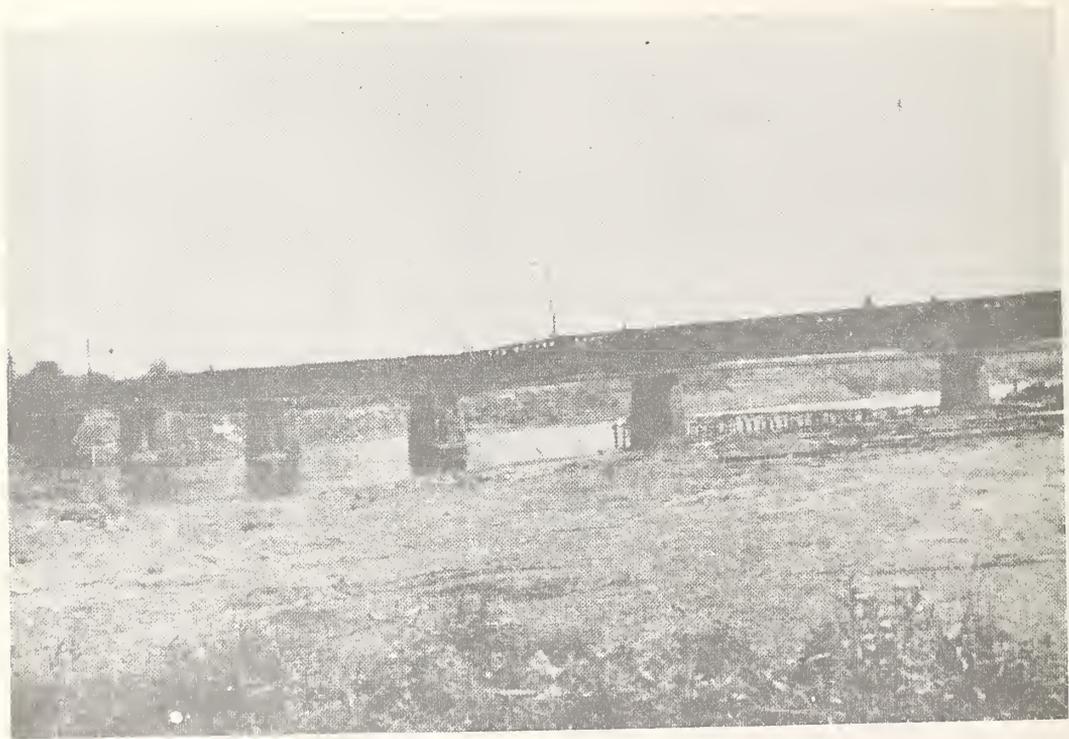
Photo. 2.64 Settlement of pier at the
Shiriuchi bridge.

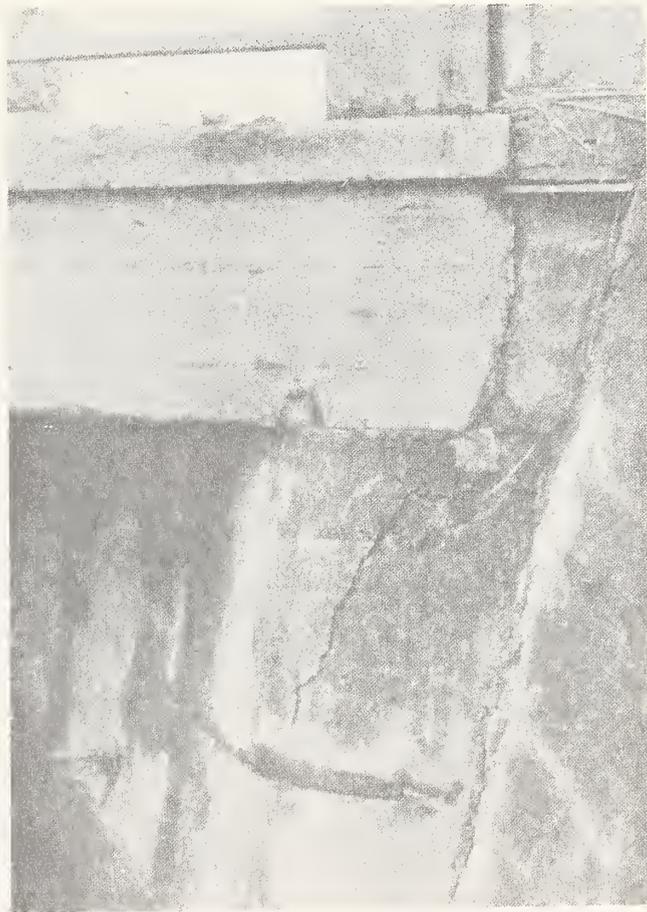
The damages to bridge structures had characteristics very much like those previously described for similar bridges during other earthquakes. Pile bent piers sustained moderate damage due to lack of stiffness (Photo 2.63) and one pier settled about 20 cm due to lack of bearing capacity in the foundation which had been scoured by the river stream (Photo 2.64). Several abutments were pushed toward the center of the river (Photo 2.65) and some abutments developed cracks in the concrete near the bearing supports (Photo 2.66, 2.67). Girders were

Photo.2.66 Damage to the abutment of the Deto bridge.

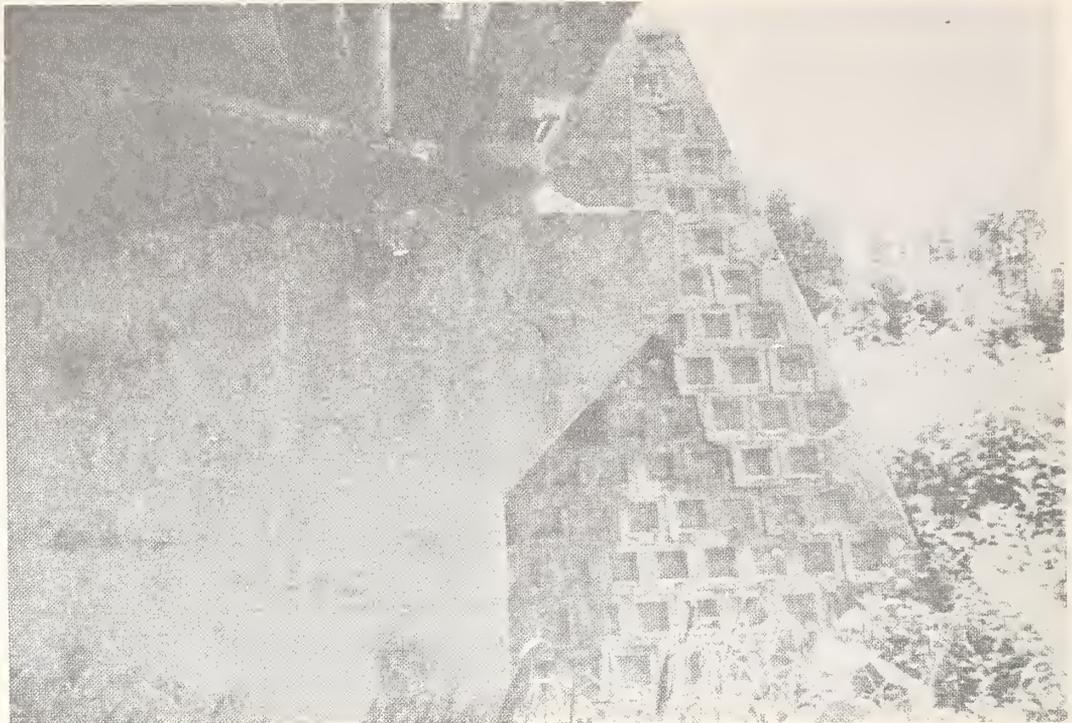
Photo. 2.67 Crack of abutment of the
Komagome bridge

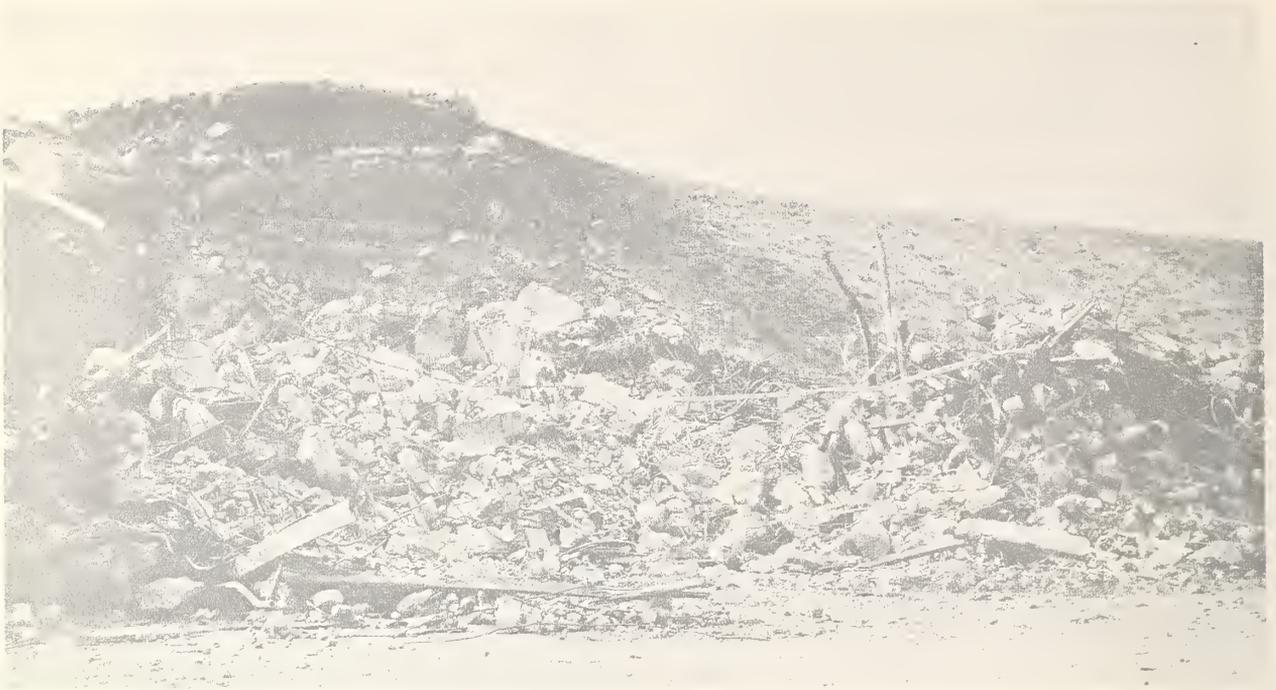
Photo. 2.71 South abutment of overcrossing at Golden State Freeway and Foothill Freeway interchange

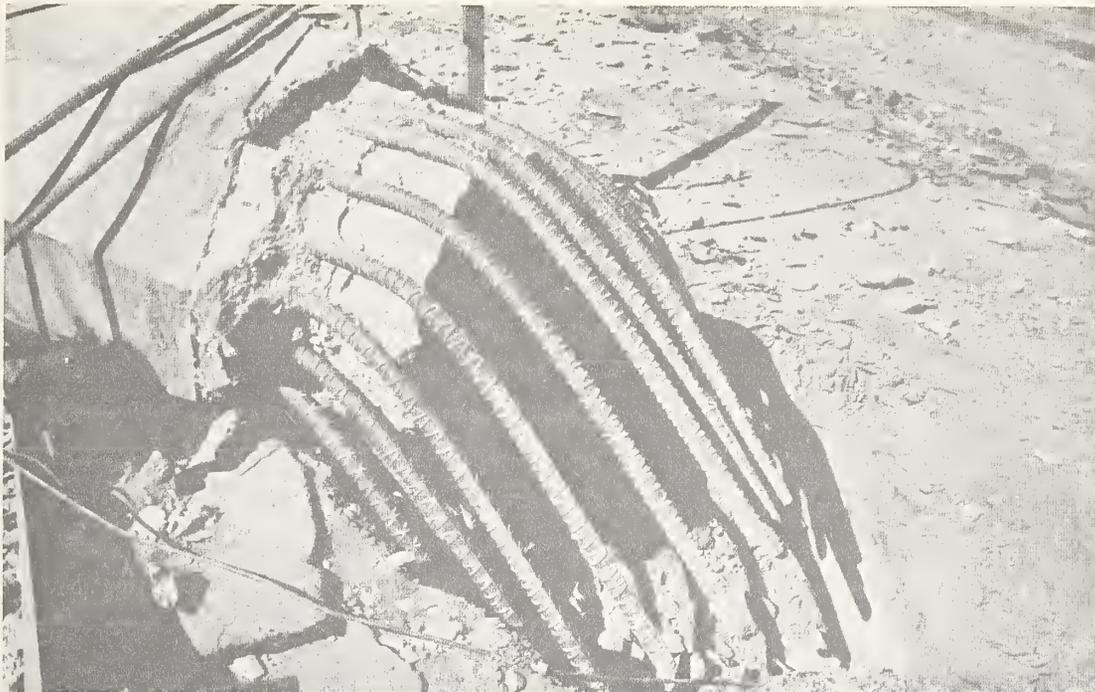
Photo. 2.97 Failure at base of column supported on a single 6 foot diameter cast-in-drilled-hole pile - Golden State Freeway and Foothill Freeway interchange

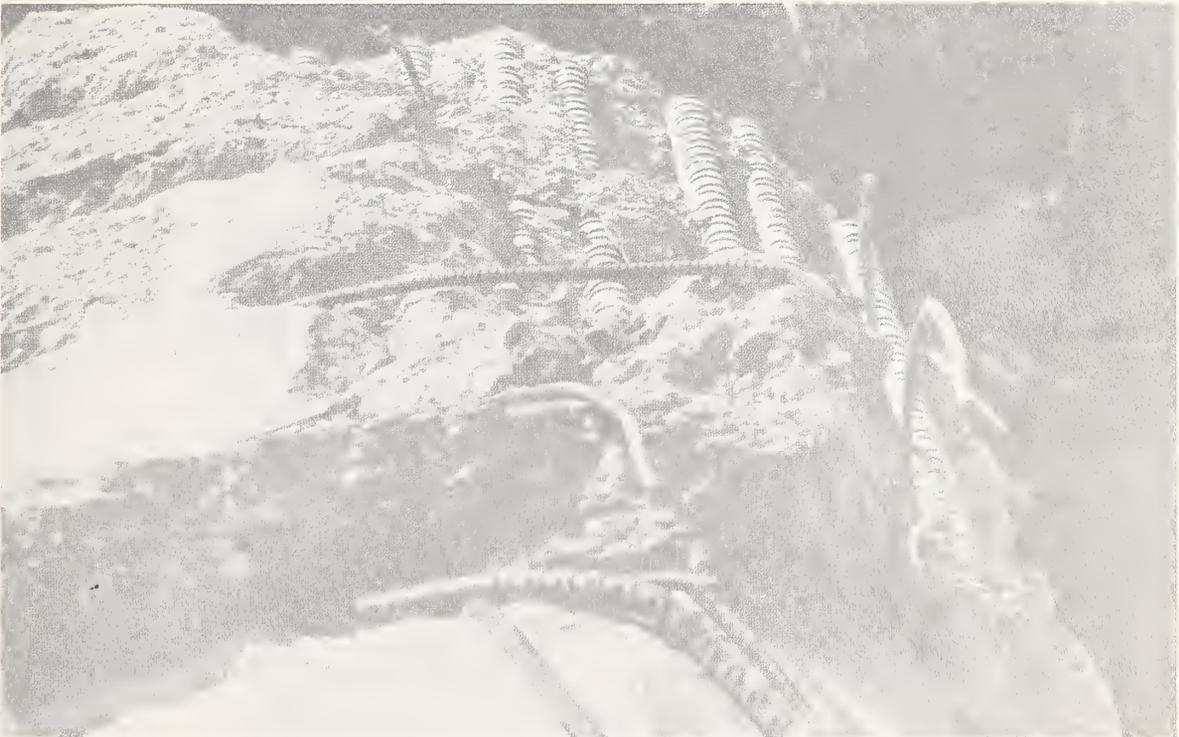
Photo. 2.110 Top end of collapsed column of overcrossing at Golden State Freeway and State Highway 14 interchange

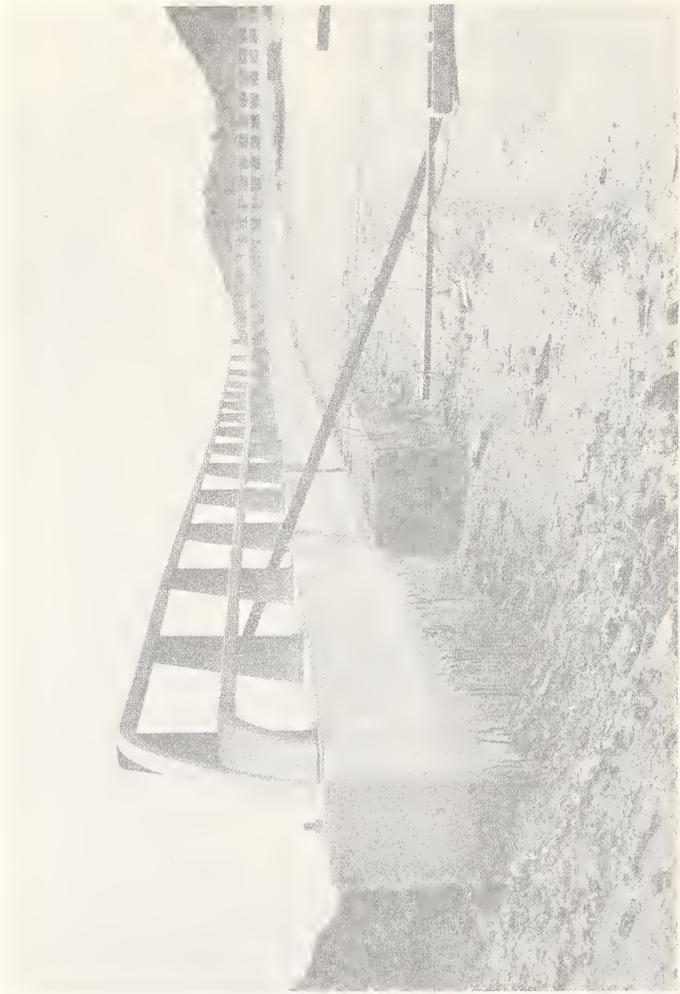
Photo. 2.111 Settlement of backfill at abutment of overcrossing - Golden State Freeway and State Highway 14 interchange

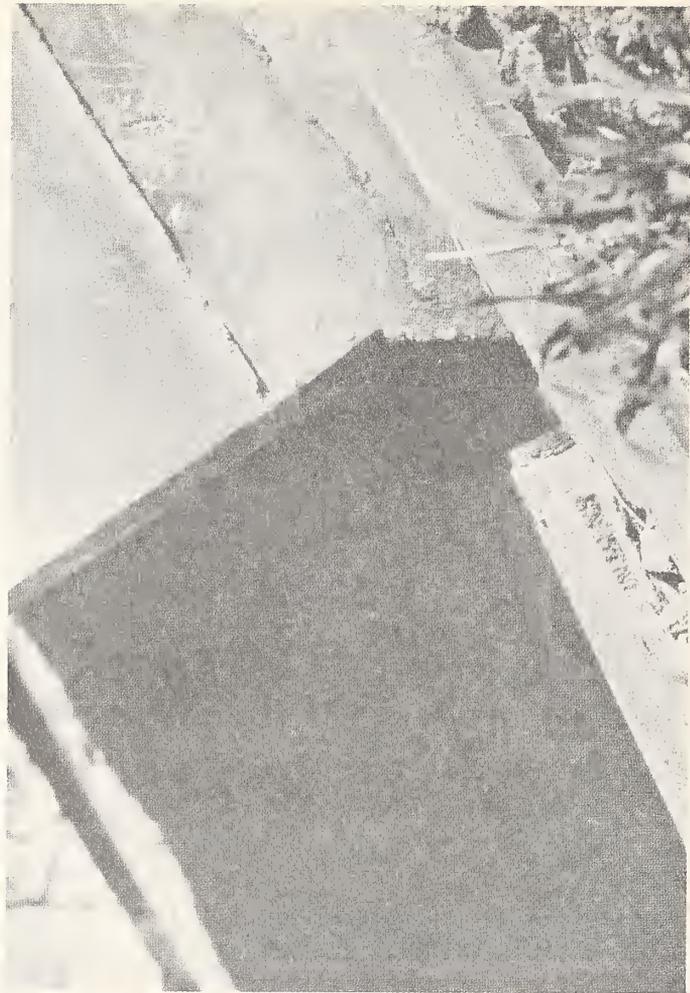
Photo. 2.120 Damaged concrete apron on abutment slope -
Roxford Street Undercrossing at Foothill
Freeway

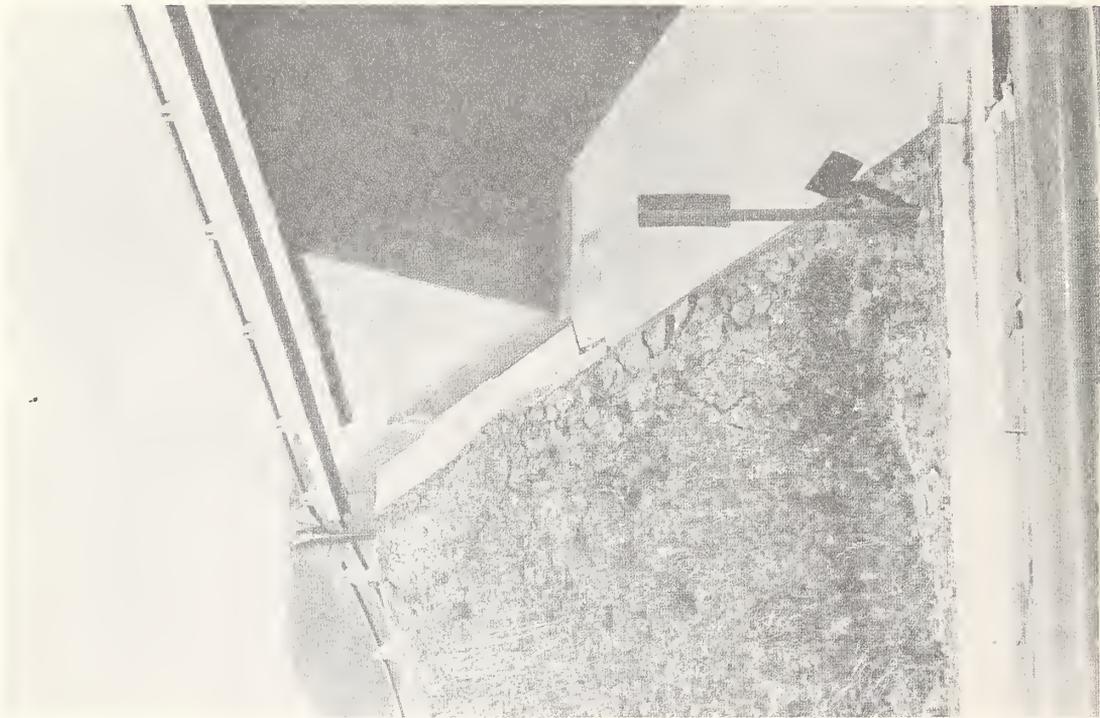
Photo. 2.119 Damaged concrete apron on
abutment slope - Roxford
Street Undercrossing at
Foothill Freeway

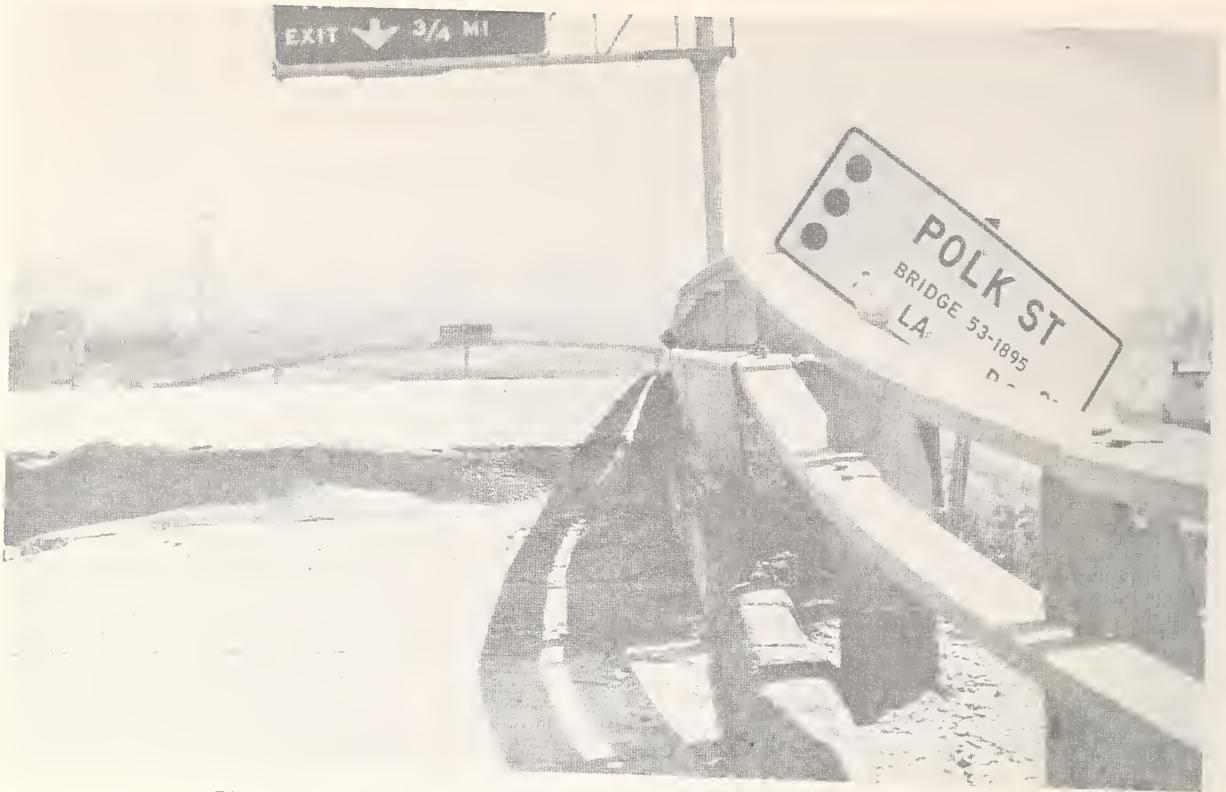
Photo. 2.123 Differential settlement of backfill at abutment - Polk Street Undercrossing at Foothill Freeway

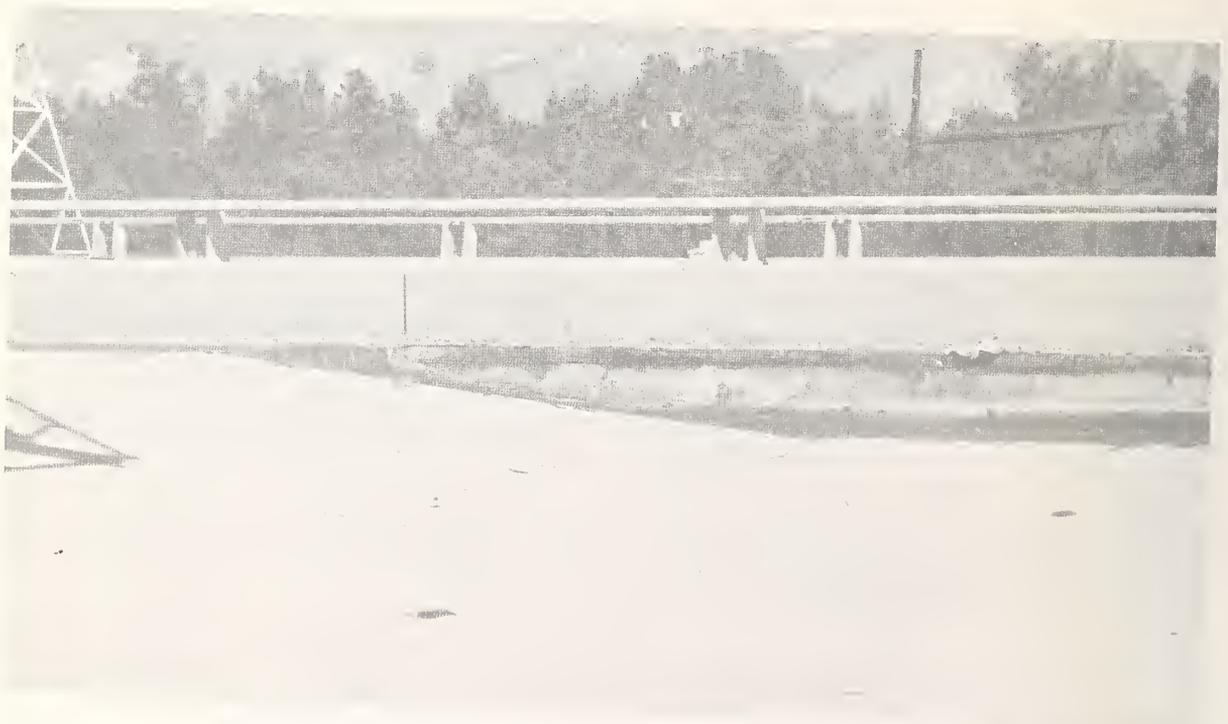
Photo. 2.124 Differential settlement of backfill at abutment - Polk Street Undercrossing at Foothill Freeway

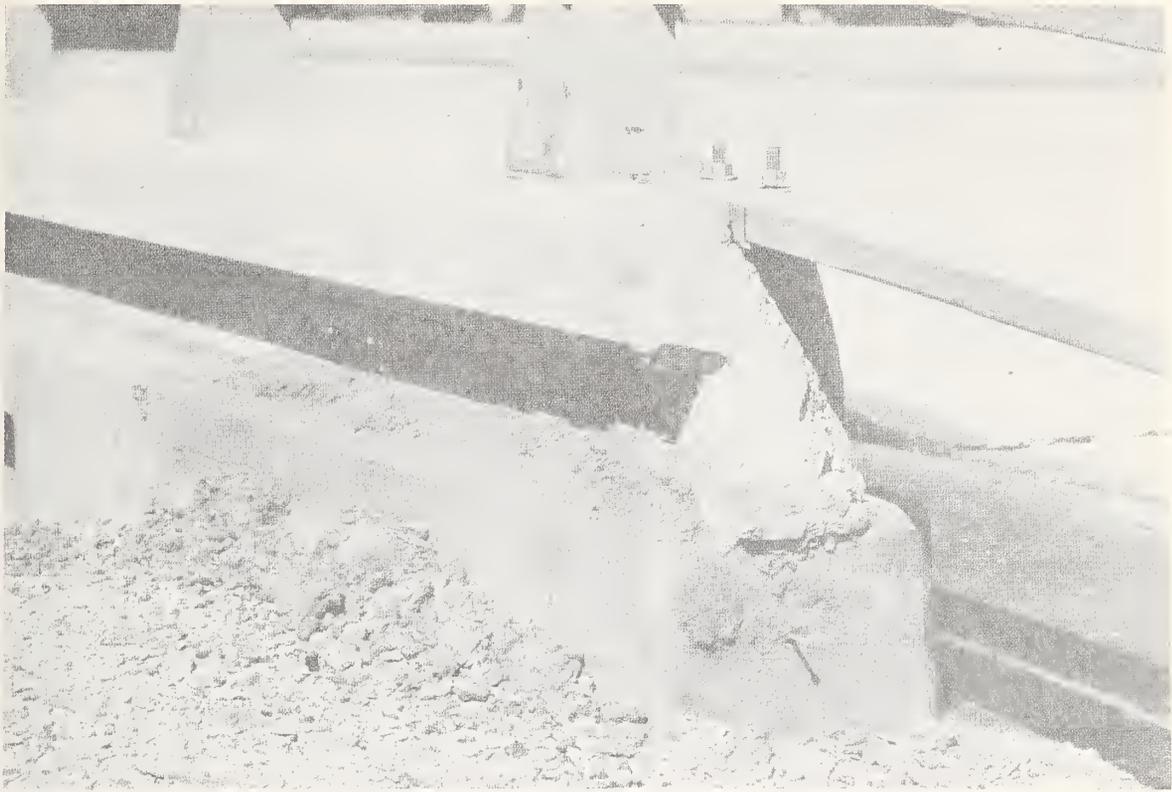
Photo. 2.125 Differential settlement of backfill at abutment - Polk Street Undercrossing at Foothill Freeway

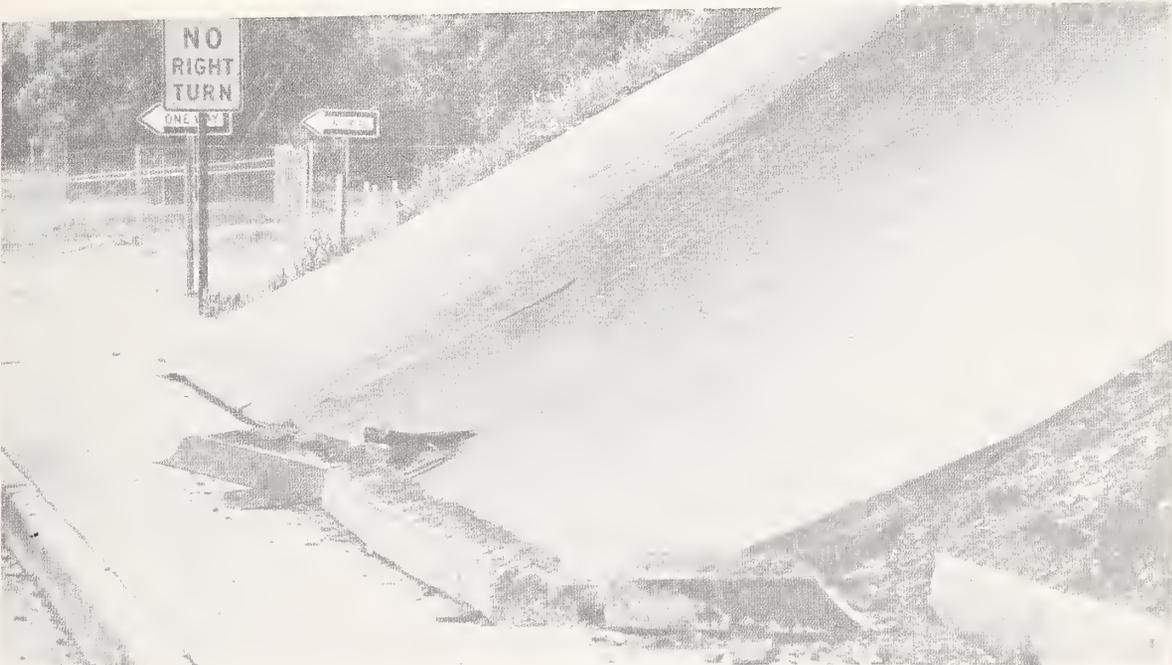
Photo. 2.126 Differential settlement of backfill at abutment - Polk Street Undercrossing at Foothill Freeway

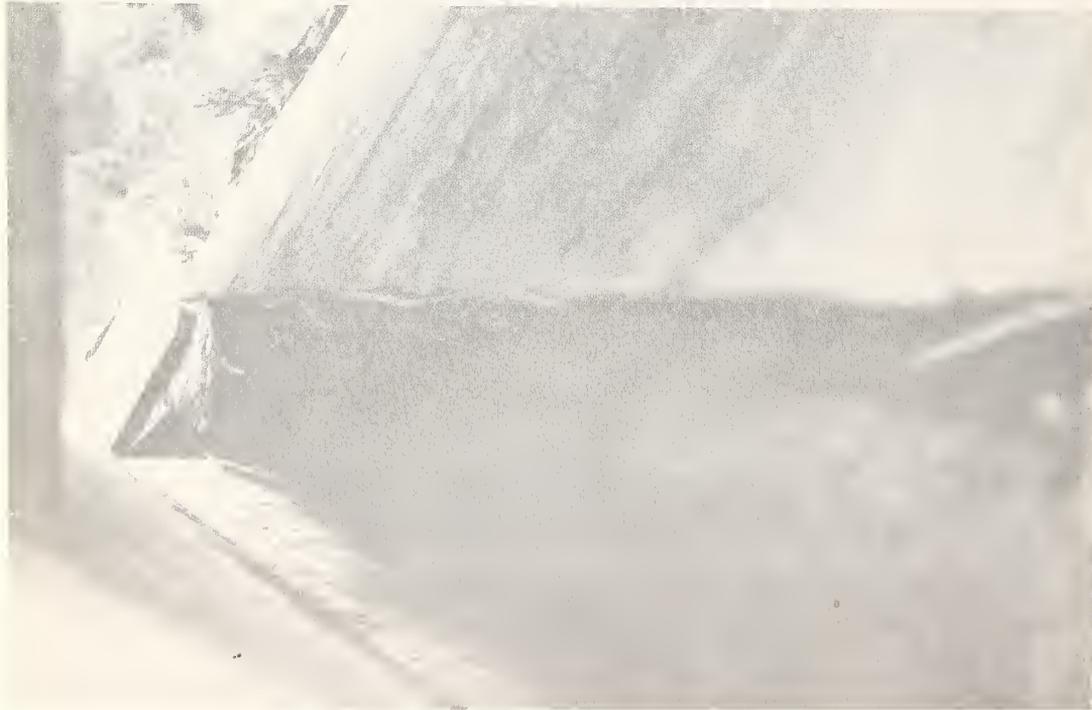
Photo. 2.127 Differential settlement of
backfill at abutment -
Polk Street Undercrossing
at Foothill Freeway

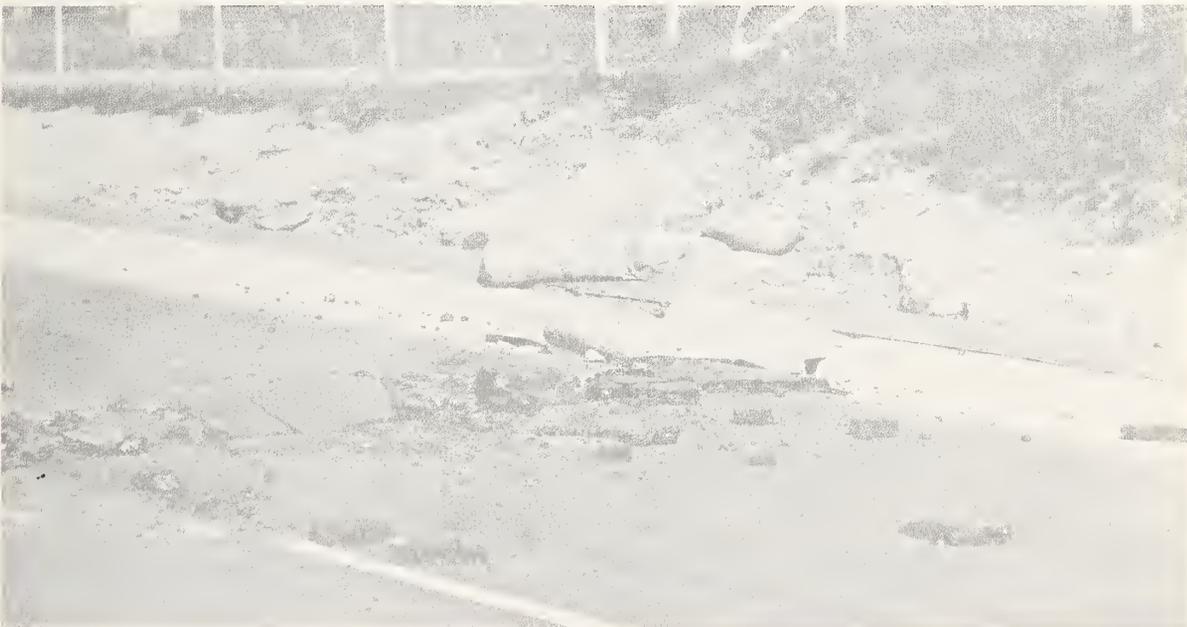
Photo. 2.130 Buckled asphalt pavement caused by large compressive ground deformations

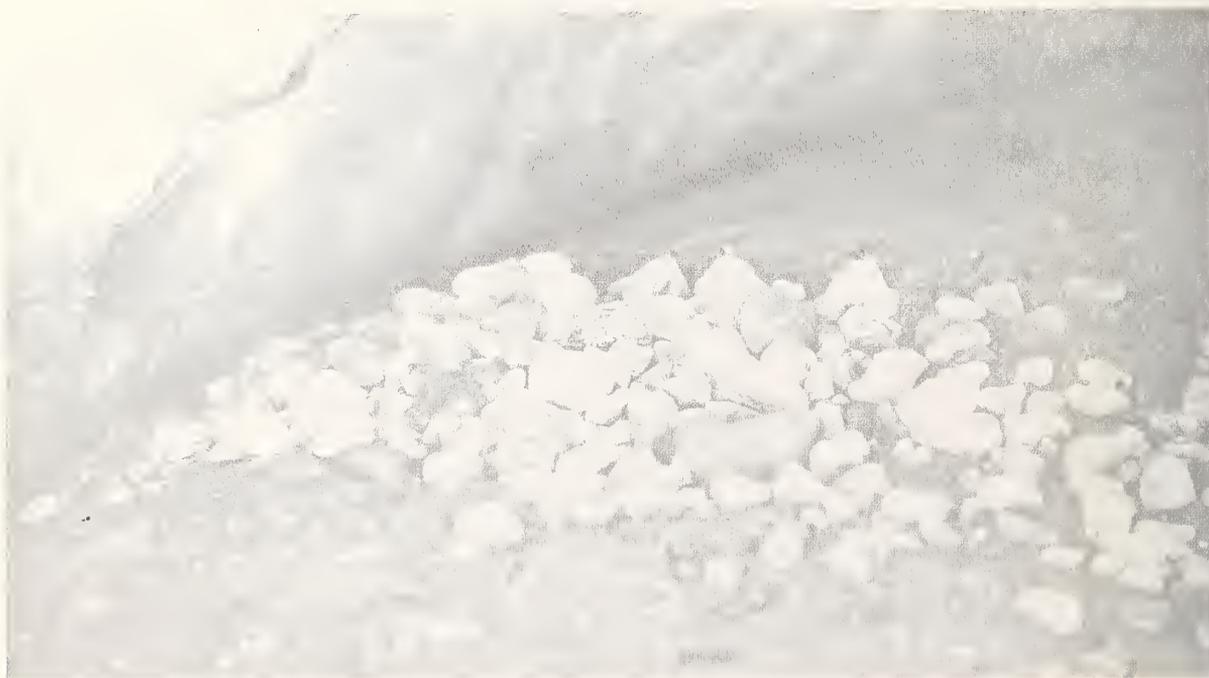
Photo. 2.132 View showing crushed rock forced out of weep hole - Bledsol Street Undercrossing at Foothill Freeway
